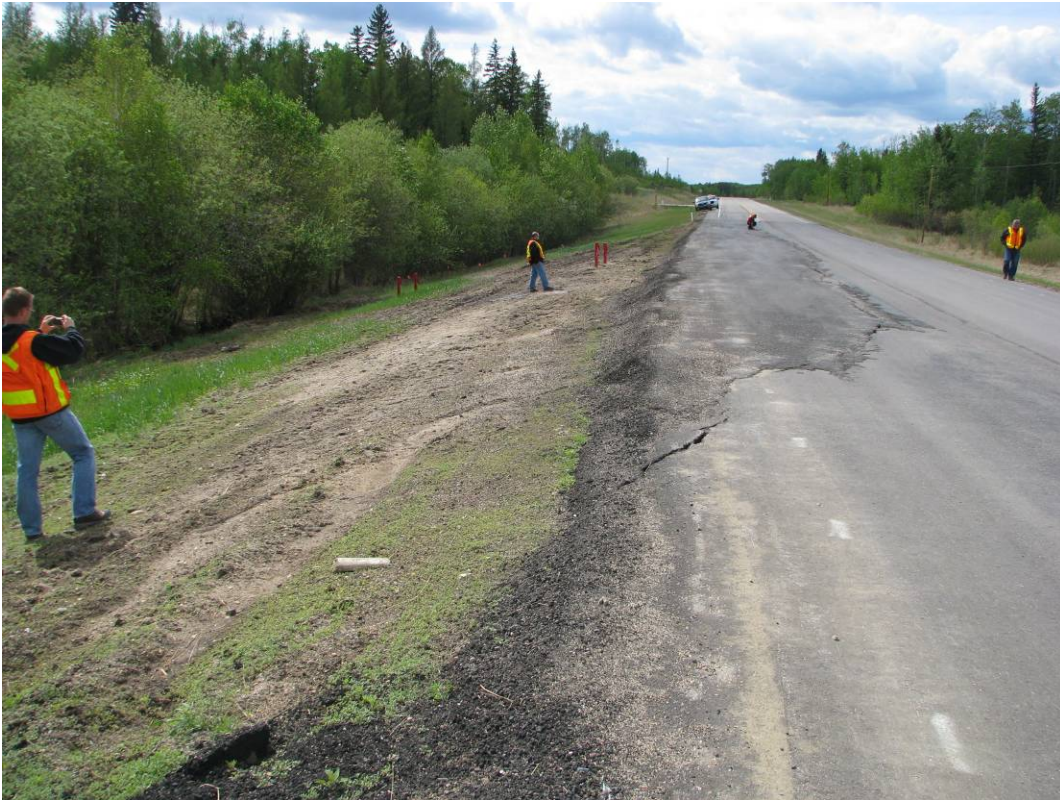
Photo #1 Looking at the highway surface at the slide area. The fresh patch defines the headscarp of the slide along the EBL(looking west)

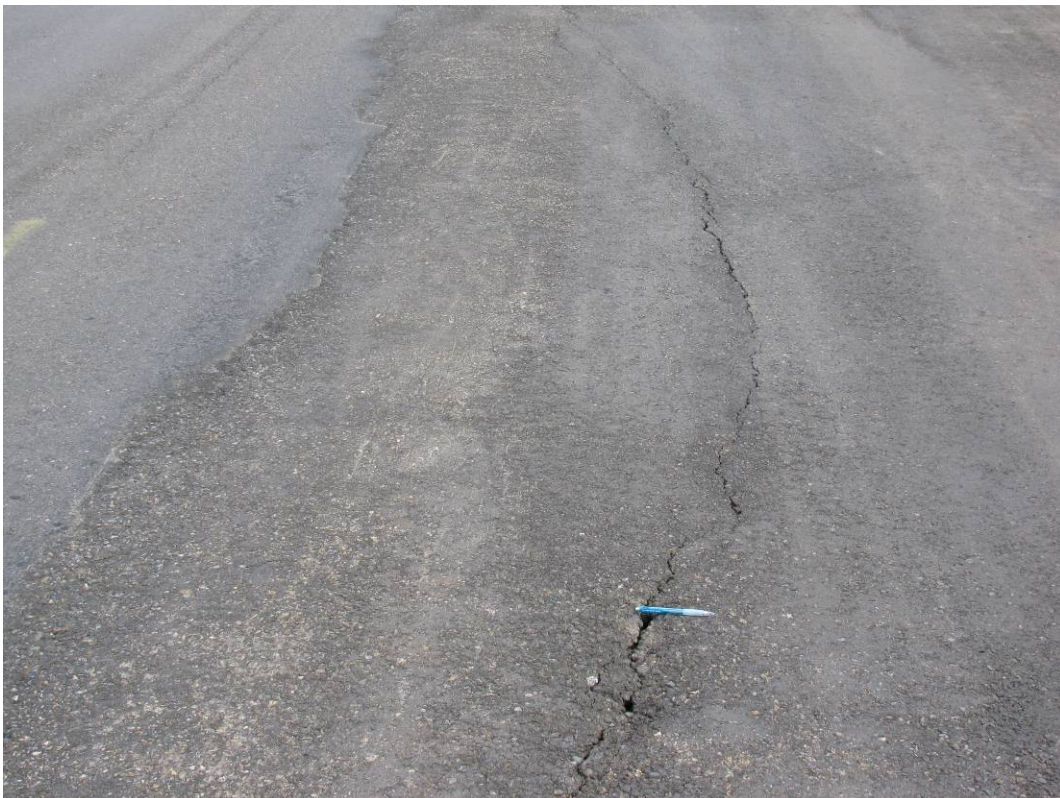
Photo #2 Looking east at an open headscarp crack in the highway EBL

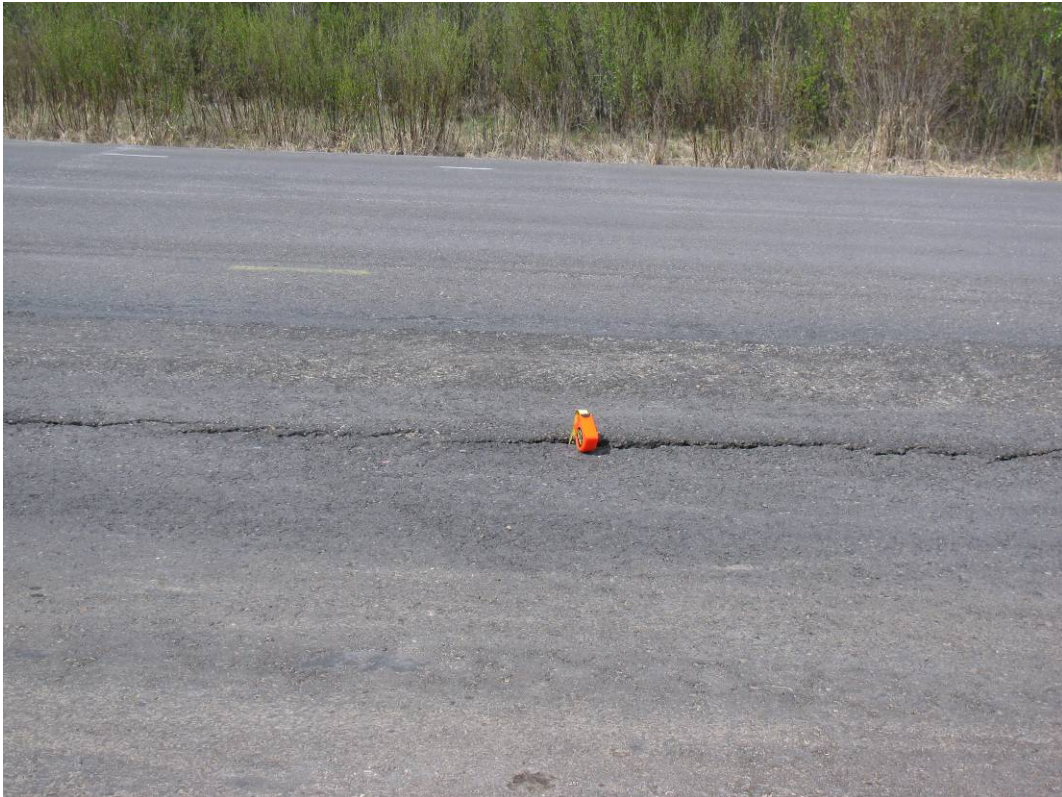
Photo #3 Looking north at an open longitudinal crack on the highway EBL; note the drop across the crack and the depression along the EBL

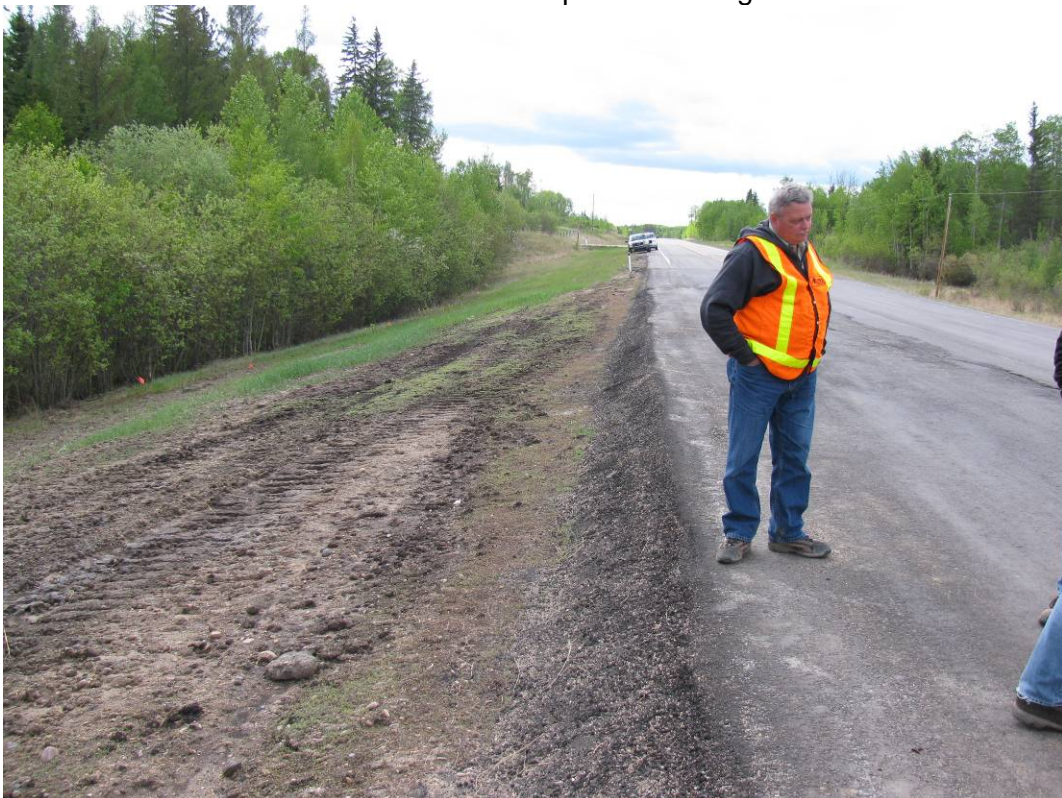
Photo #4 Looking west at the highway south side slope; note the sharp drop on the edge of the road

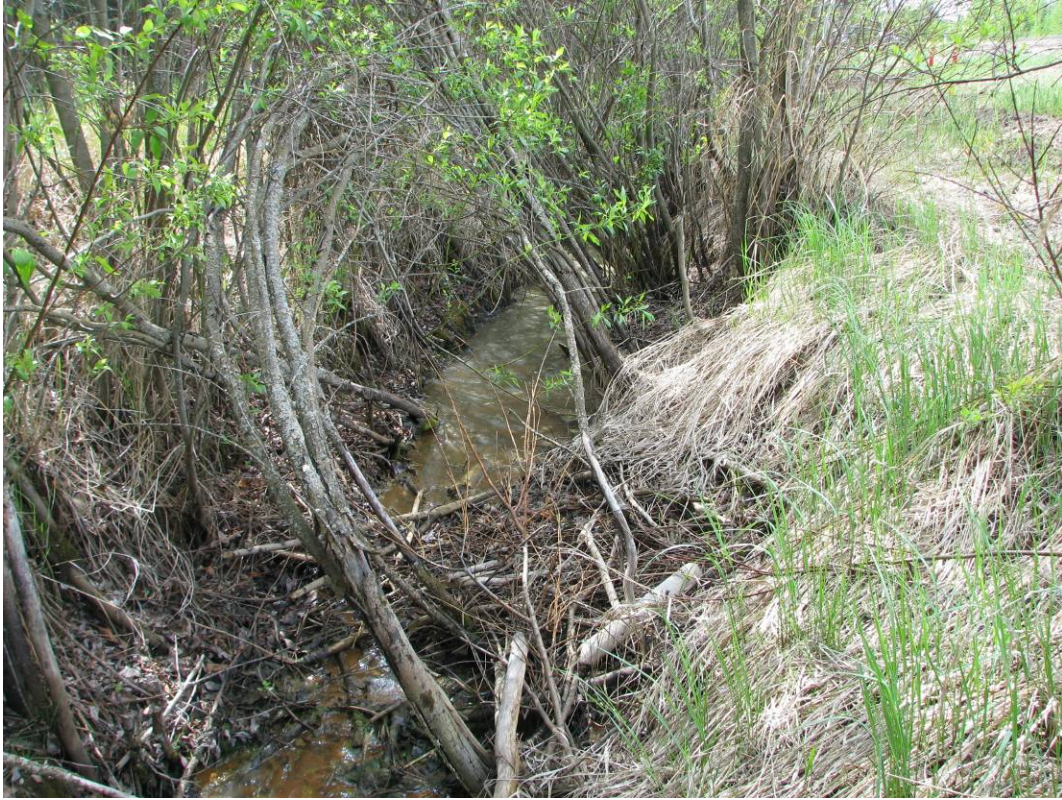
Photo #5 Looking at the south muskeg ditch; note the hump around the ditch, the titling branches and the debris falling into the ditch

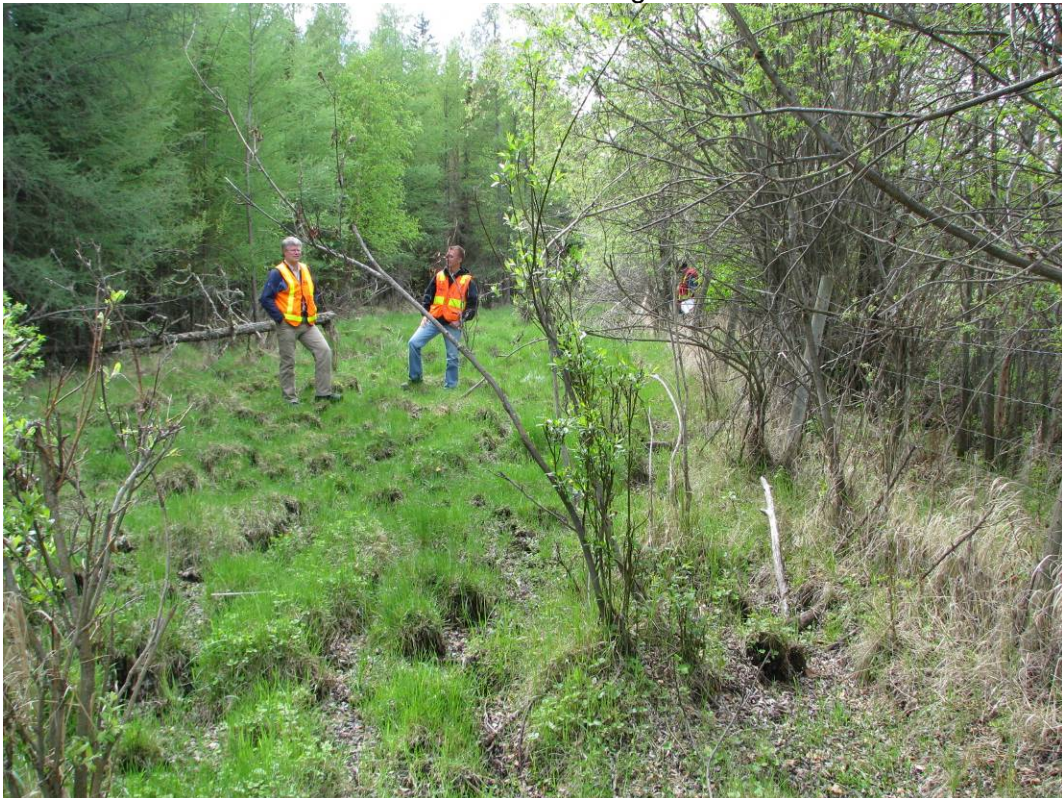
Photo #6 Looking at the terrain to the south of the fence; note the titling of the fence posts and the hummocky nature of the ground, looking west
