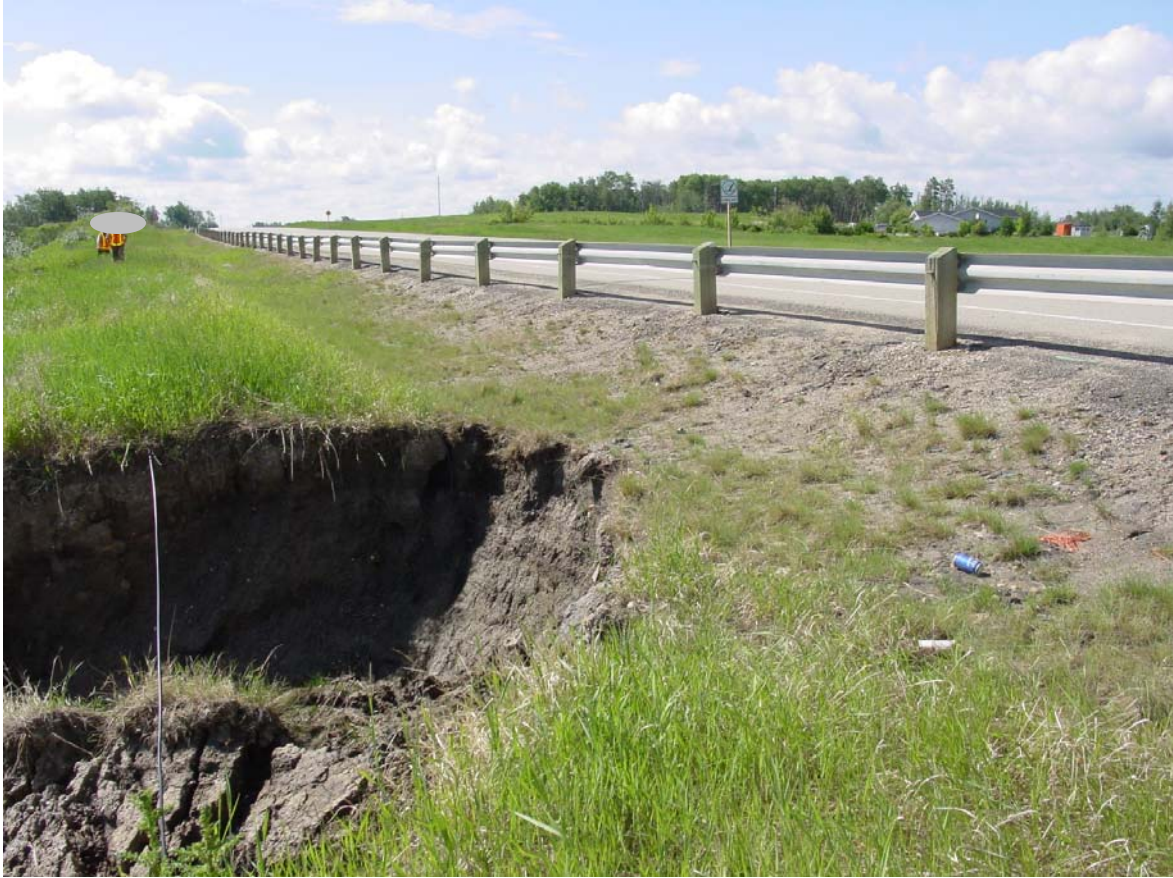
Photo 1 – Slide No 2 – note the barrier has been moved to the edge of the pavement from its previous location just left of the ditch invert. Note the cable dangling across the failure. June 15, 2005
