Lookout Slides (57+500)

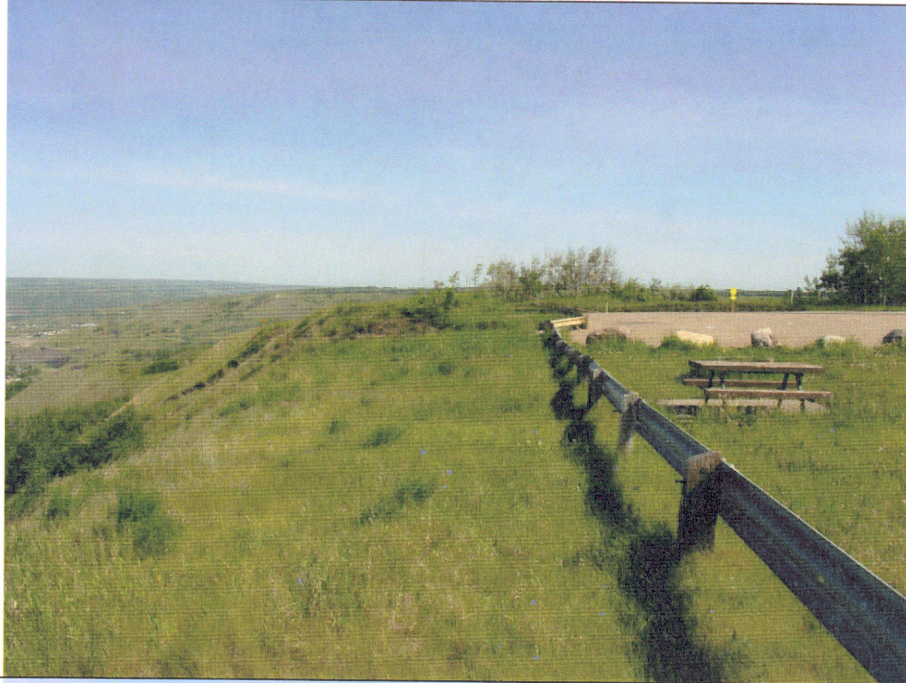
Photo 5.
Looking north towards the car park area at the Lookout. Note the jog in the guardrail where the slide is encroaching on the paved area.

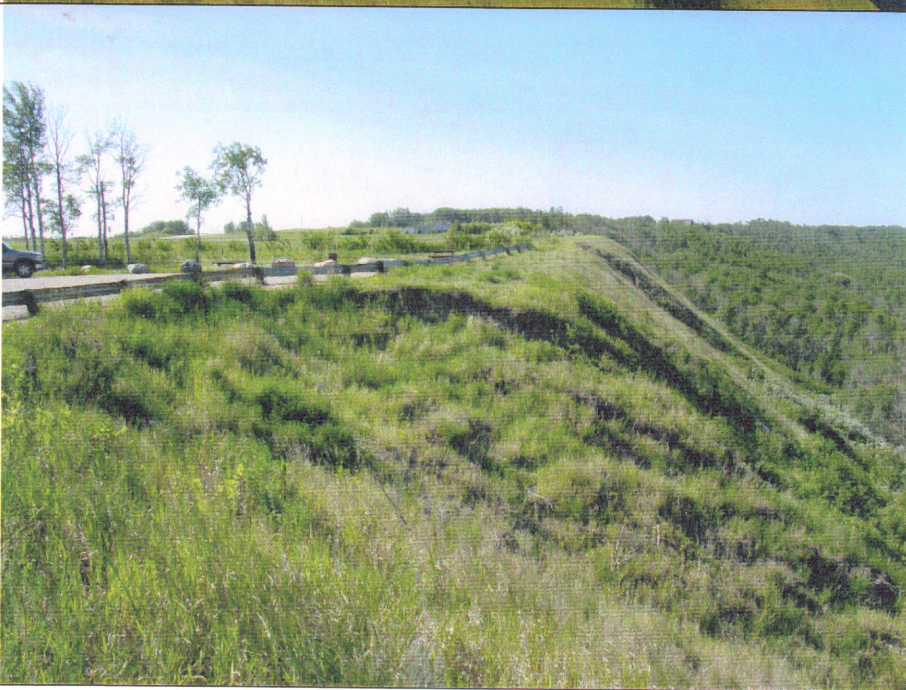
Photo 6.
Several slides on the steep slope below the Lookout area. The average slope angle is 38° . The slide area in the foreground is approximately 30 m wide and is currently encroaching on the car park.

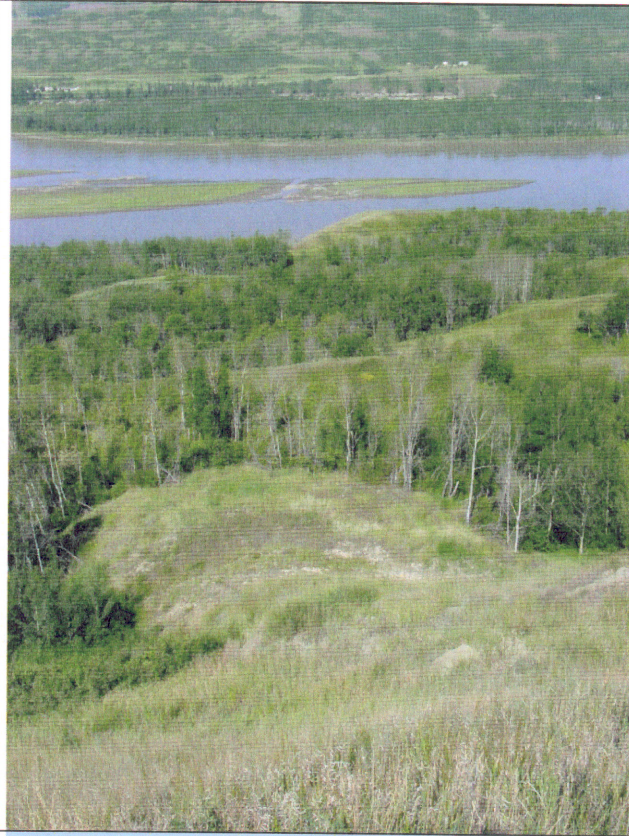
Photo 7.
Slide runout below the Lookout. The slide debris has the appearance of a flow, suggesting that water plays a part in debris mobility.

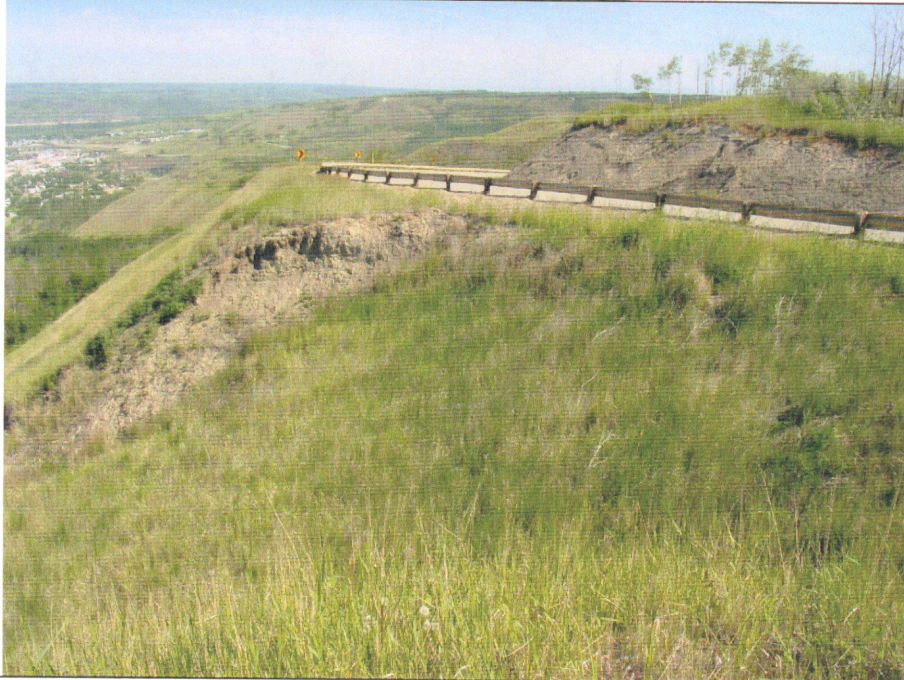
Photo 8.
Slide just beyond / to the north of the Lookout. The slide is about 26 m wide, and within 4 m of the guardrail. This is the origin of the slide runout debris in Photo 7.

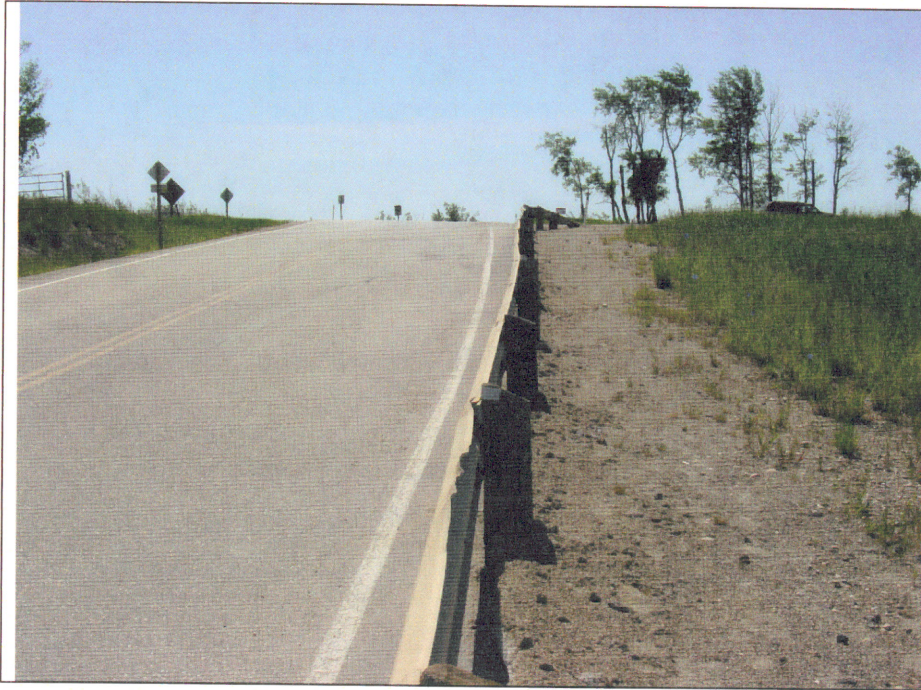
Photo 9.
Minor cracking in the
pavement at the slide
backscarp north of
the Lookout.
