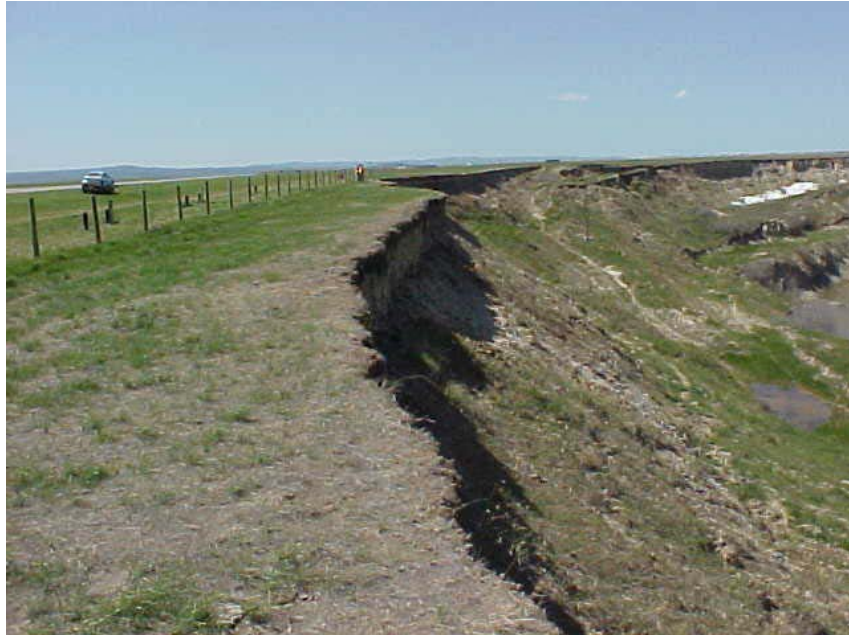
Photo 1 – Facing north across the slide scarp, central portion (May 2002).

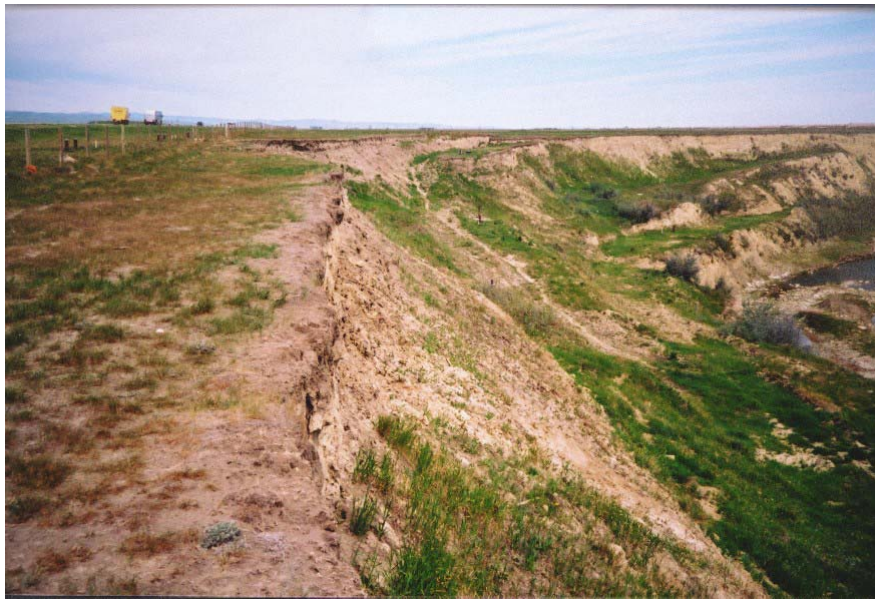
Photo 2 – Facing north across the slide scarp, central portion (May 2001).

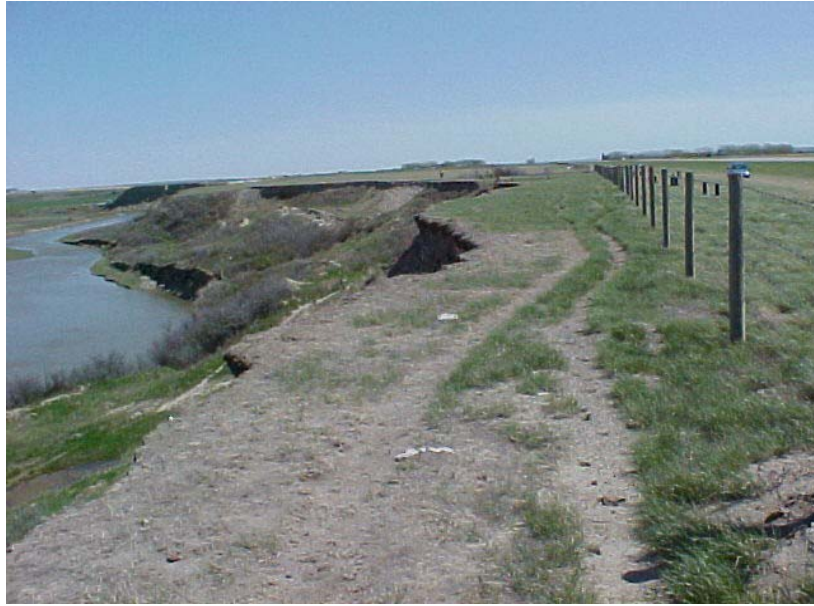
Photo 3 – Facing south across the slide scarp, central portion (May 30, 2002).

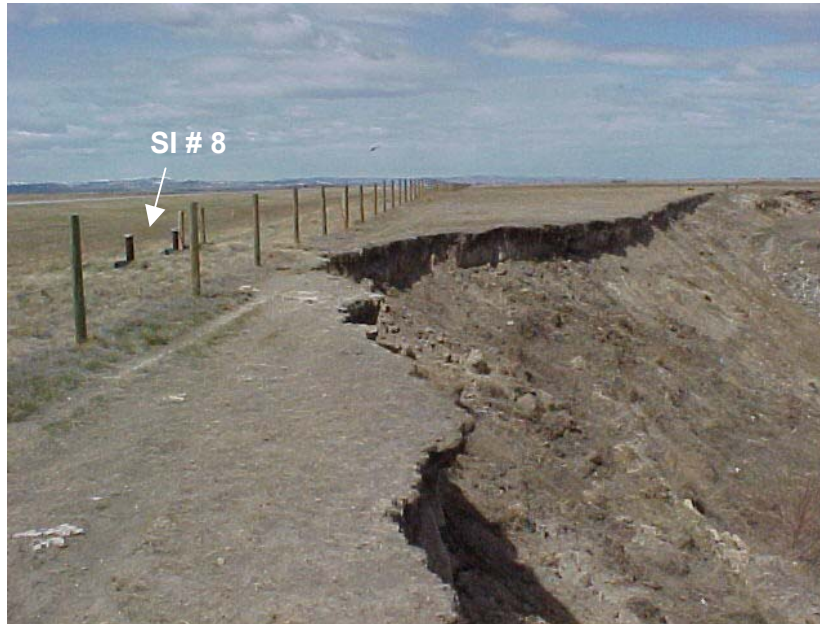
Photo 4 – Point of maximum crest retrogression, May 1, 2002 (adjacent to SI #8). There is a buried Telus line parallel to, and to the left of, the fence.

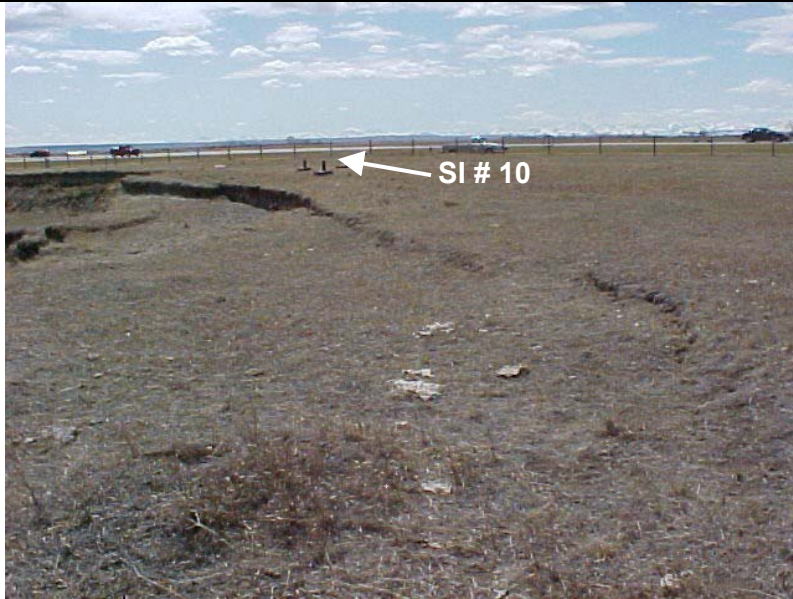
Photo 5 – Facing south towards tension cracks that delineate a new slide block developing on north flank of overall slide. SI #10 in background. (Photo from May 1, 2002).

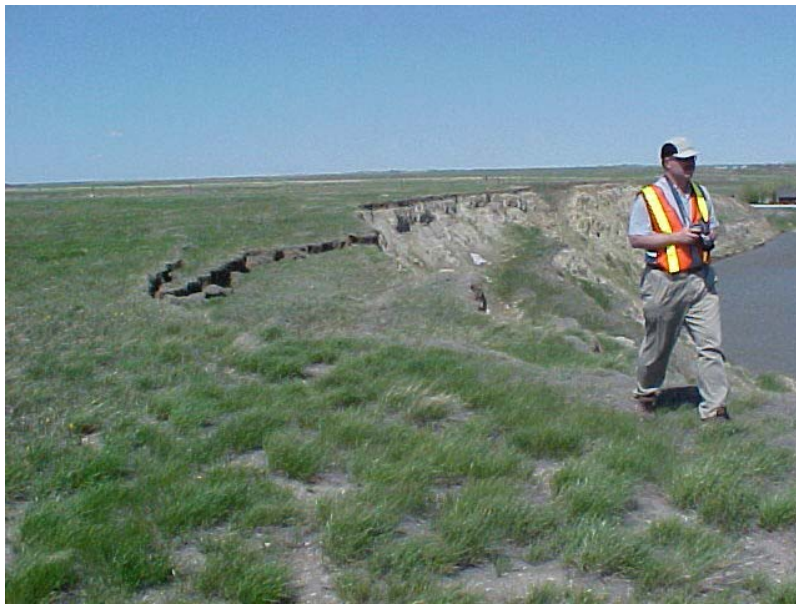
Photo 6 – Facing north from SI #10 towards new slide block developing on north flank of overall slide. (Photo from May 30, 2002).

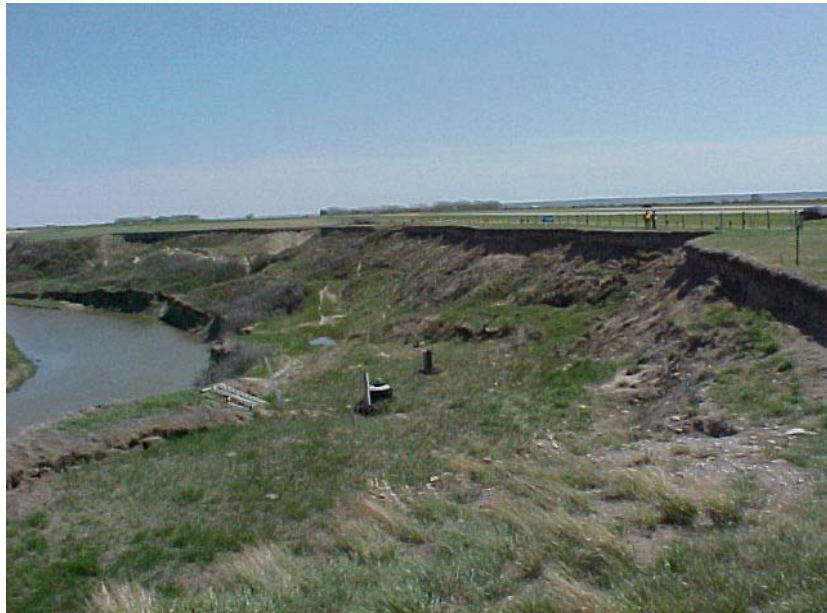
(May 2002)

Photo 7 – Facing south across slide area. Note river erosion at toe of slide.

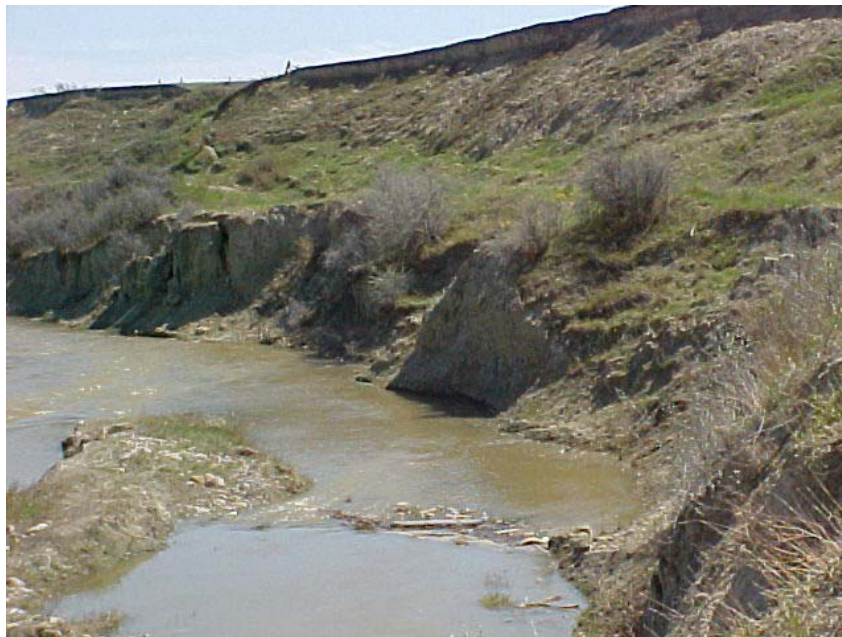
(May 2002)

Photo 8 – Close-up of toe of central portion of slide, partially protected from direct erosion by island in creek. Note oversteepened portions of toe slope.
