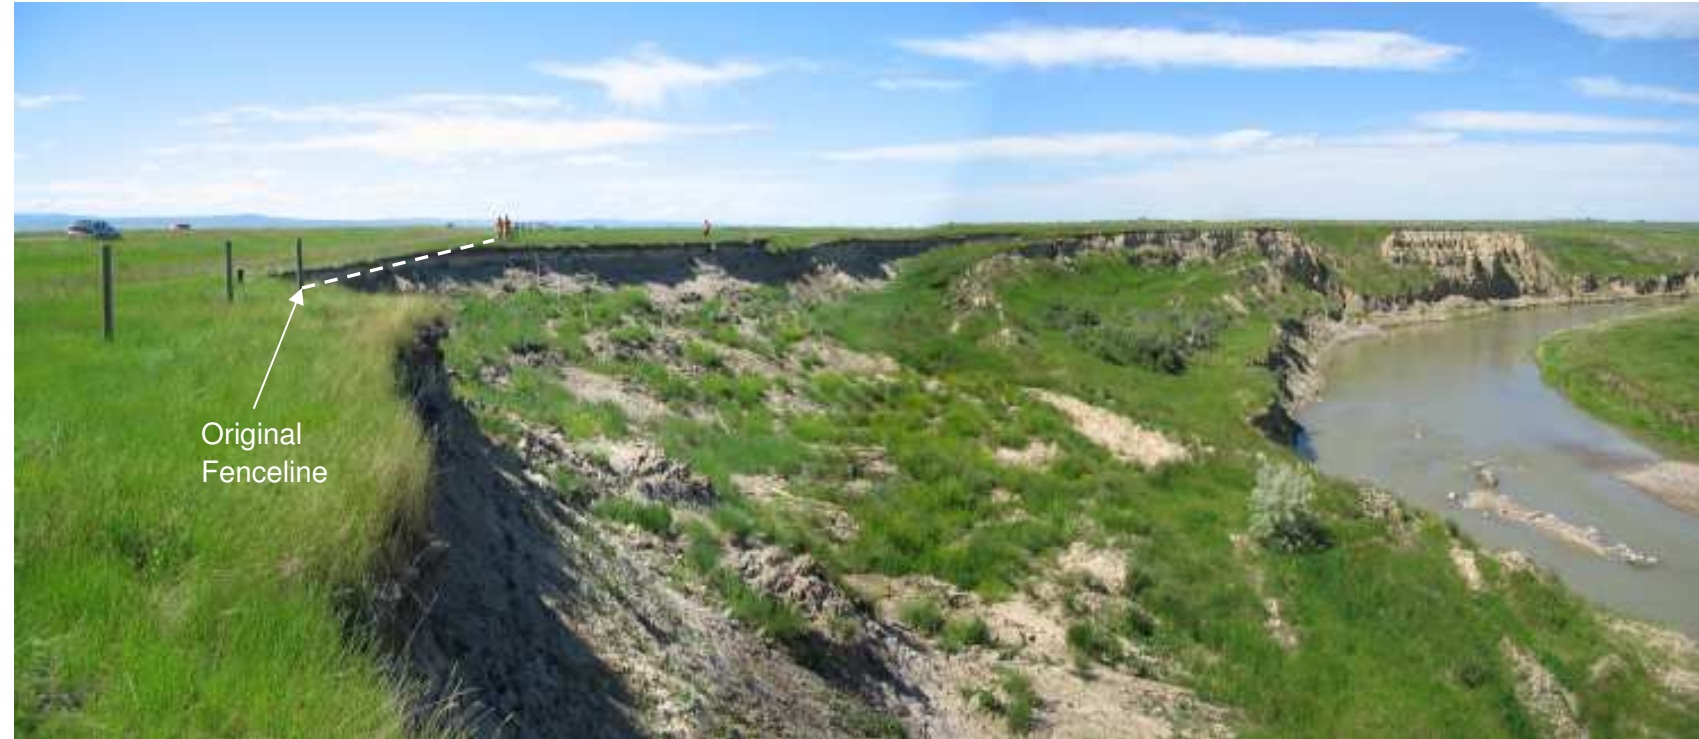
Photo S4-1 – June 2007 (top)
Facing north across the landslide area. The extent of the slope crest retrogression past the fenceline and towards the northbound lanes of Highway 2 is visible.

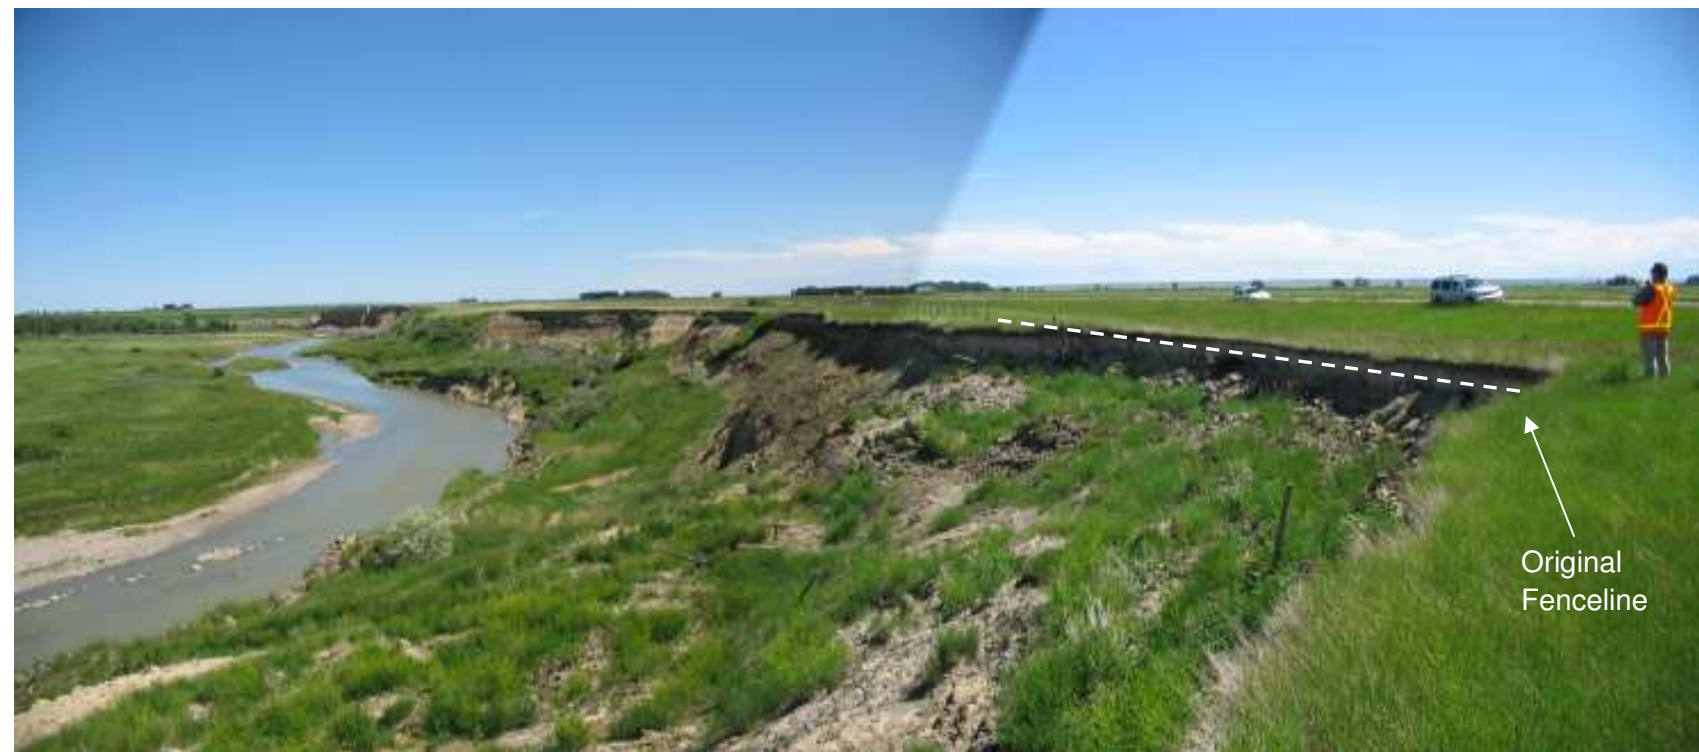
Photo S4-2 – June 2007 (bottom)
Facing south across the landslide area. The current offset between the crest of the slope in the landslide area and the northbound lanes of Highway 2 is visible.
