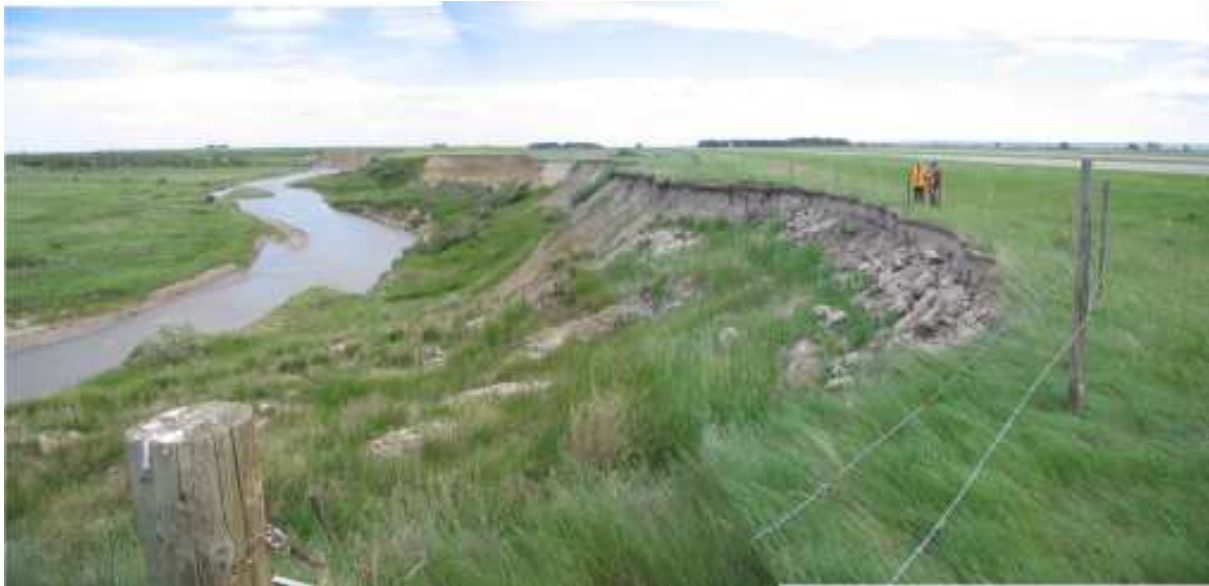
Photo S4-1 – June 2008 (top)

Facing south along the original fenceline with the westwards slope crest retrogression towards Highway 2 visible. The temporary fenceline along the slope crest/landslide headscarp has been installed since the June 2007 inspection.

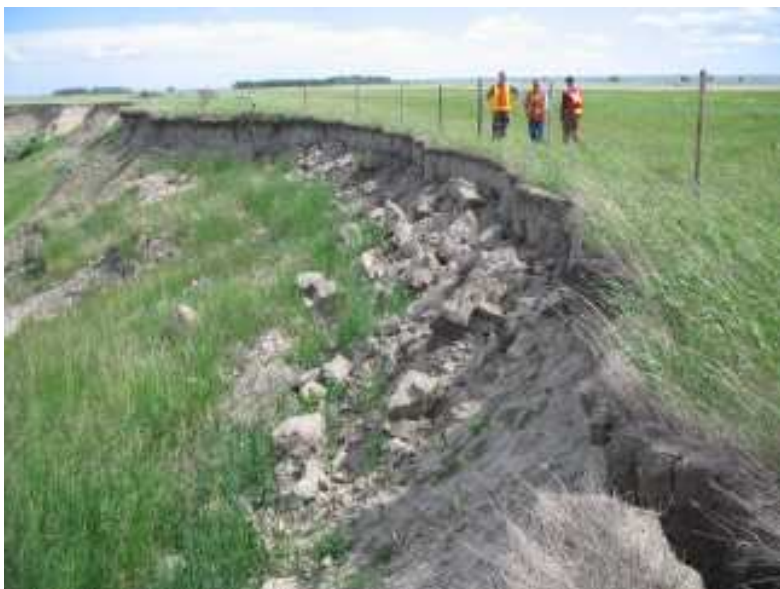
Photo S4-2 – June 2008 (bottom)

Closer view of the oversteepened headscarp west of the original fenceline.
