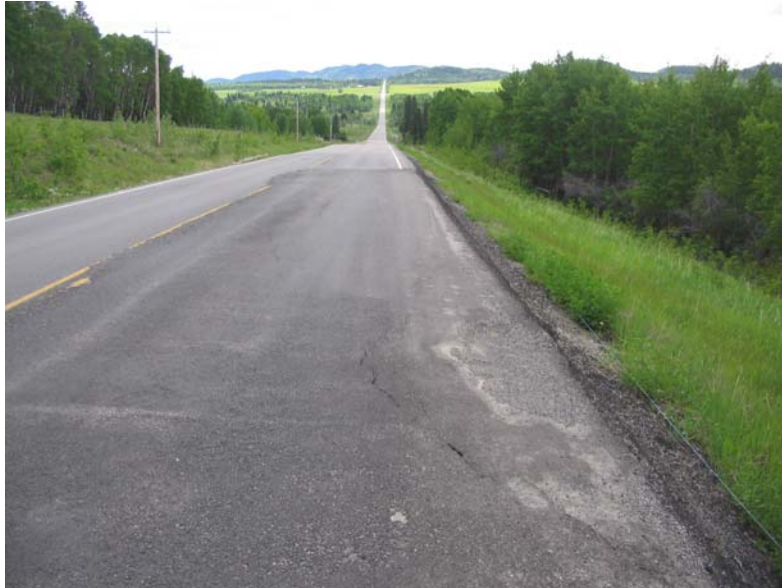
Photo S8-1 – June 2008 (top)

Facing southbound across the northern end of the S8 – Fisher Creek site. The arc-shaped settlement and cracking in the right foreground corresponds to the “Northern Cracking and Settlement Area” labelled on the site plan. The overlay visible over this area is typically re-done annually to maintain a smooth grade along the west shoulder, however the accumulated thickness of the overlays has created a steep drop-off from the edge of the pavement.

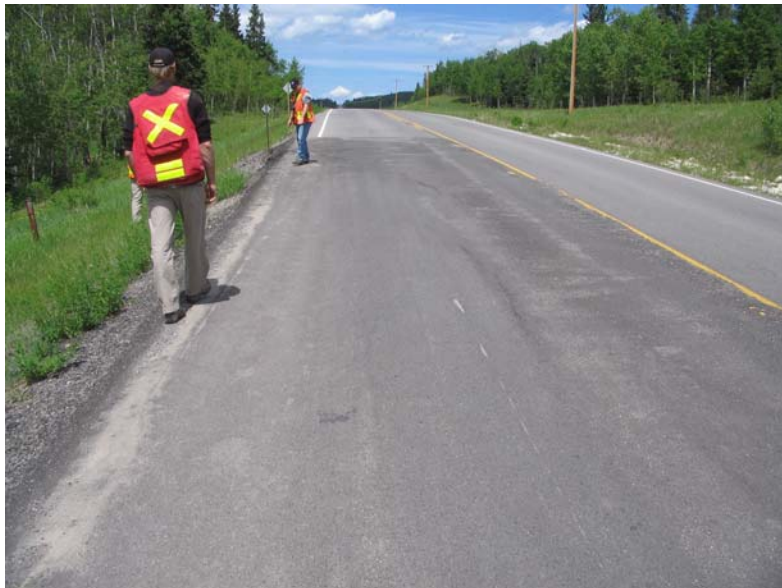
Photo S8-2 – June 2008 (bottom)

Facing northbound across the area shown in Photo S8-1.

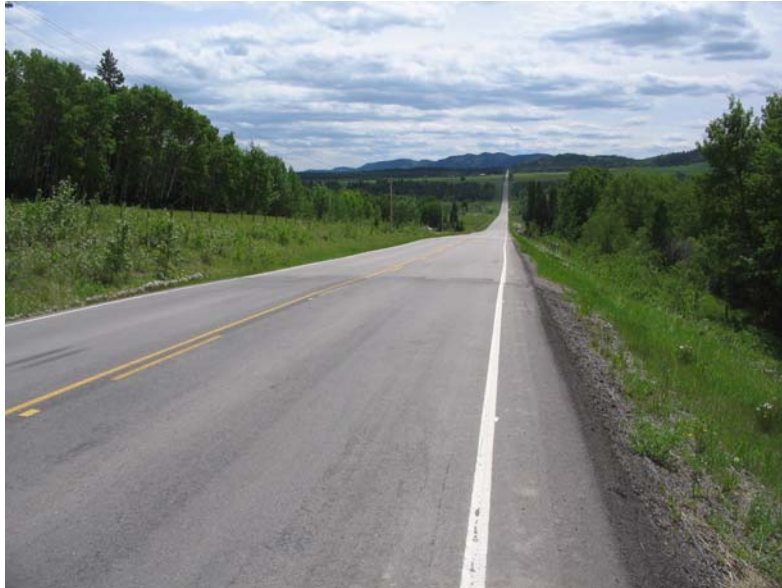
Photo S8-3 – June 2008 (top)

General view facing southbound across the south end of the site. The SI's in this area are showing ongoing movement underlying the road, however there has been little to negligible damage to the road surface across the southern end of the site.
