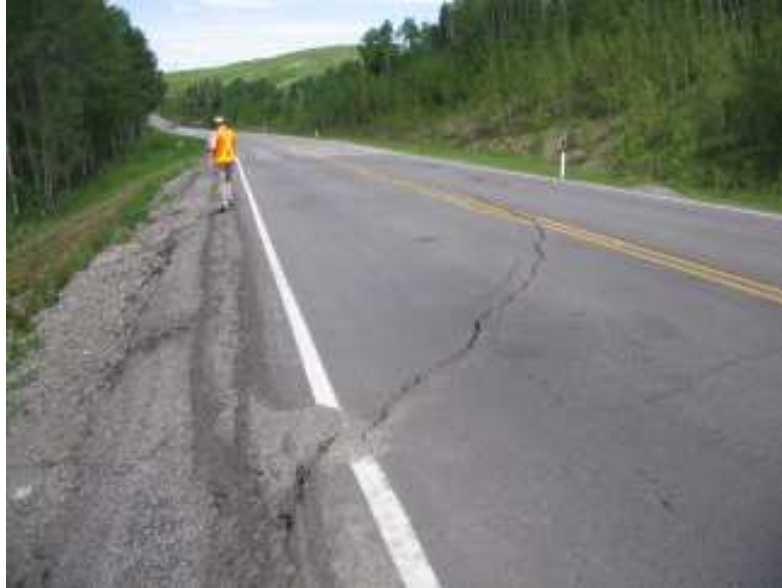
Photo S10(A)-1 – June 2008 (top)

Facing northbound across the south flank of the landslide damage to the highway. The circular crack delineating the settlement area in the southbound lane (left side of the photo) has formed repeatedly in recent years through numerous overlays and patches.

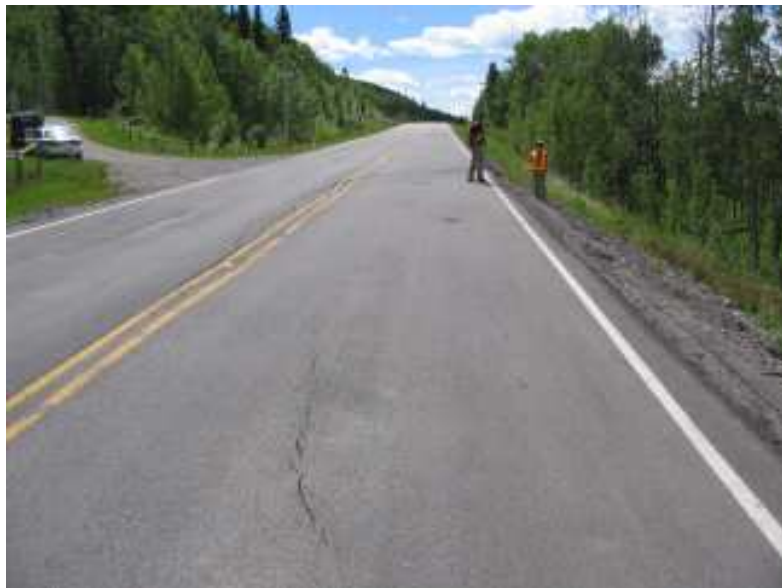
Photo S10(A)-2 – June 2008 (bottom)

Facing southbound across the landslide damage to the highway.

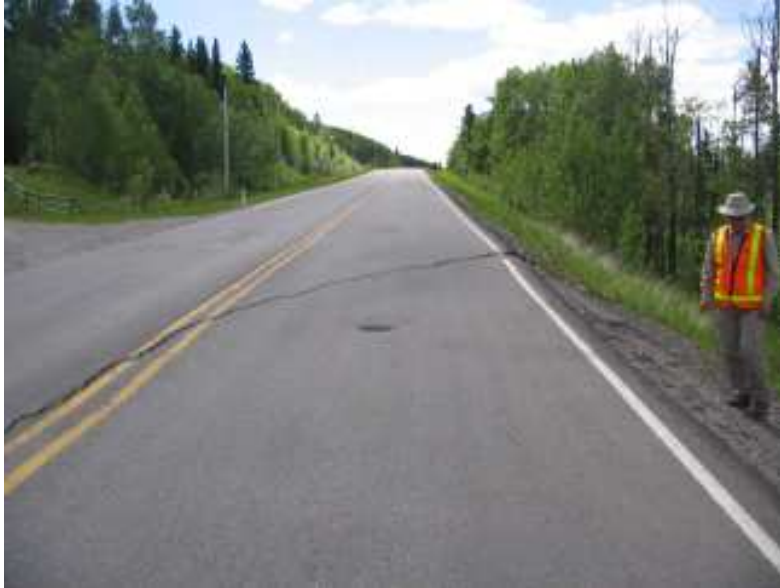
Photo S10(A)-3 – June 2008 (top)

Closer view, facing southbound, of the visible south flank of the landslide scarp that extends back to the centerline of the highway.
