PROJECT: SOUTHERN REGION GEOHAZARD ASSESSMENT				
	TITLE: SITE LOCATION, HIGHWAY 56 S32 - BOW RIVER UPSTREAM OF CROWFOOT FERRY				
CLIENT:	DATE: OCTOBER 2010	JOB No.: CG25332.200	CAD FILE: 25332B03.dwg	FIGURE No.: FIGURE S32-1	REV. A

Client	Alberta Transportation		Figure S32-2	
Project	Southern Region Geohazard Assessment		Date:	Revision
	S32 - BOW RIVER UPSTREAM OF CROWFOOT FERRY HIGHWAY 56 SCHEMATIC SITE PLAN		Oct-10	
			Job No.	
			CG25332.200	
			File No.:

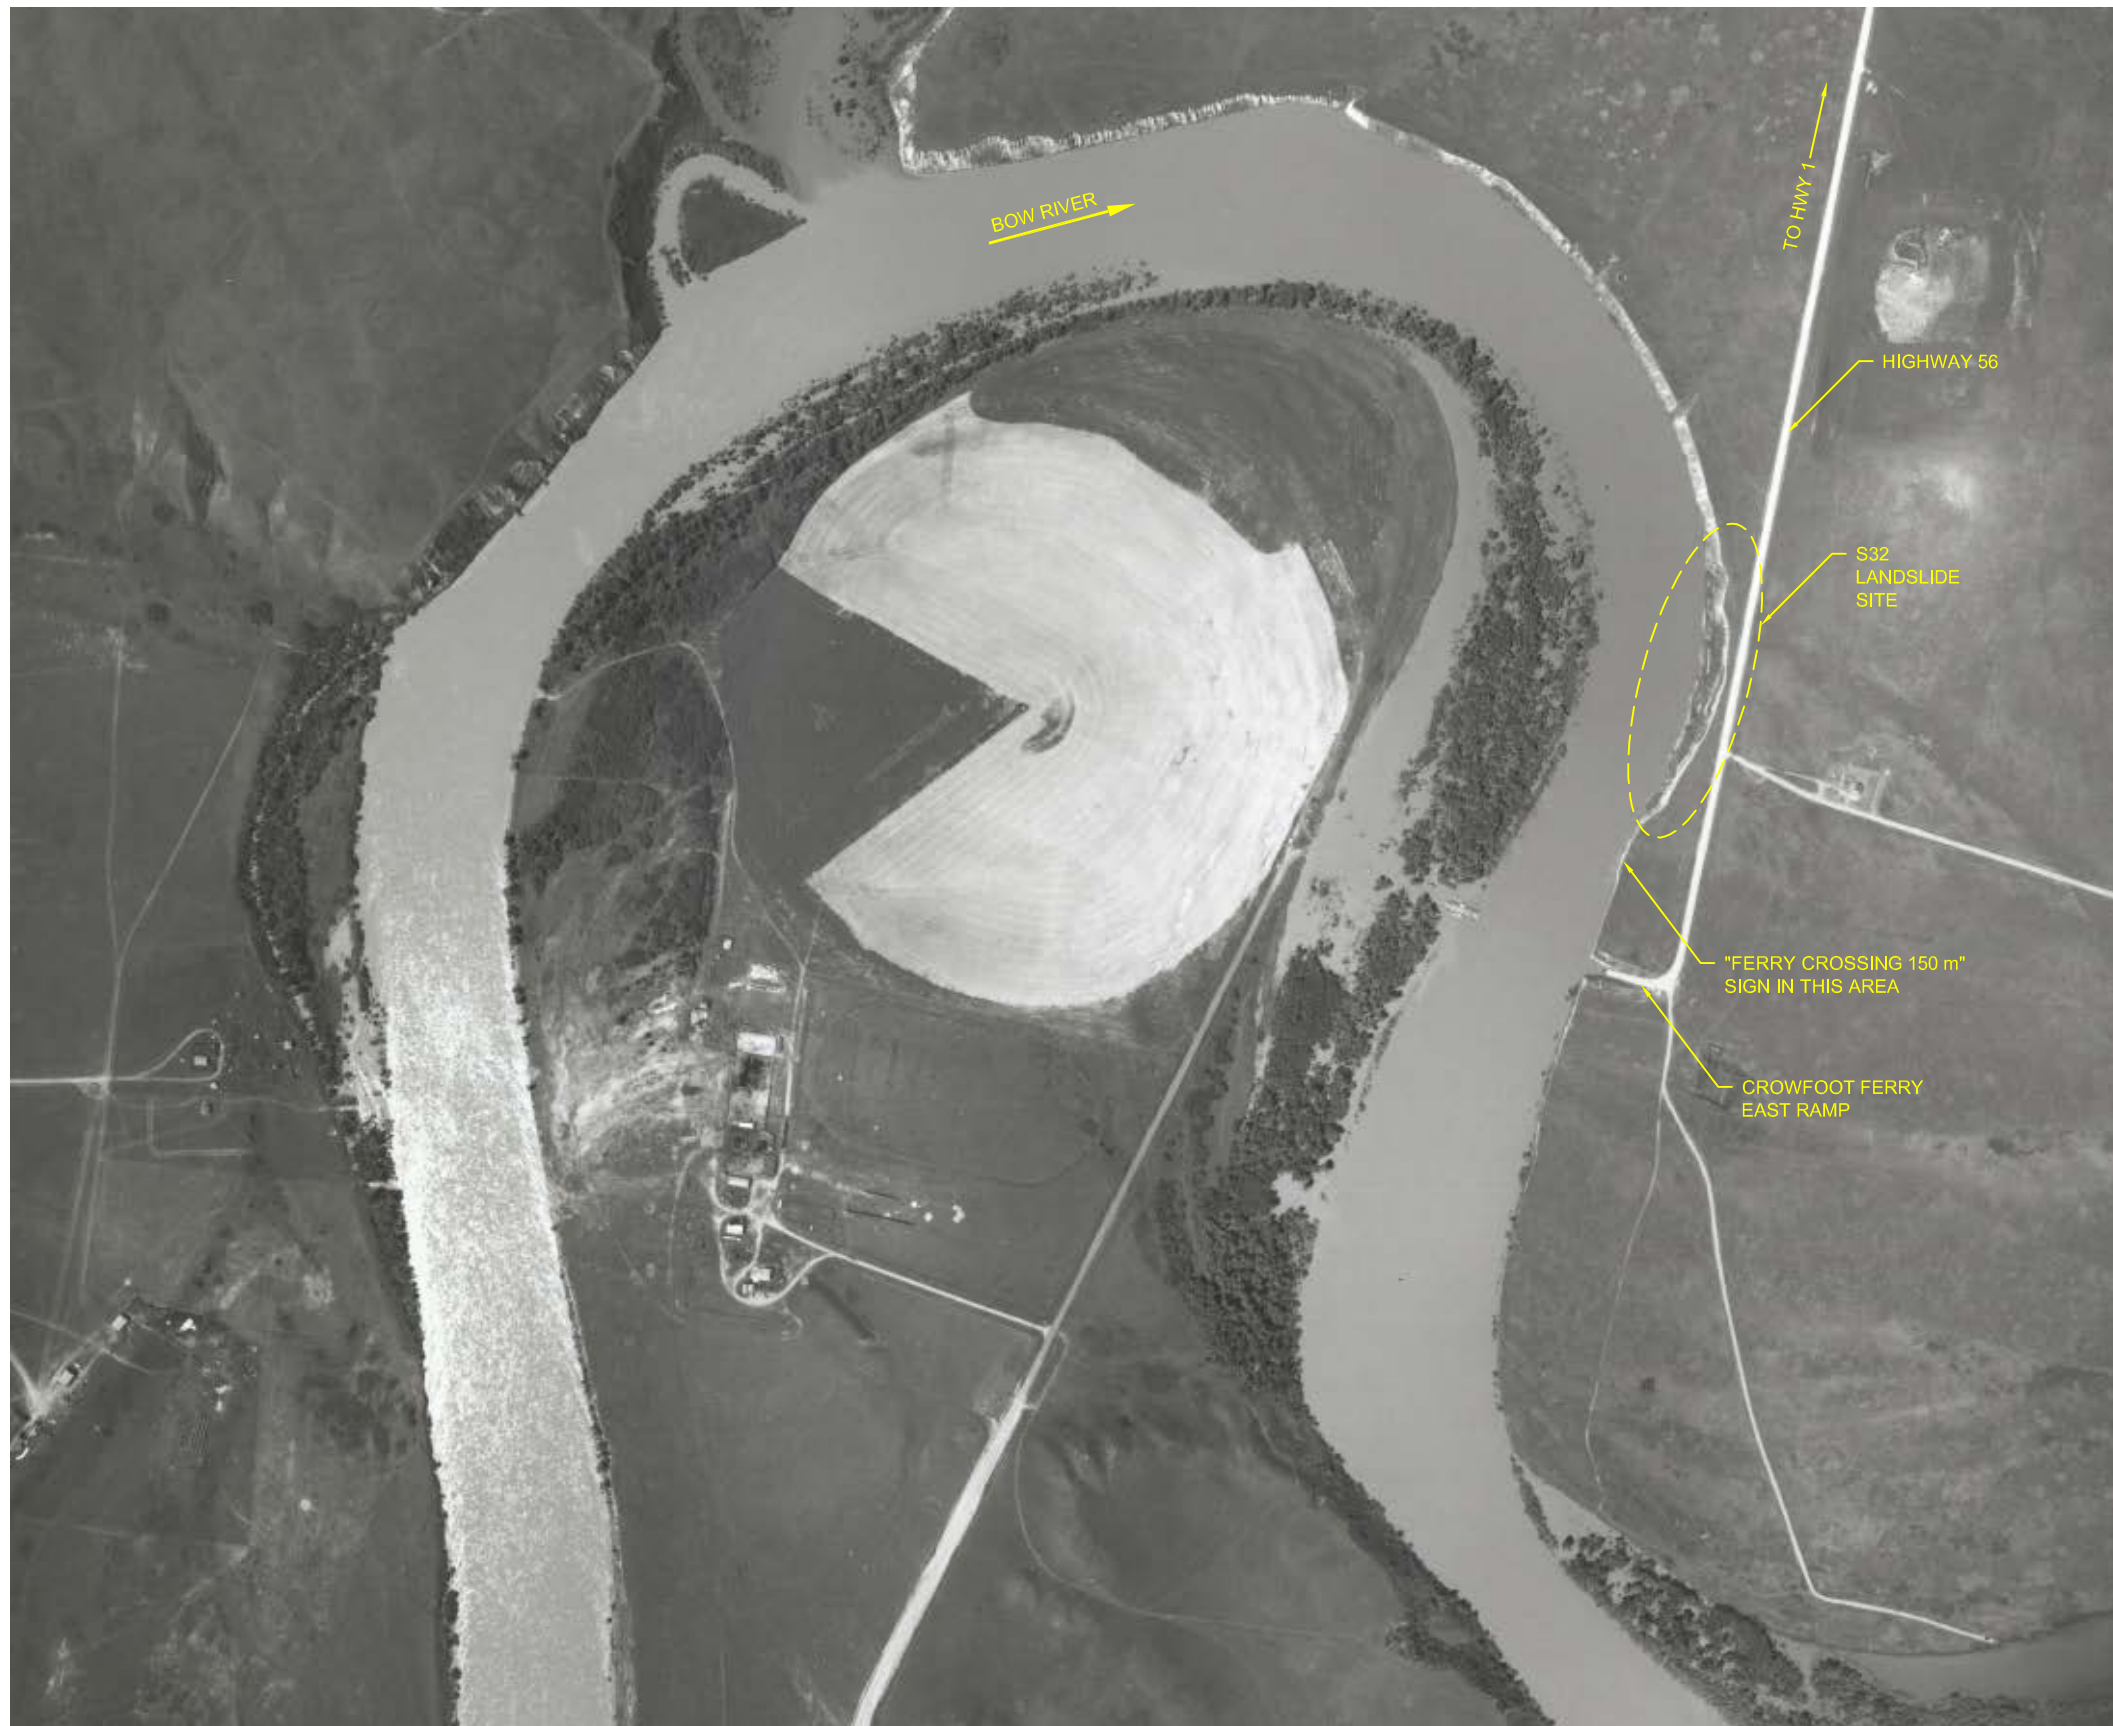
AIR PHOTO REFERENCE: JUNE 2005, GOVERNMENT OF ALBERTA, 05-164, 82I, LN-27, AS5333B #249, 1:10 000

NOTE: RIVER IN FLOOD CONDITION AT TIME OF PHOTO.
