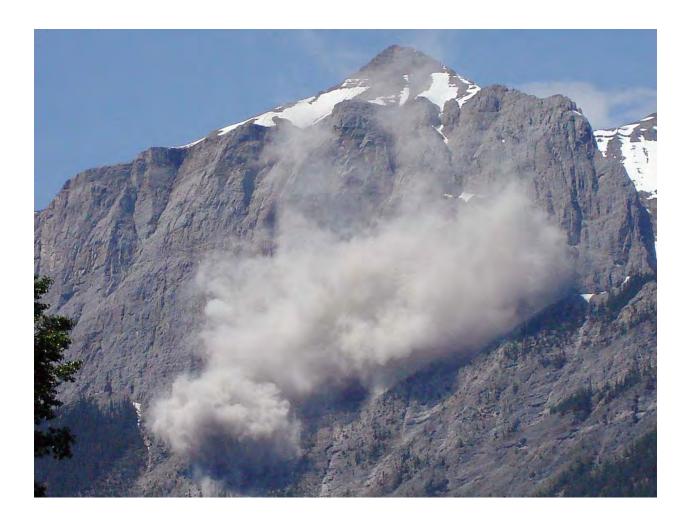
Photo 1 – Summer 2006 rockfall event originating from the upper slopes of Mount Rundle above Highway 742:02, between approximately Km 4.5 and Km 5.0 along the highway. It is understood that several boulder-sized rocks were deposited on the road surface during this event. (Photo provided to AMEC by the Parks Division.)
