Alberta Transportation Southern Region Geohazard Assessment Highway 940, Wilkinson Creek Bridge Area CG25309.B August 2009

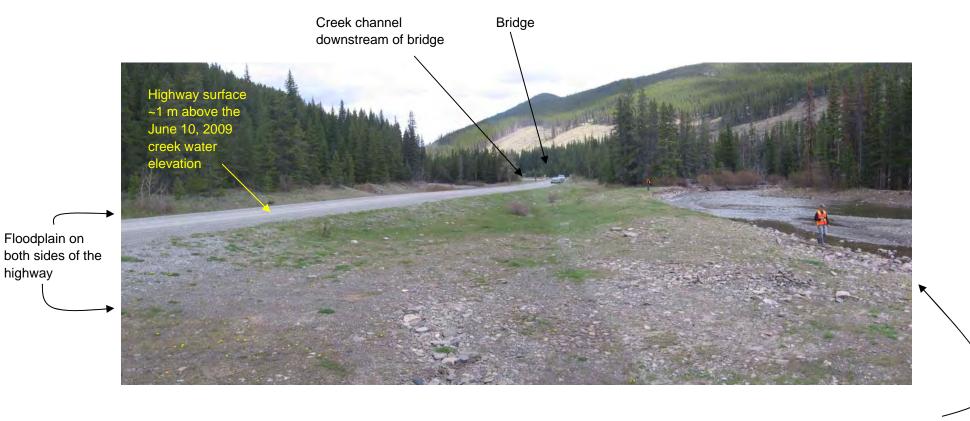
Floodplain on

highway

Photo 1 - June10, 2009 (top) Facing northbound along Highway 940 and downstream along Wilkinson Creek.

Small levee along left bank, prone to overtopping during peak flows

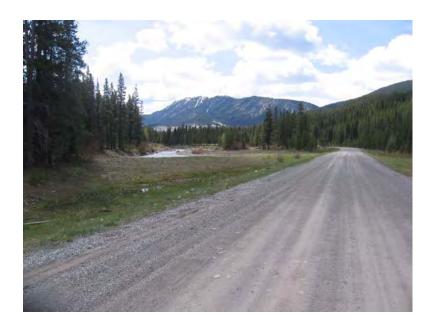
Photo 2 – June10, 2009 (top)
Facing southbound along
Highway 940 from the bridge
location, and also facing upstream
along the Wilkinson Creek channel
(visible in the left background)
