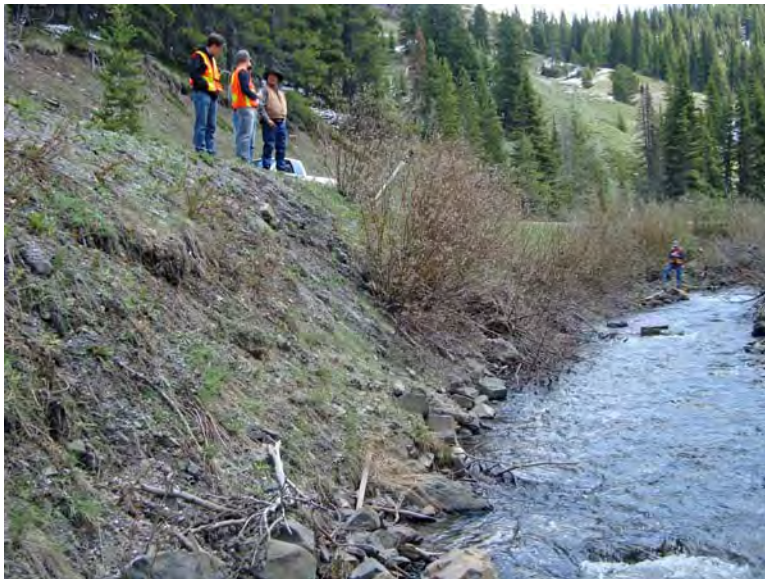
Photo 2 – June 2009

Creek erosion site at KM 82.4. Erosion does not appear to be occurring, however there is a risk that peak flow events may trigger erosion in the future that would affect the road.
