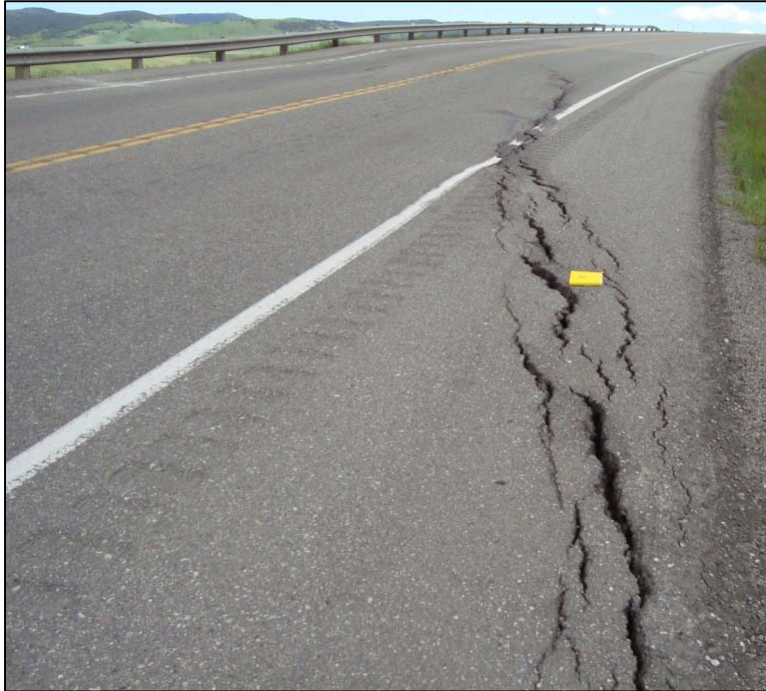
**Photo S38-1 - June 2011**  
Facing southbound across the cracks in the road surface. Note the settlement visible in the upper left corner of the photo near the guard rail.

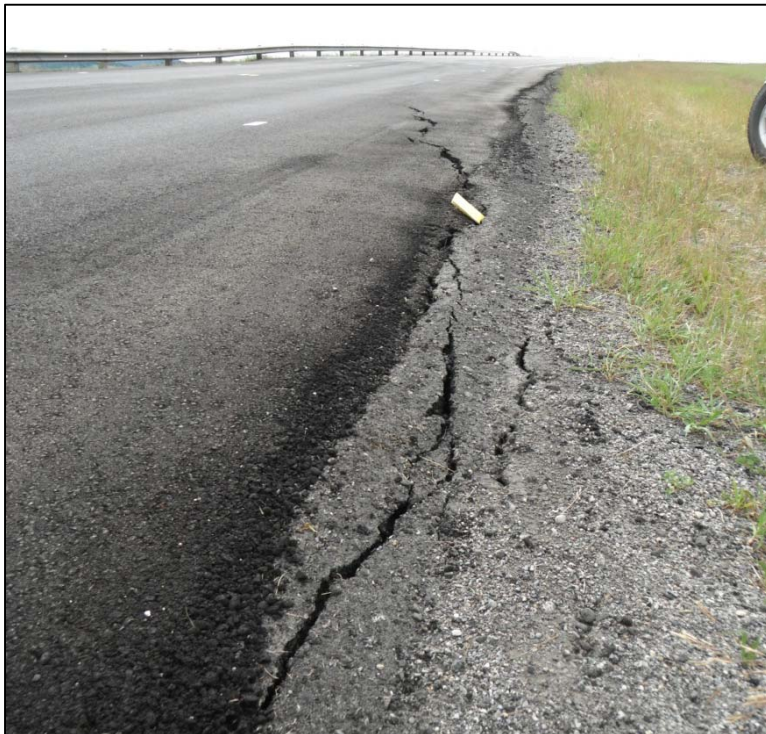
**Photo S38-2 - July 2011**  
Photo taken from the same location as Photo S38-1, approximately one month later. The road has been paved within the last month, with cracks forming through the overlay.

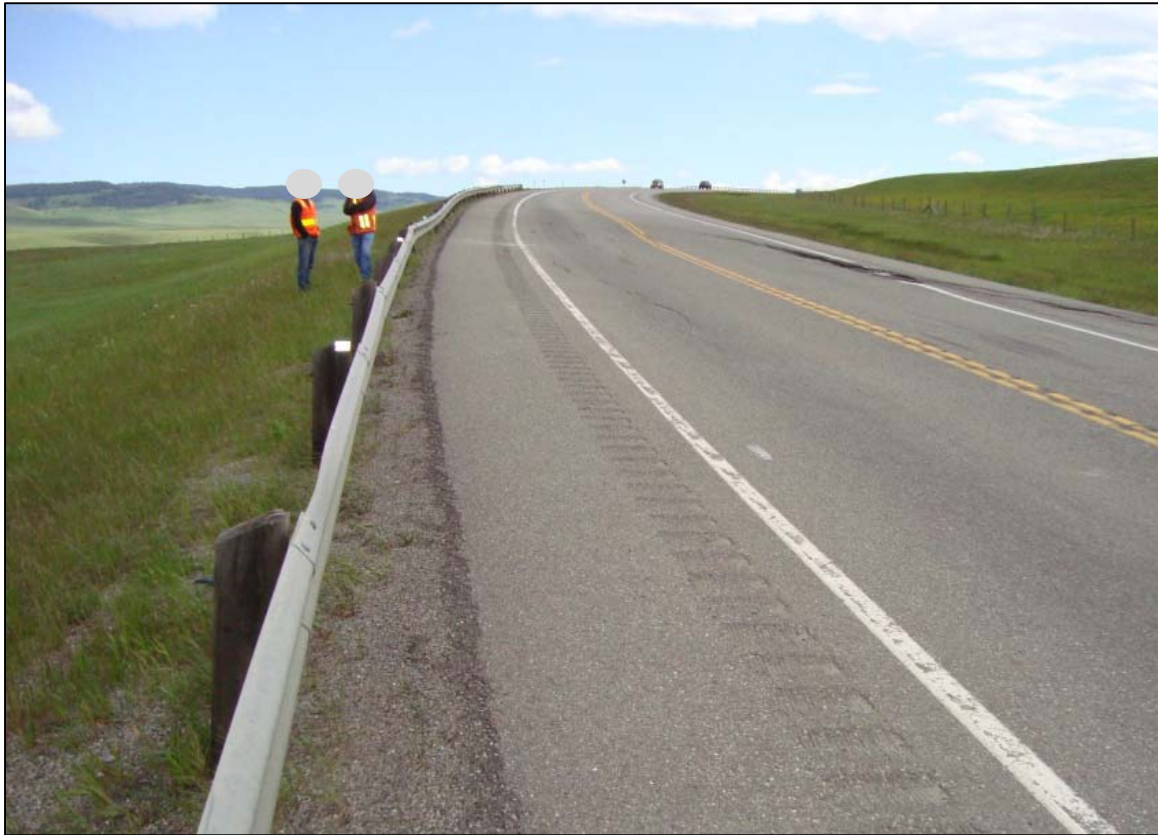
**Photo S38-3 - June 2011**  
Facing southbound across the slide area.
