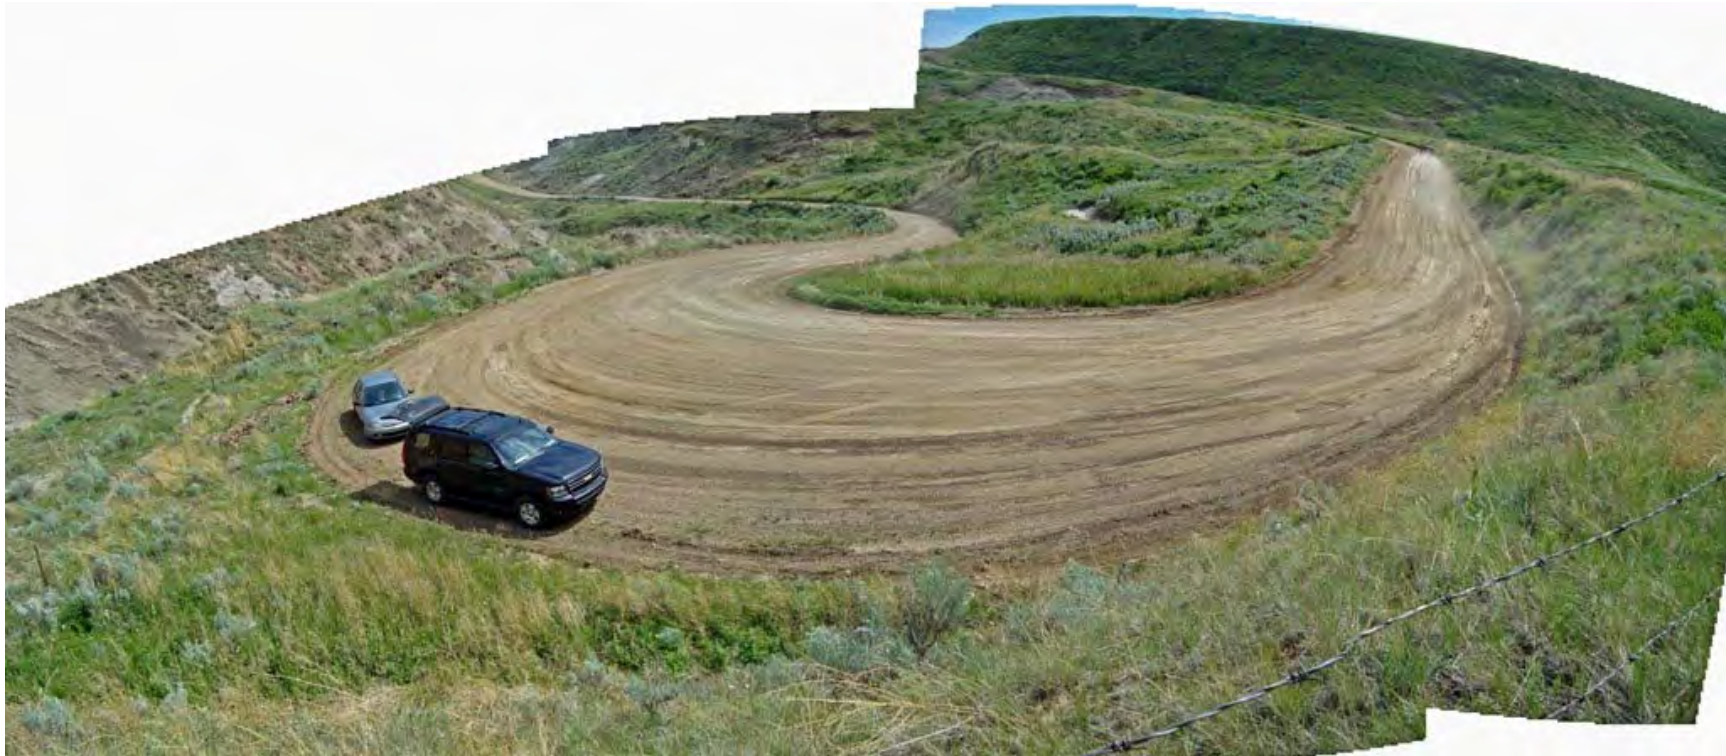
**Photo S40-1 – June 22, 2012**

An overview of the site from the hair-pin turn looking towards the east. Stitched photo is distorted near the edges due to geometric correction during image processing.

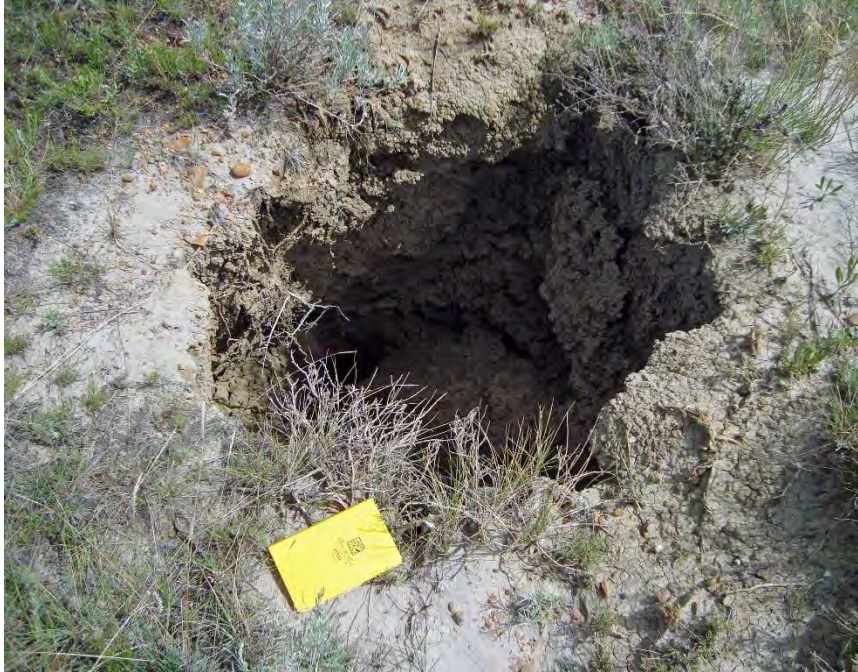
**Photo S40-2 – June 22, 2012**  
One of several typical sinkhole features found throughout the site area. This particular sinkhole was located at reference point 97 on Figure S40-1.

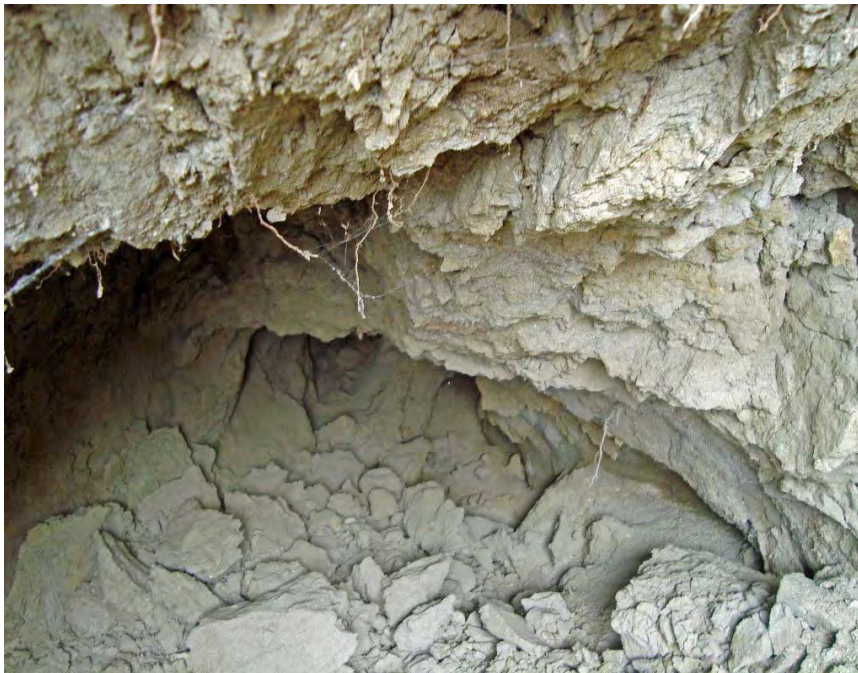
**Photo S40-3 – June 22, 2012**  
An example of a sub-surface erosion tunnel connected to one of the holes discovered at ground surface. The soils in this area were highly susceptible to erosion.

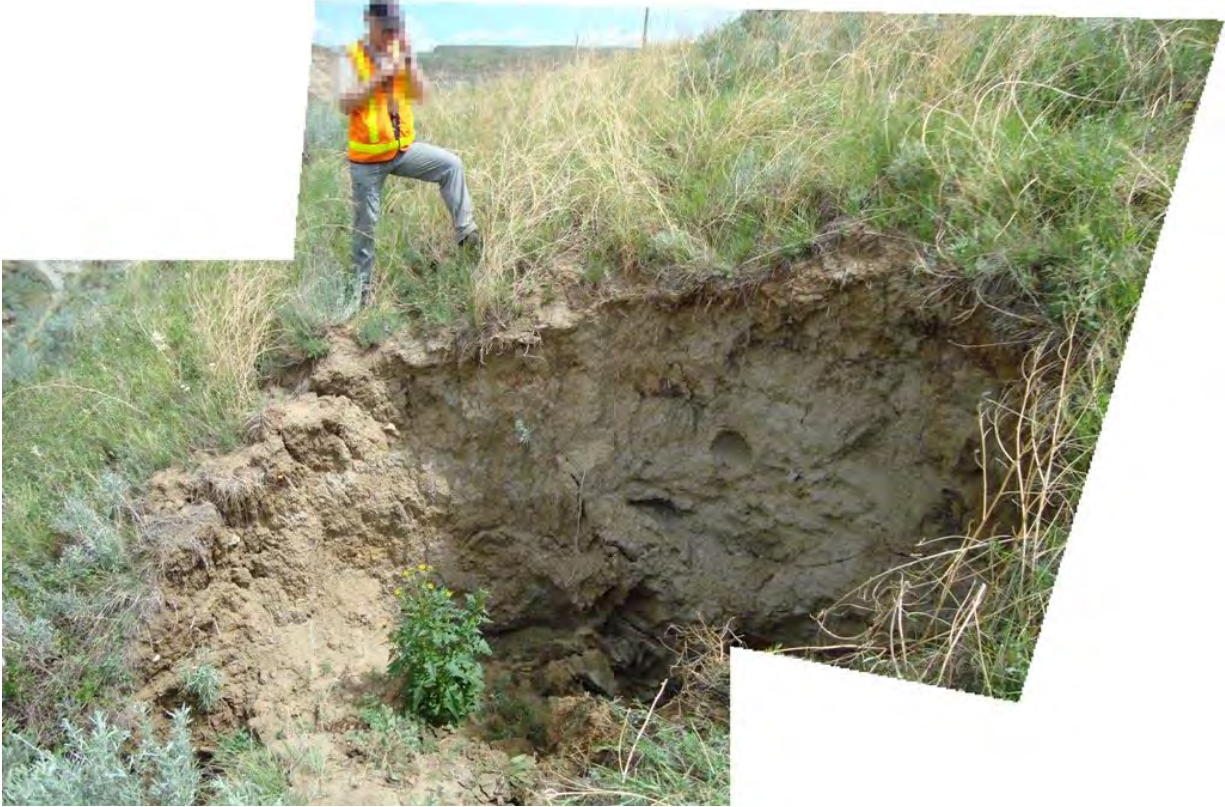
**Photo S40-4 – June 22, 2012**

Damage observed to the slope north of the road where a void has reached the ground surface causing it to collapse.
