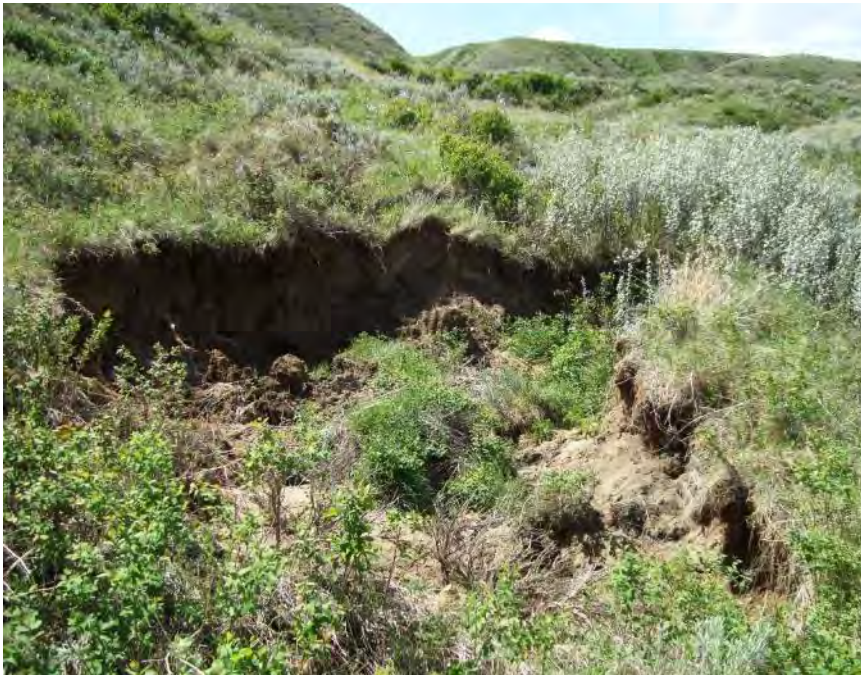
Photo S40-1 – May 2013
Standing south of the highway looking at the apparent recent collapse of a sinkhole observed around the area marked by WPT 60 on the site plan.

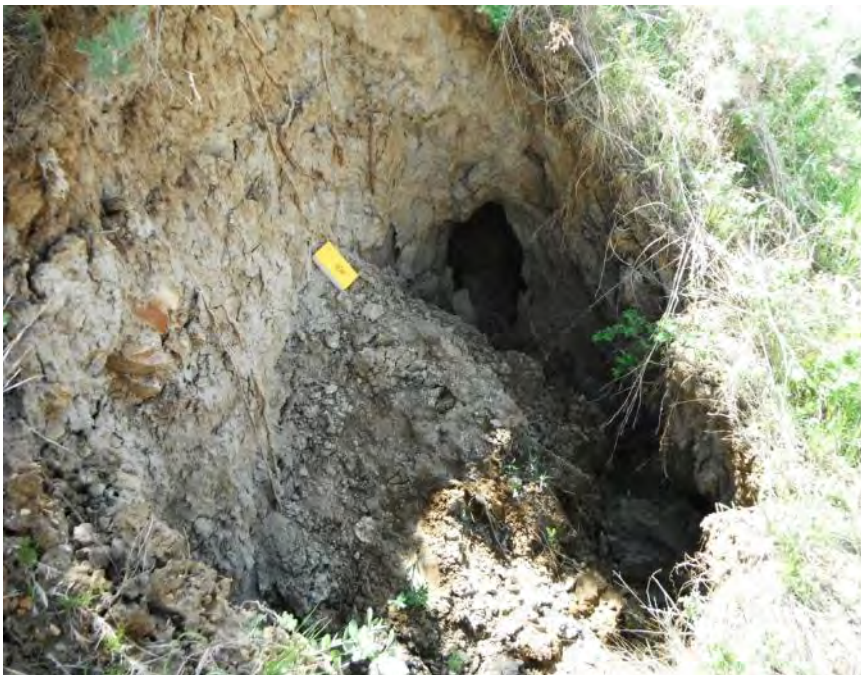
Photo S40-2 – May 2013
Standing at the north highway edge looking towards a collapsed sinkhole that has eroded a vertical face up to the road. A tunnel appears to be connected that runs beneath the highway located at WPT 105.

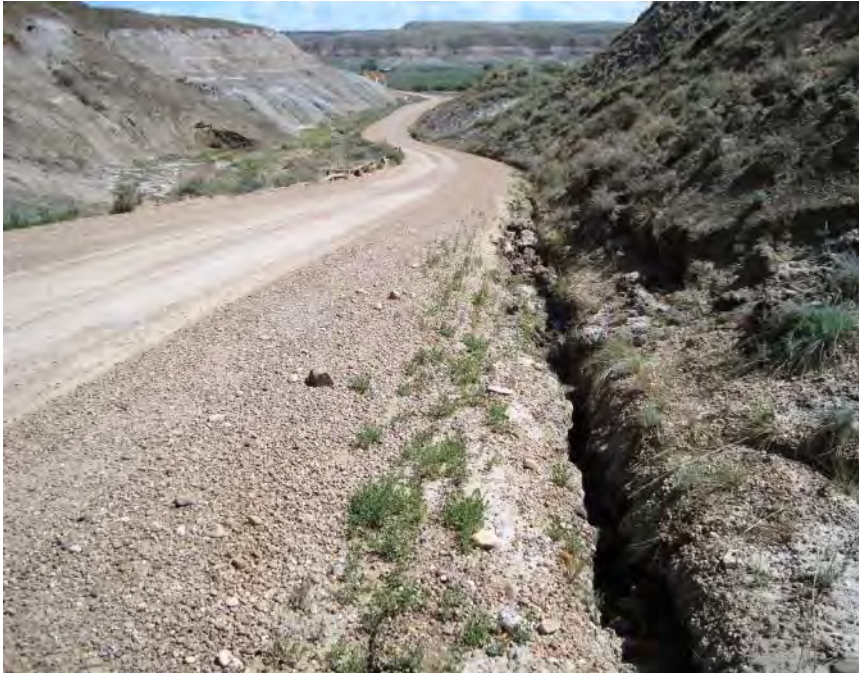
Photo S40-3 – May 2013
Standing on the southeast
road shoulder looking
towards the east at the
south ditch erosion.
