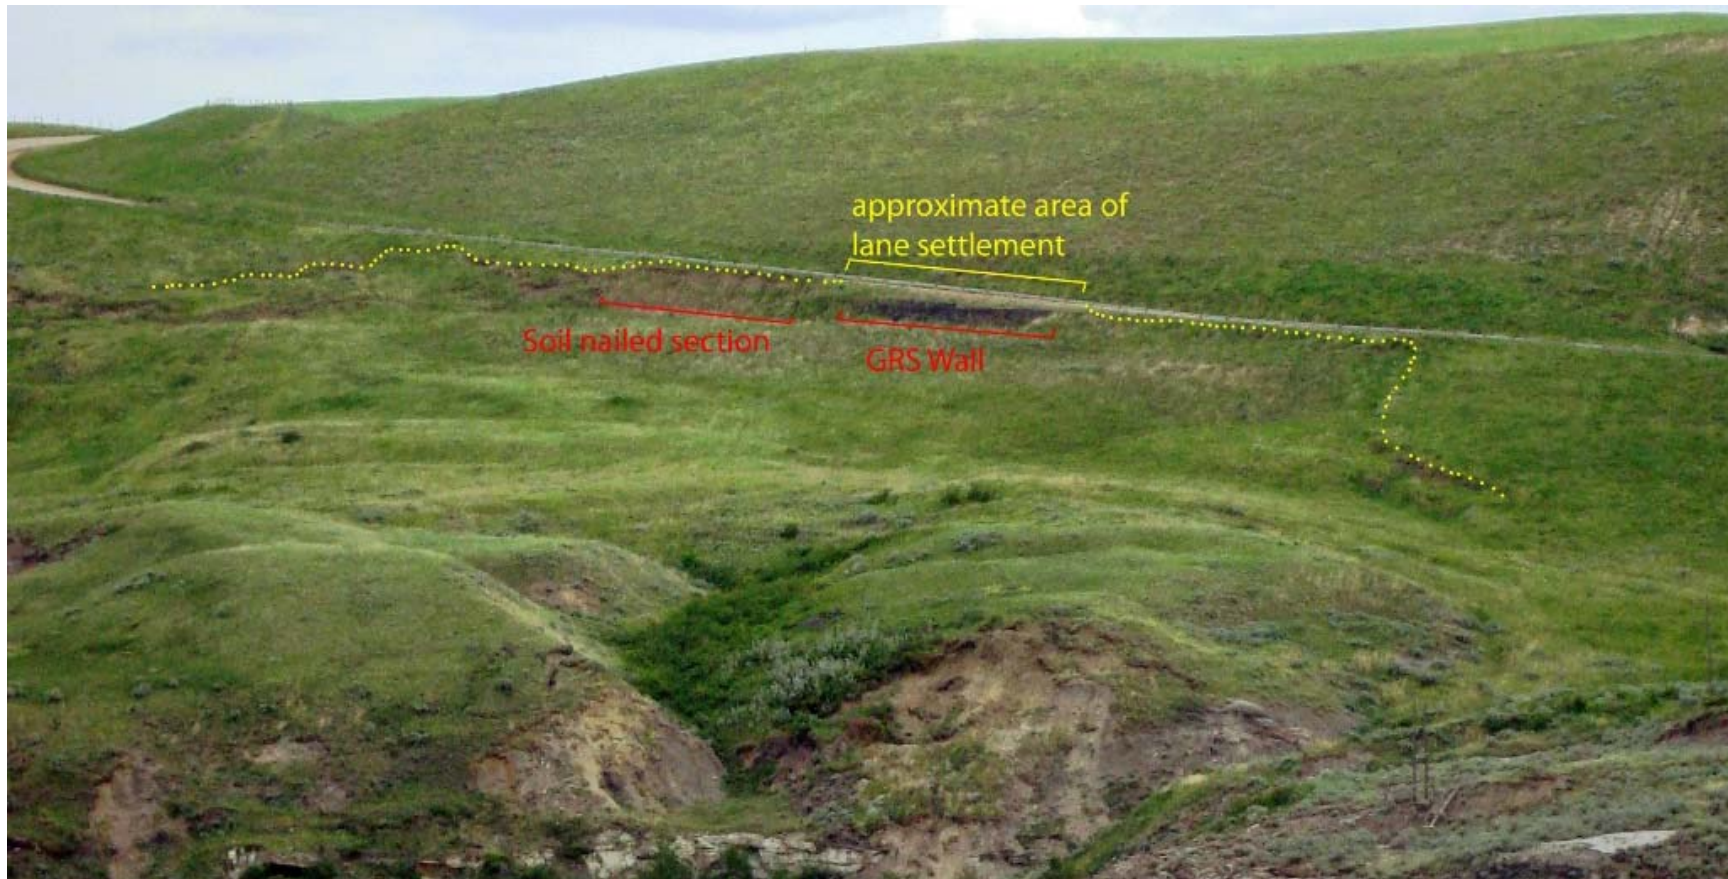
Photo S41-1 – June 22, 2012

Facing east towards the site from across the valley. Well-developed landslide topography is visible below the highway. The headscarp is marked in the photograph.

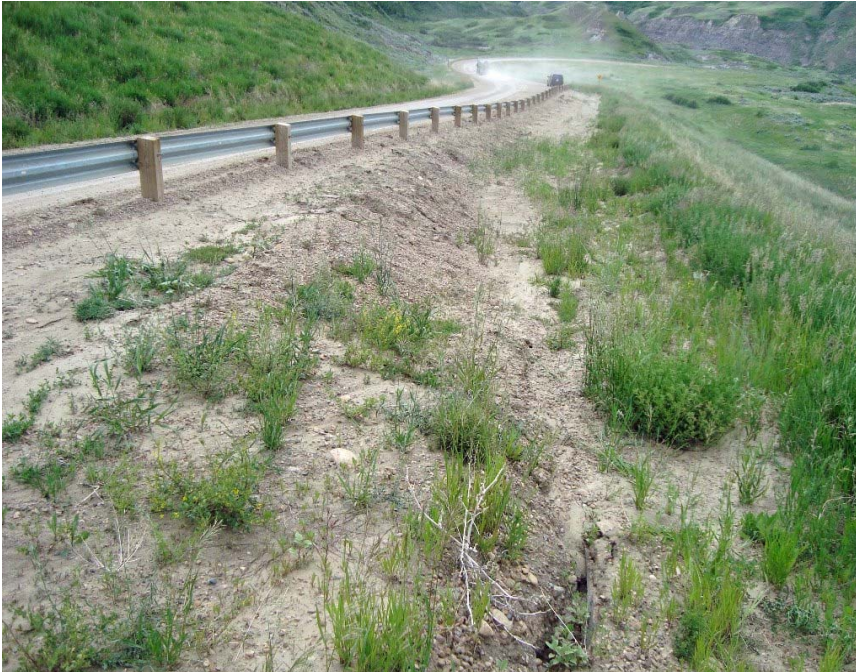
Photo S41-2 – June 22, 2012

Facing southwest from the old guardrail position, looking towards the closed southbound lane and area of settlement within the now closed road surface.

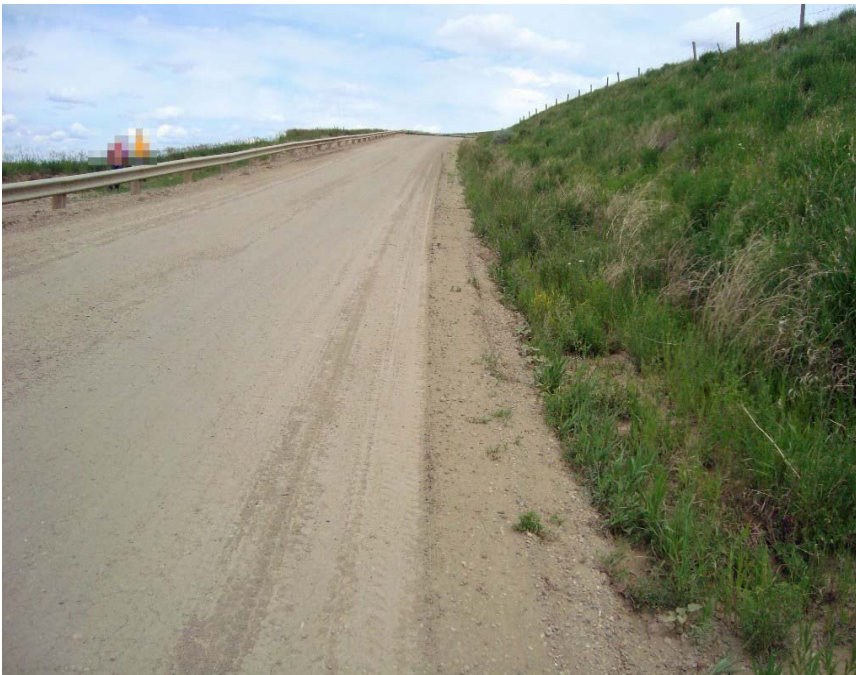
Photo S41-3 – June 22, 2012

Facing northeast on the upslope side of the road near the south end of the site. No cracking in the upslope highway lane was observed.
