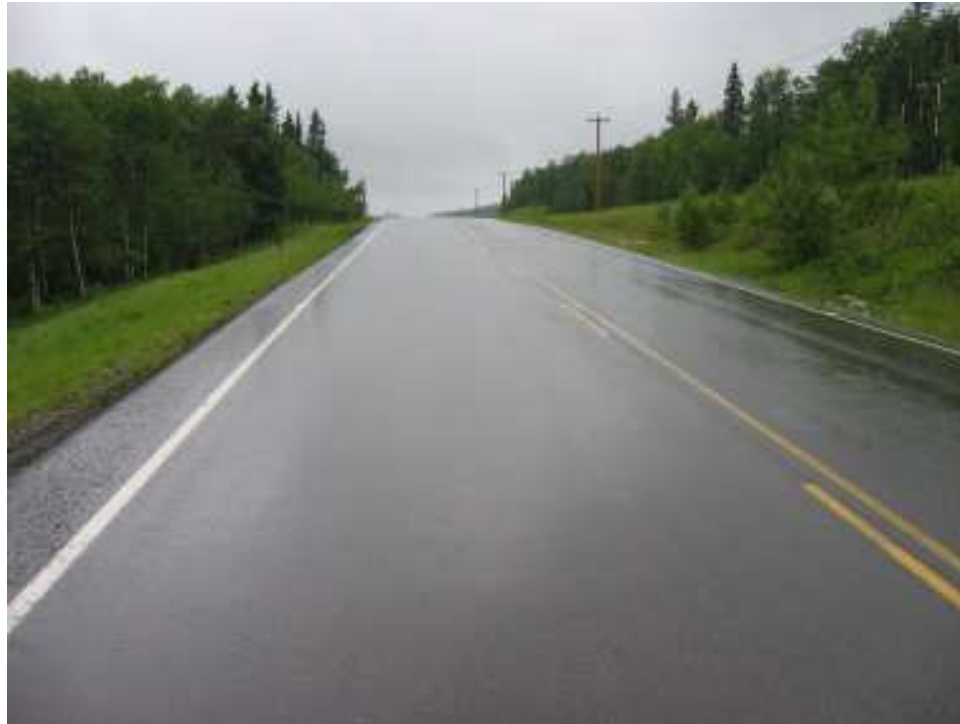
Photo S8-1 (upper left) – June 2005 – facing north across the northern area of the site. No significant cracking or settlement was noted.

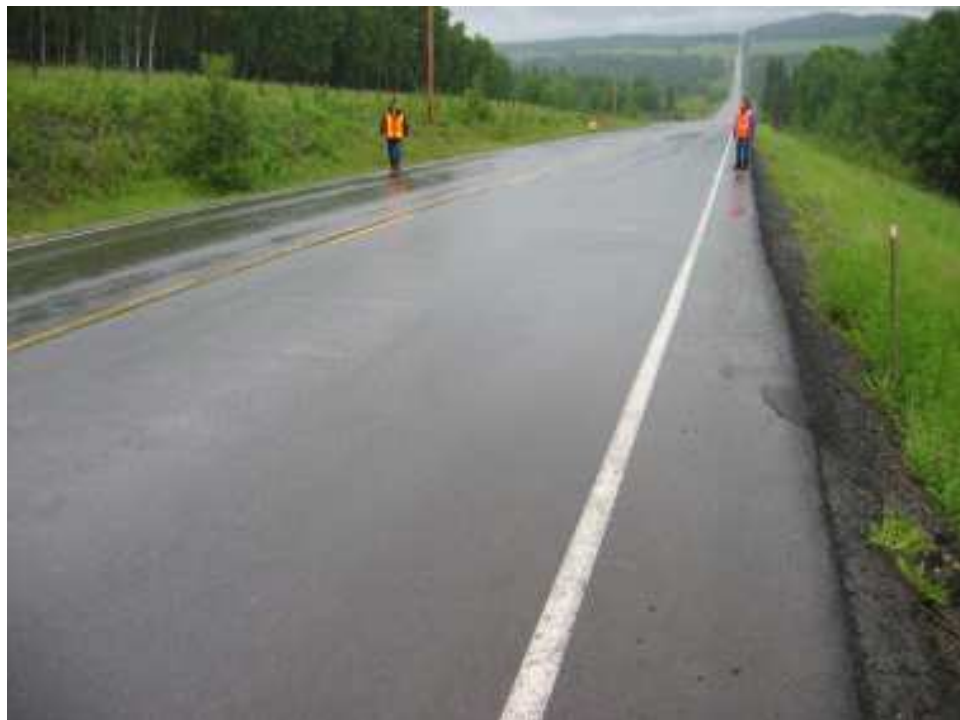
Photo S8-2 (lower left) – June 2005 – facing south along the southern area of the site. No significant cracking or settlement was noted.

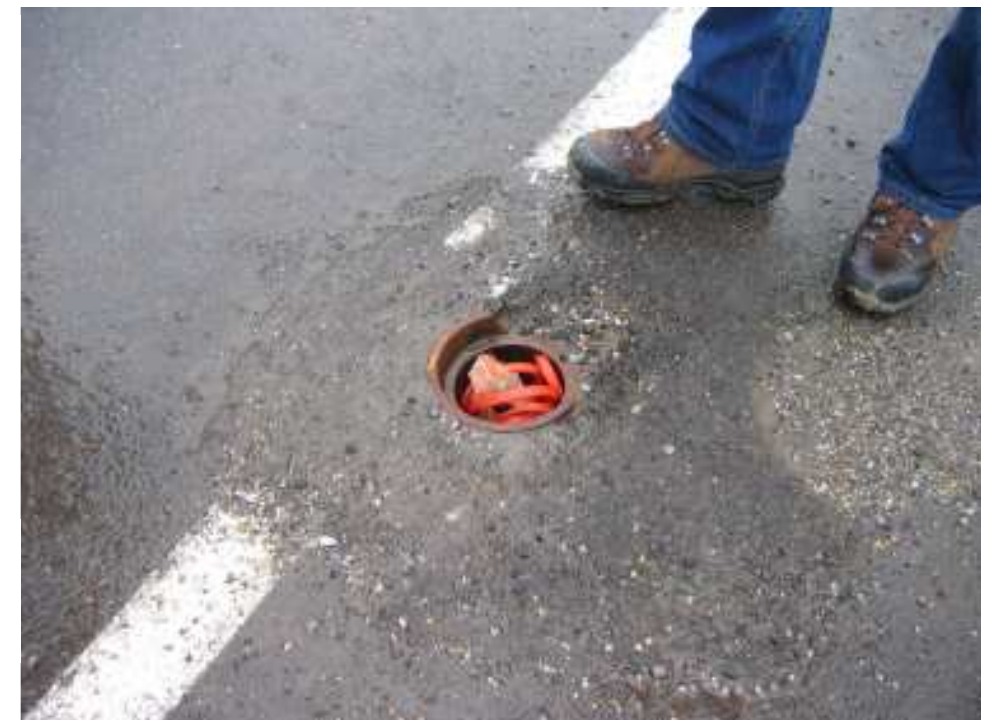
Photo S8-3 (lower right) – June 2005 – Pneumatic piezometer lead cables exposed in Borehole 2002-2. Protective cover has been destroyed, most likely by a snowplow.
