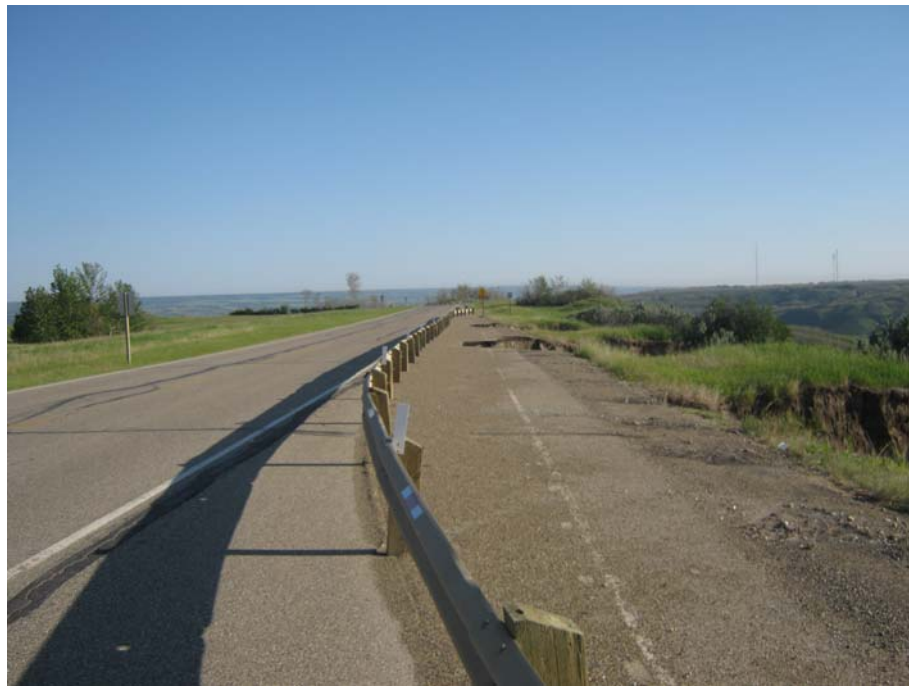
Photo 1.
Looking north along Hwy744 from the south end of Slide 4.

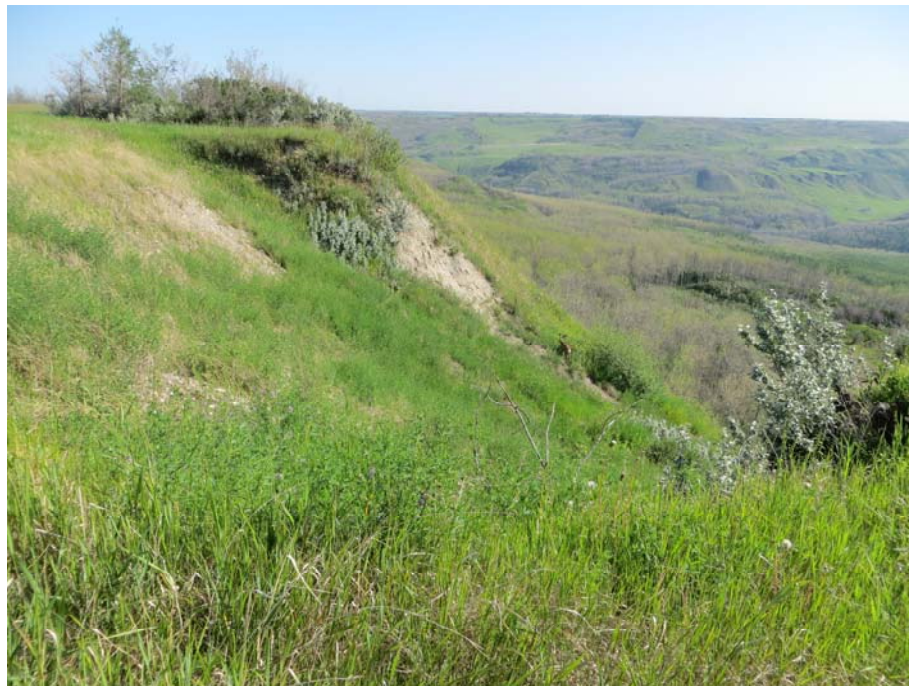
Photo 2.
No significant change in the backscarp of Slide 1 since 2011 – the repair continues to be effective.

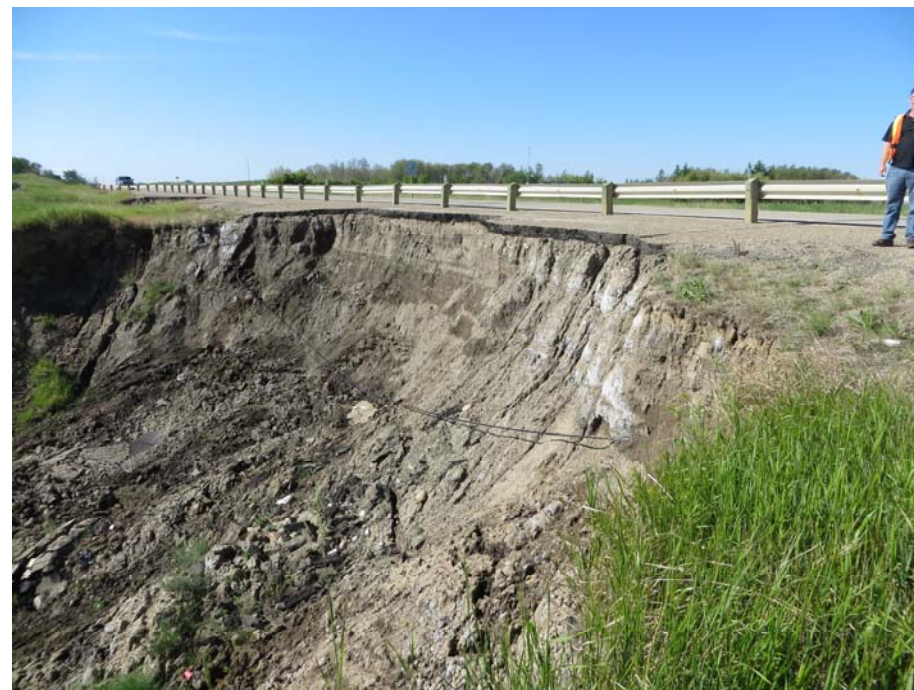
Photo 3.
Retrogression movement in the backscarp of Slide 2. The backscarp is now at 1 m from the new guardrail alignment. The Telus telecommunications cable is hanging in the same position as in 2011. Some fresh debris is visible below the scarp and dark seepage stains are also visible from about 1 m to 2 m below the top of the asphalt surface.

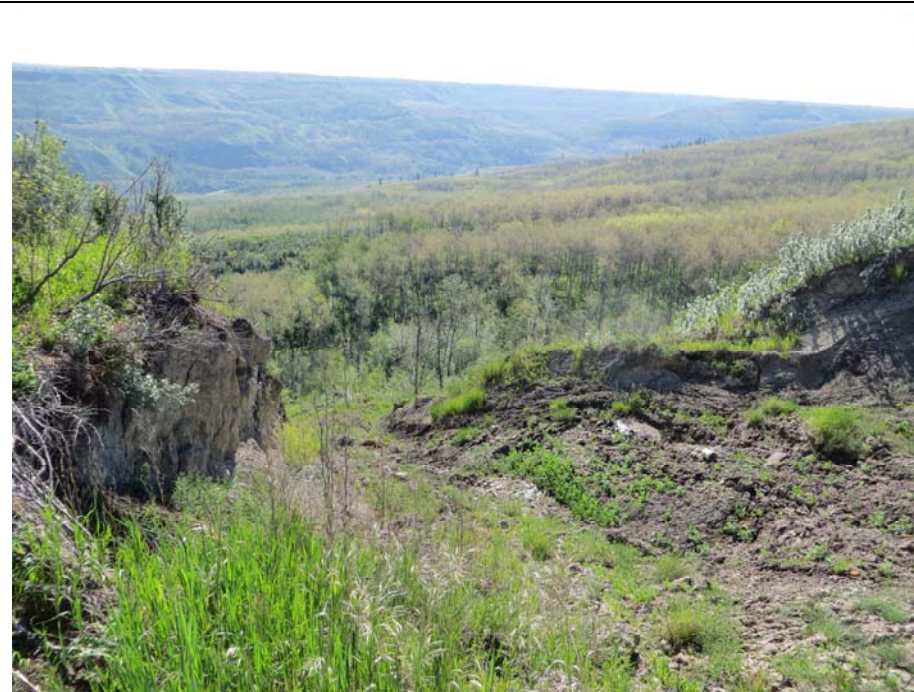
Photo 4.
Slide bowl of Slide 2 – additional debris has been added since 2011.

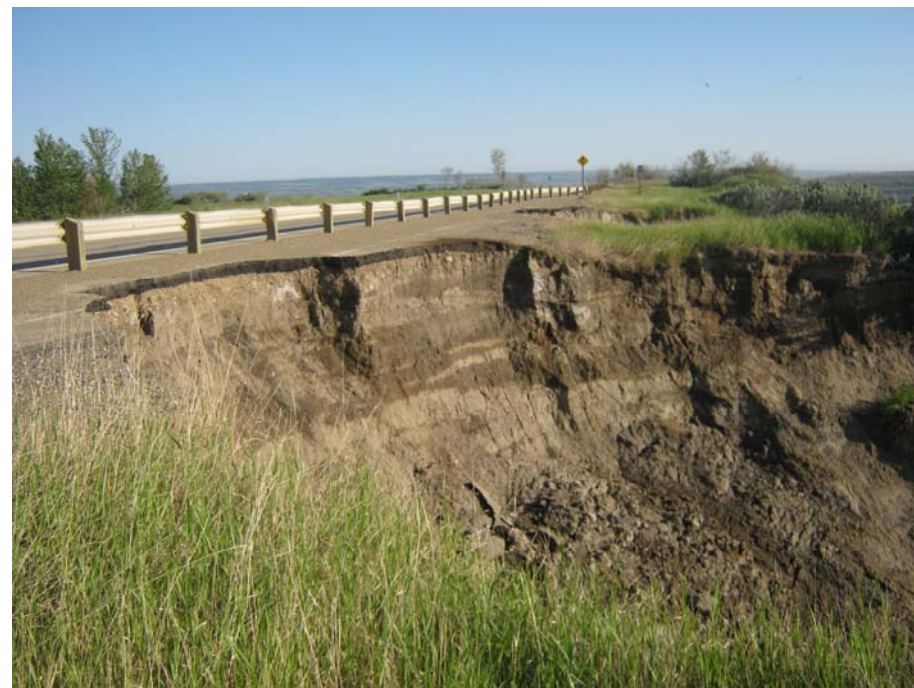
Photo 5.
 North side of Slide 3. Substantial retrogression of the backscarp, dark zones of seepage are visible from 1m to 3 m below the top of asphalt pavement, the Telus communications cable has fallen into the slide debris with additional debris flow observed below the backscarp.

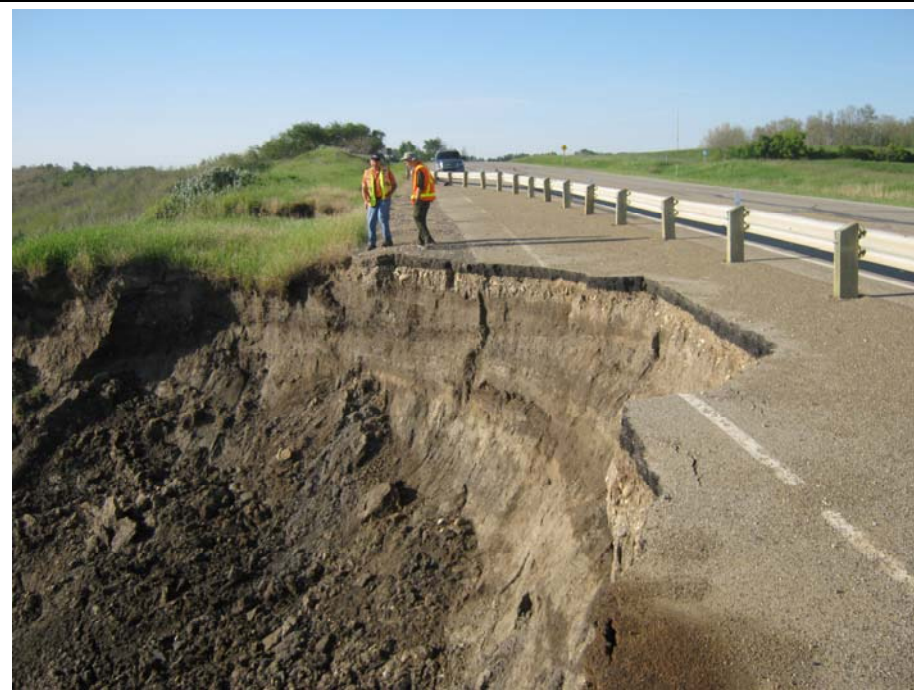
Photo 6.
 Looking south at the significant retrogression of the backscarp of Slide 3 (about 5 m since August 2011), now at 1 m from the new guardrail alignment and about 32 m in width.

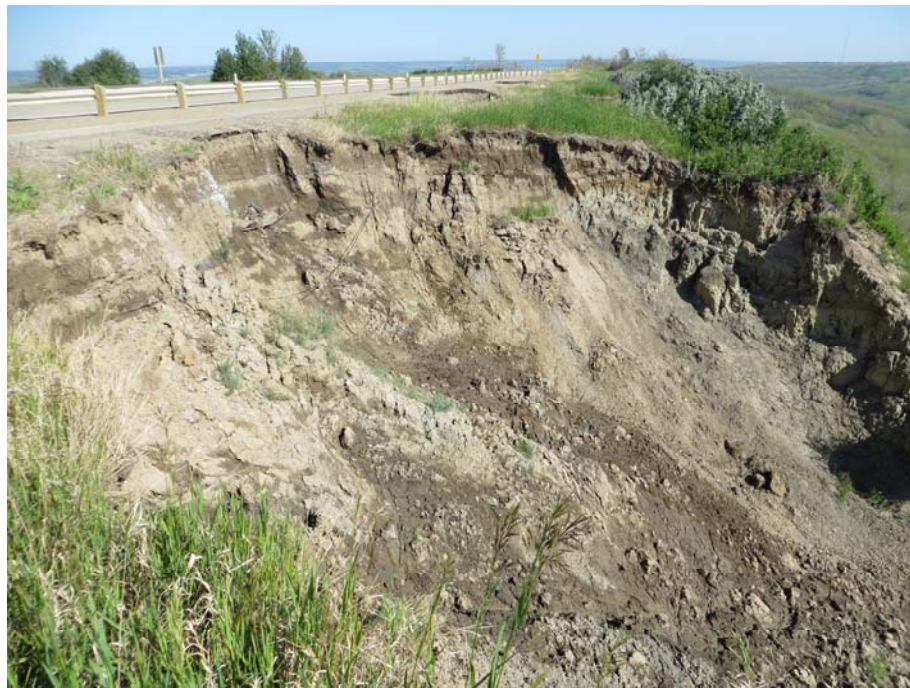
Photo 7.
Looking northwards across the backscarp of Slide 4. There has been retrogression since August 2011 and some movement in the slide bowl, which is now 35 m in width. The backscarp is now at about 4m from the new guardrail alignment (increase of 0.4 m since 2011).

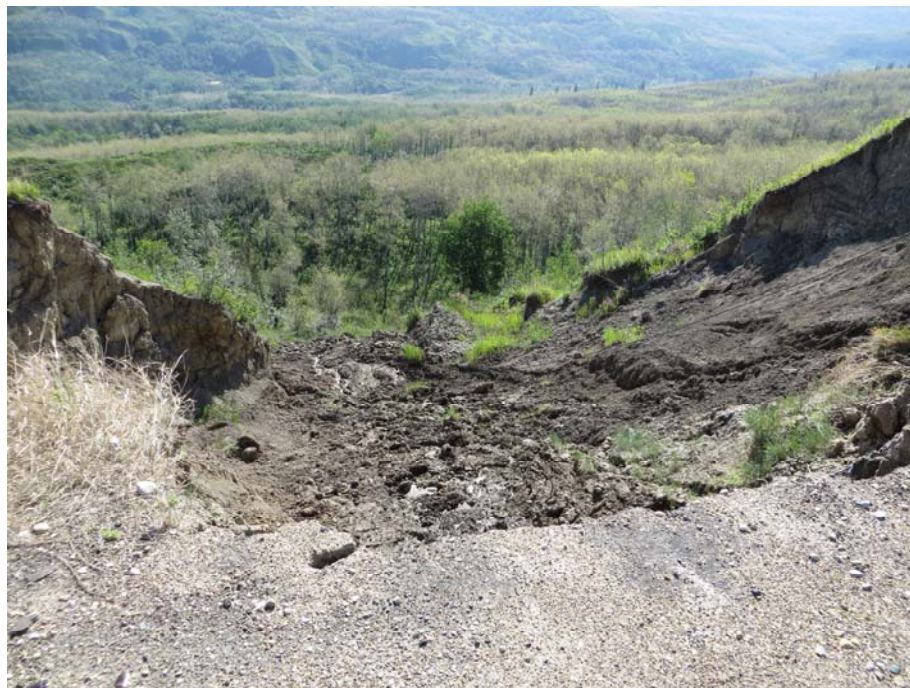
Photo 8.
Looking downslope at additional debris surface flow from Slide 4.
