PROJECT: SOUTHERN REGION GEOHAZARD ASSESSMENT AND INSTRUMENTATION MONITORING			
		TITLE: SITE S26 - ELKWATER AREA 'A'			
CLIENT:		DATE: OCTOBER 2010	JOB No.: CG25332.200	CAD FILE: 25332L02.dwg	FIGURE No.: FIGURE S26-1
				REV. A

PROJECT: SOUTHERN REGION GEOHAZARD ASSESSMENT AND INSTRUMENTATION MONITORING				
	TITLE: SITE S26 - ELKWATER AREA 'B'				
CLIENT:	DATE: OCTOBER 2010	JOB No.: CG25332.200	CAD FILE: 25332L03.dwg	FIGURE No.: FIGURE S26-2	REV. A

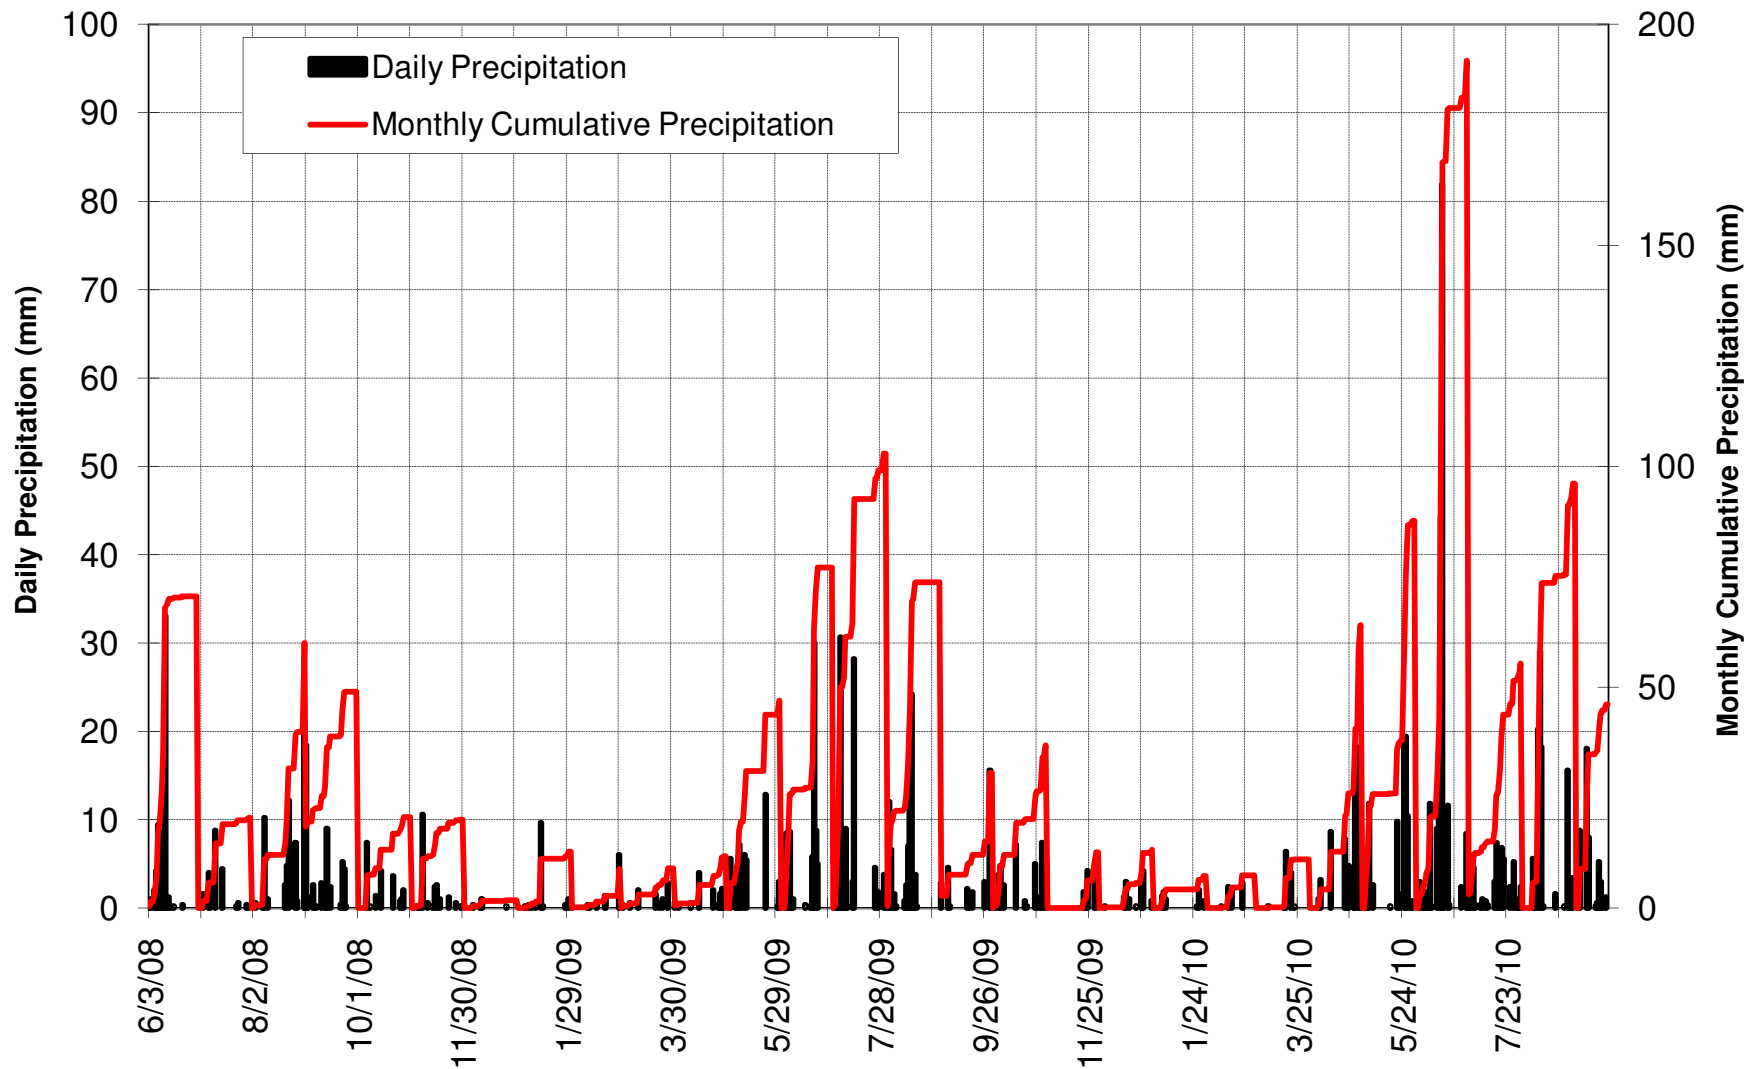
Client	Alberta Transportation		Figure S26-3	
Project	S26 - Hwy 41:03 - Elkwater		Date:	Revision
Precipitation Recorded At S26 - Elkwater			Oct-10	
			Job No.	
			CG25332.200	
				Weather Station.xls

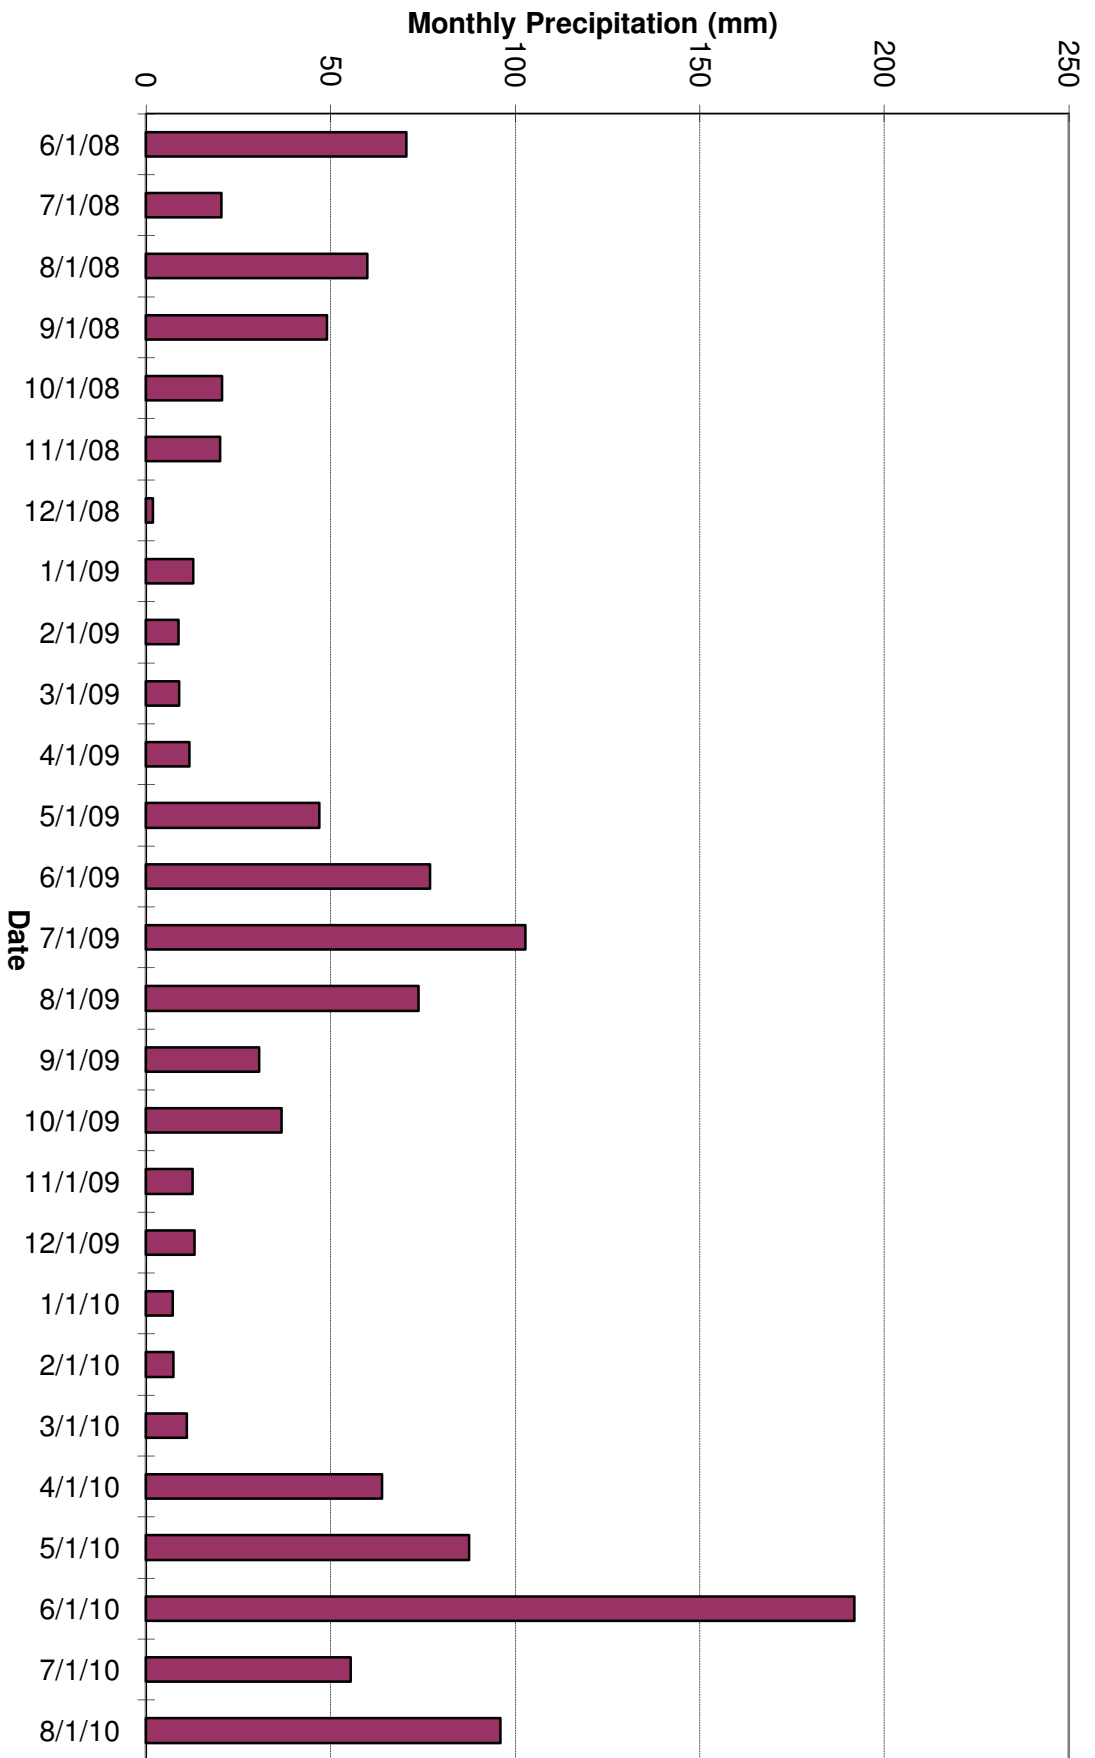
Client		Alberta Transportation	
Project		S26 - Elkwater	
Date:		Oct-10	Revision:
Job No.:		CG25332.200	
File No.:		Figure 1.xls	
Precipitation Measured at Elkwater Weather Station		Figure S26-4
