ALBERTA TRANSPORTATION AND  
ECONOMIC CORRIDORS GRMP  
NORTH CENTRAL (ATHABASCA AND FORT  
McMURRAY DISTRICTS)  
INSTRUMENTATION MONITORING - Spring 2025

**SITE NC090: HWY 2:42 BAPTISTE CREEK BRIDGE  
NW APPROACH FILL LANDSLIDE (BF7055)**

**ALBERTA TRANSPORTATION AND ECONOMIC CORRIDORS  
NORTH CENTRAL REGION - ATHABASCA AND FORT McMURRAY DISTRICTS  
INSTRUMENTATION MONITORING FIELD SUMMARY (NC090)  
SPRING 2025**

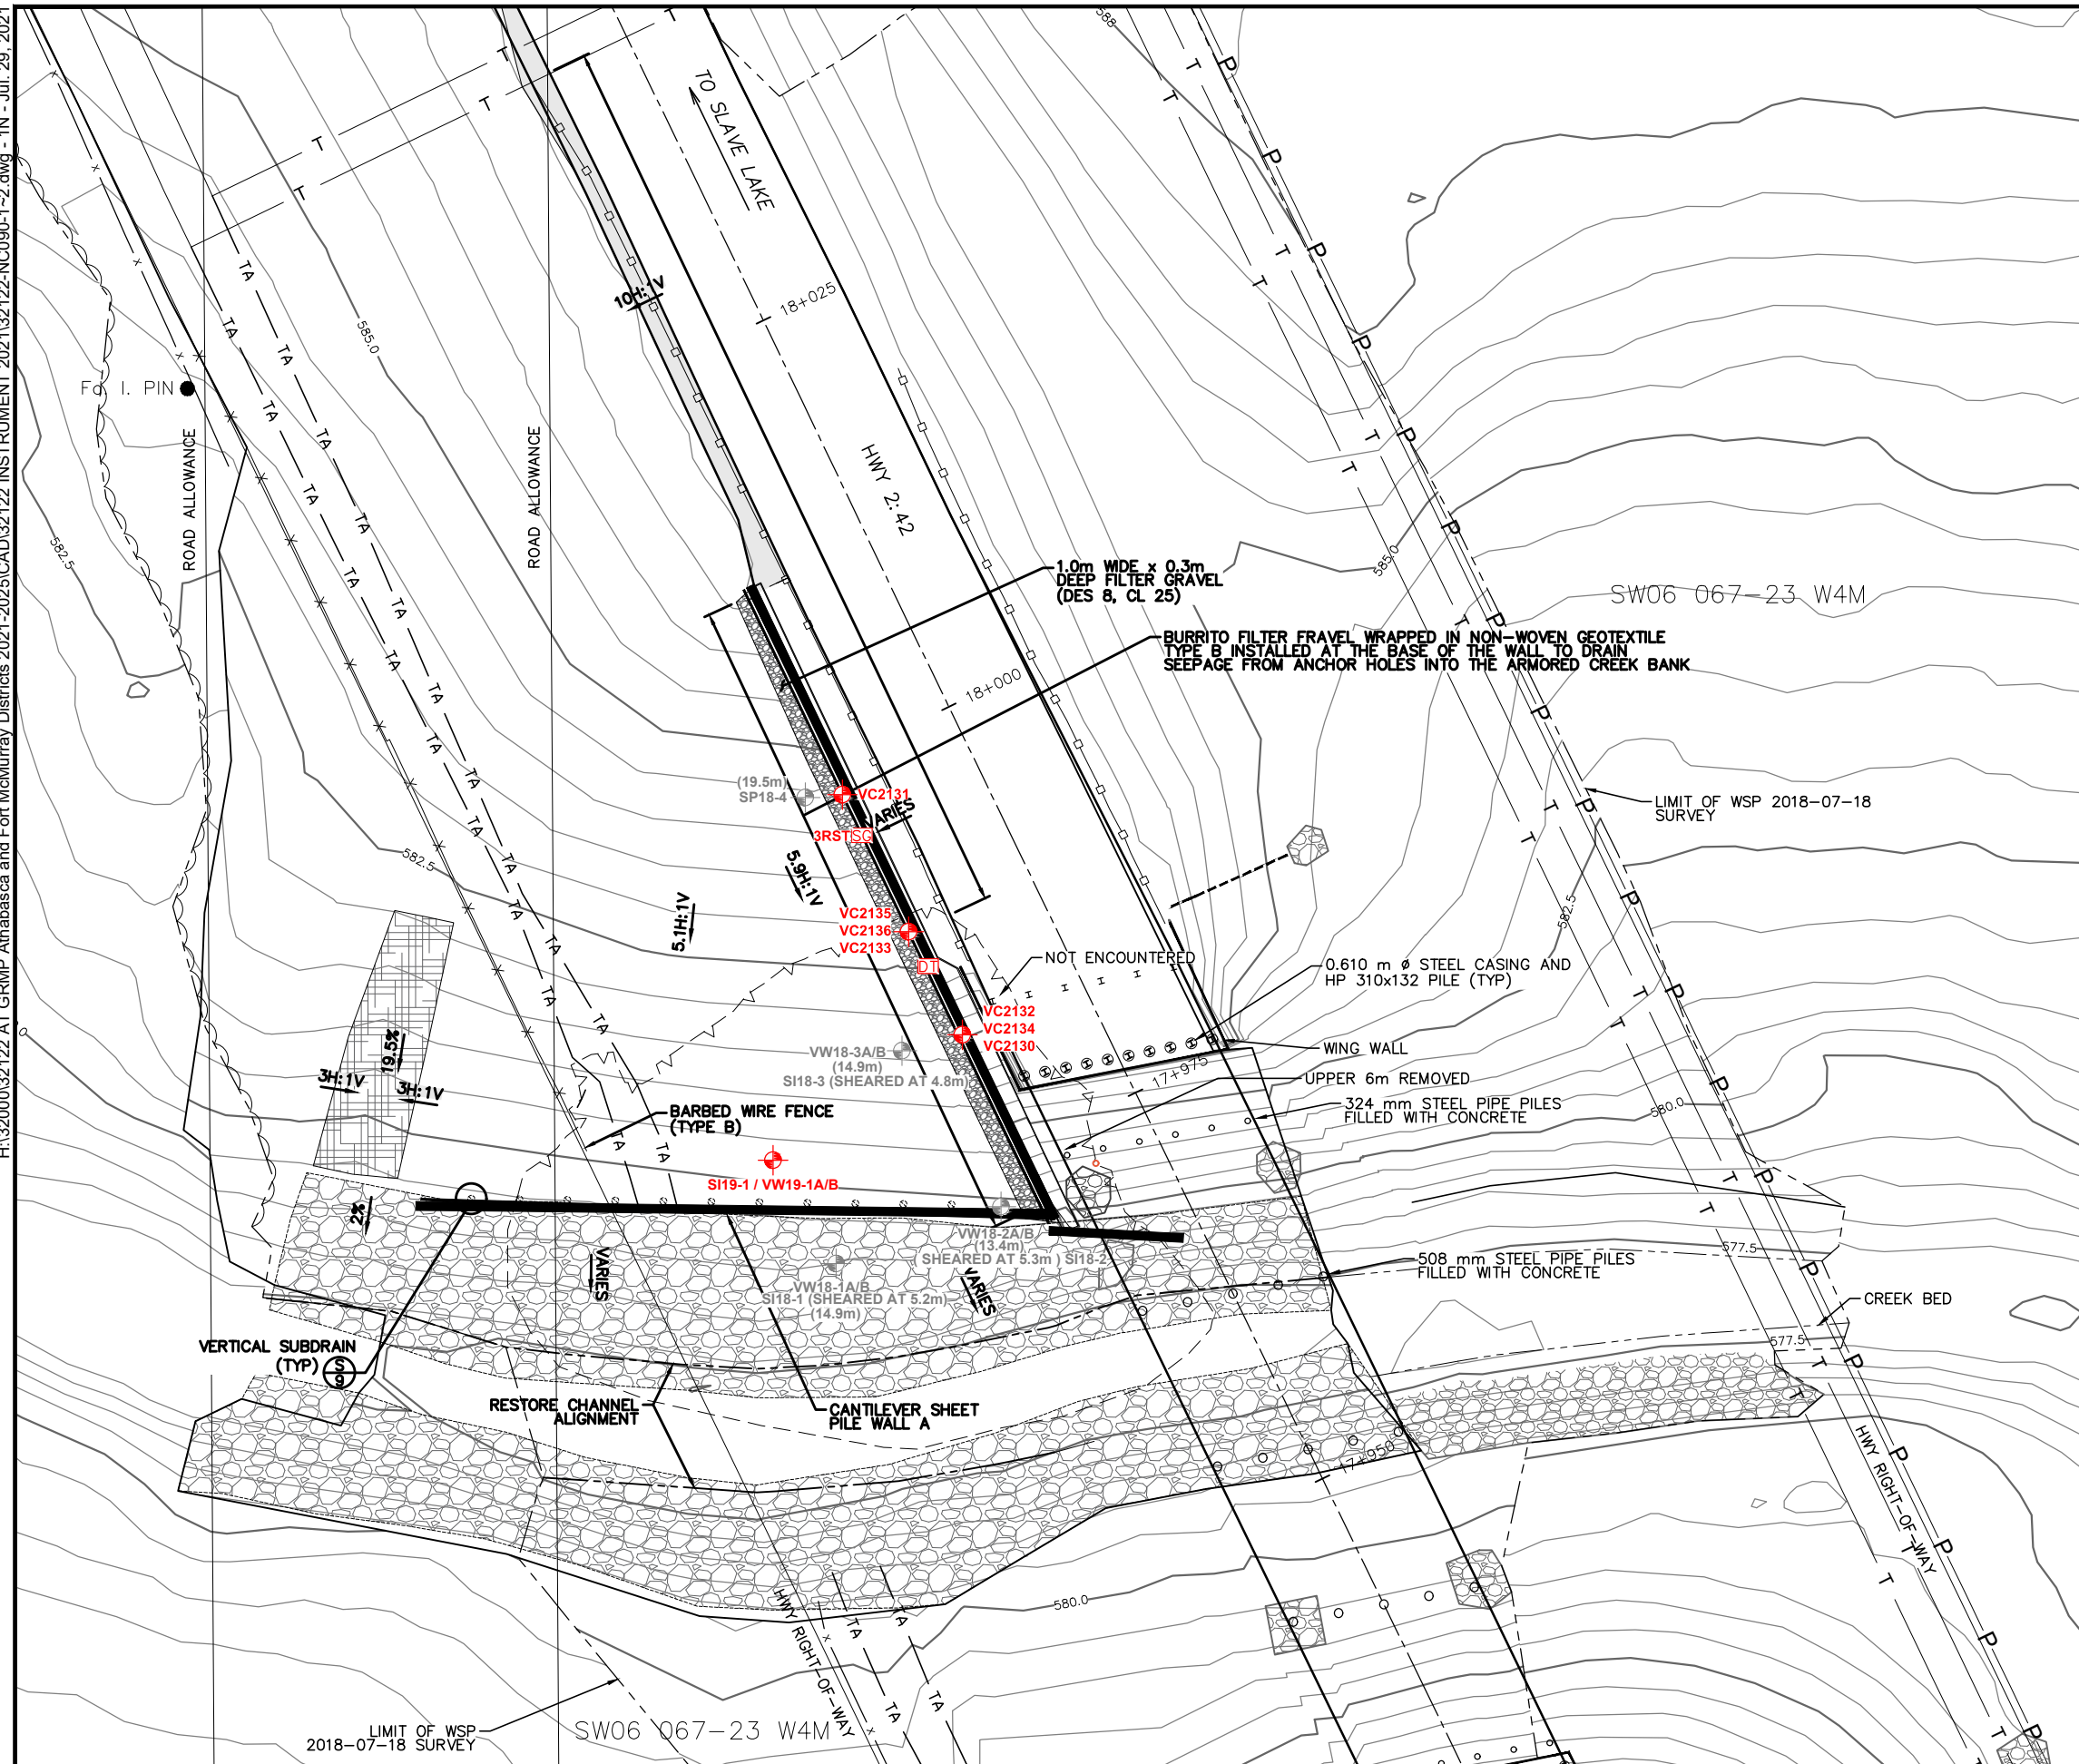
**DWG No. 32122-NC090-1**

| 7 load cells, 3 VW strain gauges and 2 VW Piezometers are wired to a Campbell Scientific CR6 datalogger mounted on the west face of the sheet pile wall |

**NORTH CENTRAL  
(ATHABASCA AND FORT MCMURRAY DISTRICTS)  
NC090: HWY 2:42 BAPTISTE CREEK BRIDGE (BF7055)  
SITE PLAN SHOWING APPROXIMATE  
INSTRUMENT LOCATIONS**

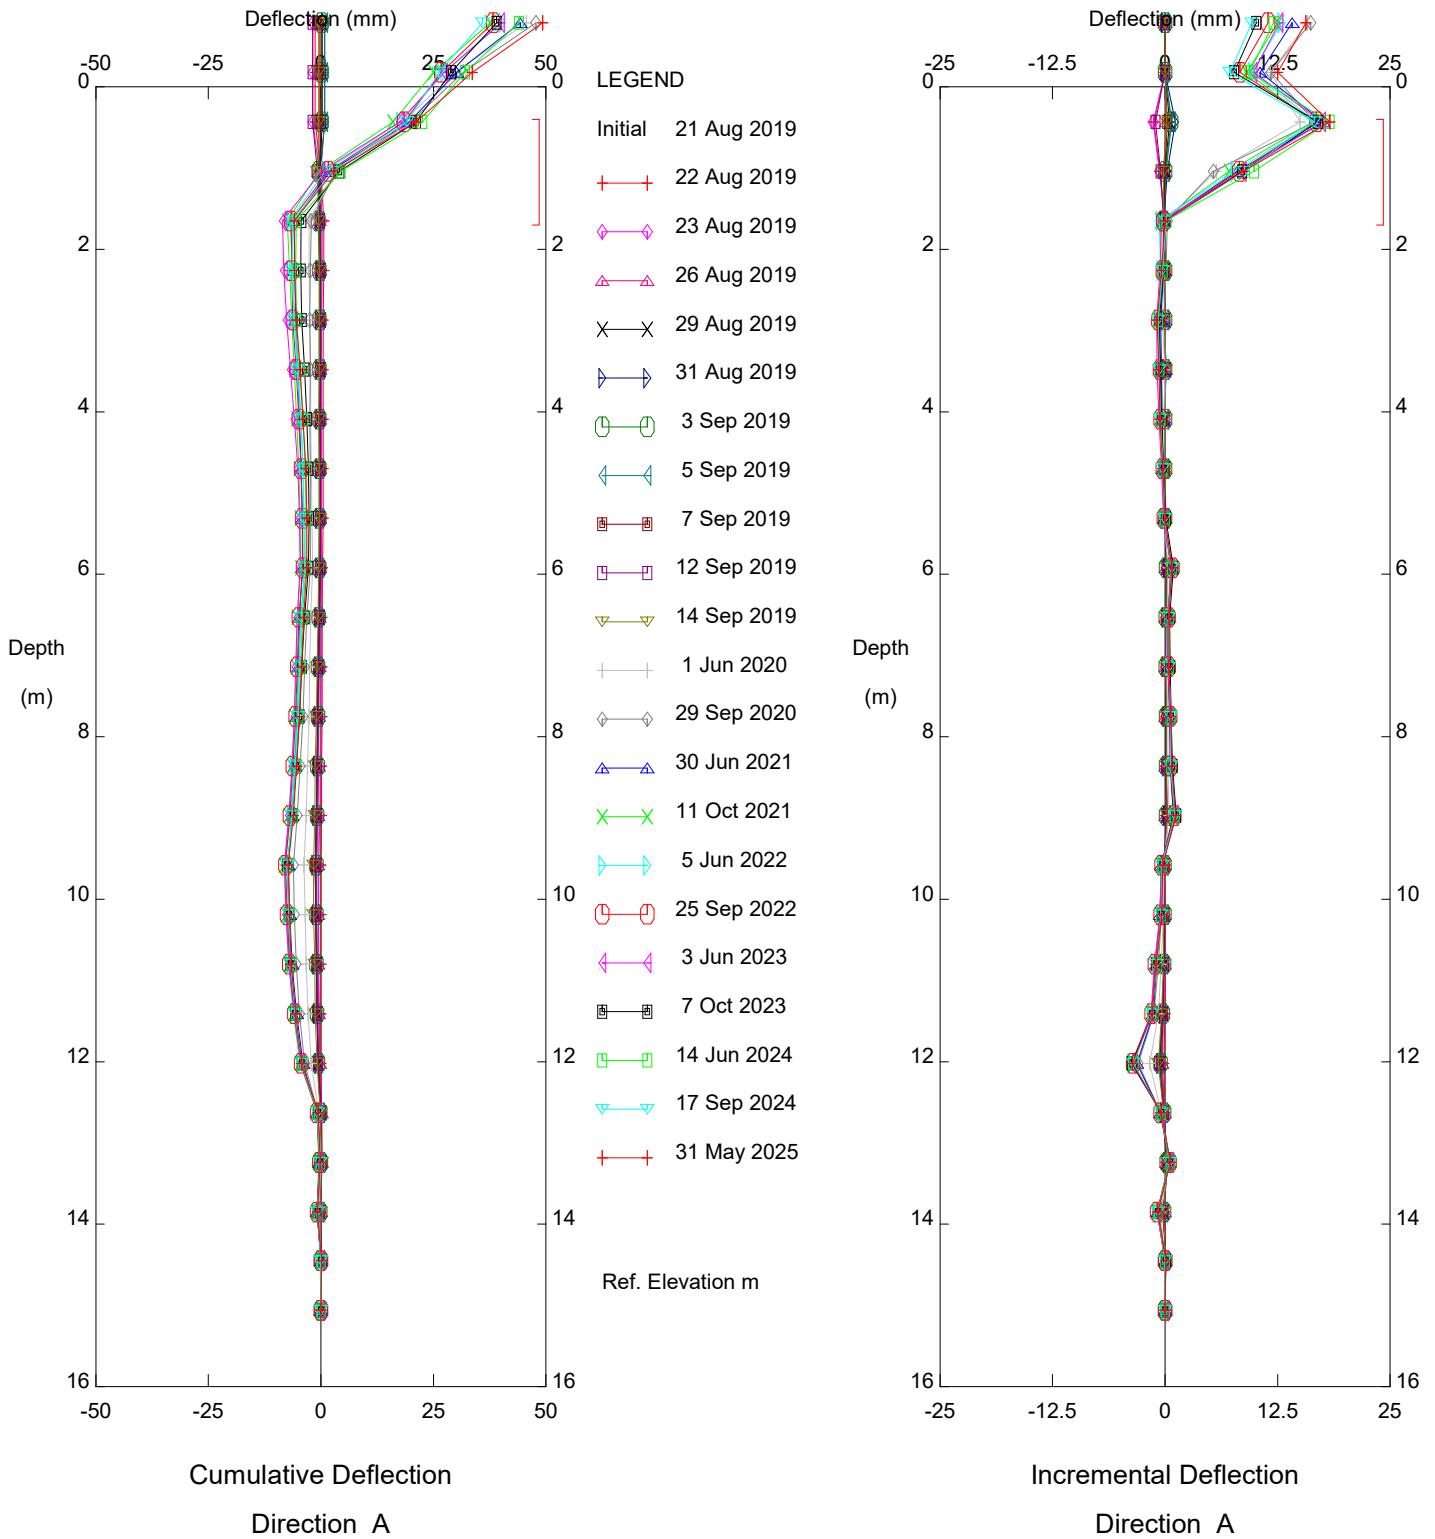
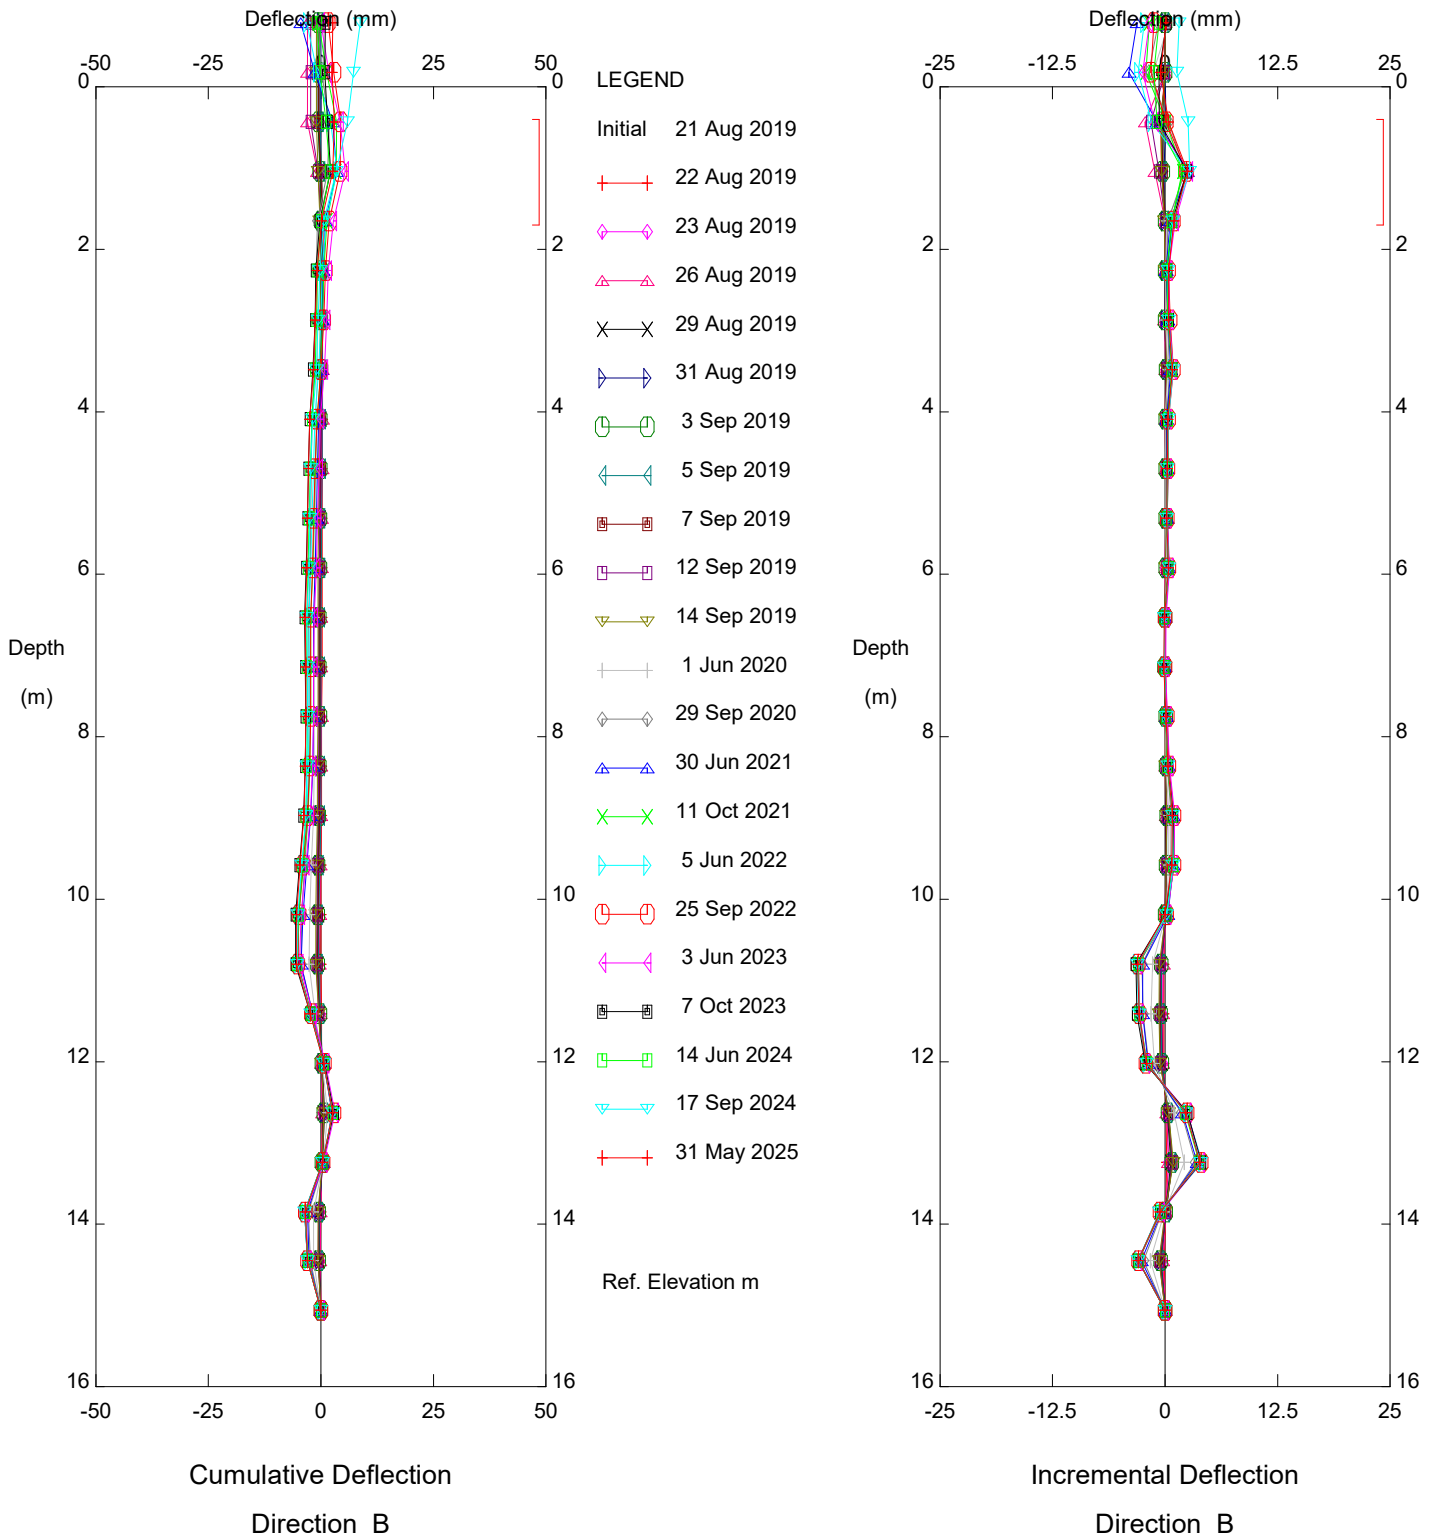
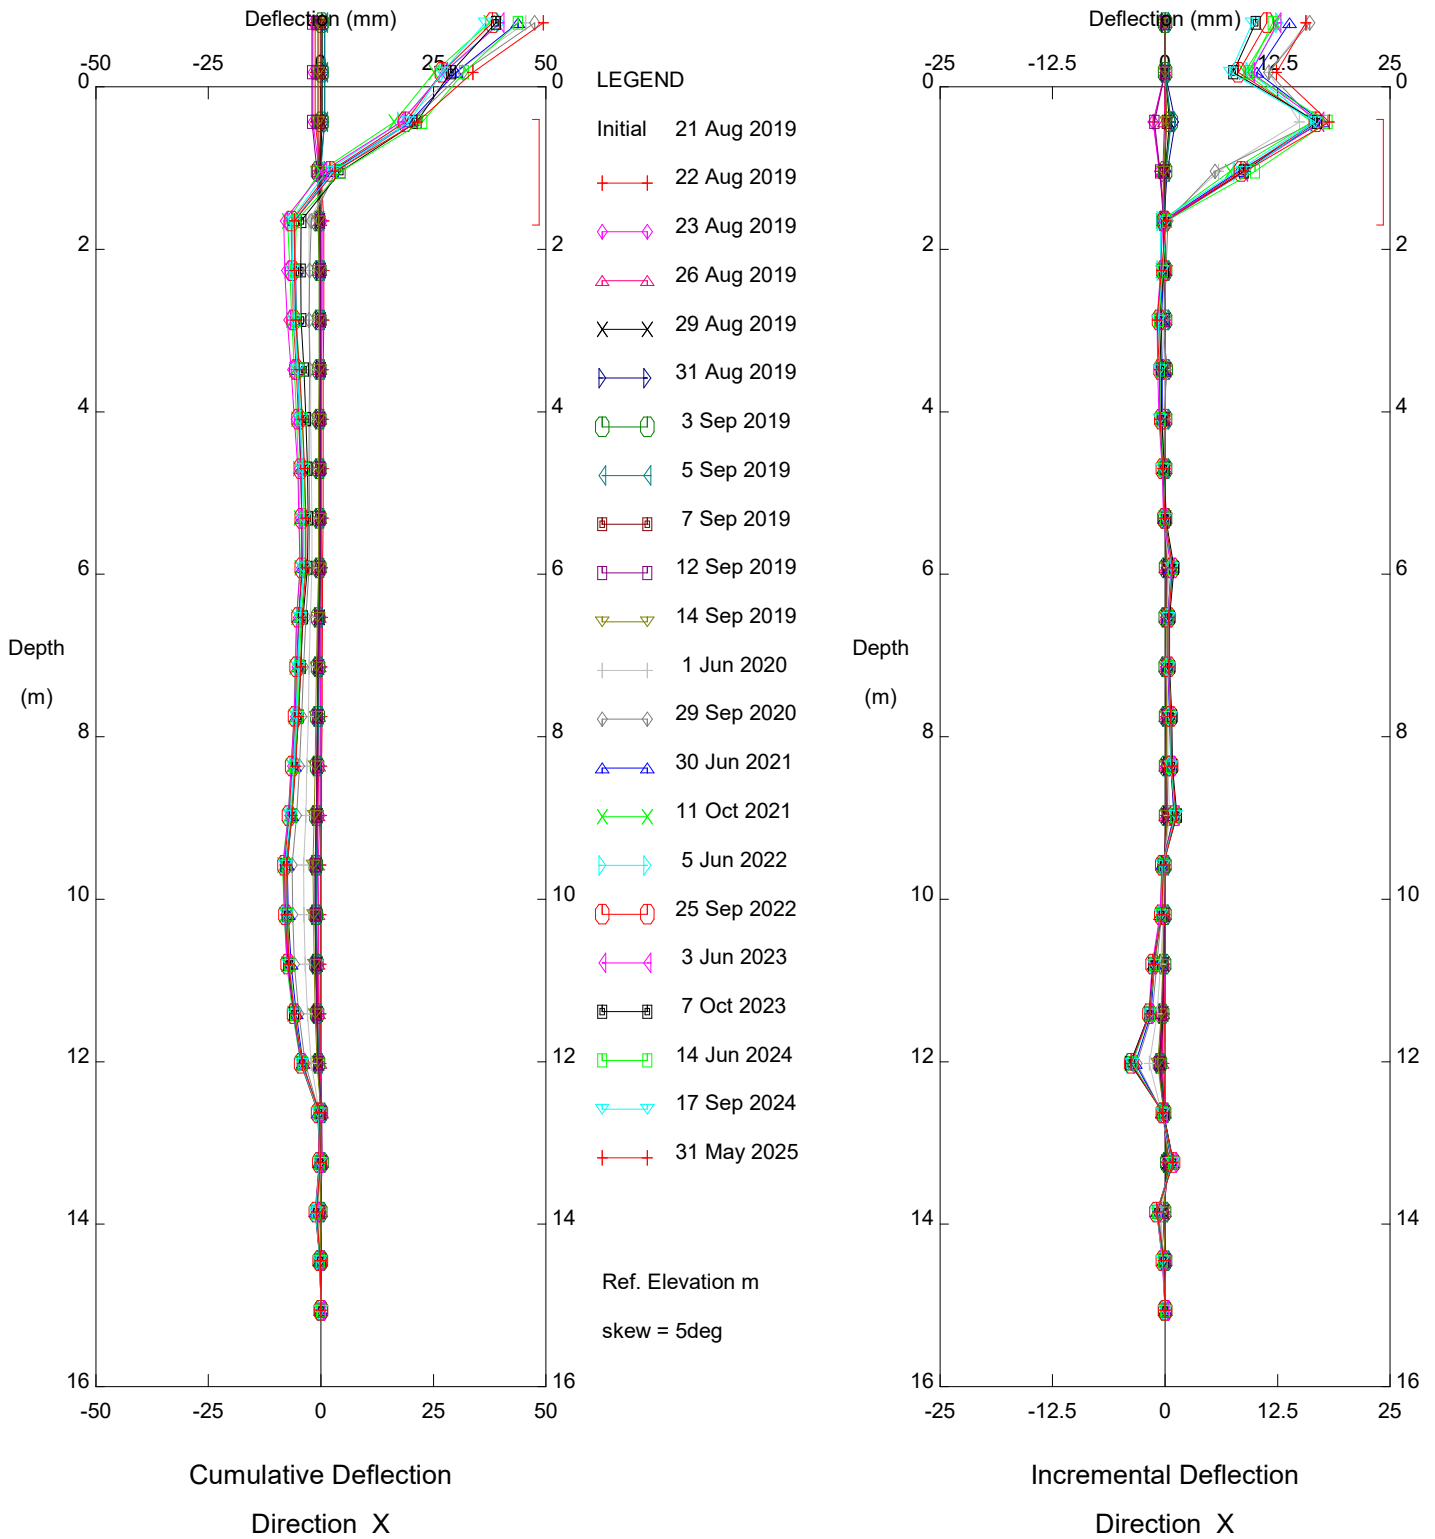
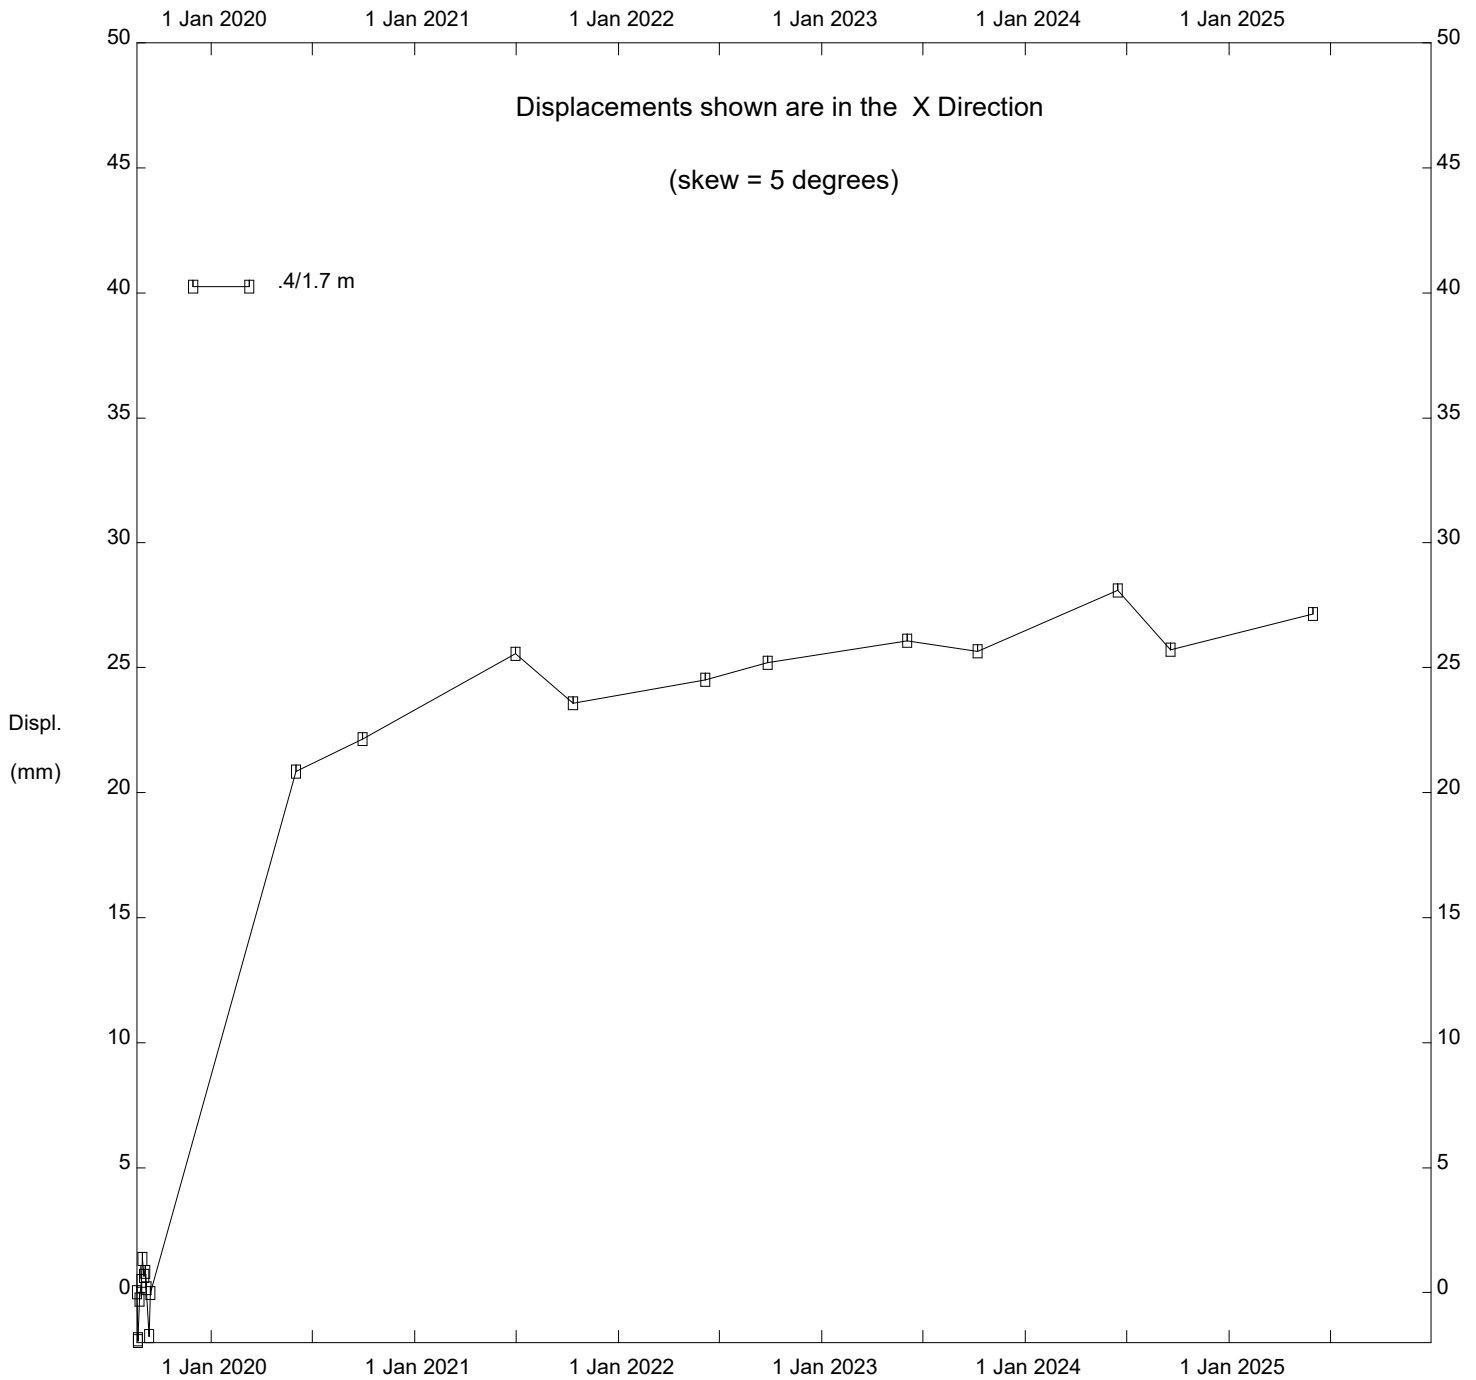
| Discussion | |
|---|---|
| <b>Interpretation of Monitoring Results:</b> | <p>Slope inclinometer SI19-1, installed upslope of the cantilever sheet pile wall, showed a rate of movement of 2.0 mm/yr over 0.4 m to 1.7 m depth since the fall of 2024 readings.</p> <p>Vibrating wire piezometers VW19-1A and VW19-1B showed increases in groundwater level of 0.19 m and 0.37 m, respectively, since the fall of 2024 reading. Both vibrating wire piezometers have shown a pattern of seasonable variation in groundwater level, with the highest groundwater levels typically recorded between the months of April and June. The seasonal variation in groundwater level is more pronounced in VW19-1A, which is installed closer to the ground surface at 5 m depth.</p> <p>Load cells VC2135, VC2132, VC2136, VC2134, and VC2133 showed increases in measured load, ranging from 0.60 kN in load cell VC2133 to 4.53 kN in VC2132 since the fall of 2024 readings.</p> <p>Load cells VC2131 and VC2130 showed decreases in measured load of 0.14 kN and 0.10 kN, respectively, since the fall of 2024 readings.</p> |

Hwy 2:42 Baptiste Creek Bridge, Inclinator SI19-1

| <b>Future Work:</b> | The instruments should be read again in the fall of 2025. |

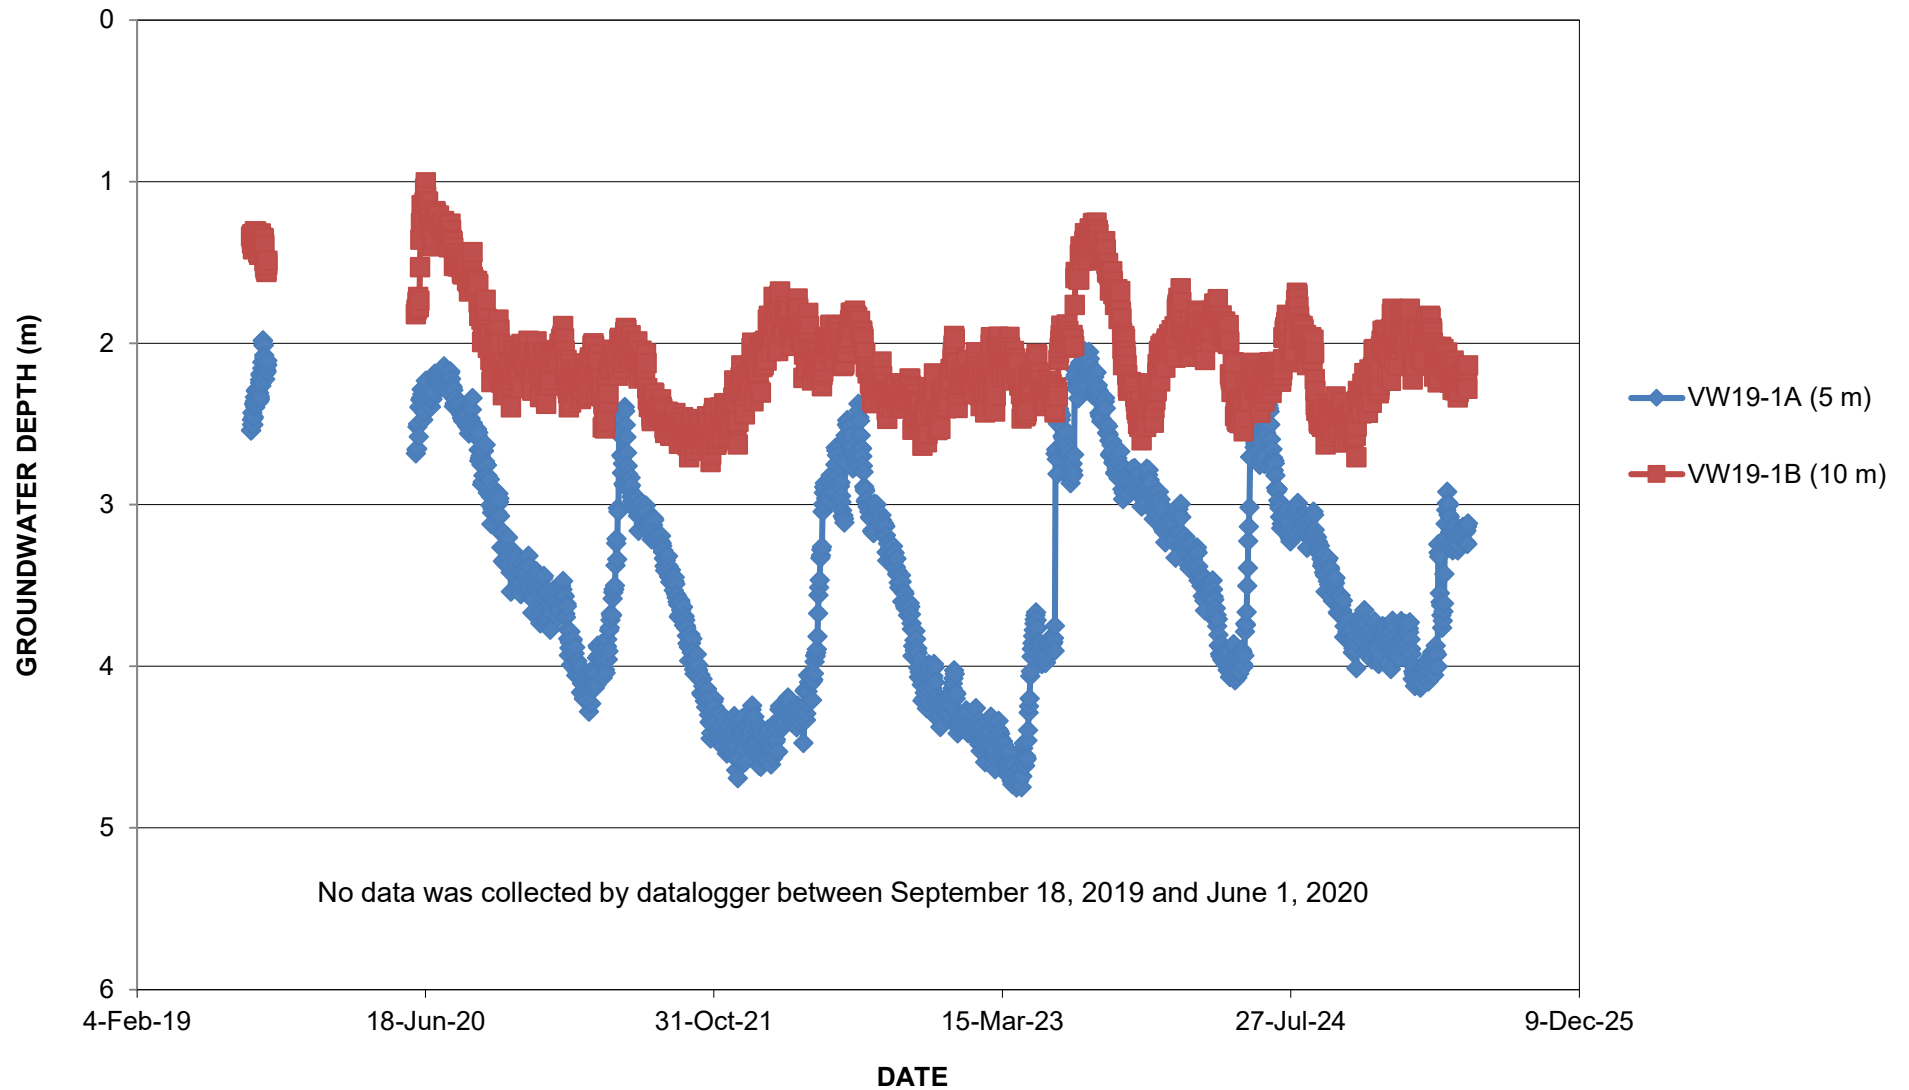
**FIGURE NC090-1**  
**PIEZOMETER DATA FOR HWY 2:42 BAPTISTE CREEK**

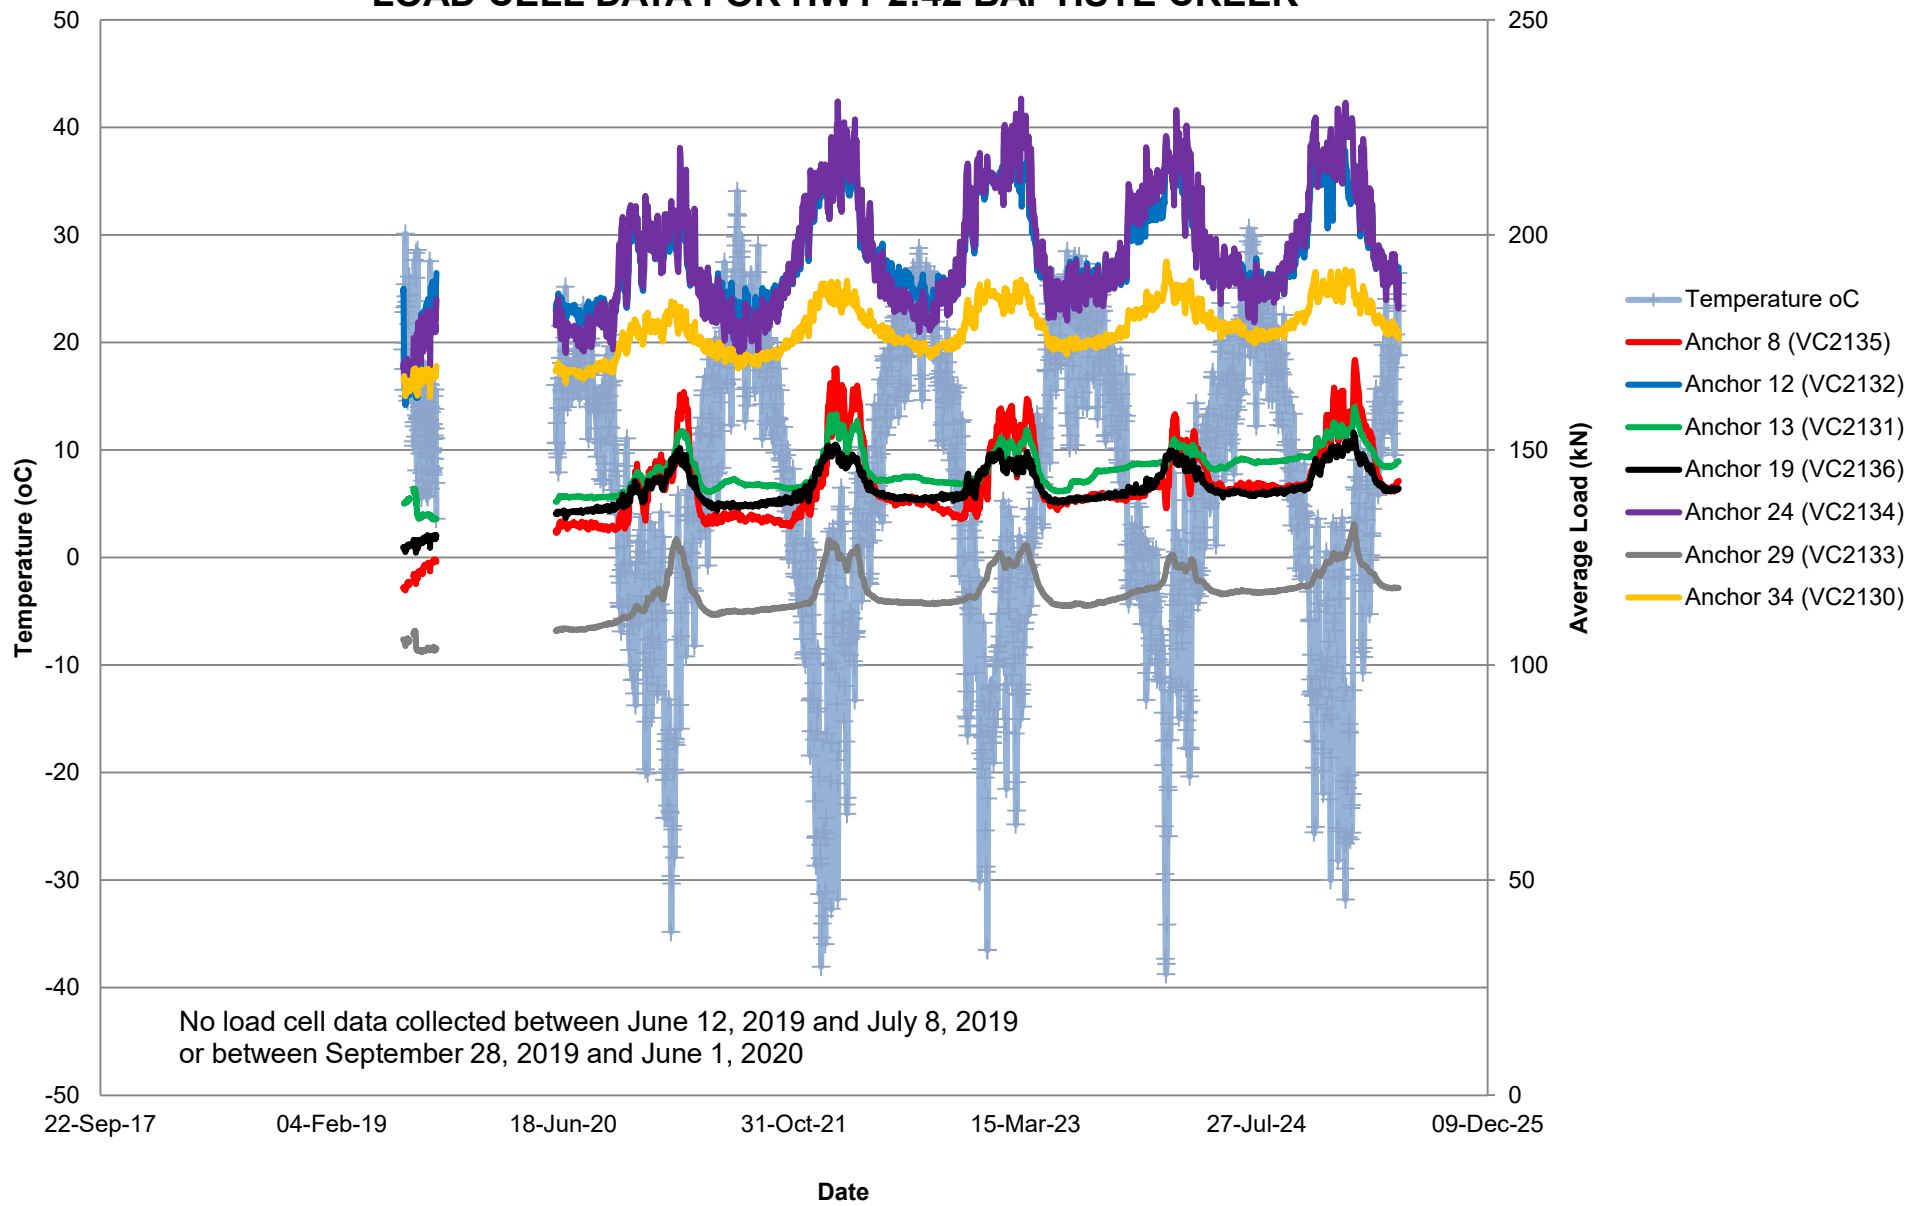
| | <p>Load Cells VC2135, VC2132, VC2131, VC2136, and VC2133 registered their maximum recorded loads during January and February 2025. The load cells have generally shown a pattern of seasonal variation in loads, with the highest loads typically recorded during the winter months. VC2135, VC2131, and VC2136 are currently above their design load by 2.81 kN, 7.40 kN, and 1.15 kN, respectively.</p> <p>The upper, middle, and lower strain gauges showed increases in total micro-strain of 3.21 <math>\mu\epsilon</math>, 4.46 <math>\mu\epsilon</math> and 1.80 <math>\mu\epsilon</math>, respectively, since the fall of 2024 readings. In general, the strain gauge readings continue to reflect minimal bending stresses in the tied-back sheet pile wall.</p> <p>The instrumentation readings indicate that the pile walls have performed well since construction completion.</p> |

**FIGURE NC090-2**  
**LOAD CELL DATA FOR HWY 2:42 BAPTISTE CREEK**

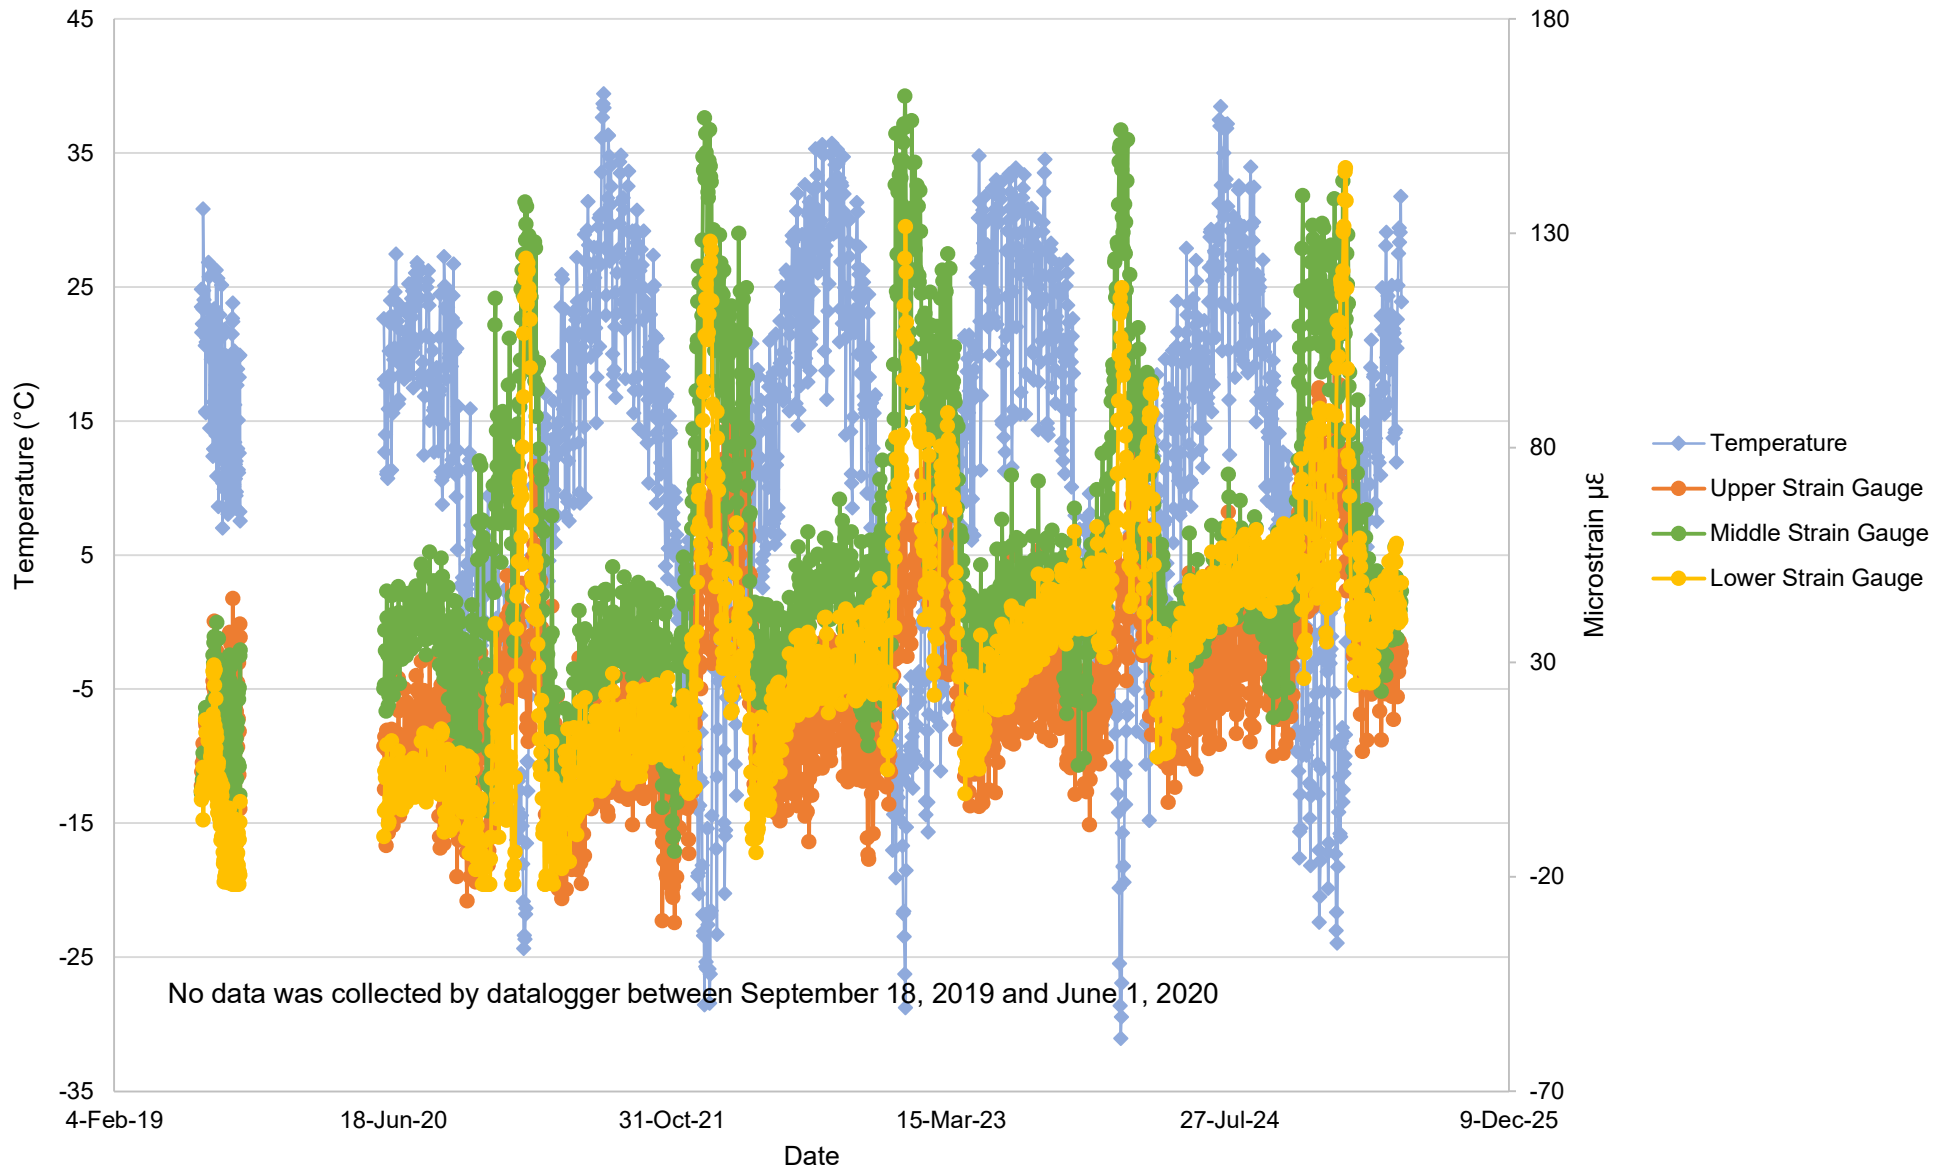
**FIGURE NC090-3**  
**STRAIN GAUGE DATA FOR HWY 2:42 BAPTISTE CREEK**
