SITE NUMBER AND NAME C56 H836:02 Settlement Repair		HIGHWAY & KM km 9	PREVIOUS INSPECTION DATE May 17, 2011	INSPECTION DATE June 14, 2012
LEGAL DESCRIPTION 11-29-23-W4	NAD 83 COORDINATES N 5704031 E 351107	RISK ASSESMENT PF: 1 CF: 1 TOTAL: 1

LAST READING DATE:	
PRIMARY SITE ISSUE: Pavement Settlement – slide on shoulder.	
APPROXIMATE DIMENSIONS: 40 m long	
DATE OF ANY REMEDIAL ACTION: 160 (5 rows) launched soil nails installed in July 2010.

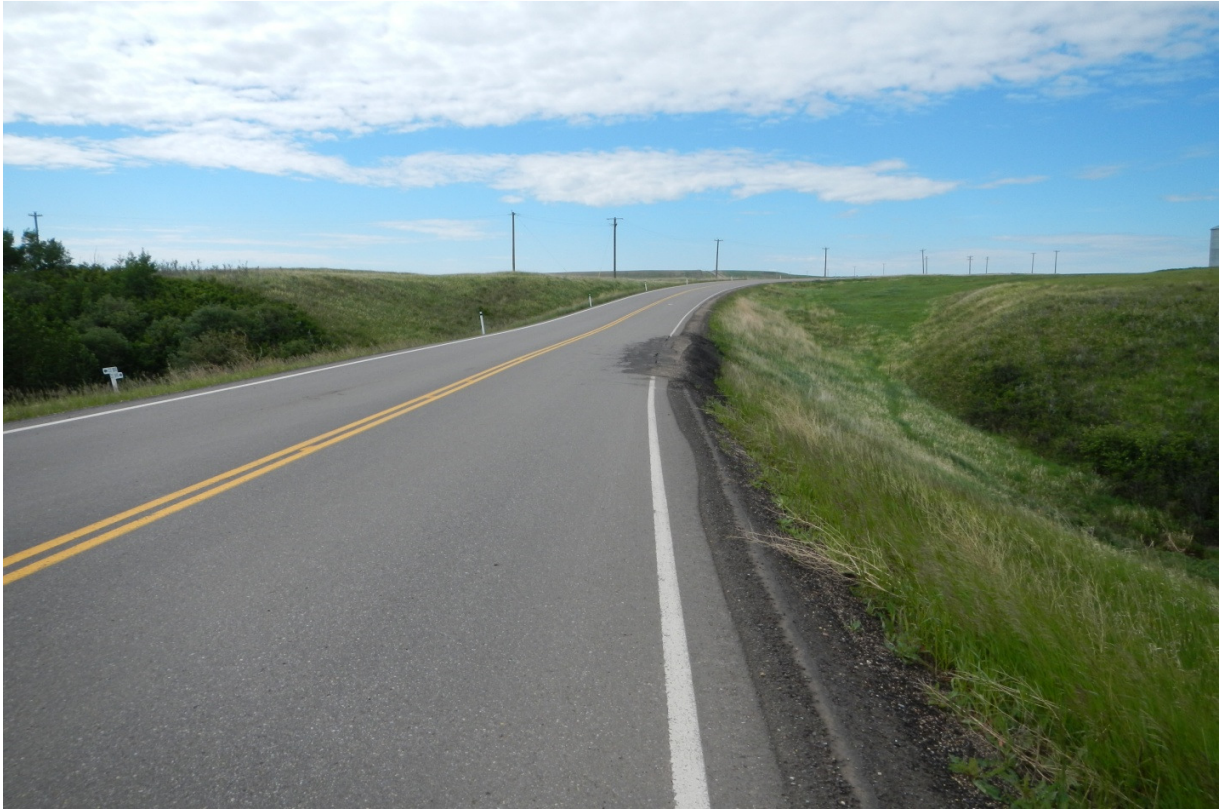
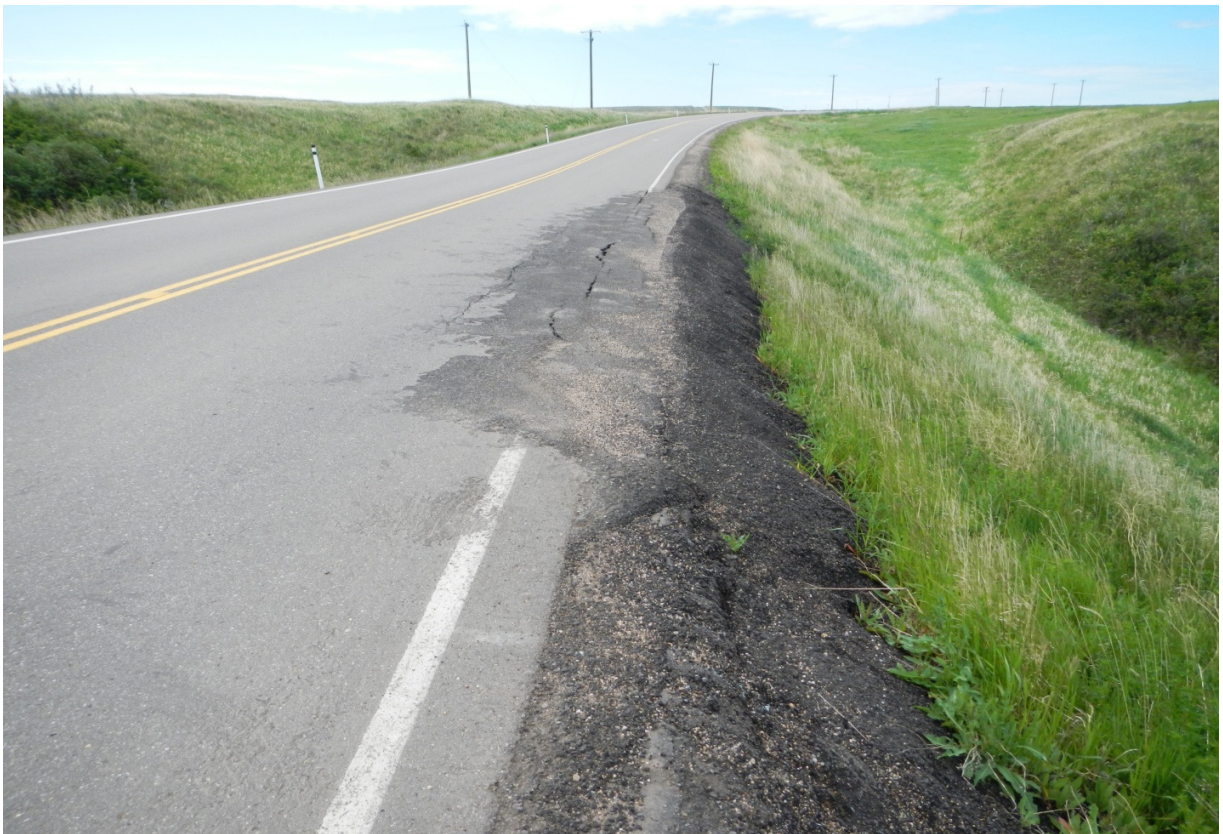
Site C56 H836
June 14, 2012

ITEM	CONDITION EXISTS		DESCRIPTION AND LOCATION	NOTICABLE CHANGE FROM LAST INSPECTION	
	YES	NO		YES	NO
Pavement Distress	X		Cracking along white line at edge of pavement.	X	
Slope Movement		X			
Erosion		X			
Seepage		X			
Culvert Distress		X

COMMENTS & RECOMMENDATIONS
See attached photos.
The crack should be filled and sealed to prevent water infiltration.
MCI to monitor – remove from Geohazard program.
