SITE NUMBER AND NAME C51 H841:02 Erosion		HIGHWAY & KM	PREVIOUS INSPECTION DATE June 18, 2007	INSPECTION DATE June 13, 2008
LEGAL DESCRIPTION NE 29-27-20-W4	NAD 83 COORDINATES N 5689106 E 377410		RISK ASSESMENT PF: 1 CF: 1 TOTAL: 1

LAST READING DATE:	
PRIMARY SITE ISSUE: Ditch erosion, embankment slide	
APPROXIMATE DIMENSIONS:	
DATE OF ANY REMEDIAL ACTION: Ditch erosion infilled with gravel summer 2007. Embankment slide trimmed by maintenance contractor since previous inspection.

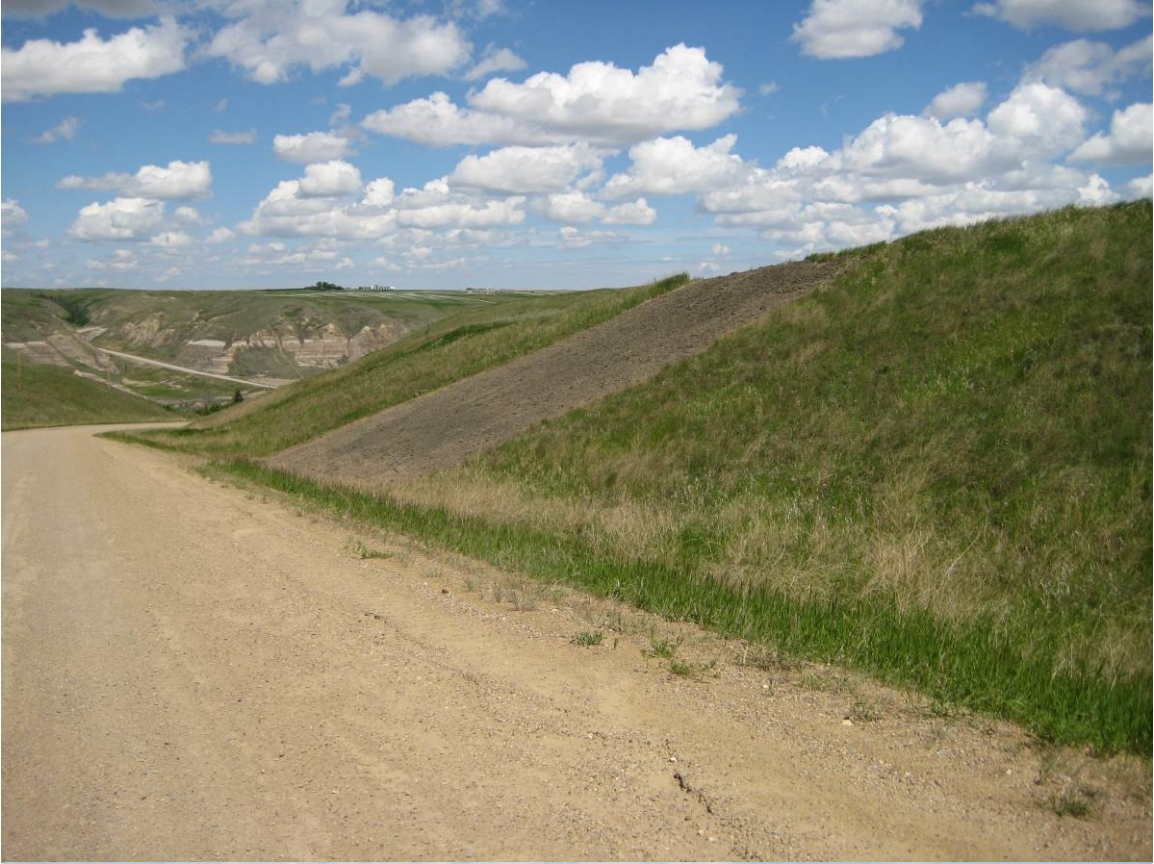
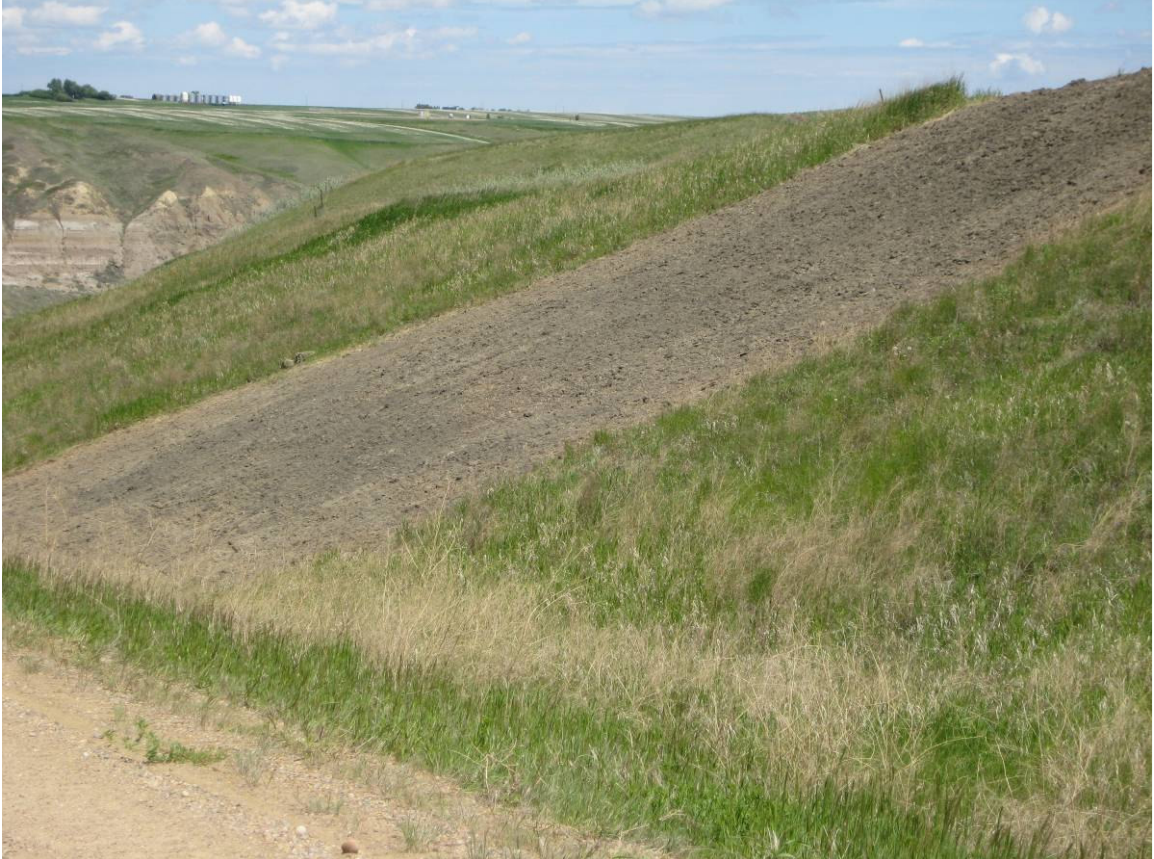
Site C51 H841:02 Erosion
June 13, 2008

ITEM	CONDITION EXISTS		DESCRIPTION AND LOCATION	NOTICABLE CHANGE FROM LAST INSPECTION	
	YES	NO		YES	NO
Pavement Distress		X			X
Slope Movement	X		No slope movement is apparent since trimming.	X	
Erosion	X		Erosion had cut into highway edge; channel was filled with gravel but erosion continued. Additional gravel was added to channel and erosion does not appear to have progressed further.	X	
Seepage		X			X
Culvert Distress		X			X
