SITE NUMBER AND NAME: C019 Upper Slide		HIGHWAY & KM: 575:04, 25.654	PREVIOUS INSPECTION DATE: June 13, 2017	INSPECTION DATE: June 12, 2018
LEGAL DESCRIPTION: 02-27-029-21 W4M	NAD 83 COORDINATES: UTM Northing Easting 12 5707581 369918		RISK ASSESSMENT: PF: 4 CF: 4 TOTAL: 16	
AVERAGE ANNUAL DAILY TRAFFIC (AADT): 980 (west) (Ref No. 106230)			CONTRACT MAINTENANCE AREA (CMA): 21

PRIMARY SITE ISSUE: A slide on a steep embankment slope in a narrow valley on the north side (westbound lane) of Hwy 575.

PROJECT CENTRAL REGION GEOHAZARD RISK MANAGEMENT PROGRAM		
TITLE Site Plan C019 - Upper Slide Hwy 575:04, km 25.654		
SCALE 1:1,000	PROJECT No. A05115A02	FIG No. 1

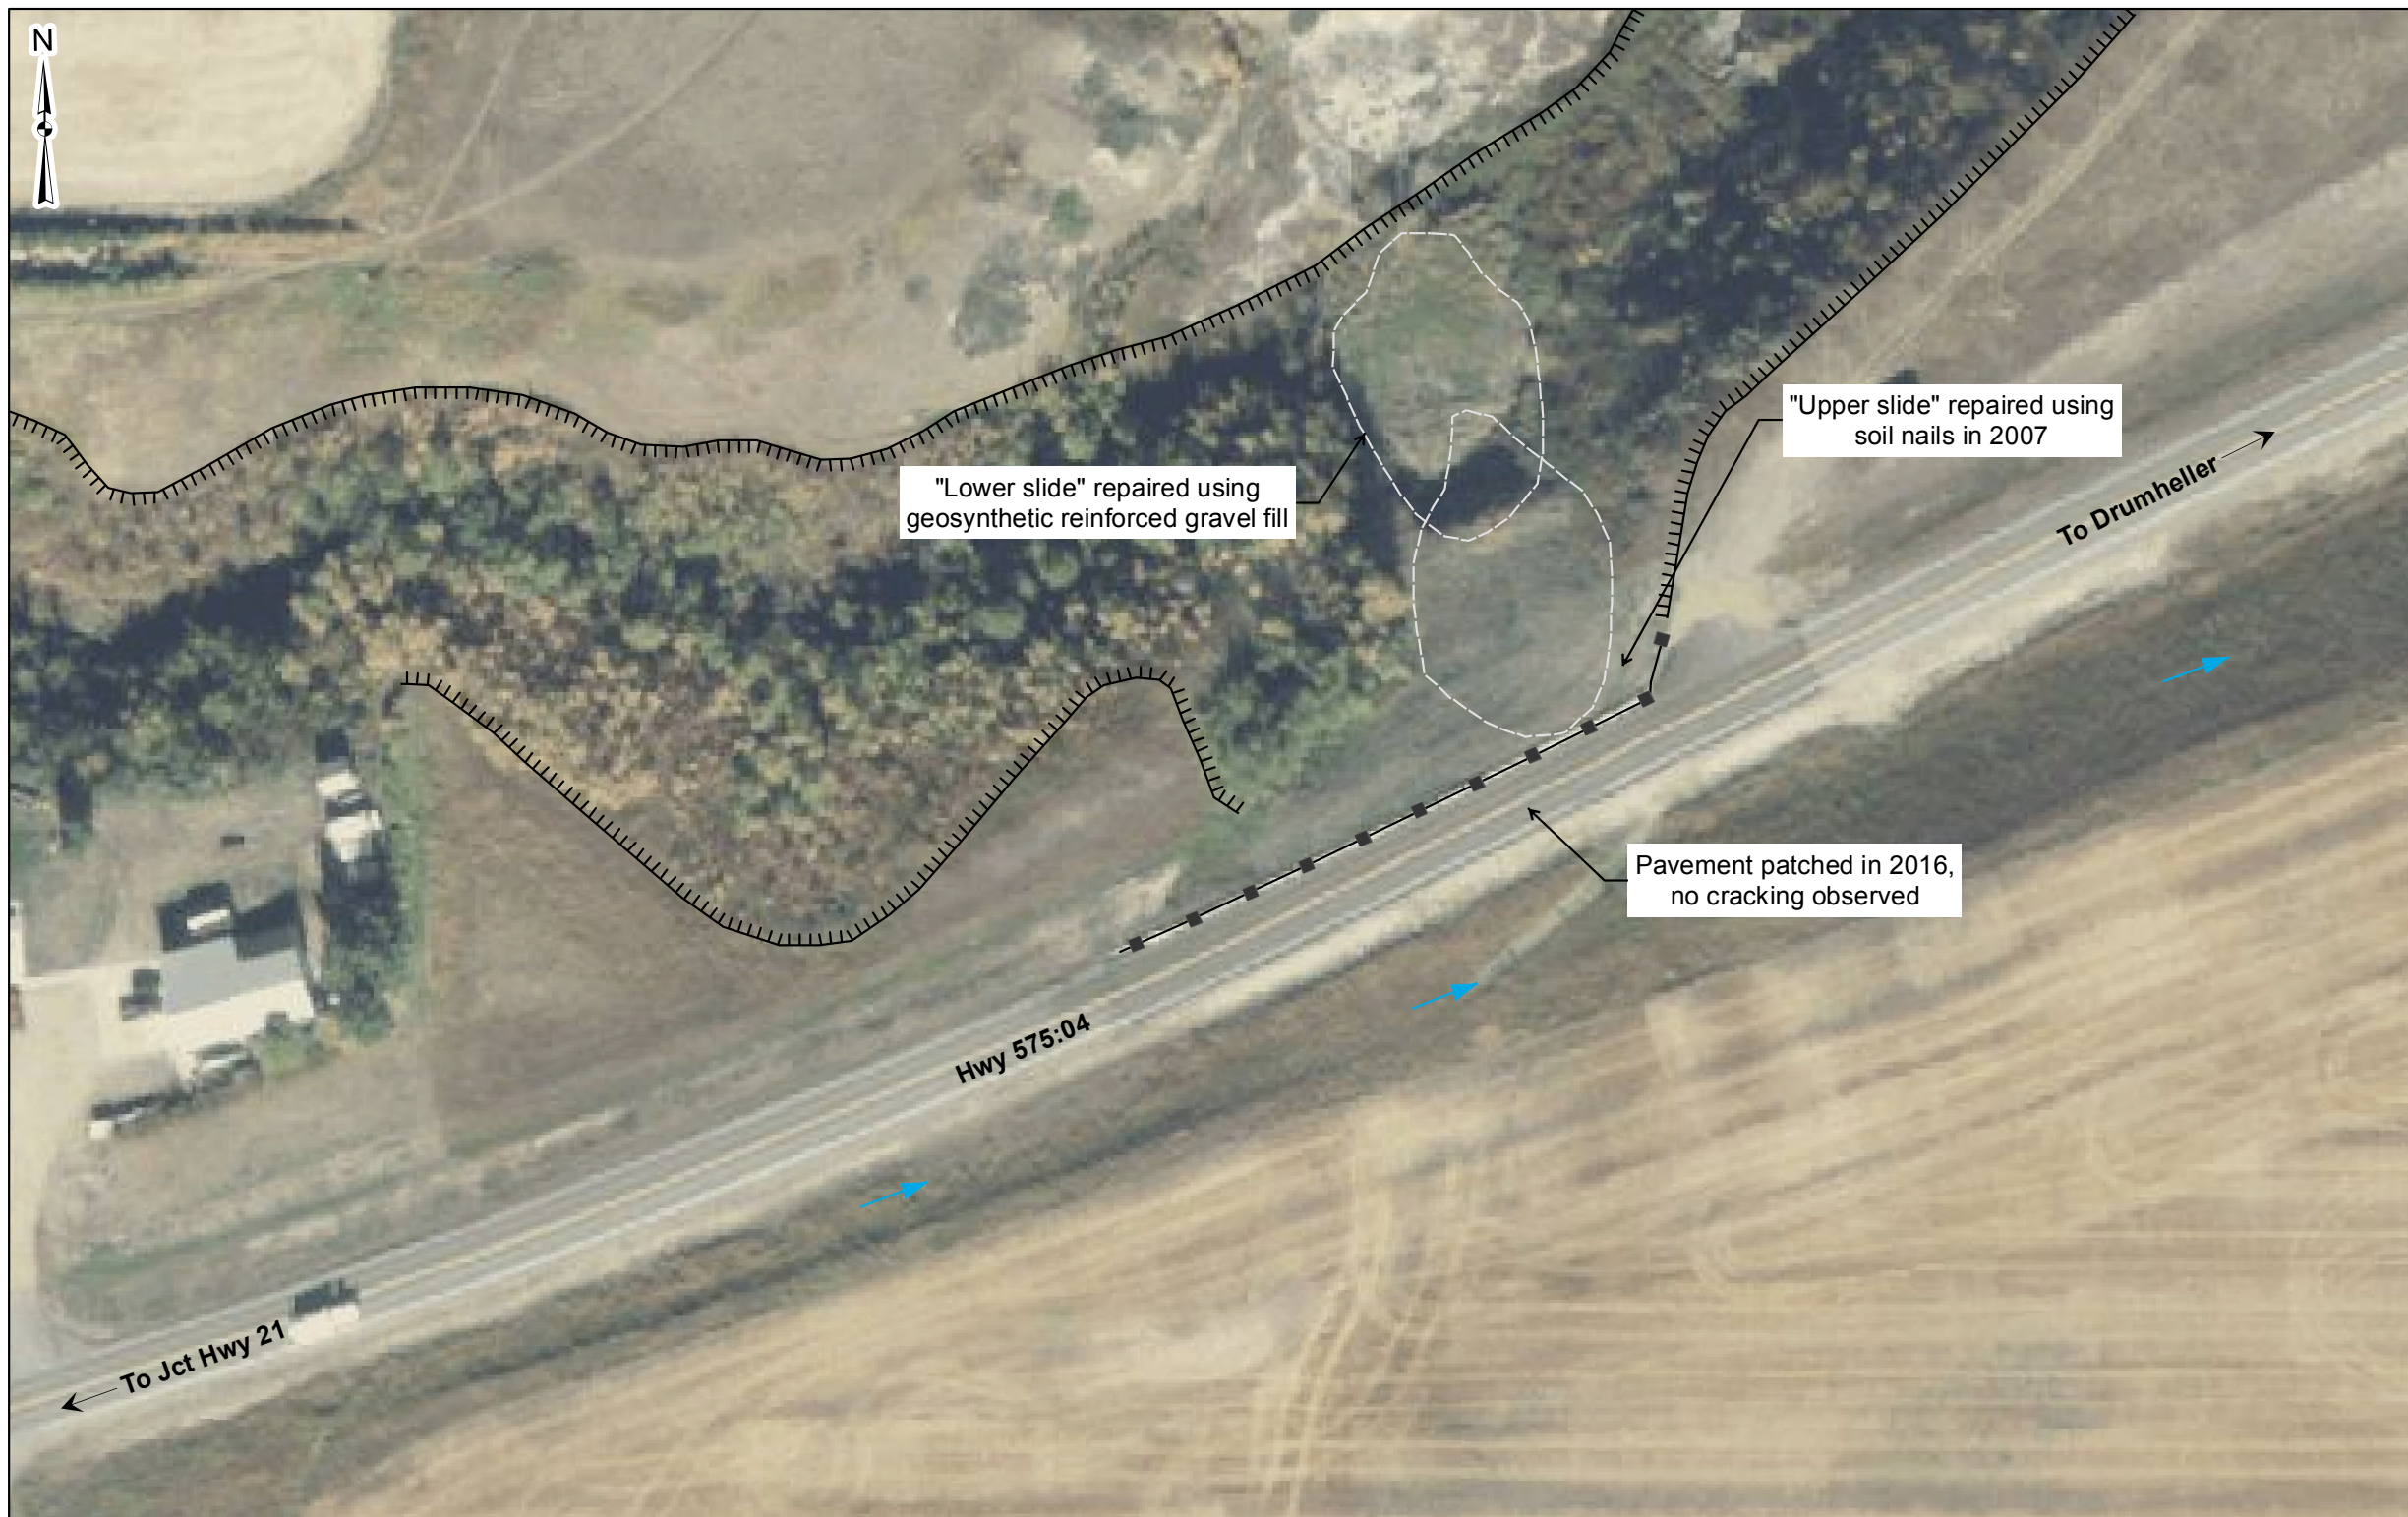
APPROXIMATE DIMENSIONS: The slide is approximately 30 m wide, and the highway embankment is approximately 30 m high sloped at approximately 3H:1V. A 5 m wide bench is located at an approximate height of one-quarter the slope height.

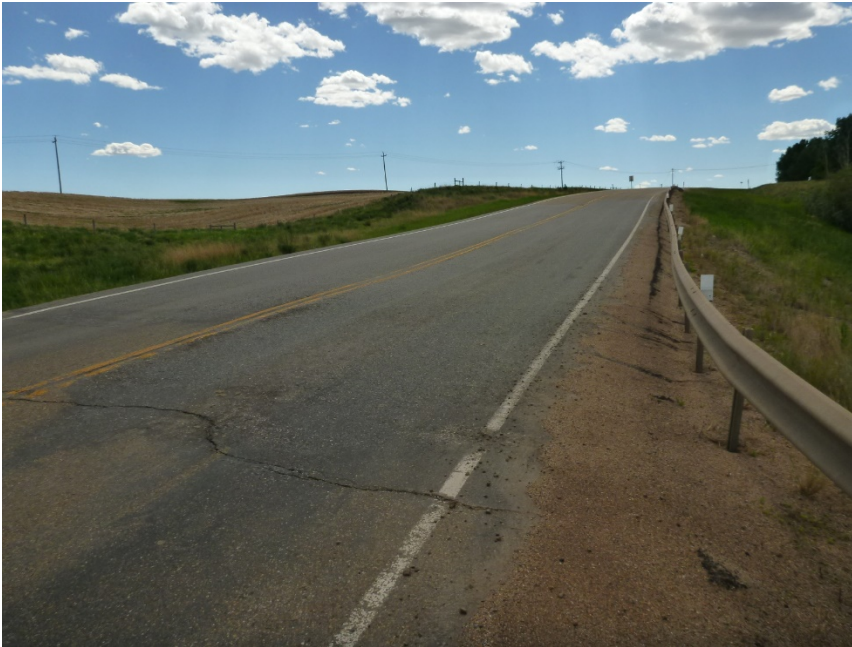
During the 2018 inspection, the AT MCI noted that the pavement patch appears to have settled since 2017. The amount of settlement is minor, compared to 2017 conditions.

Photo 1 The pavement was patched in 2016 and appears to have settled since the 2017 inspection (see photo 2). Photo taken June 12, 2018 looking southwest.

The site is recommended to be inspected every 2 years.

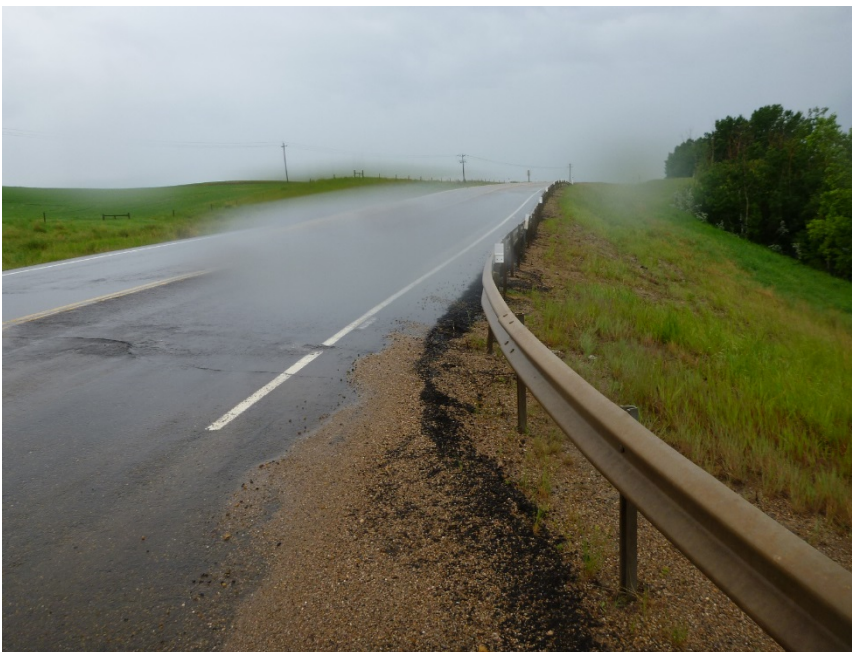
Photo 2 View of the pavement patch that was taken during the 2017 inspection. Photo taken June 13, 2017 looking southwest.
