ALBERTA TRANSPORTATION AND
ECONOMIC CORRIDORS GRMP
PEACE REGION
(GRANDE PRAIRIE DISTRICT - NORTH)
INSTRUMENTATION MONITORING - FALL 2025

Site Number	Location	Name	Hwy	km
GP004A	HWY 49:06 C1 10.586	Burnt River Bridge	49:06	Km 10.6
Legal Description: 12-10-78-4 W6		UTM Co-ordinates		
		11U E 403183.13	N	6178764.13

Current Monitoring:	1-Oct-2025	Previous Monitoring	17-June-2025
Instruments Read By:	Mr. Niraj Regmi, G.I.T and Mr. Angelo Castillo, of Thurber

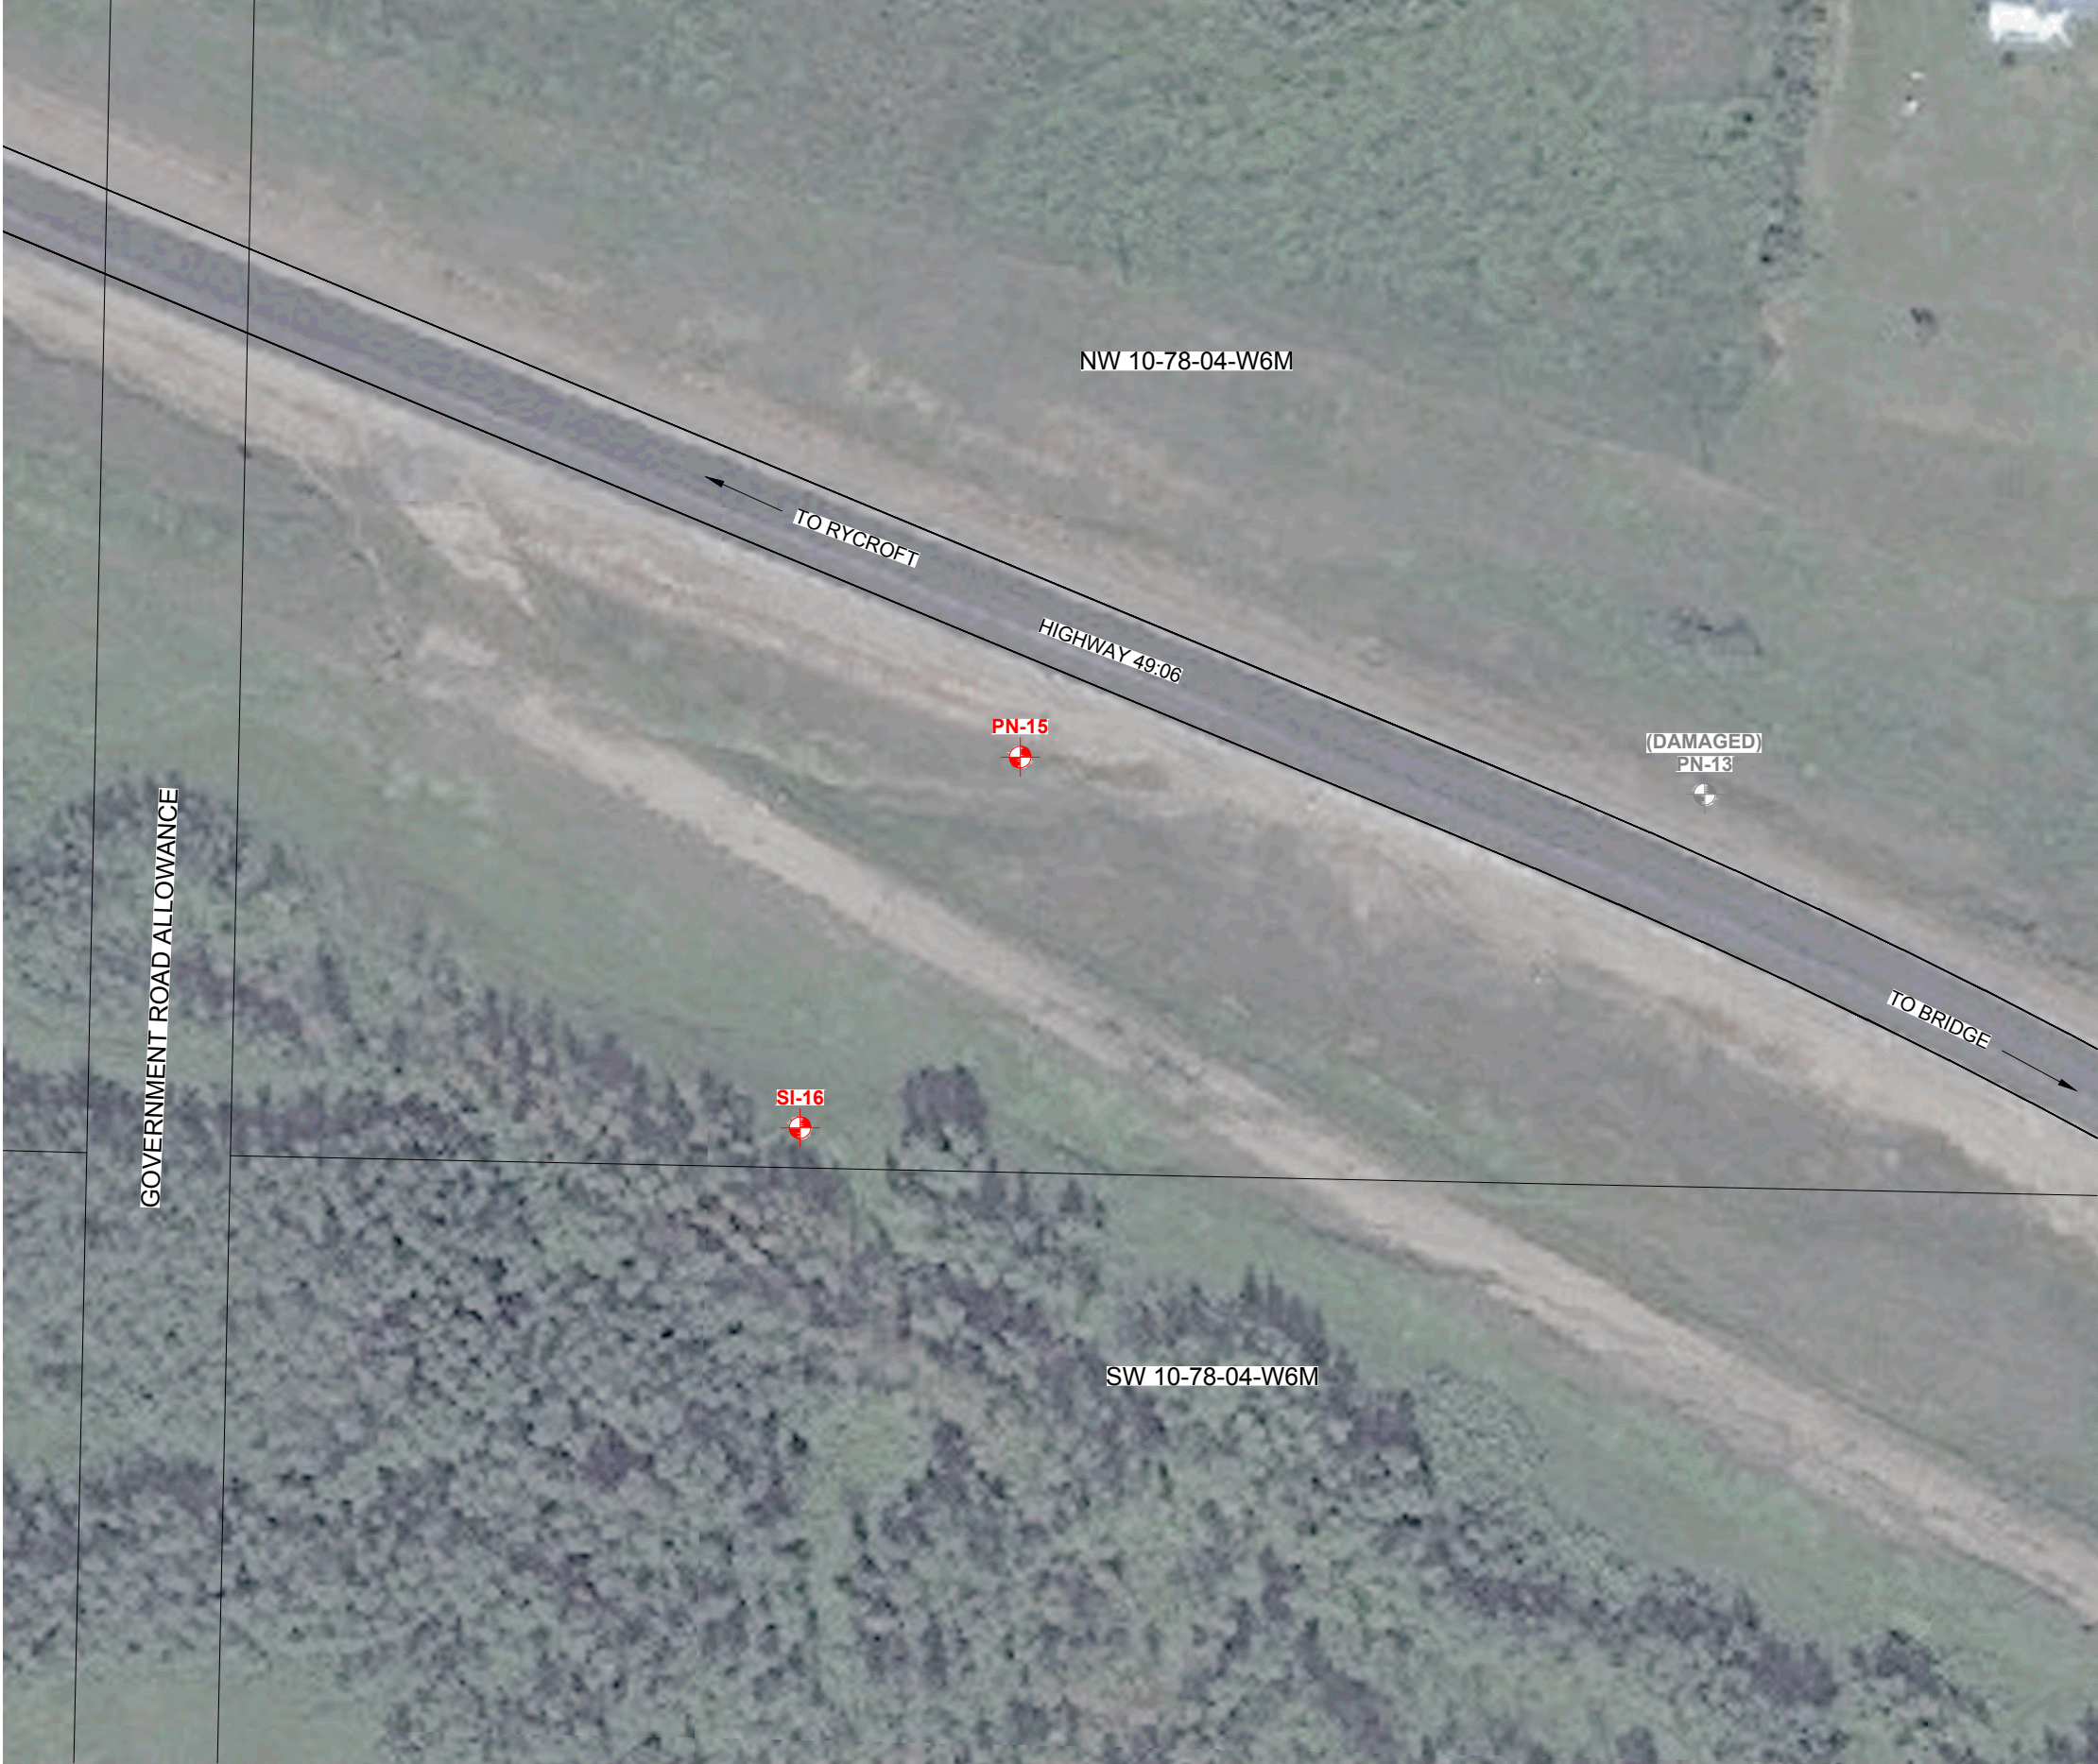
DWG No. 32123-GP004A

APPROXIMATE INSTRUMENT LOCATION
- SI SLOPE INCLINOMETER
- PN PNEUMATIC PIEZOMETER

GP004A: HWY 49:06 BURNT RIVER BRIDGE
INSTRUMENT LOCATIONS

Drawing 32123-GP004A in Appendix A provides a sketch of the approximate location of the monitoring instrumentation for this site

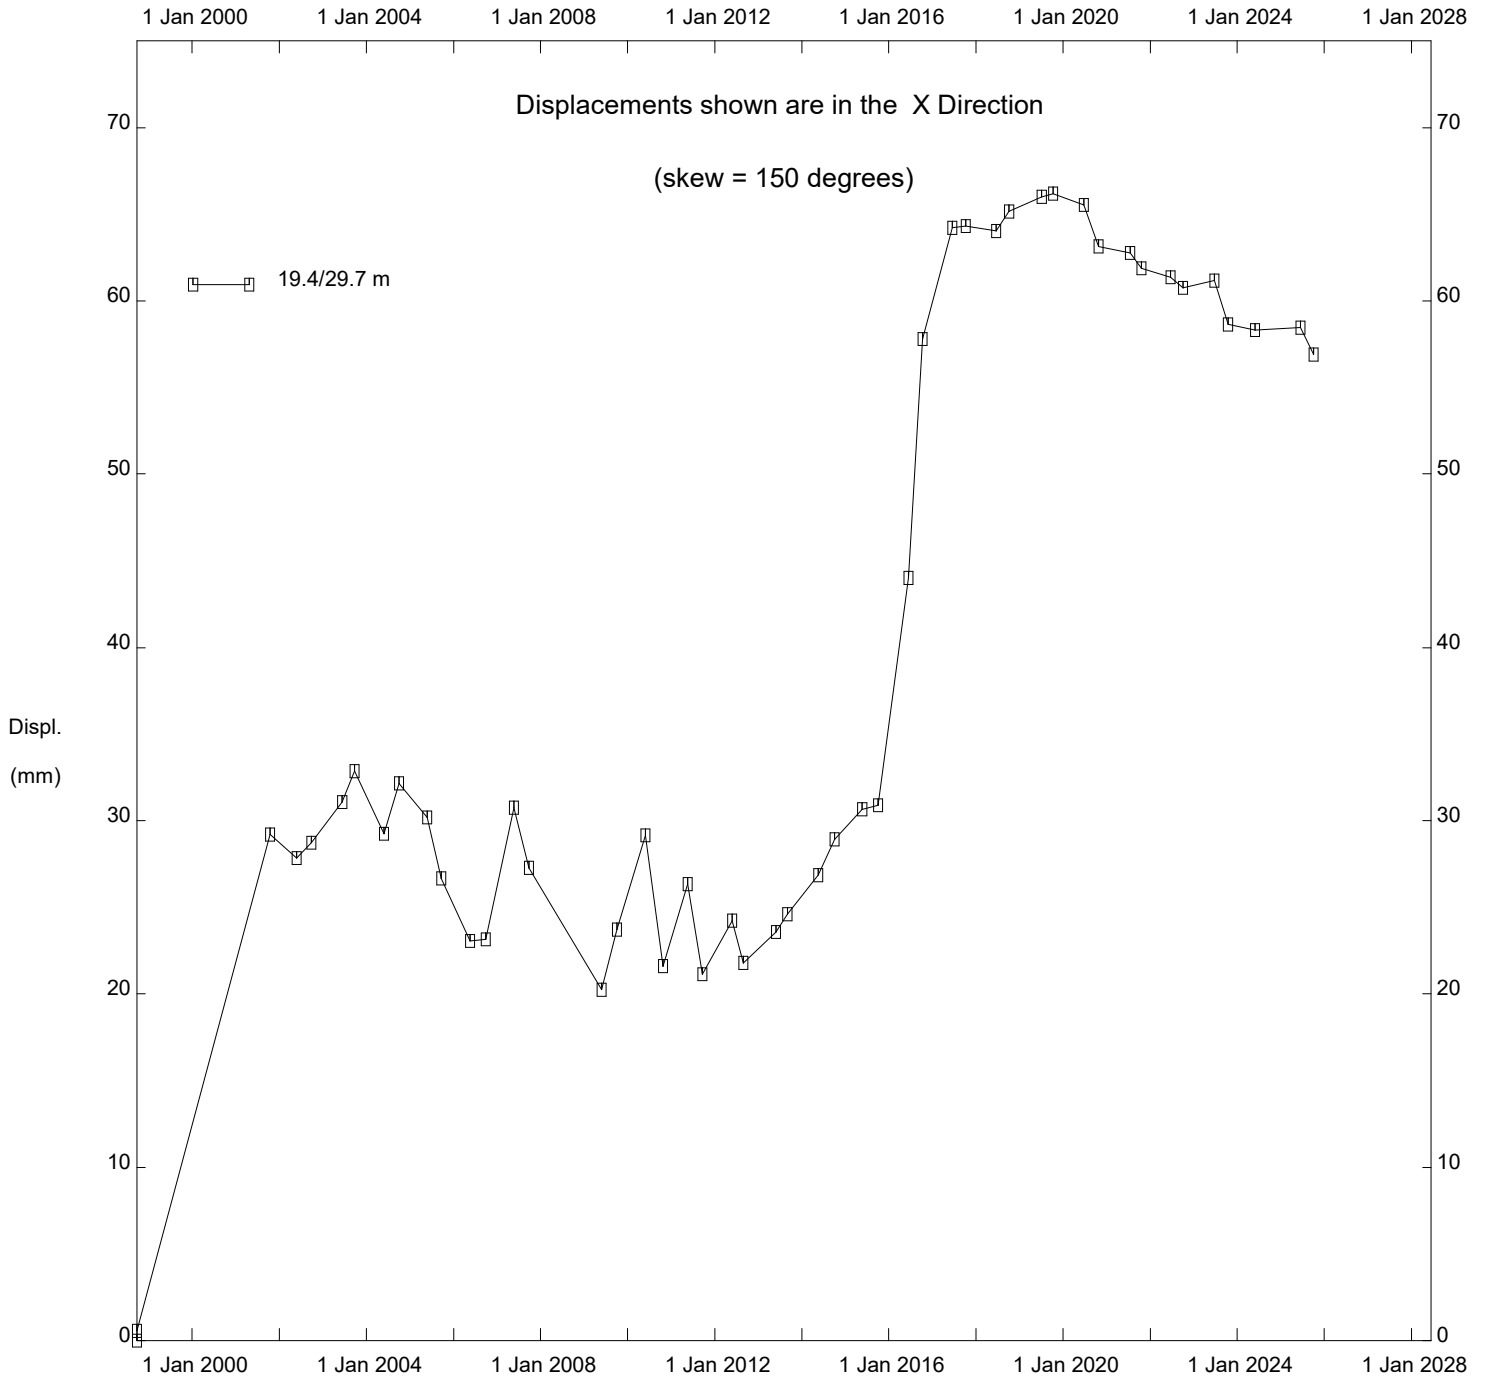
GP004A Burnt River West Approach, Inclinator SI-16

Discussion	
Zones of New Movement:	None
Interpretation of Monitoring Results:	<p>Slope inclinometer SI-16 showed a rate of movement of -5.3 mm/yr over 19.4 m to 29.7 m depth since the spring of 2025 readings. SI-16 had previously shown movement in a northwest direction towards the slope over the previous reading cycles, and a small movement downslope in this reading cycle. Based on the readings, it is possible that SI-16 is not installed deep enough to capture a deeper slide surface at the site.</p> <p>Pneumatic piezometer PN-15 showed a decrease in groundwater level of 0.21 m since the spring of 2025 readings. Pneumatic piezometer results are summarized in Table GP004A -2 and are plotted in Figure GP004A-1 in Appendix A.</p>
Future Work:	The instruments at this site have shown little change for the past several years, and the reading frequency should be reduced to once annually.
Instrumentation Repairs:	No instrumentation repairs are required at this time.

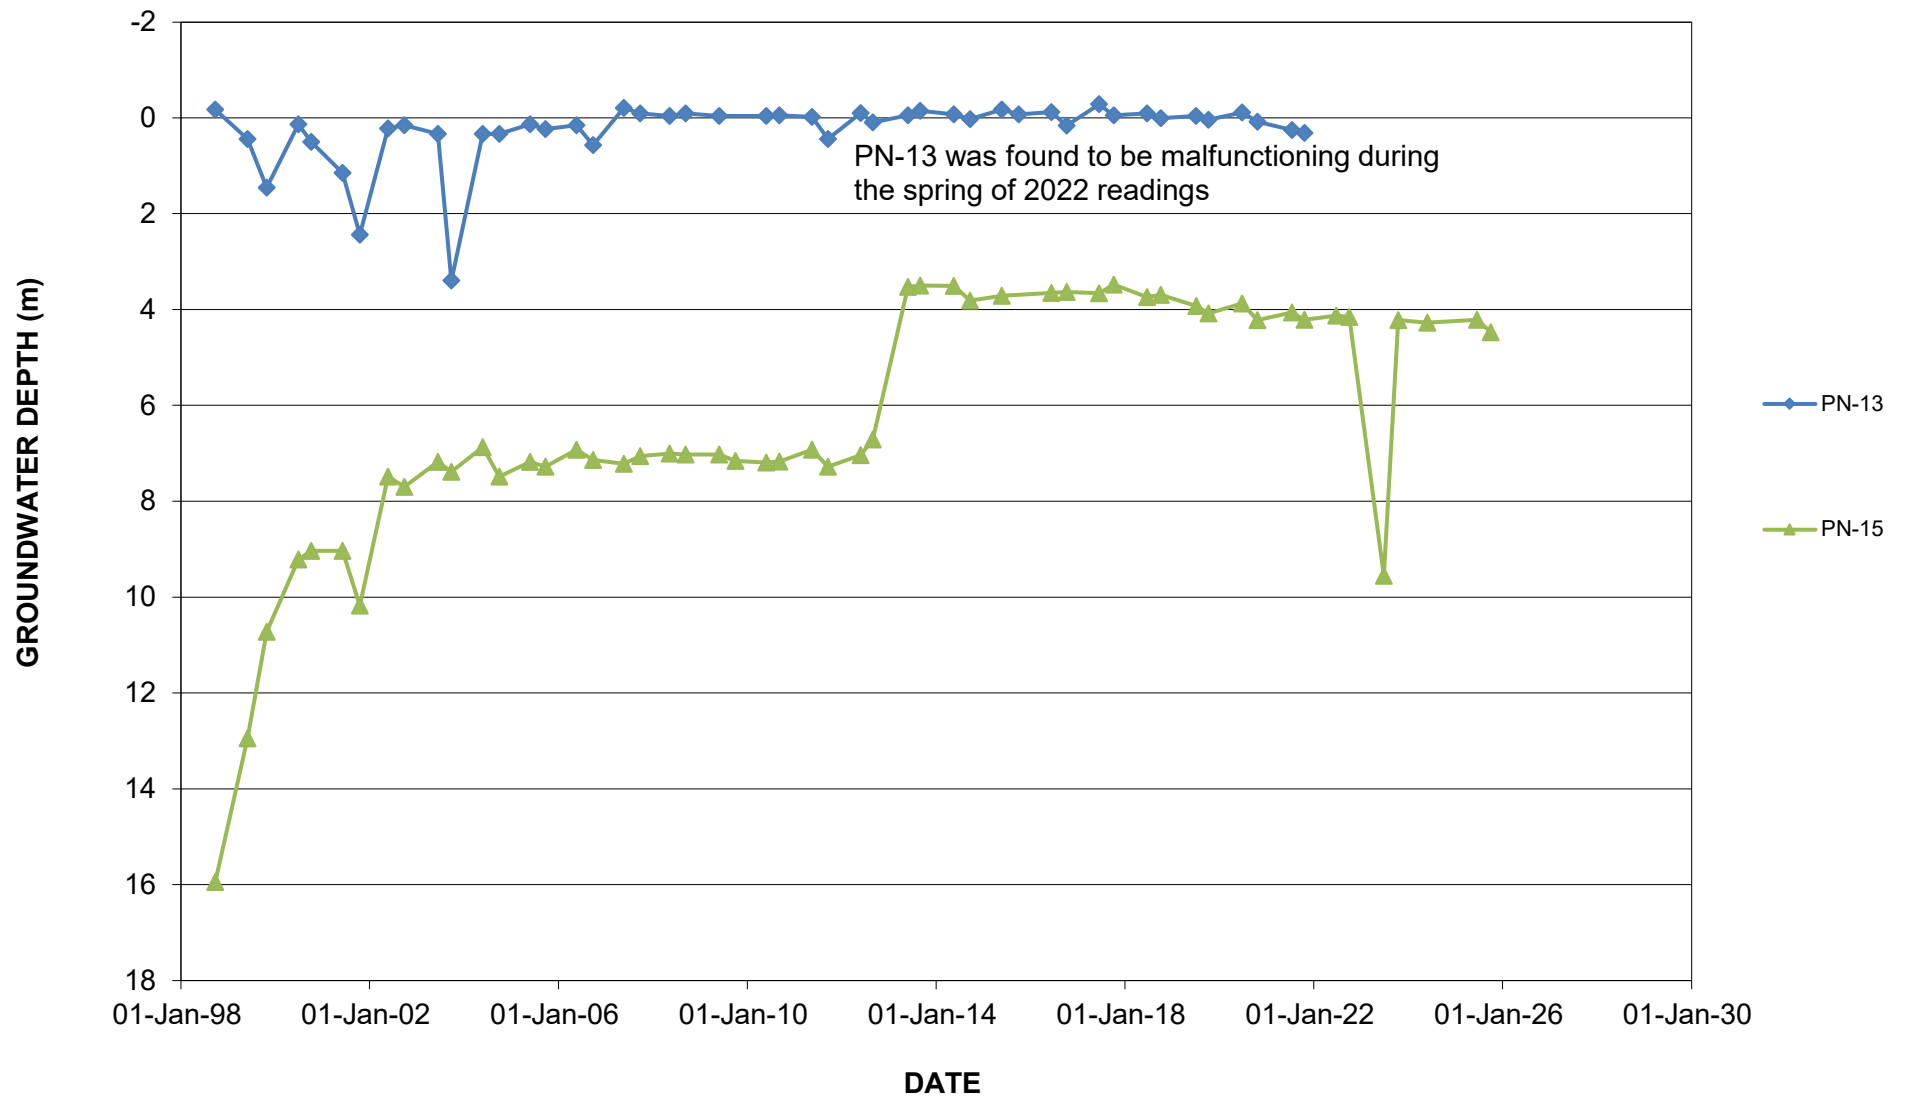
FIGURE GP004A-1
PIEZOMETER DATA FOR HWY 49:06, BURNT RIVER BRIDGE

INSTRUMENT #	DATE INITIALIZED	TIP DEPTH (m)	GROUND ELEV. (m)	CURRENT STATUS	HIGHEST MEASURED WATER LEVEL BGS (m)	MEASURED PORE PRESSURE (kPa)	CURRENT WATER LEVEL BGS (m)	PREVIOUS WATER LEVEL BGS (m)	CHANGE IN WATER LEVEL SINCE PREVIOUS READING (m)
PN-13	September 24, 1998	14.0	-	Malfunctioning	-0.29* in June 2017	N/A	N/A	N/A	N/A
PN-15	September 24, 1998	23.8	-	Operational	3.50 in August 2013	189.5	567.62	567.83	-0.21
