ALBERTA TRANSPORTATION AND
ECONOMIC CORRIDORS GRMP
PEACE REGION
(GRANDE PRAIRIE DISTRICT - NORTH)
INSTRUMENTATION MONITORING - SPRING 2025

Site Number	Location	Name	Hwy	km
GP004A	HWY 49:06 C1 10.586	Burnt River Bridge	49:06	Km 10.6
Legal Description: 12-10-78-4 W6		UTM Co-ordinates		
		11U E 403183.13	N	6178764.13

Current Monitoring:	17-June-2025	Previous Monitoring	29-May-2024
Instruments Read By:	Mr. Niraj Regmi, G.I.T and Mr. Godfred Etiendem, of Thurber

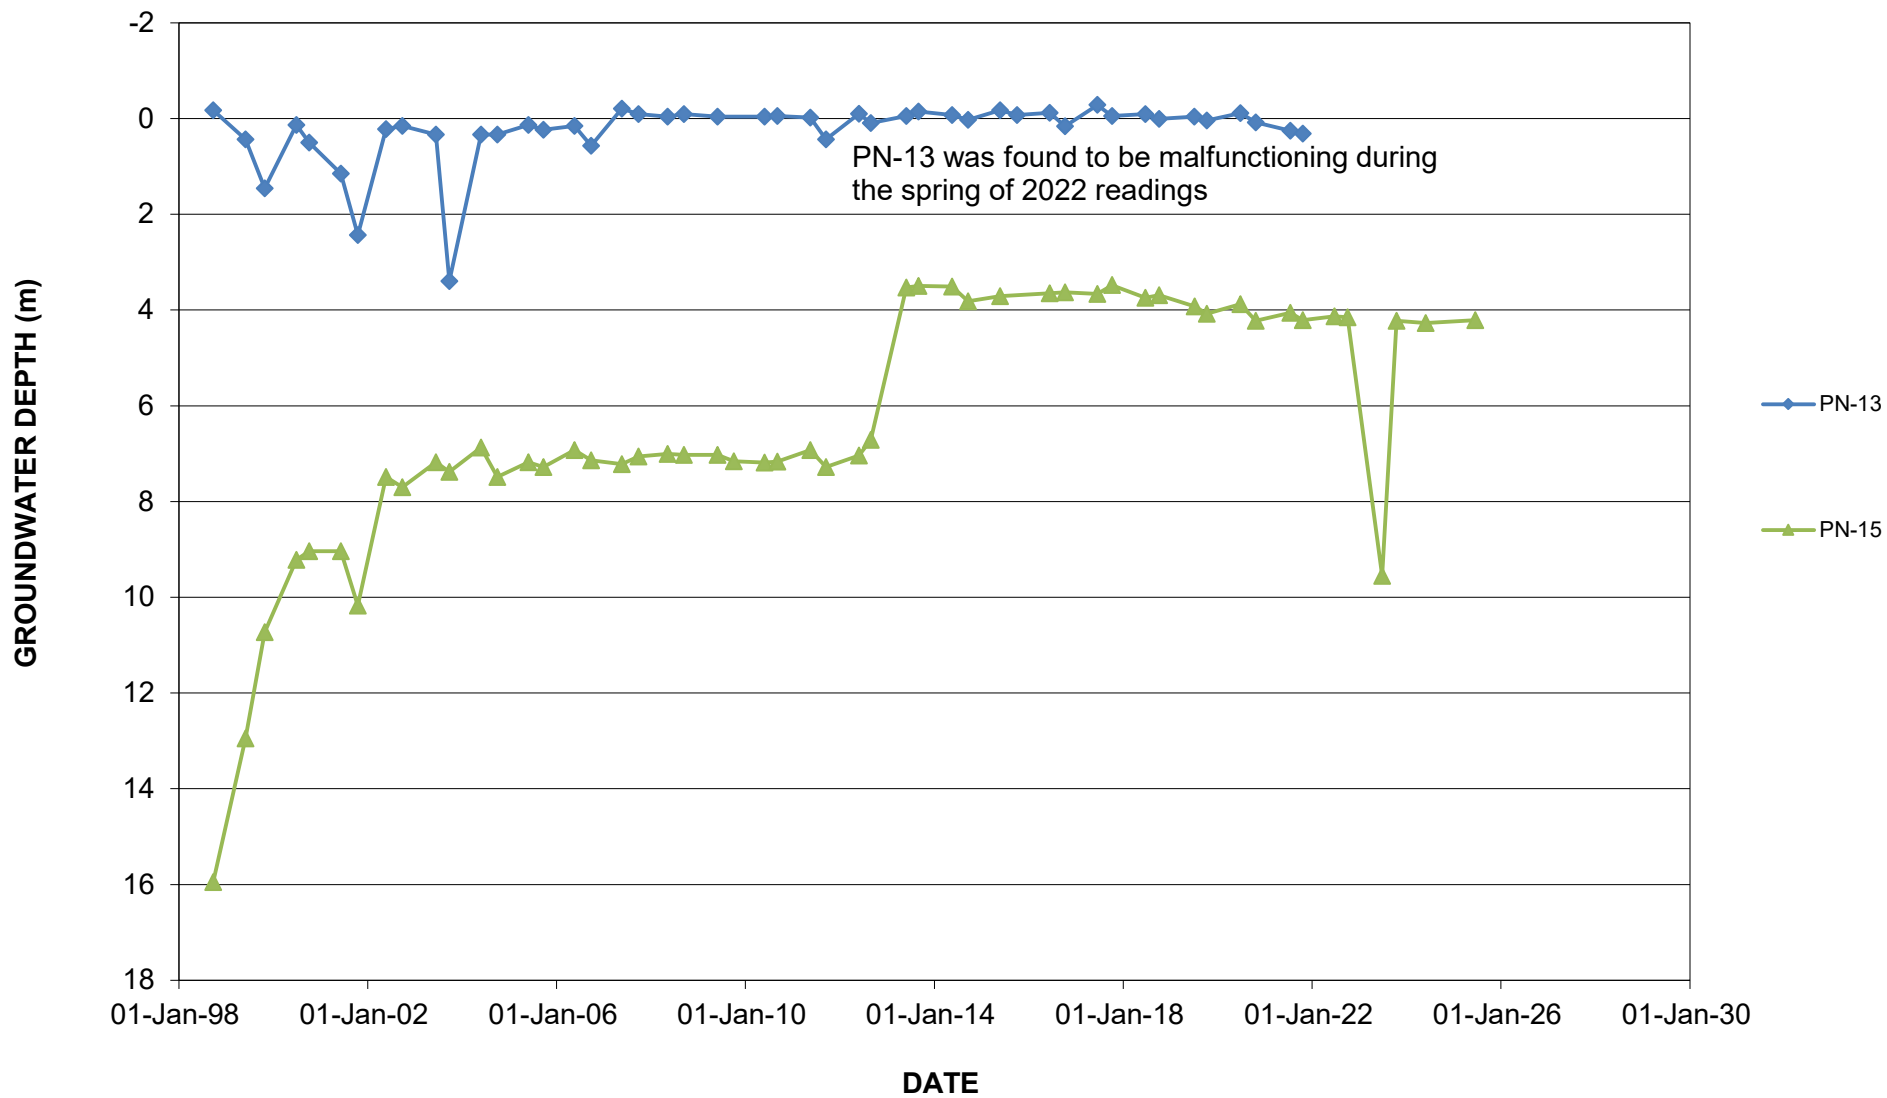
FIGURE GP004A-1
PIEZOMETER DATA FOR HWY 49:06, BURNT RIVER BRIDGE

INSTRUMENT #	DATE INITIALIZED	TIP DEPTH (m)	GROUND ELEV. (m)	CURRENT STATUS	HIGHEST MEASURED WATER LEVEL BGS (m)	MEASURED PORE PRESSURE (kPa)	CURRENT WATER LEVEL BGS (m)	PREVIOUS WATER LEVEL BGS (m)	CHANGE IN WATER LEVEL SINCE PREVIOUS READING (m)
PN-13	September 24, 1998	14.0	-	Malfunctioning	-0.29* in June 2017	N/A	N/A	N/A	N/A
PN-15	September 24, 1998	23.8	-	Operational	3.50 in August 2013	192.1	4.21	4.27	0.06
