November 28, 2025

**CON0022166 Peace Region (Grande Prairie District – South) GRMP Instrumentation Monitoring Site GP042; H40:36, km 37.524 Wanyandie Creek Embankment Slide Section C – 2025 Fall Readings**

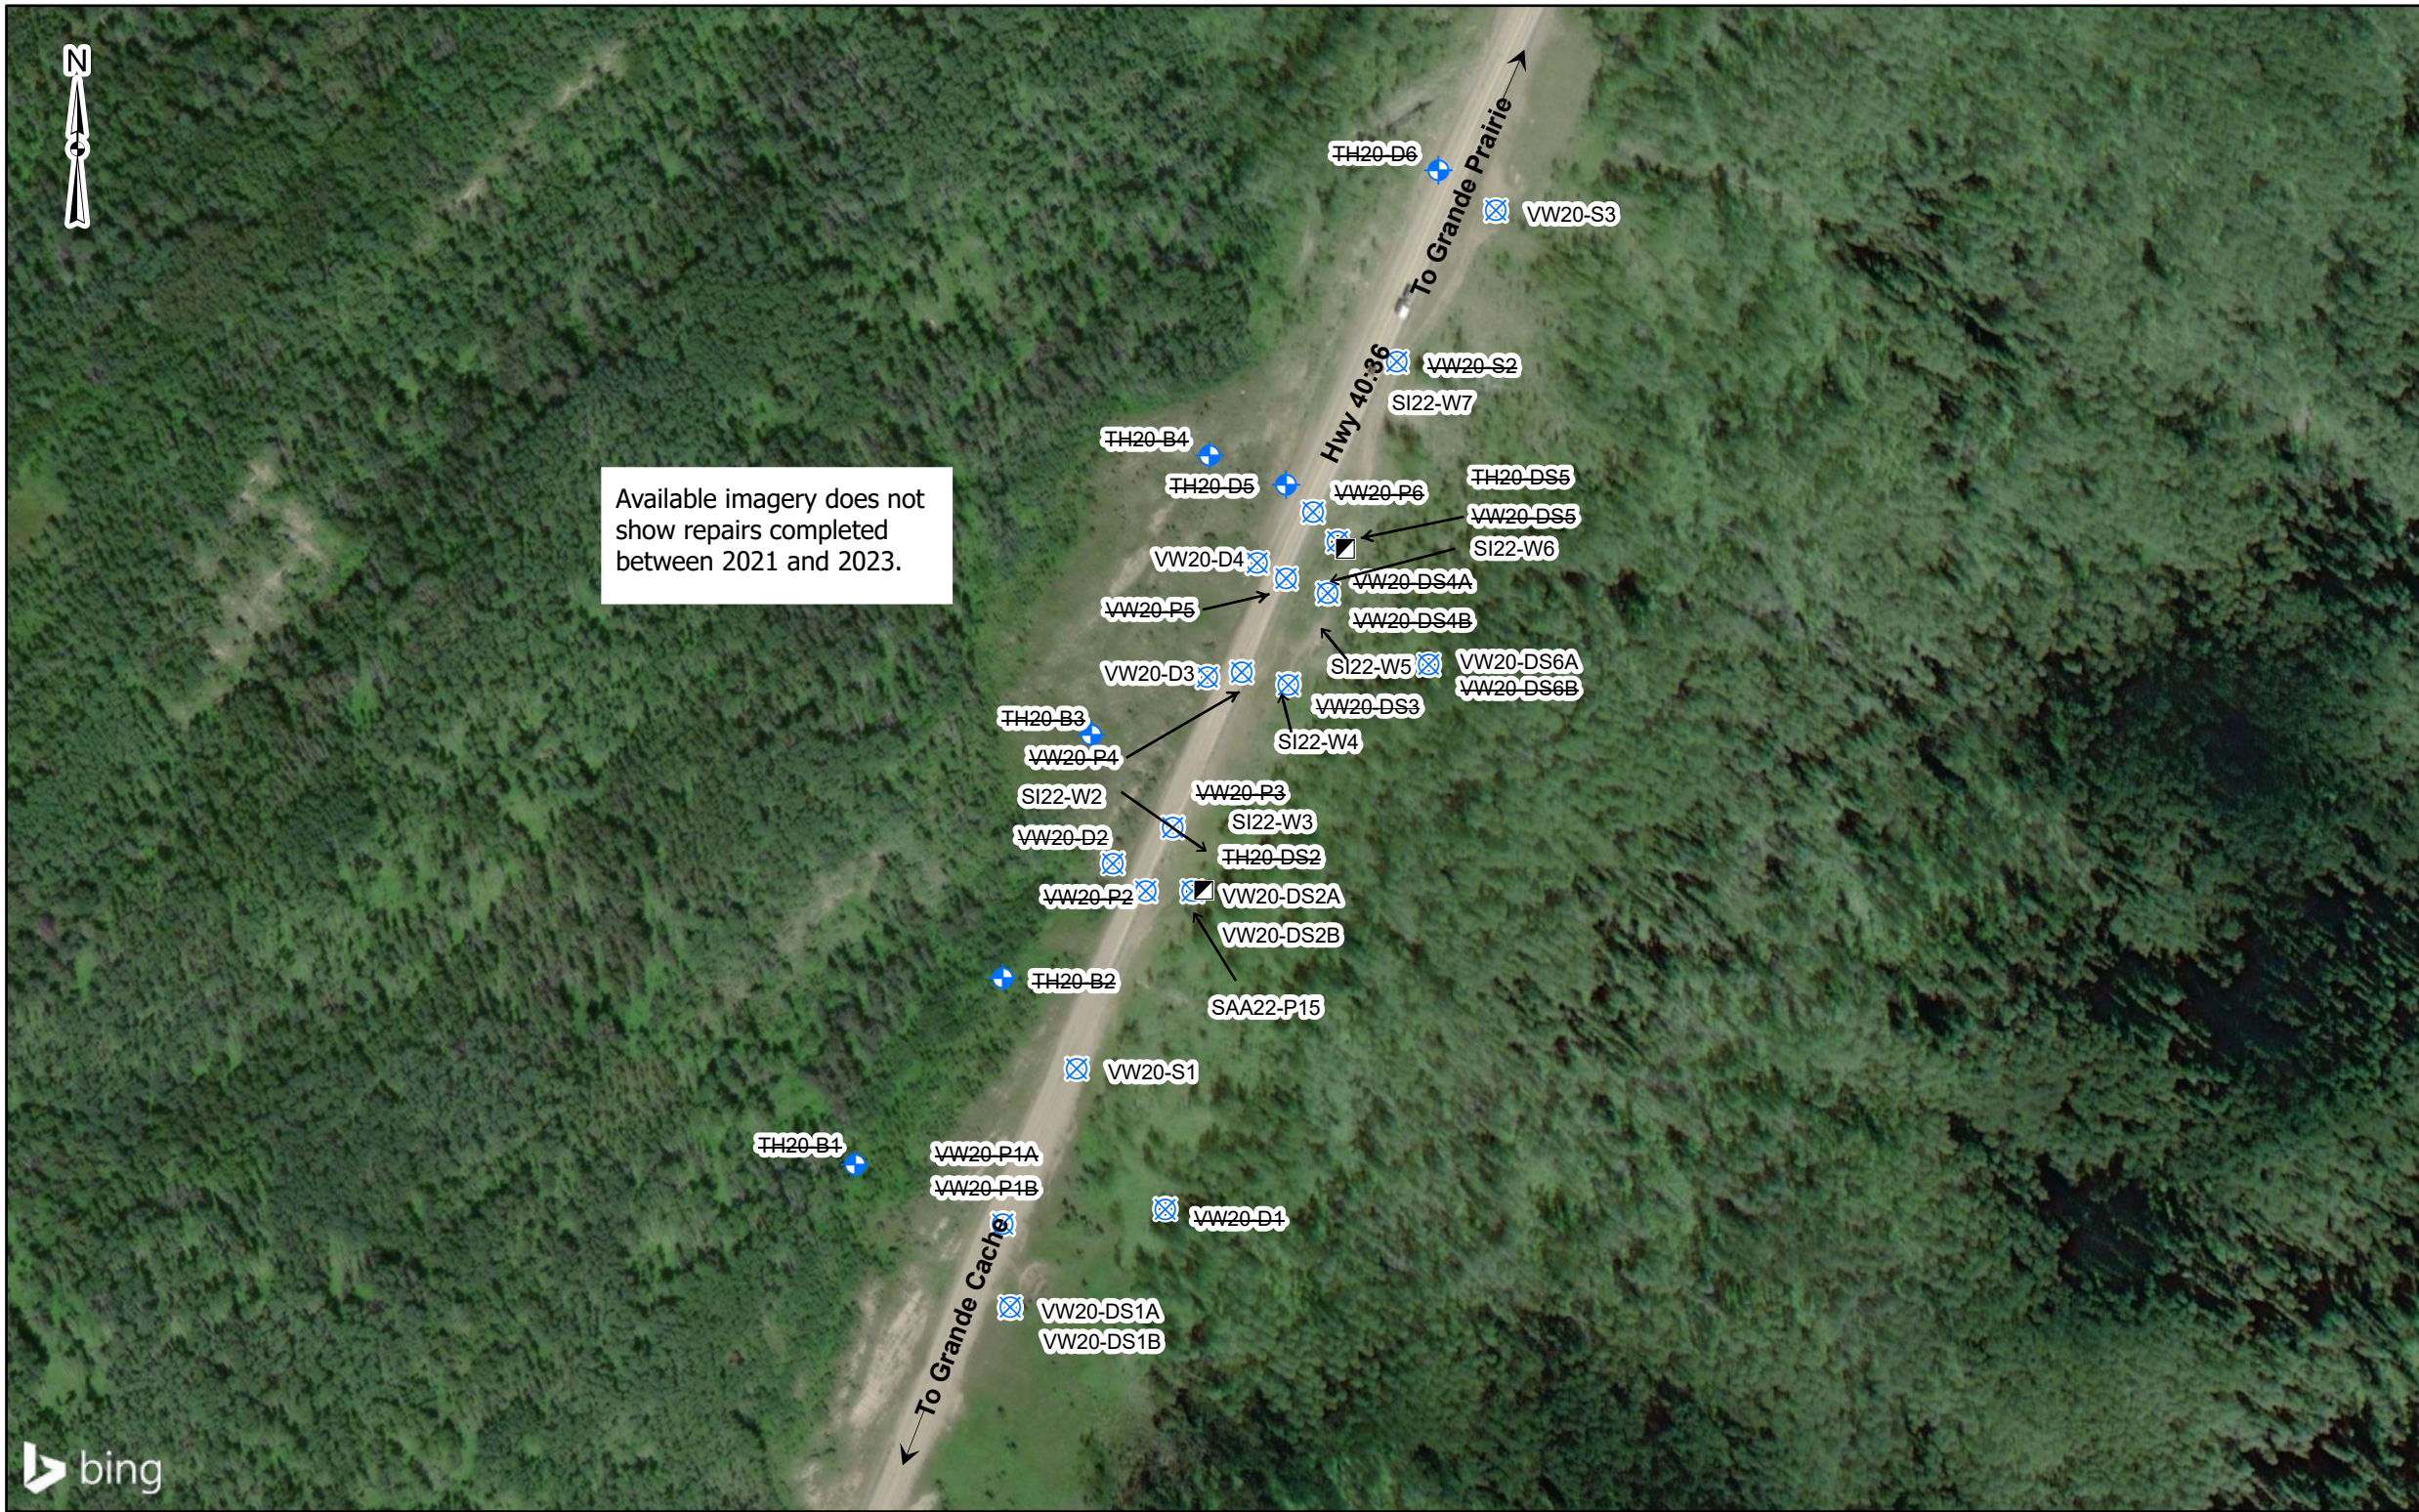
PROJECT	PEACE REGION (GRANDE PRAIRIE DISTRICT-SOUTH) GEOHAZARD RISK MANAGEMENT PROGRAM	
TITLE	Site Plan GP042 - Wanyandie Creek Embankment Slide Hwy 40:36, km 37.524	
SCALE	PROJECT No.	FIG No.
1:3,000	A05116A01	1

Six slope inclinometers (SIs) (SI22-W2 through W7), nine vibrating wire piezometers (VWPs) (VW20-S1/S3, VW20-D3/D4, and VW20-DS1A/1B/2A/2B/6A), one shape accelerometer array (SAA) (SAA22-P15), and seven vibrating wire load cells (Anchor 3U, 5L, 15U/L, 27U/L, and 37U) were read at the GP042 site (includes the GP050 site as well) in the Peace Region (Grande Prairie District – South) (GP South Region) on September 4, 2025, by Evan Hergott, E.I.T. and Katrina Cereno, E.I.T. of Klohn Crippen Berger Ltd. (KCB). These instruments were read as part of the GP South Region Geohazard Risk Management Program (GRMP). The site is located on Hwy 40:36, km 37.524. The approximate site coordinates are 5997170 N, 380027 E (UTM Zone 11, NAD 83). A site plan is presented on Figure 1.
