**ALBERTA TRANSPORTATION
PEACE REGION (GRANDE PRAIRIE)
INSTRUMENTATION MONITORING RESULTS**

FALL 2020

**SITE GP038-1: HWY 40:38, 2.0 km NORTH OF KAKWA RIVER BRIDGE
SITE GP038-2: HWY 40:38, CALLOUT SITE 1.6 km NORTH OF KAKWA
RIVER BRIDGE**

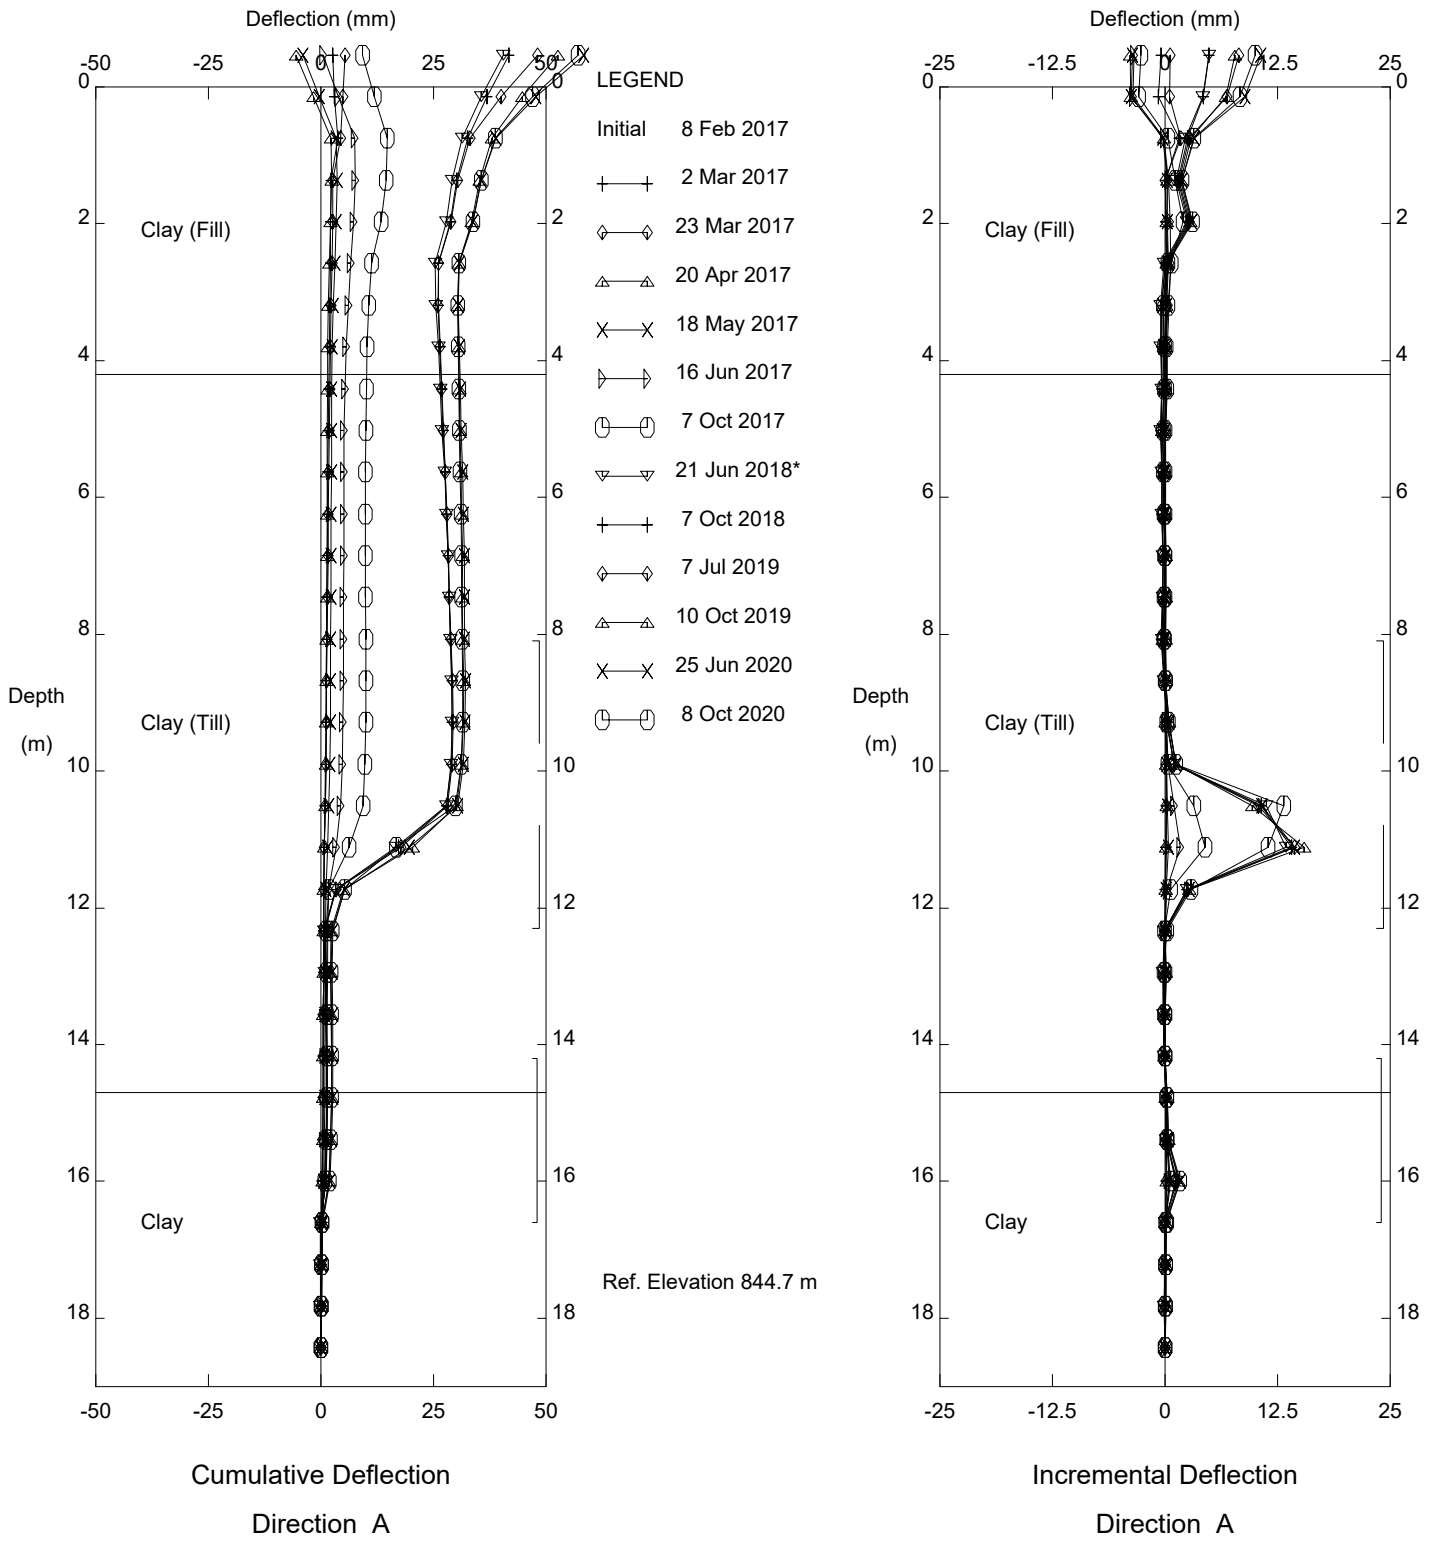
GP38 Kakwa River Bridge, Inclinometer SI17-1

Zones of new movement were not observed in SI17-1 since the spring of 2020 readings.

SI17-1 showed no discernible movement since the spring of 2020 readings.

The instruments should be read again in the spring of 2021.

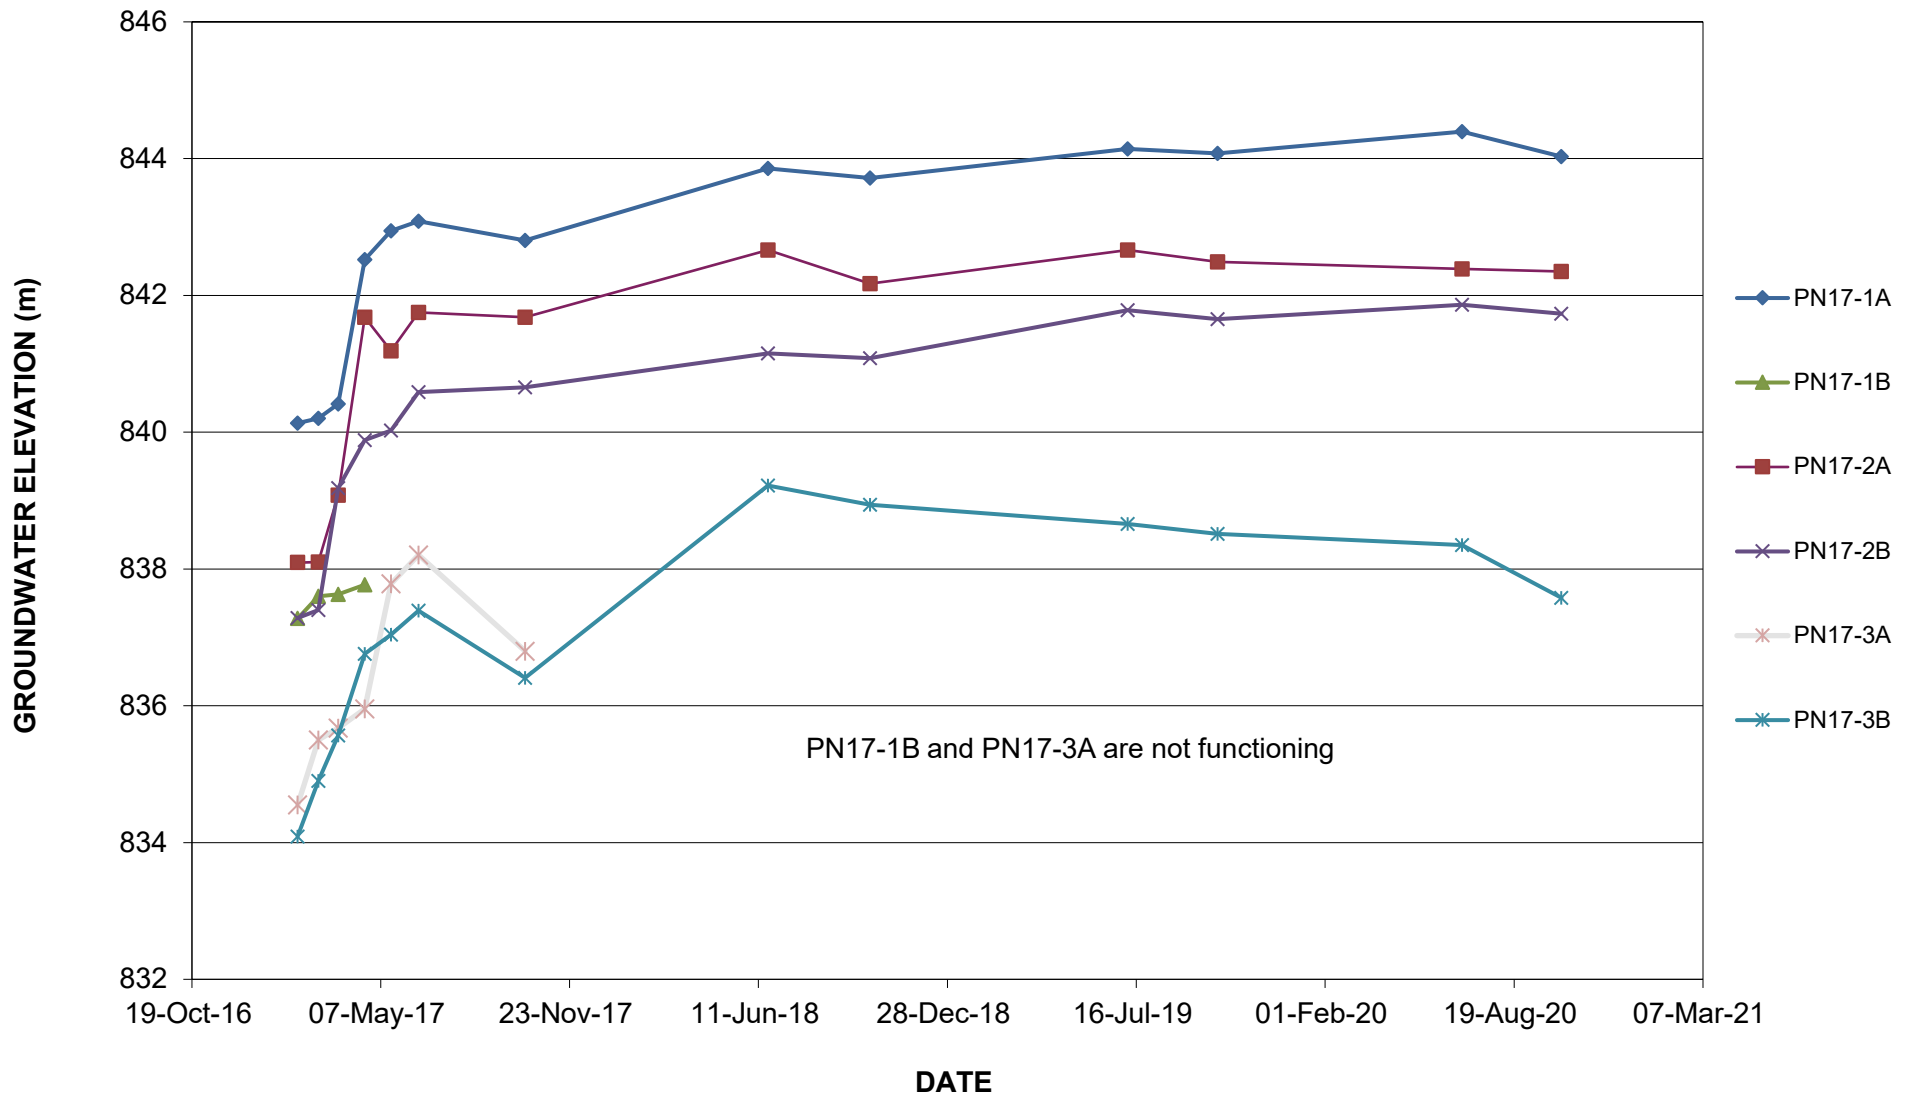
FIGURE GP038-1-1
PIEZOMETRIC ELEVATIONS FOR HWY 40:38 1.6 km NORTH OF KAKWA RIVER

Pneumatic piezometers PN17-1A, PN17-2A, PN17-2B, and PN17-3B showed decreases in groundwater level of 0.36 m, 0.04 m, 0.13 m, and 0.77 m, respectively, since the spring of 2020 readings. The pneumatic piezometer results are summarized in Table GP038-1-2 below and are plotted on Figures GP038-1-1 (by elevation) and GP038-1-2 (by depth) in Section D.

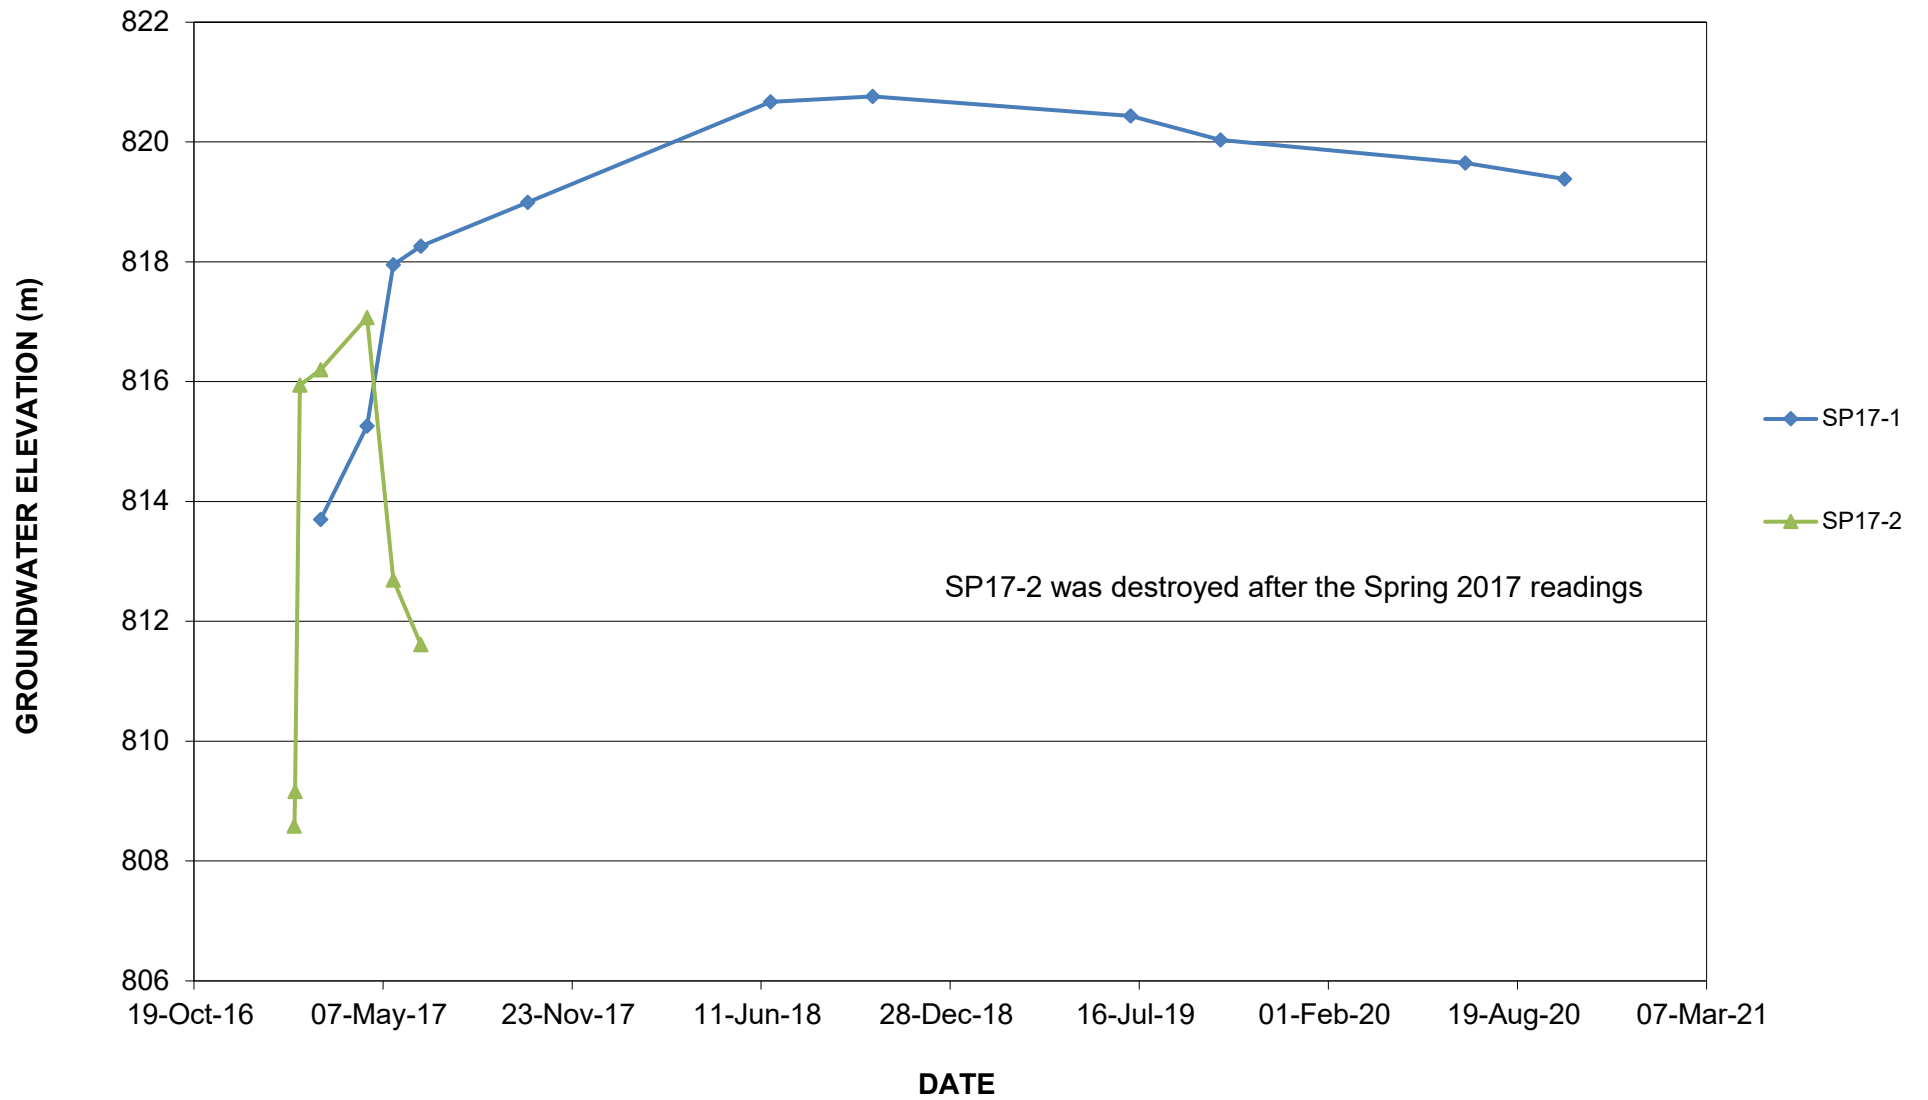
**FIGURE GP038-2-1
PIEZOMETRIC ELEVATIONS FOR HWY 40:38 NORTH OF KAKWA RIVER
(CALLOUT SITE)**

Standpipe piezometer SP17-1 showed a decrease in groundwater level of 0.27 m since the spring of 2020 readings. The standpipe piezometer results for the Callout Site are summarized in Table GP038-2-1 below and are plotted on Figures GP038-2-1 (by elevation) and GP038-2-2 (by depth) in Section D.
