# PEACE REGION – SWAN HILLS GEOHAZARD RISK ASSESSMENT SITE INSPECTION FORM

SITE NUMBER SH 7	SITE NAME Island Creek Slide	HIGHWAY & KM HWY 33:14	PREVIOUS INSPECTION DATE September, 2011	INSPECTION DATE July 4, 2012			
LEGAL DESCRIPTION	NAD 83	PREVIOUS RISK ASSESSMENT PF: 2 CF: 1 TOTAL: 2					
SE33-71-09 W5M	COORDINATES N 6,110,760	PF: 2 CURRENT RISK ASSE	TOTAL: 2				
	E 607,250	<b>PF</b> : 3	<b>CF</b> : 2	<b>TOTAL:</b> 6 – See Comments

GEO HAZARD ASSESSMENT PEACE REGION (SWAN HILLS)

SH7: HWY 33:14 - ISLAND CREEK SLIDE SITE PLAN DATE:
AUGUST, 2012
PROJECT No.:

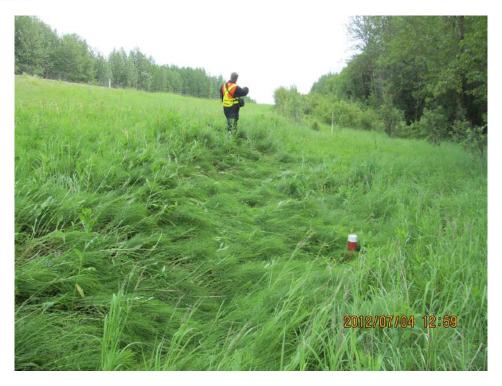
I) Potential retrogression of a slide on the Swan River valley slope. The headscarp of the slide is currently located within the south ditch of the highway (Photo's 1 and 2). In 2000, the highway was re-aligned to the north above the headscarp of the slide. Prior to re-alignment, the headscarp of the slide extended to the approximate centreline of the highway. However, there has been no observable retrogression of the slide headscarp or signs of highway distress noted since re-alignment.

SH7 Photo 1: Looking east along headscarp of slide in south ditch (July 2012)

Monitoring of the operational instrumentation and annual inspection of the site should be continued.

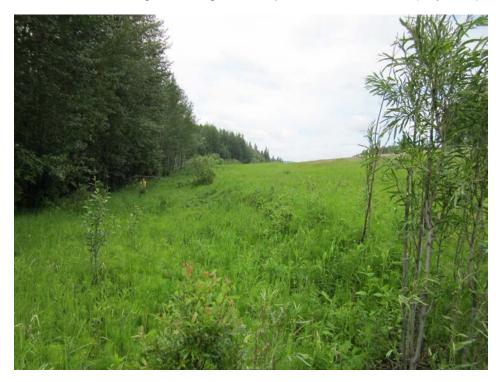
SH7 Photo 2: Looking west along headscarp of slide in south ditch (July 2012)
