Site Number	Location	Name	Hwy	km
PH053	HWY 684:02 30 + 400 to 29 + 400	Shaftesbury Trail	684:02	28.35 to 30.30
<b>Legal Description:</b> 9-30-83-21 W5		<b>UTM Co-ordinates</b>		
		11U E 481072	N	6232048

<b>Current Monitoring:</b>	07-Jun-2025	<b>Previous Monitoring</b>	18-May-2024
<b>Instruments Read By:</b>	Mr. Niraj Regmi, G.I.T and Mr. Godfred Etiendem, of Thurber

**ALBERTA TRANSPORTATION AND ECONOMIC CORRIDORS GRMP (CON0022164)  
PEACE REGION (PEACE RIVER DISTRICT)  
INSTRUMENTATION MONITORING RESULTS**

**SITE PH053: HWY 684:02, SHAFTESBURY TRAIL**

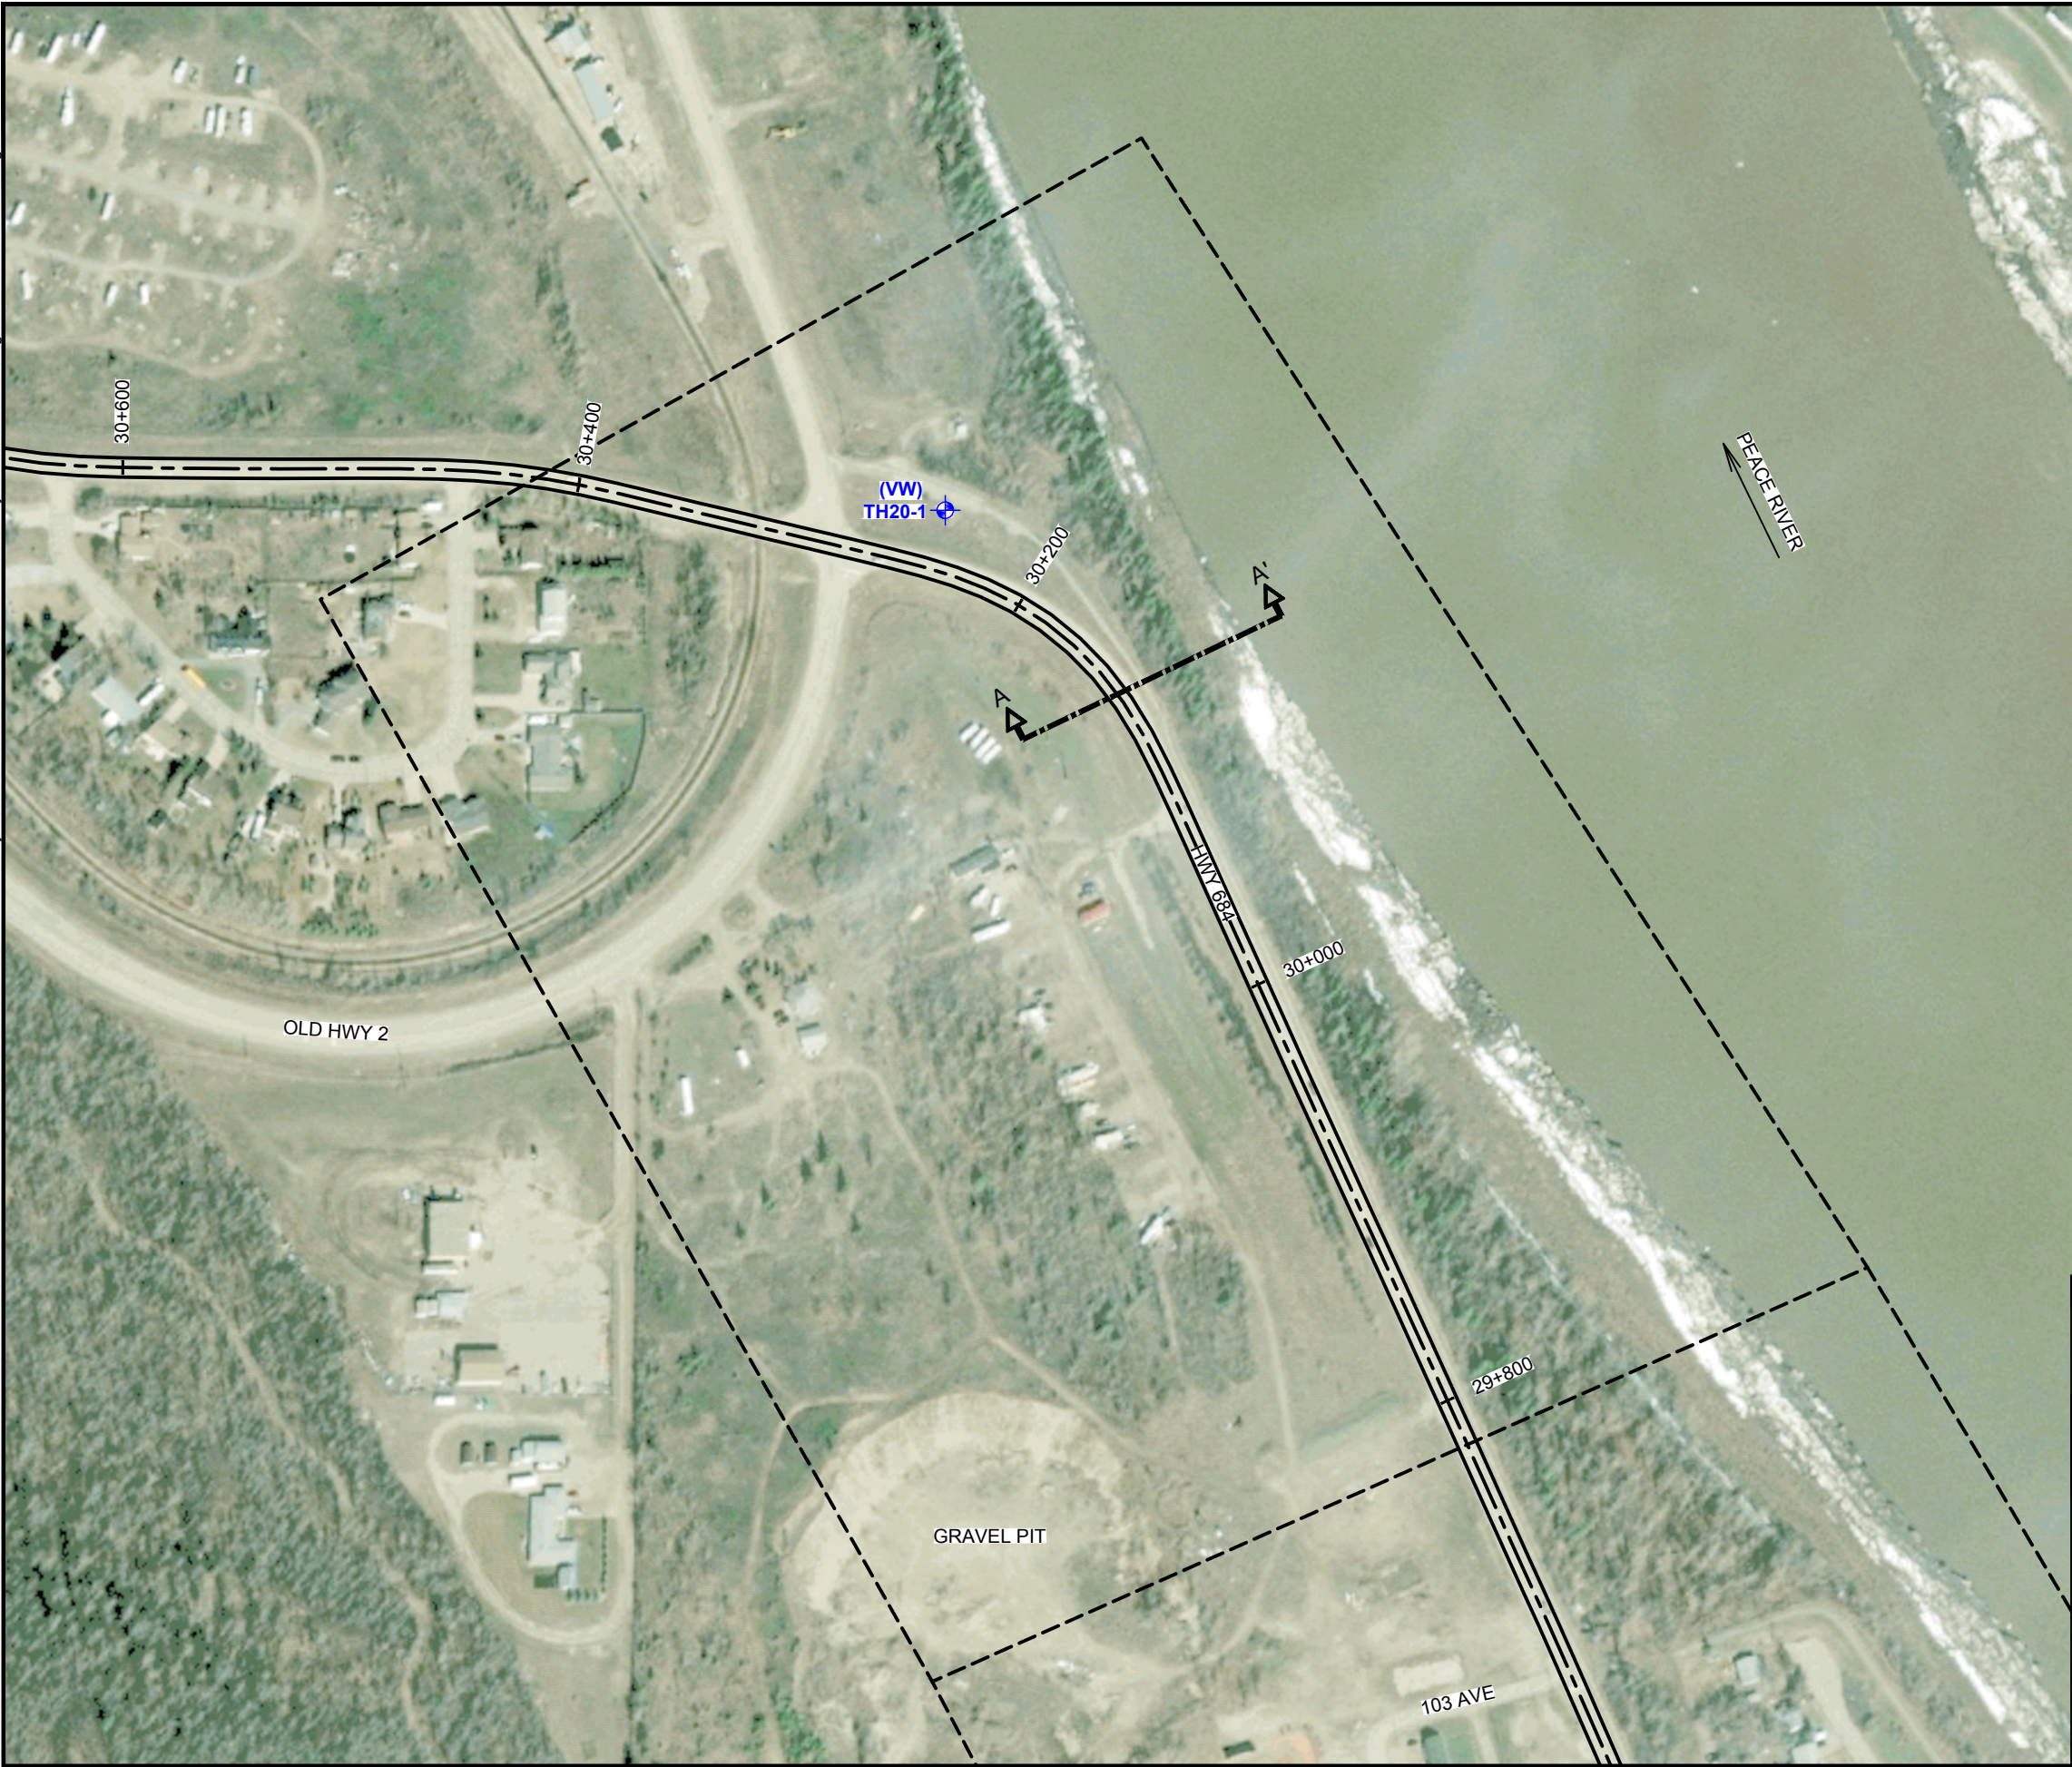
DWG No. 23838-2

DETAIL PLAN  
(SHEET 1 OF 4)

Drawings 23838-2 and 23838-3 in Appendix A provides a sketch of the approximate locations of the monitoring instrumentation for this site.

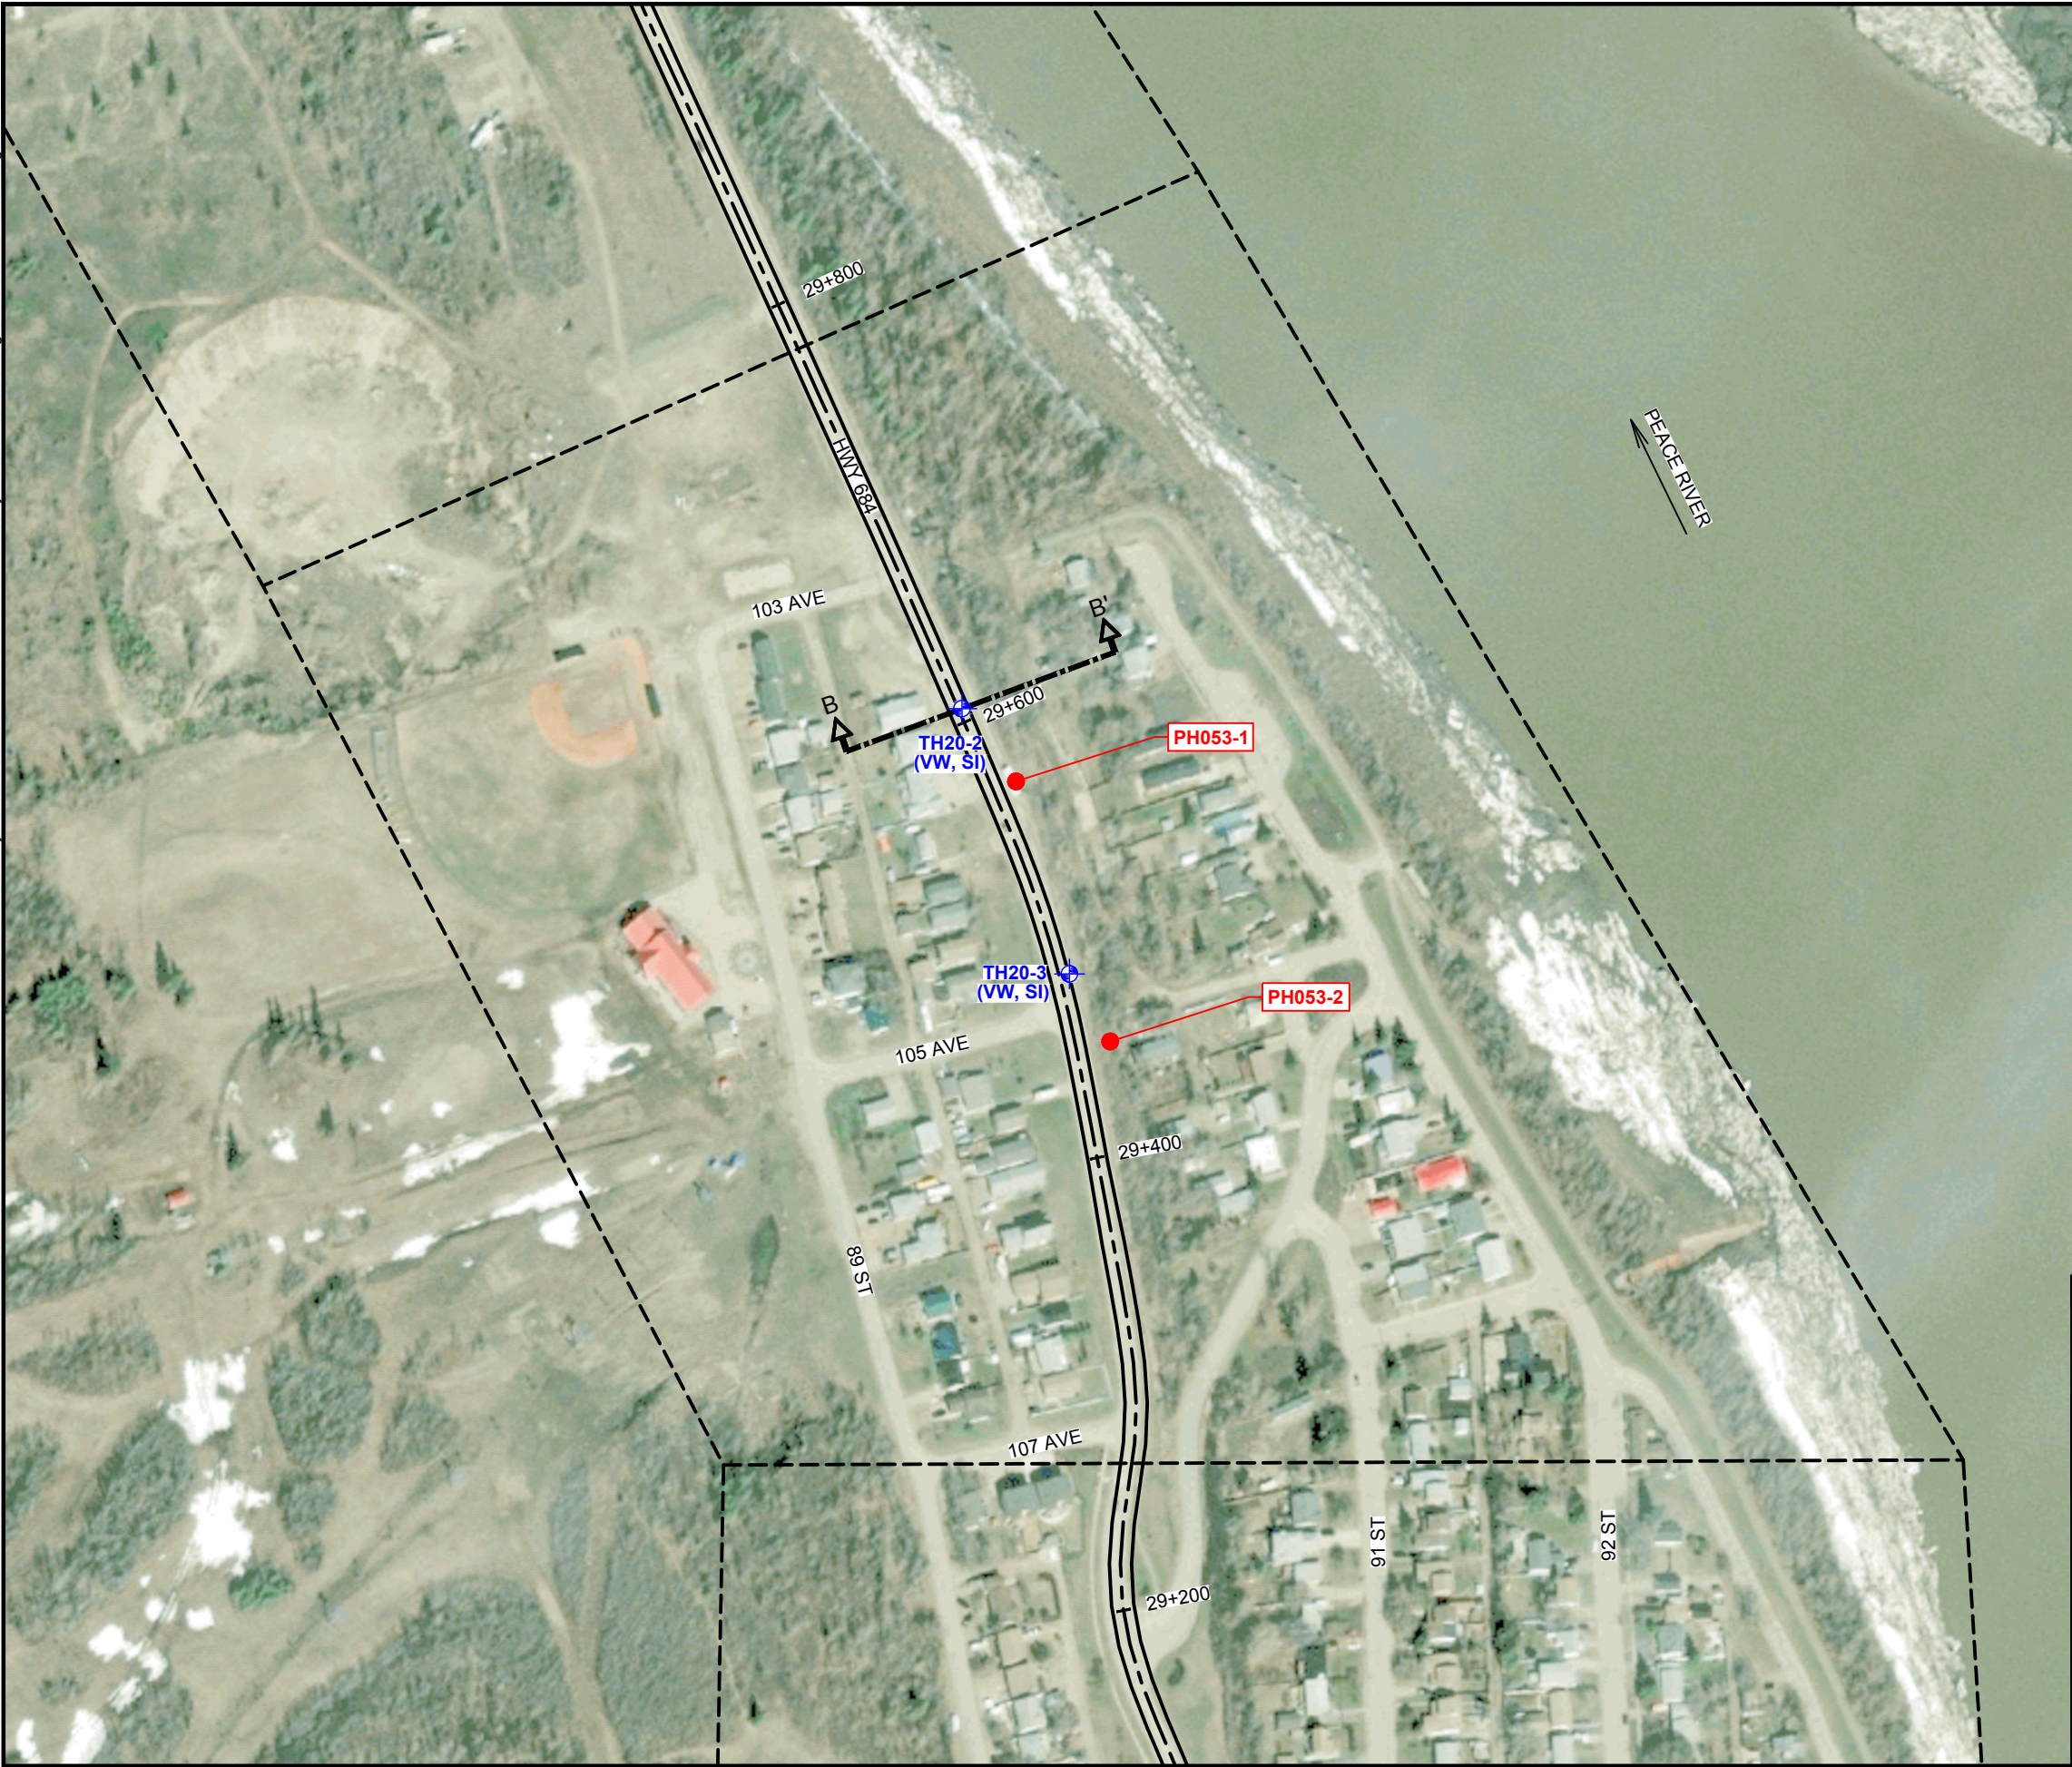
DWG No. 23838-3

DETAIL PLAN  
(SHEET 2 OF 4)

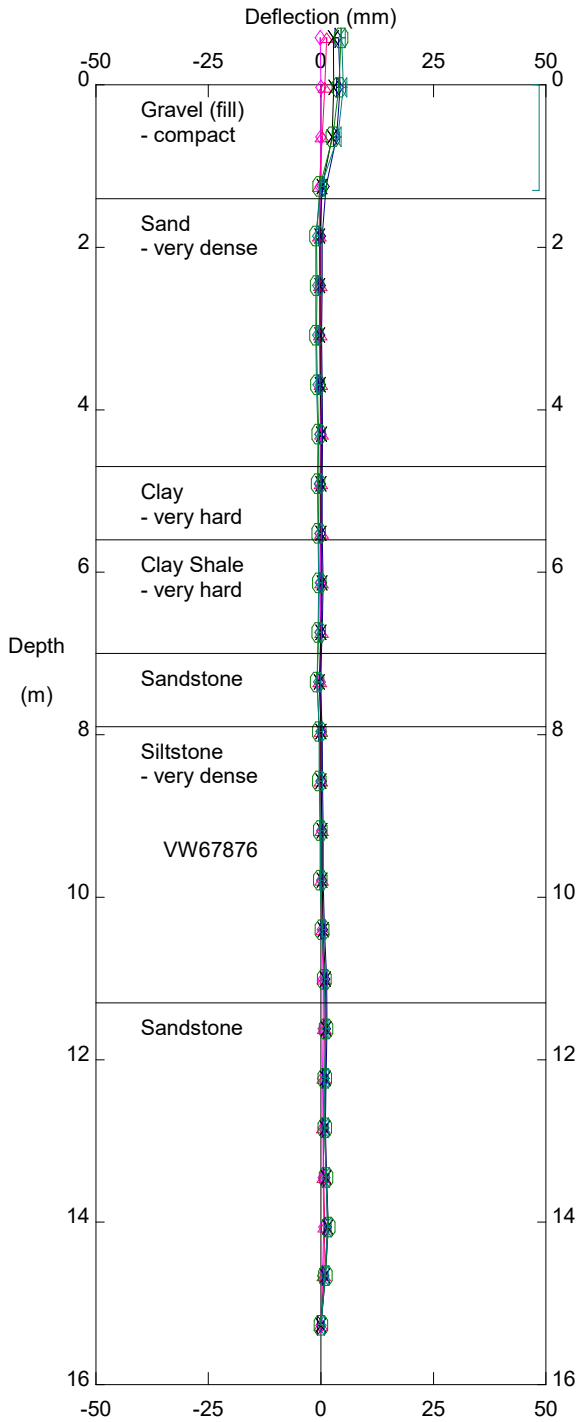
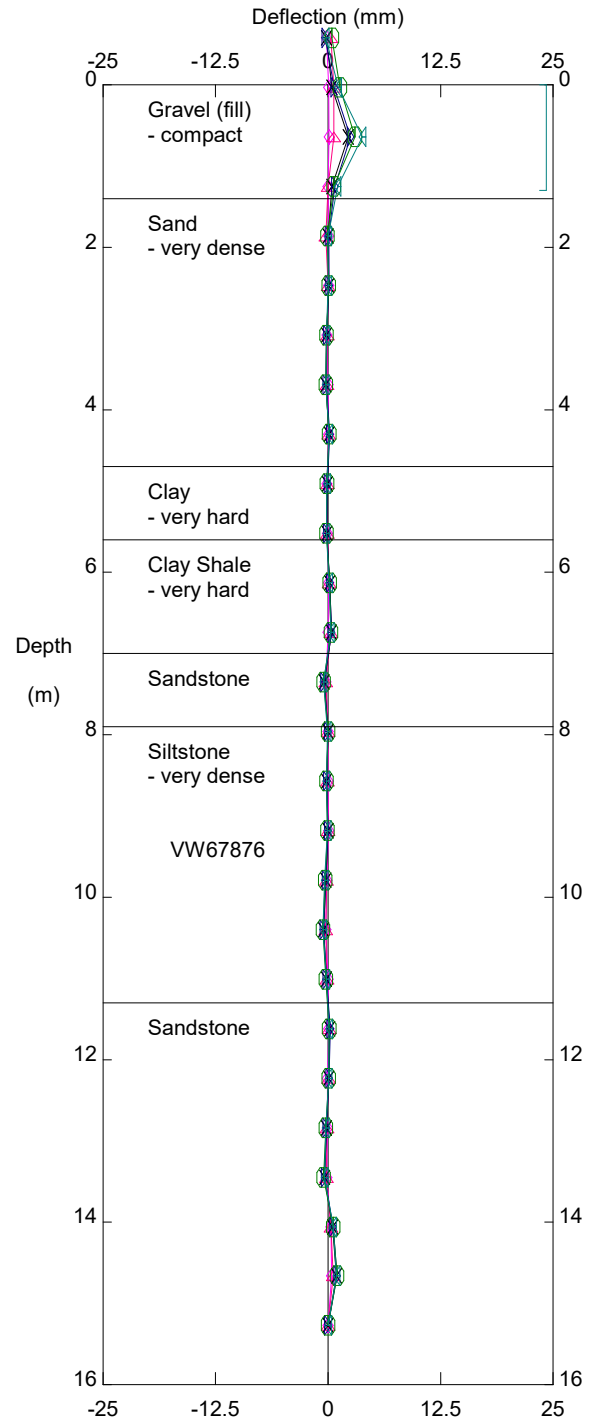
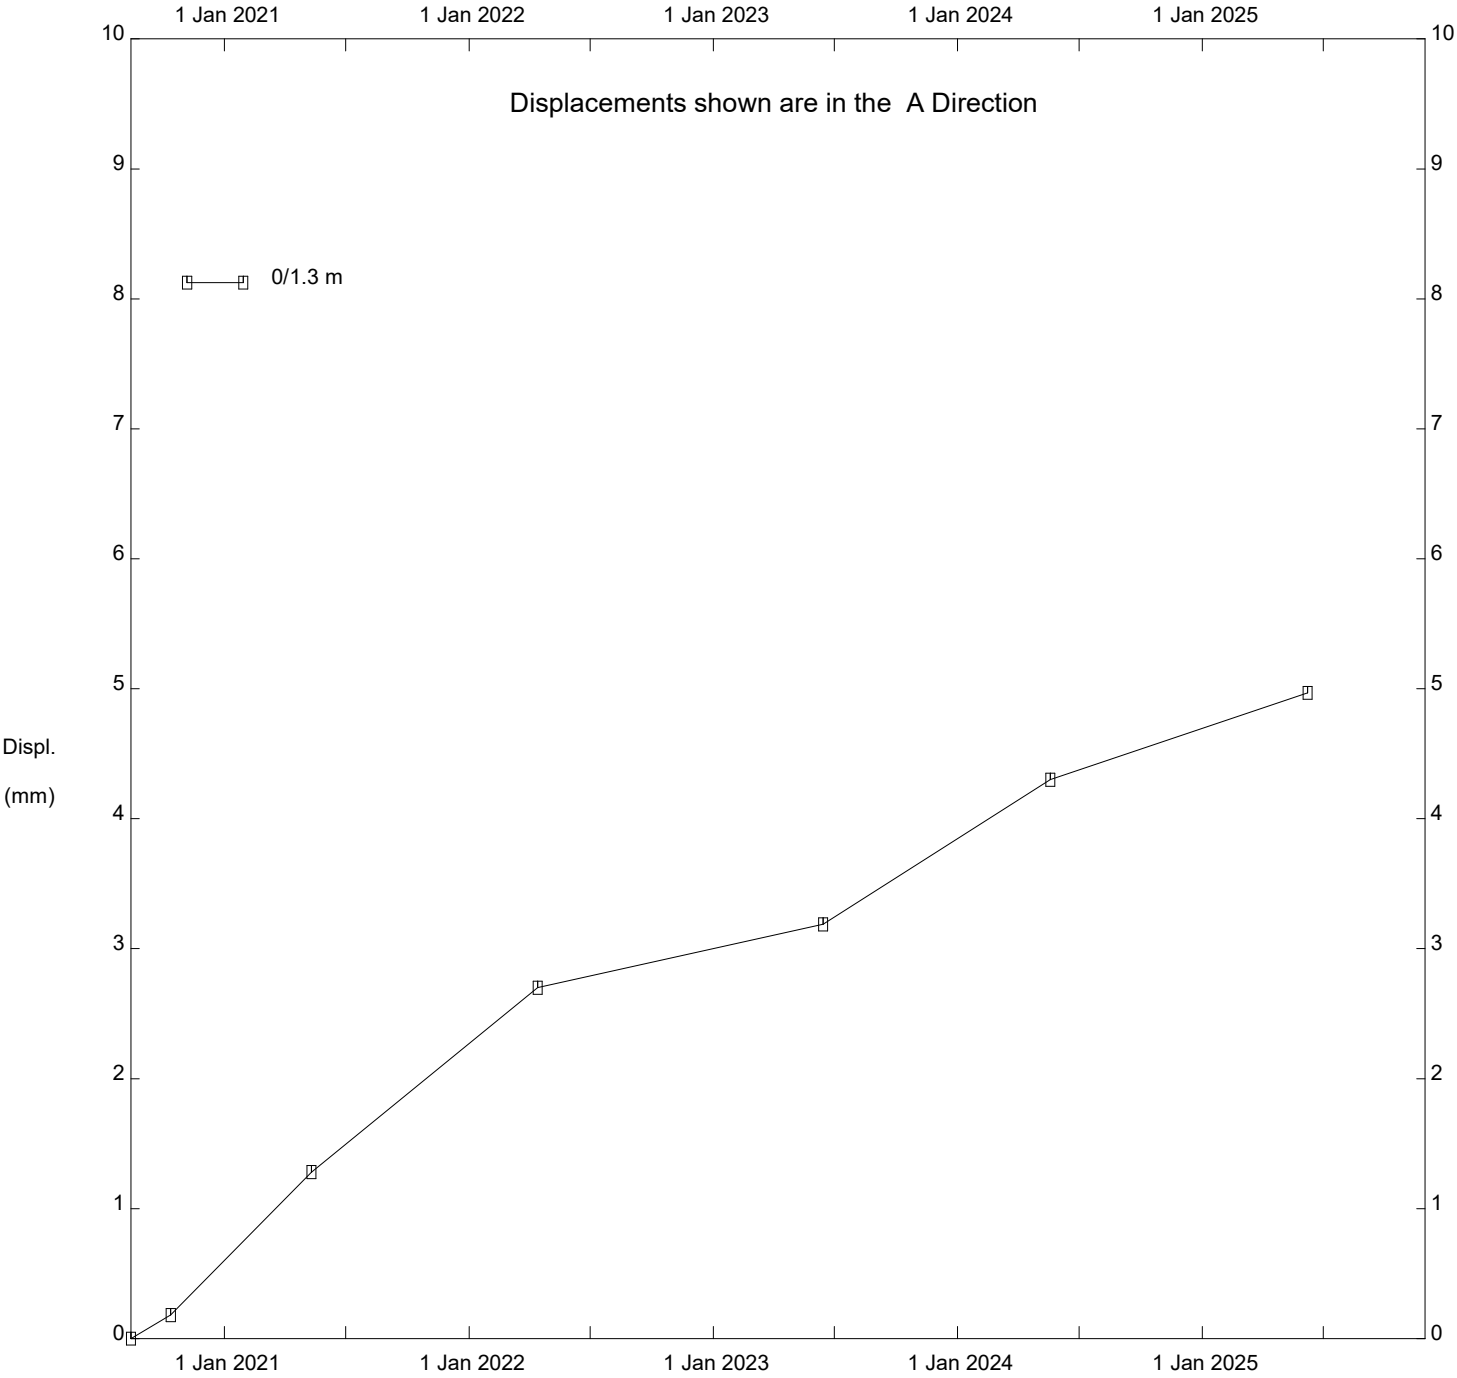
HWY 684 Shaftesbury Trail, Inclinator SI20-2

Discussion	
<b>Zones of New Movement:</b>	None
<b>Interpretation of Monitoring Results:</b>	<p>SI20-2 showed a cumulative movement of 5.0 mm over 0 m to 1.3 m depth with a rate of movement of 0.6 mm/yr since the previous readings on May 18, 2024.</p> <p>SI20-3 showed a cumulative movement of 3.7 mm over 0 m to 1.3 m depth with a rate of movement of 1.0 mm/yr since the previous readings on May 18, 2024.</p> <p>Vibrating wire piezometer VW20-1 showed an increase in groundwater level of 0.38 m compared to the May 18, 2024 readings. VW20-2 was dry during the spring 2025 readings but showed water level above the tip between January 19 and October 11, 2024. VW20-3 showed a decrease in groundwater level of 0.04 m since the May 18, 2024 reading. VW20-3 has previously shown a trend of increasing groundwater levels until December 2024, showing a historical maximum groundwater elevation of 325.05 on December 1, 2024. Since December, it has shown a seasonal decrease in water level.</p>
