**ALBERTA TRANSPORTATION  
PEACE REGION (PEACE RIVER / HIGH LEVEL)  
INSTRUMENTATION MONITORING RESULTS**

**FALL 2020**

**SITE PH005-1: HWY 35:08, MEIKLE RIVER SLIDE (km 25.5)**

**ALBERTA TRANSPORTATION  
PEACE REGION (PEACE RIVER / HIGH LEVEL)  
INSTRUMENTATION MONITORING FIELD SUMMARY (PH005-1)  
FALL 2020**

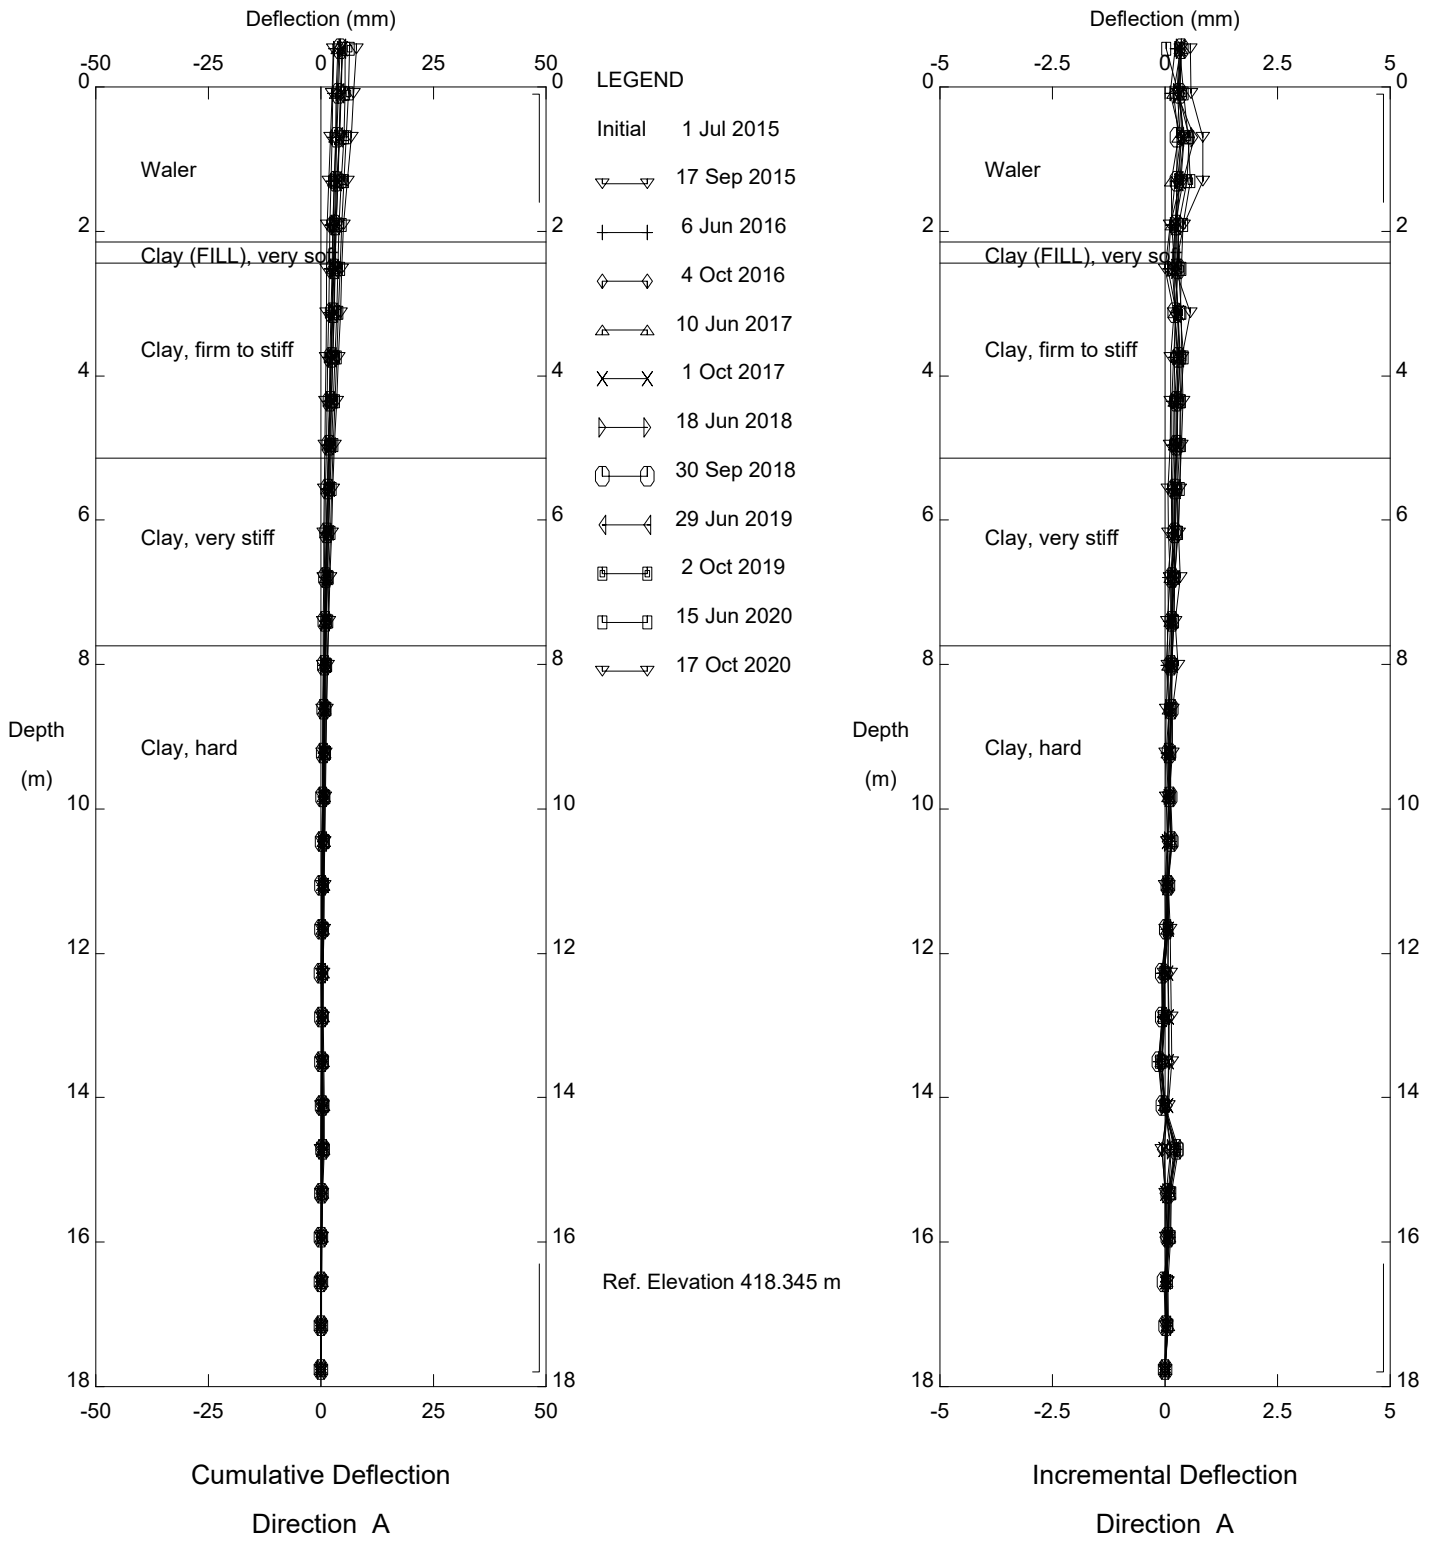
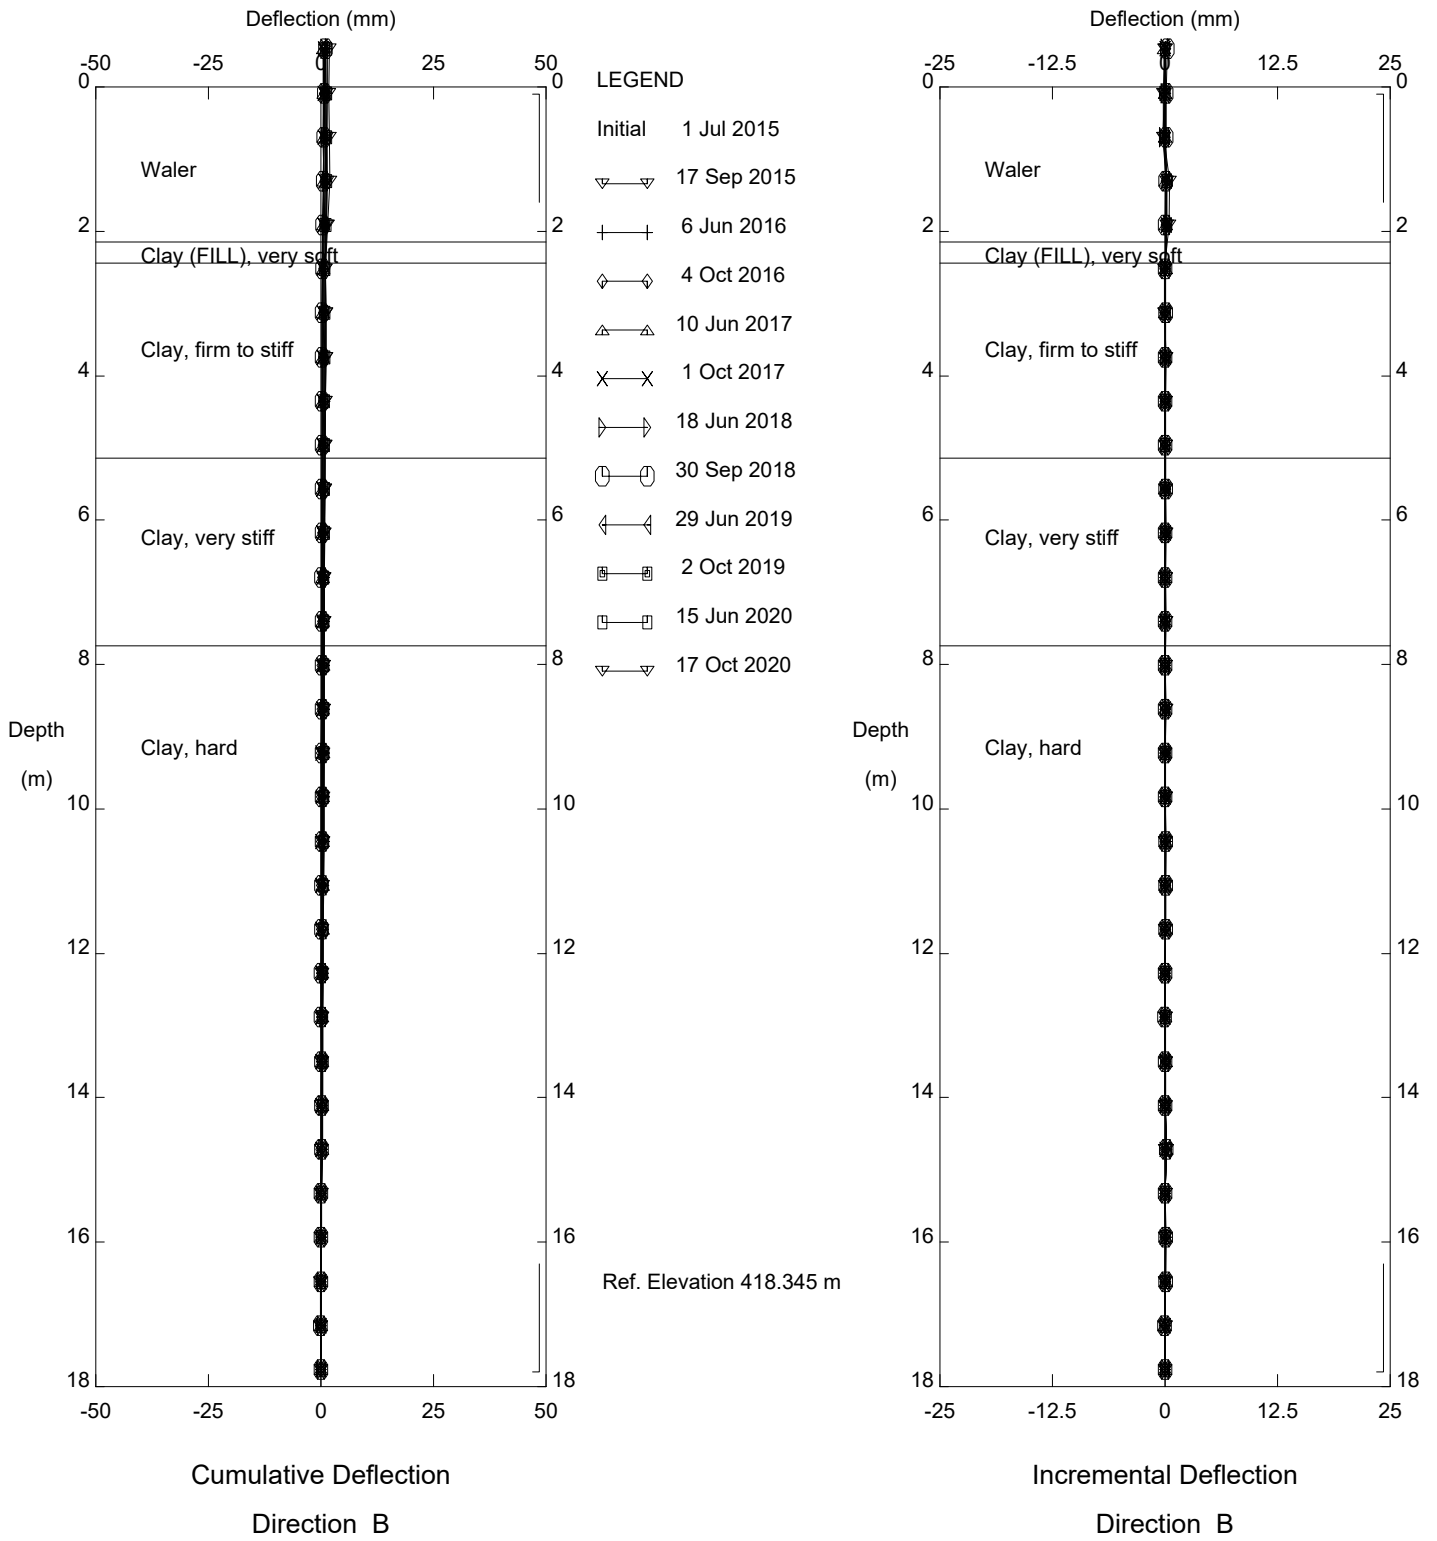
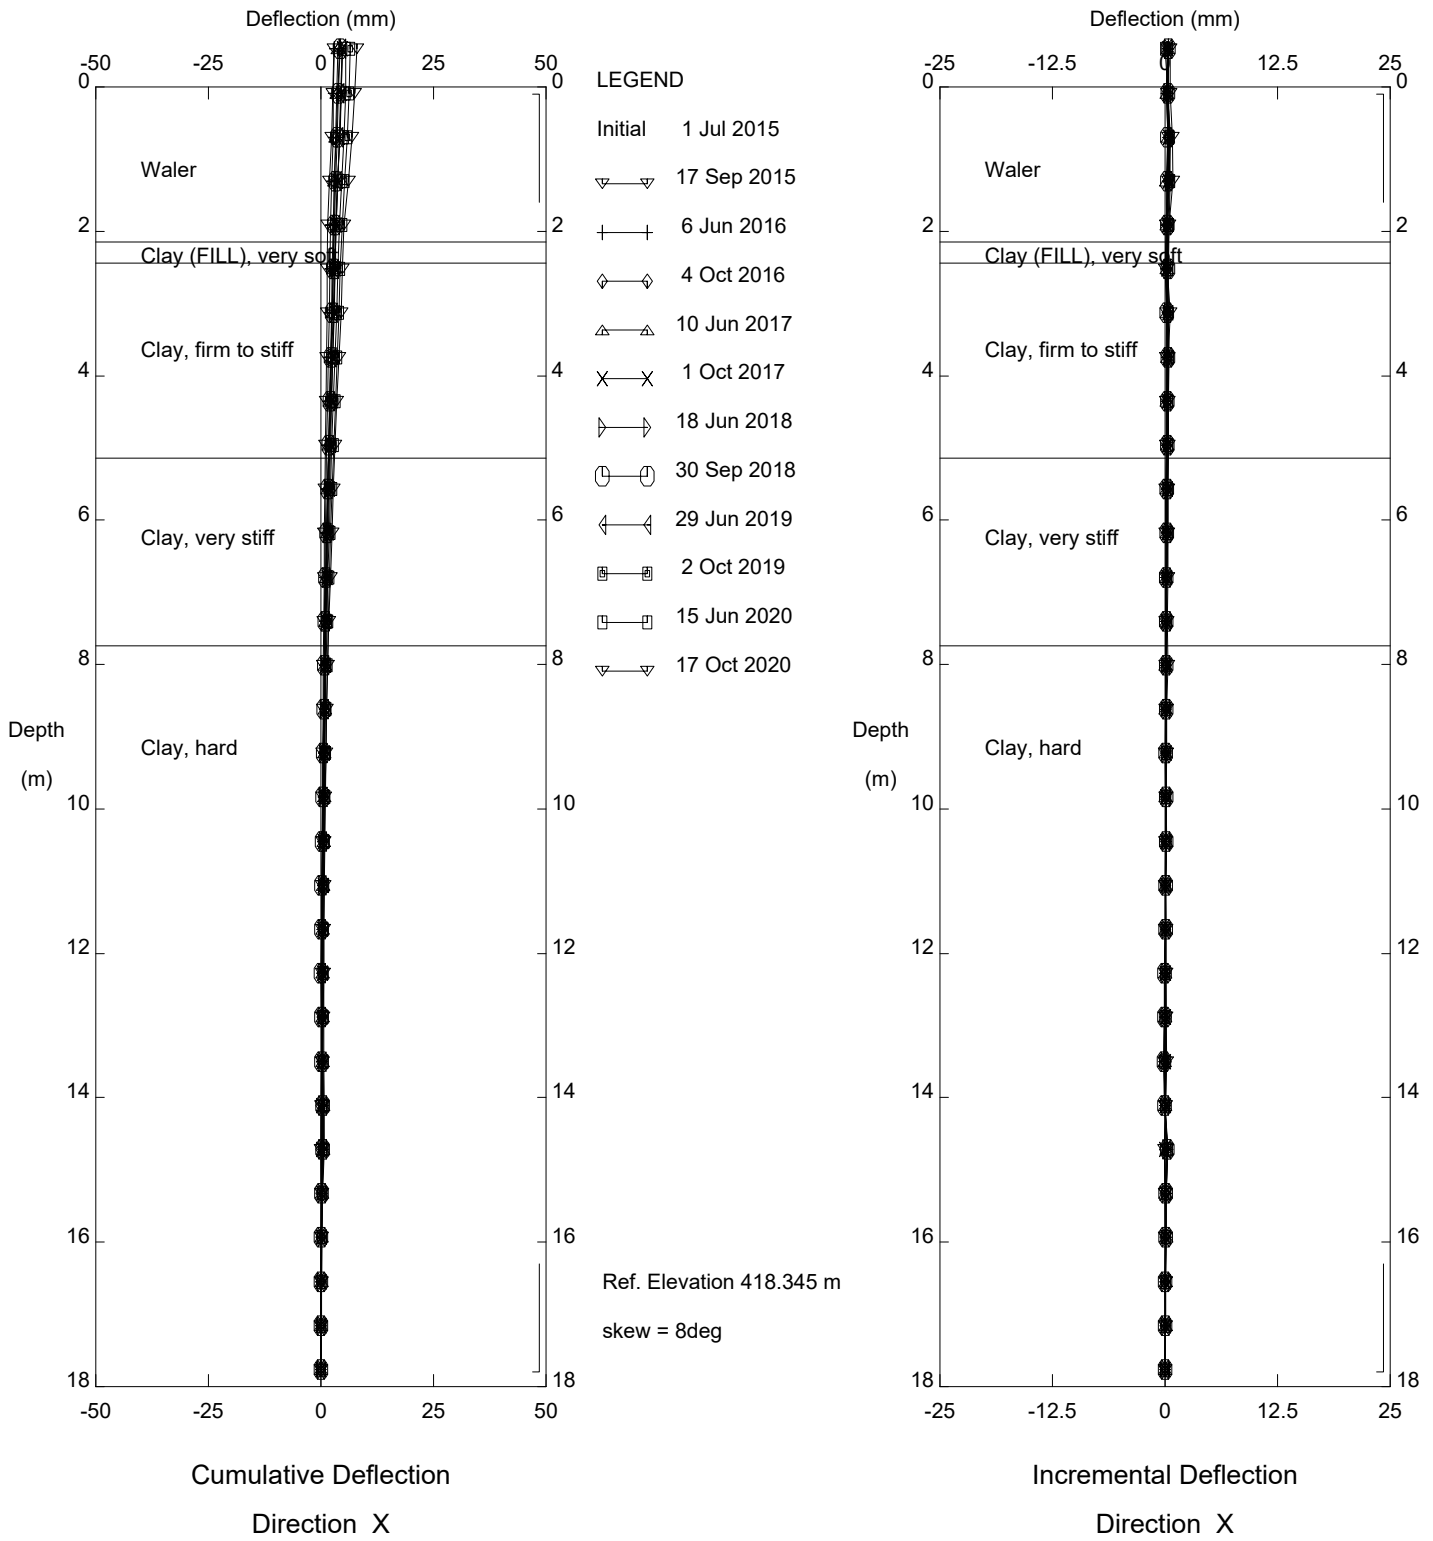
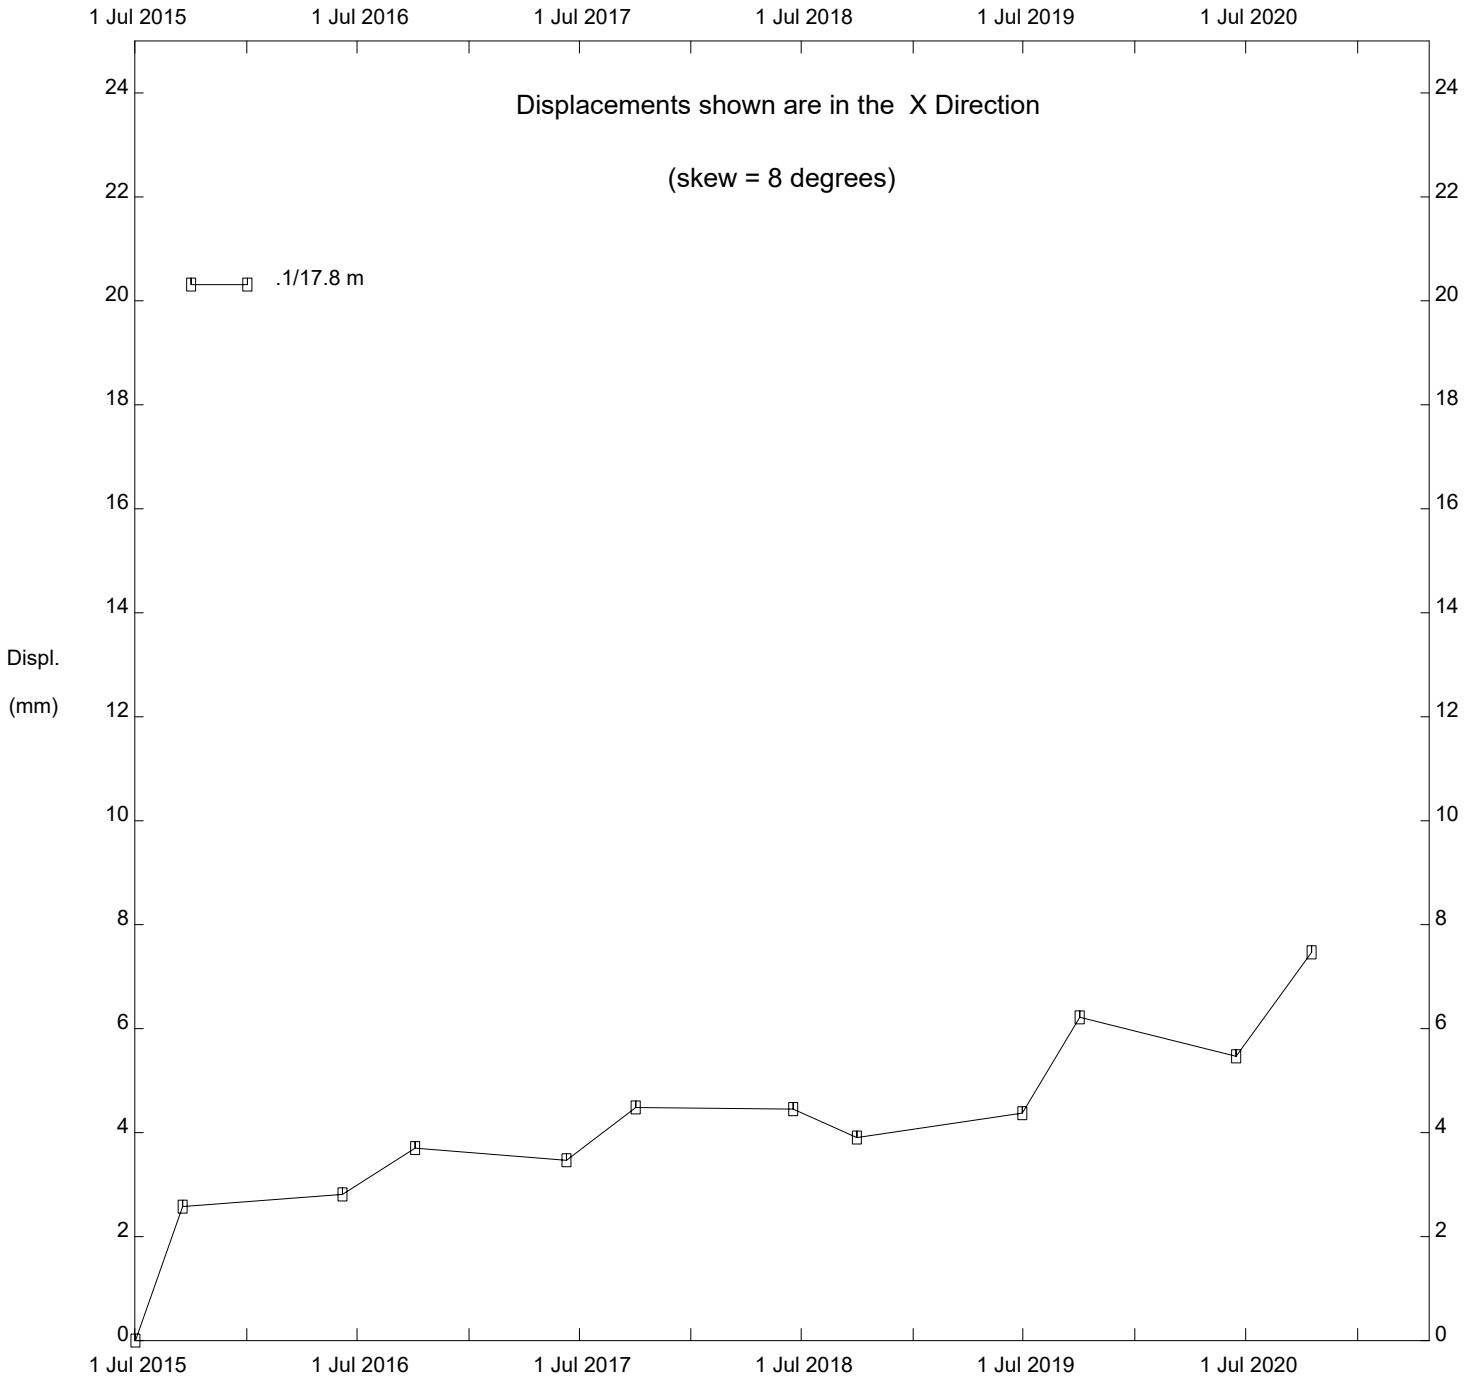
HWY 35:08 Meikle River, Inclinometer SI-P14

The movement zones for the slope inclinometers installed in the piles are defined over the length of the pile and water. SI-P14 showed a movement rate of 5.8 mm/yr since the spring of 2020 readings. SI-P23 showed a rate of movement of 7.2 mm/yr over 0.4 m to 17.5 m depth. SI-P32 showed no discernible movement over 0 m to 16.4 m. These three SIs have measured total pile head deflections to date ranging from 7.5 mm to 8.3 mm.

The instruments should be read again in the spring of 2021.

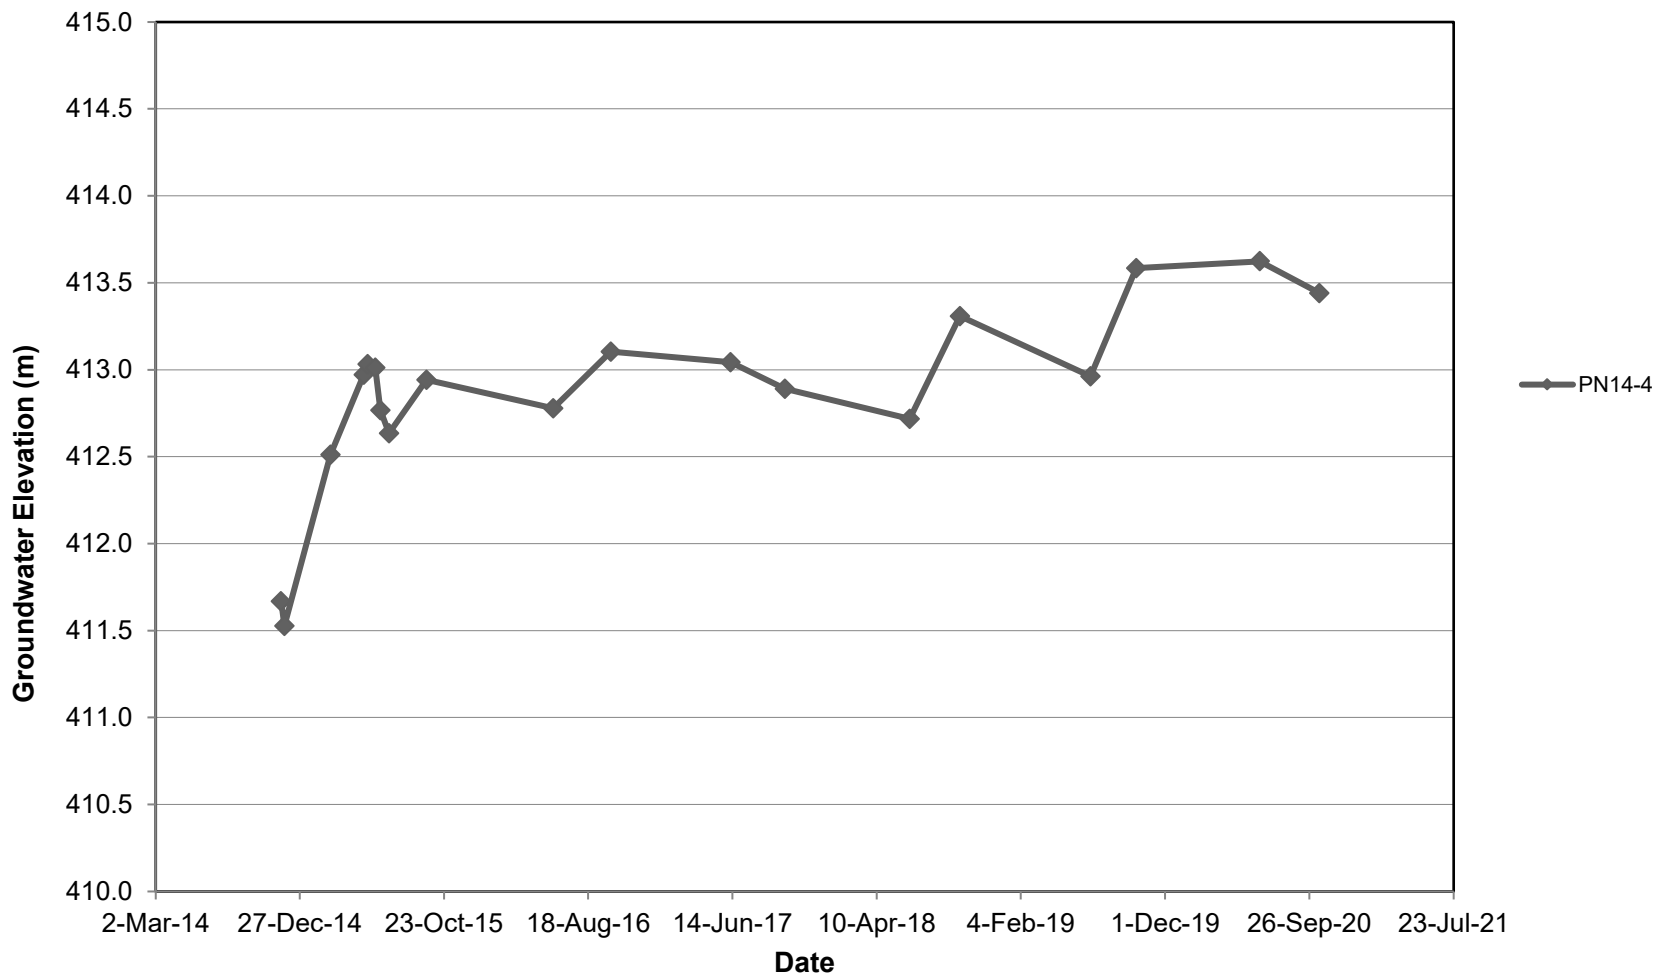
**FIGURE PH005-1-1**  
**PIEZOMETER DATA FOR HWY 35:08 (PH005-1) MEIKLE RIVER LANDSLIDE**

The water level in pneumatic piezometer PN14-4 decreased by 0.18 m since the spring of 2020 readings. The pneumatic piezometer readings are summarized in Table PH005-1-2 below and are plotted on Figures PH005-1-1 (by elevation) and PH005-1-2 (by depth) in Section D.
