ALBERTA TRANSPORTATION AND ECONOMIC CORRIDORS GRMP PEACE REGION – (PEACE RIVER DISTRICT) INSTRUMENTATION MONITORING - SPRING 2025

Site Number	Location	Name	Hwy	km
SH004	HWY 49:12 C1 2.560	Little Smoky River (S of Bridge)	49:12	Km 2.6
Legal Description:		UTM Co-ordinates		
10-33-74-21 W5		11U E 489444	N 61	45583

Current Monitoring:	06-Jun-2025	Previous Monitoring	17-May-2024	
Instruments Read By:	Mr. Niraj Regmi, G.I.T., and Mr. Godfred Etiendem, Thurber

ALBERTA TRANSPORTATION AND ECONOMIC CORRIDORS PEACE REGION (PEACE RIVER DISTRICT) INSTRUMENTATION MONITORING FIELD SUMMARY (SH004) SPRING 2025

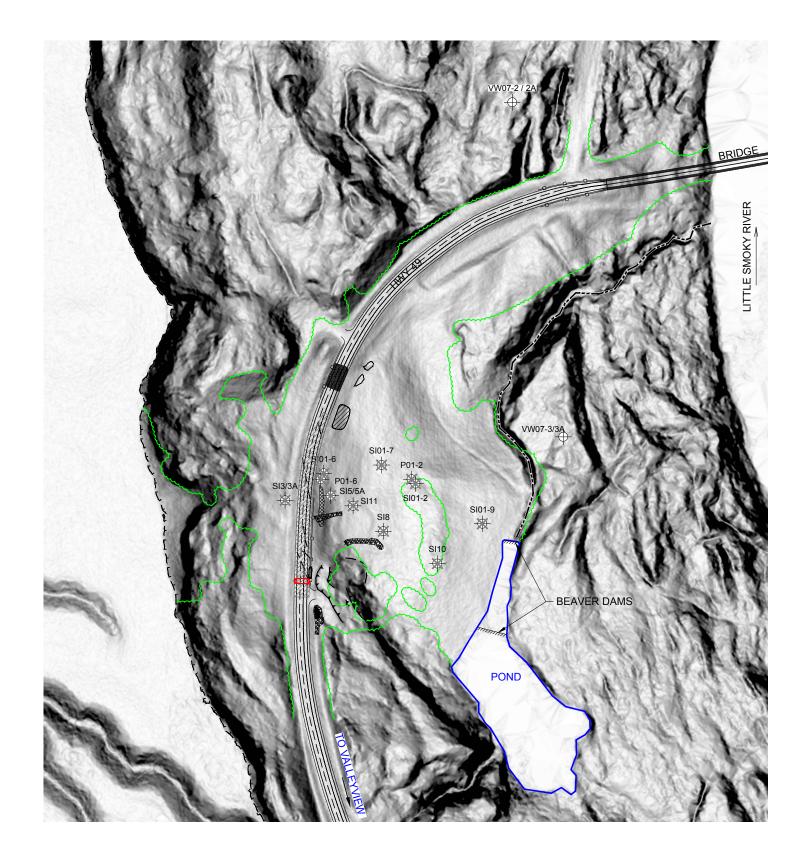
DWG No. 32123-SH004

Drawing 32121-SH004 in Appendix A provides a sketch of the approximate locations of the monitoring instrumentation for this site.

SH004: HWY 49:12 LITTLE SMOKY RIVER BRIDGE - SOUTH OF BRIDGE SITE PLAN SHOWING APPROXIMATE INSTRUMENT LOCATIONS

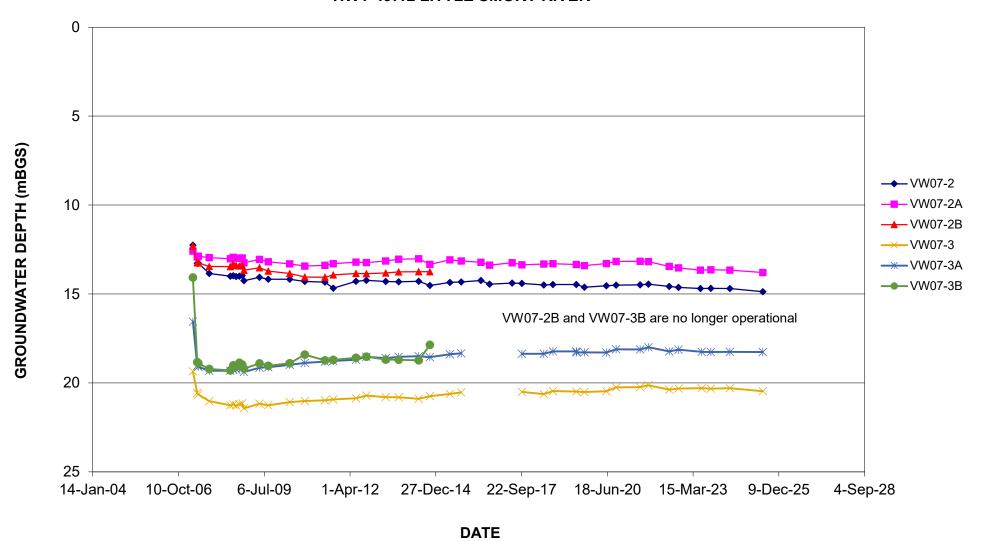
FIGURE SH004-1 VIBRATING WIRE PIEZOMETER READINGS FOR HWY 49:12 LITTLE SMOKY RIVER

Discussion				
Zones of New Movement:	None			
Interpretation of Monitoring Results:	Vibrating wire piezometers VW07-2, VW07-2A, VW07-3, and VW07-3A showed decreases in groundwater level of 0.17 m, 0.13 m, 0.17 m, and 0.02 m, respectively, since the spring of 2024 readings. There has been a generally lowering of the groundwater level in VW07-			
	2 and VW07-2Aby about 0.05 m/yr since 2007. The water level in VW07-3 and VW07-3A have both remained relatively constant since 2007.			
Future Work:	The instruments should be read again in the spring of 2026.			
Instrumentation Repairs:	No instrument repairs are required at this time.			
Additional Comments:
