**ALBERTA TRANSPORTATION
PEACE REGION (PEACE RIVER / HIGH LEVEL)
INSTRUMENTATION MONITORING RESULTS**

FALL 2020

SITE PH069-1: PEACE RIVER HOSPITAL

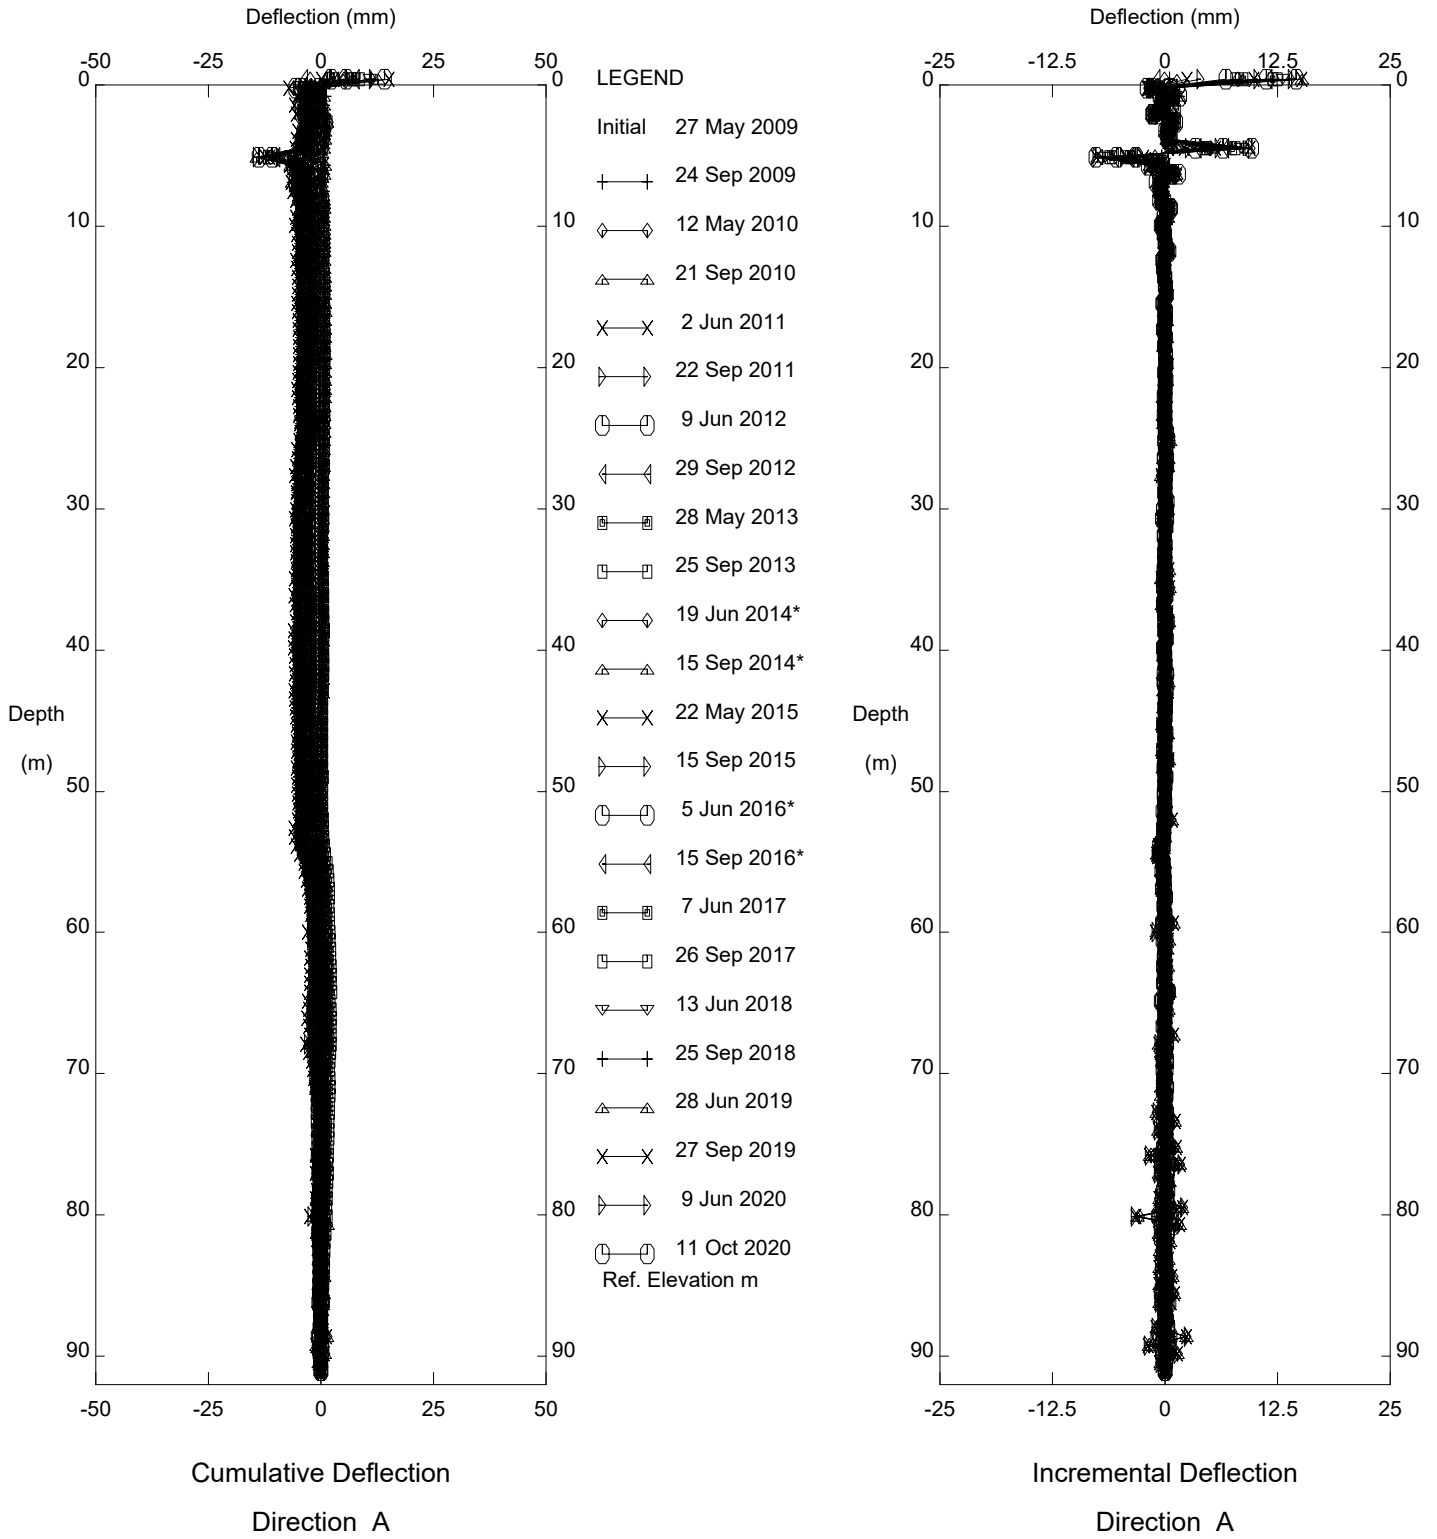
PH069-1 PEACE RIVER HOSPITAL, Inclinometer SI-1

No new zones of movement were observed in SI-1 since the spring of 2020 readings.

SI-1 continued to show no discernible movement.

The instruments should be read again during the spring of 2021 program.

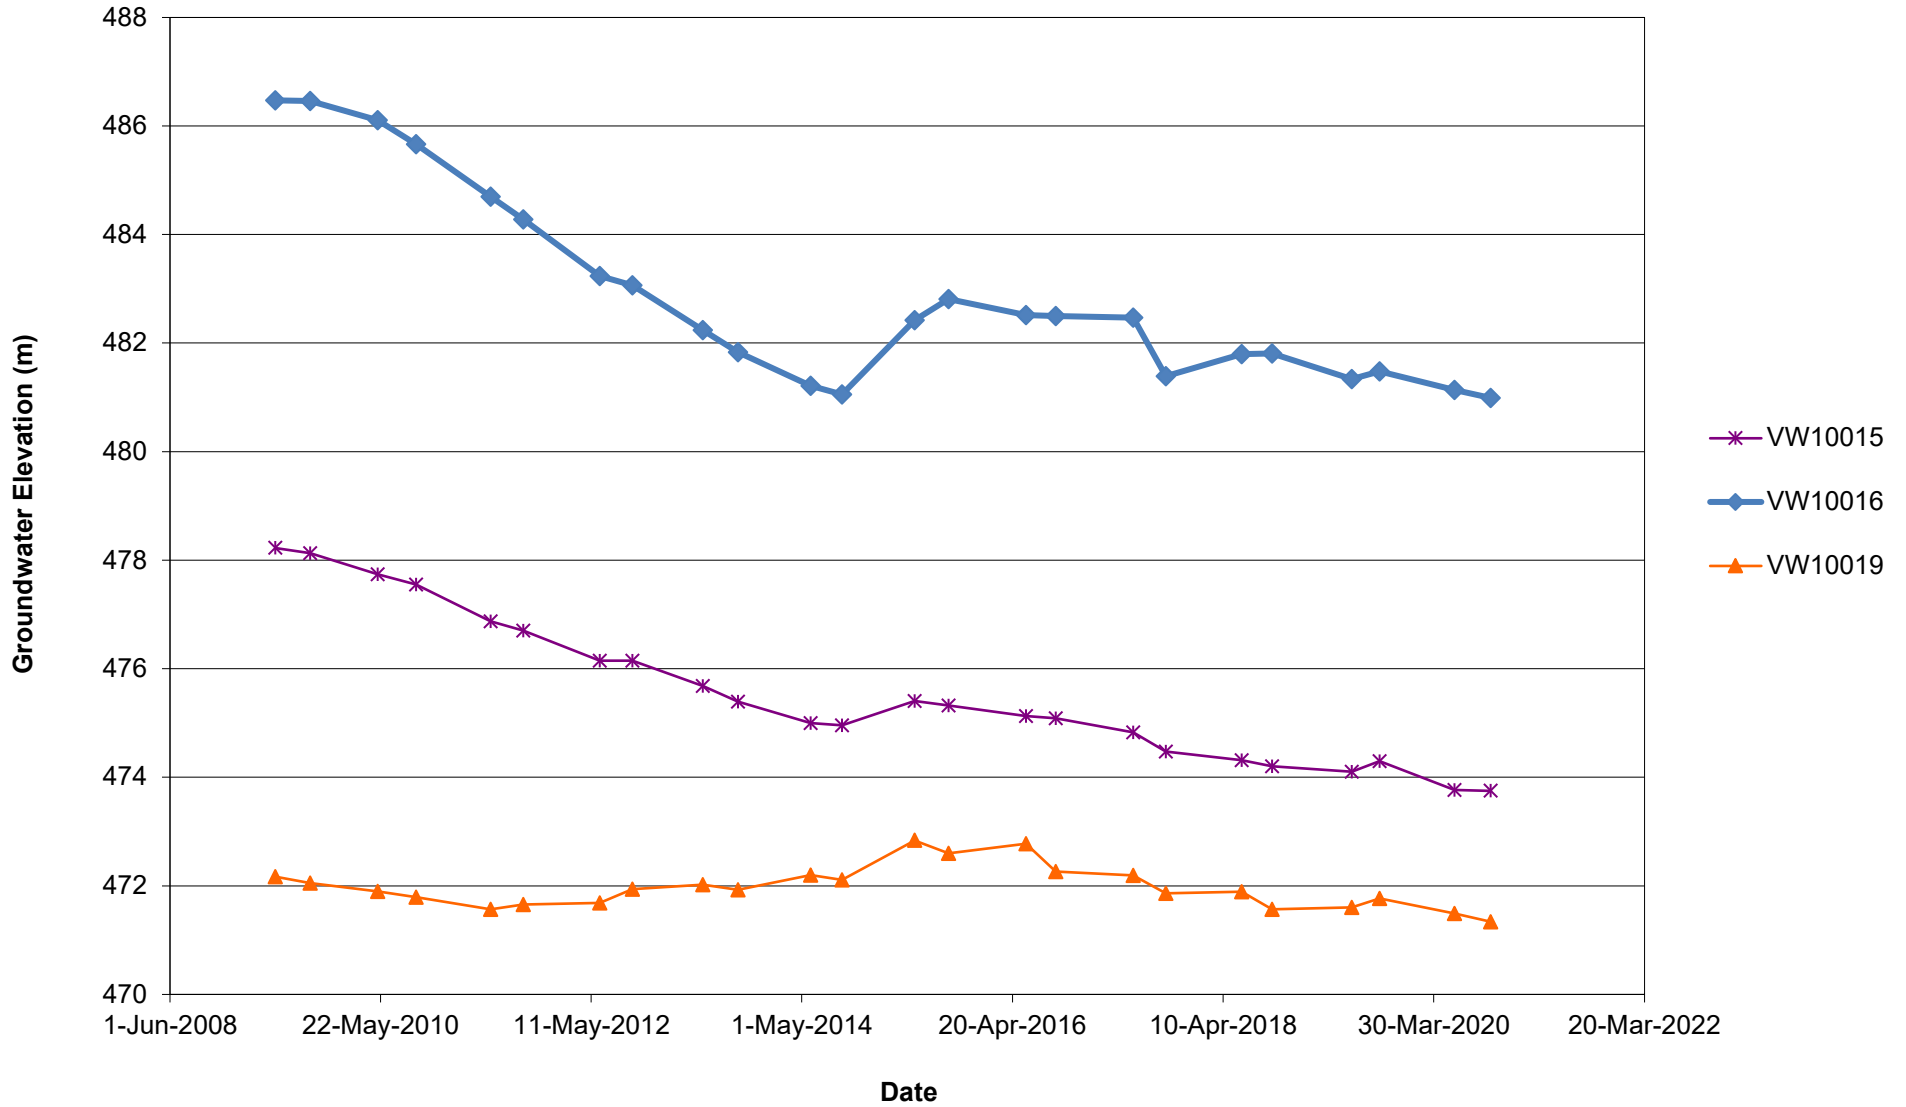
FIGURE PH069-1-1
PEACE RIVER HOSPITAL - VIBRATING WIRE PIEZOMETERS

Vibrating wire piezometers VW10015 and VW10016 and VW10019 showed decreases in groundwater level of 0.01 m, 0.14 m, and 0.15 m, respectively, since the spring of 2020 readings. The piezometer readings are summarized in Table PH069-1-2, and are plotted in Figure PH069-1-1 in Section D.
