Movement Monitoring Technologies: case studies - University of Alberta

Renato Macciotta Pulisci, Ph.D., P.Eng.

Content

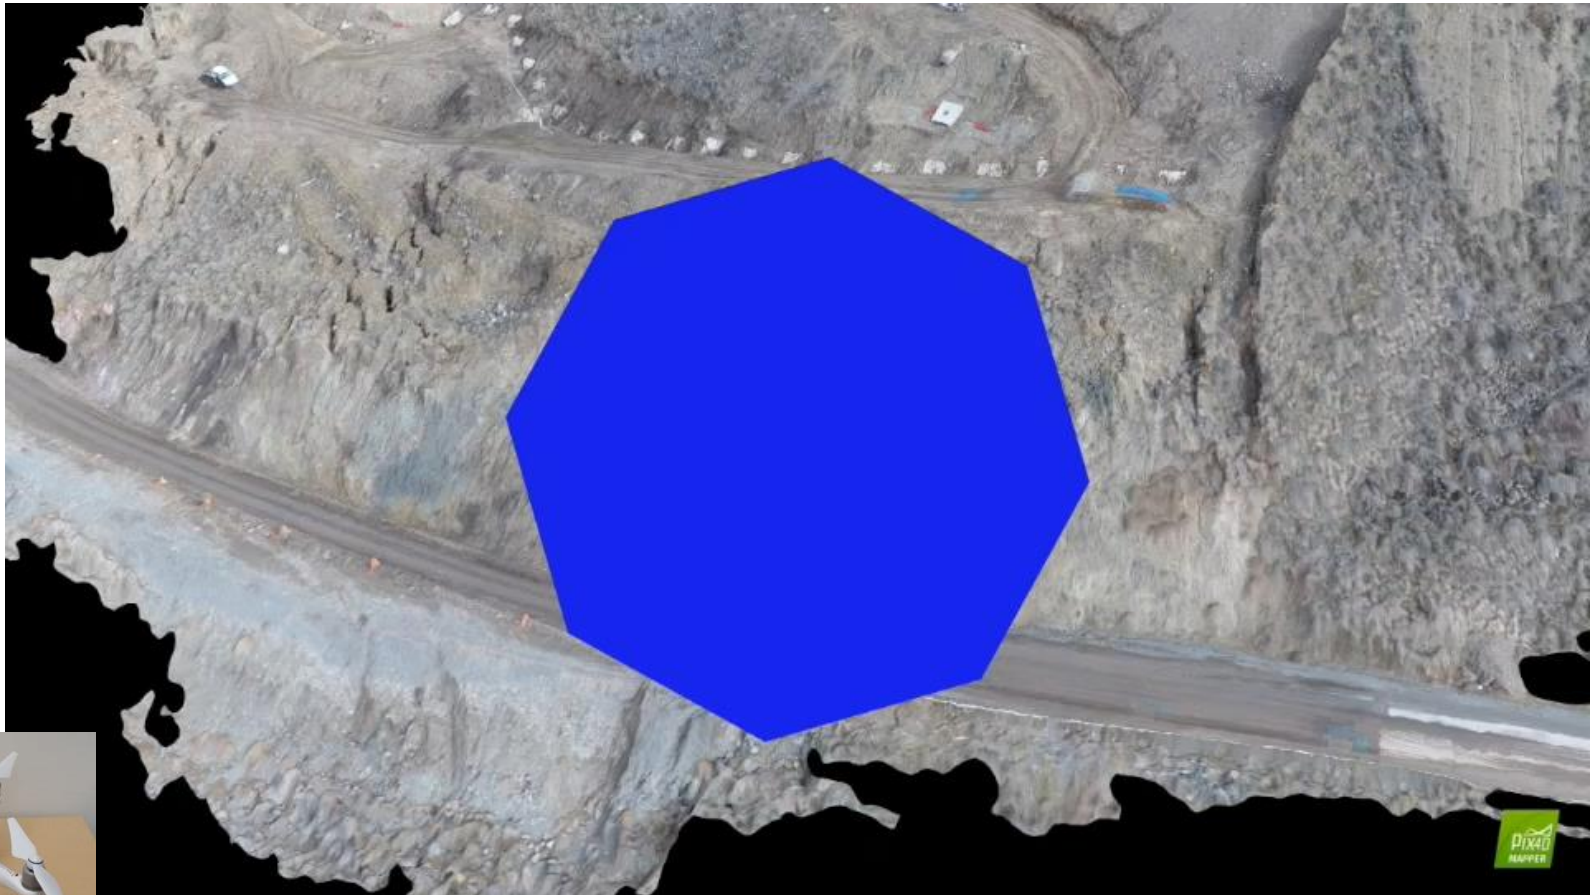
UAV model

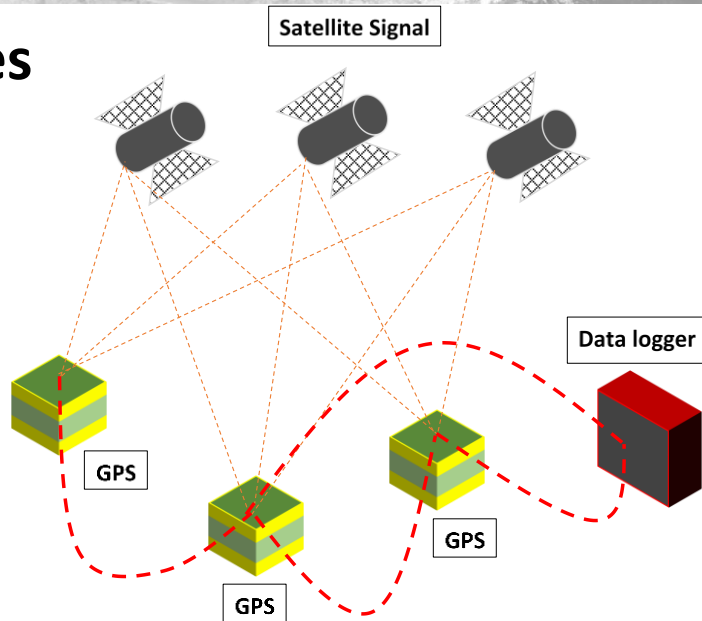
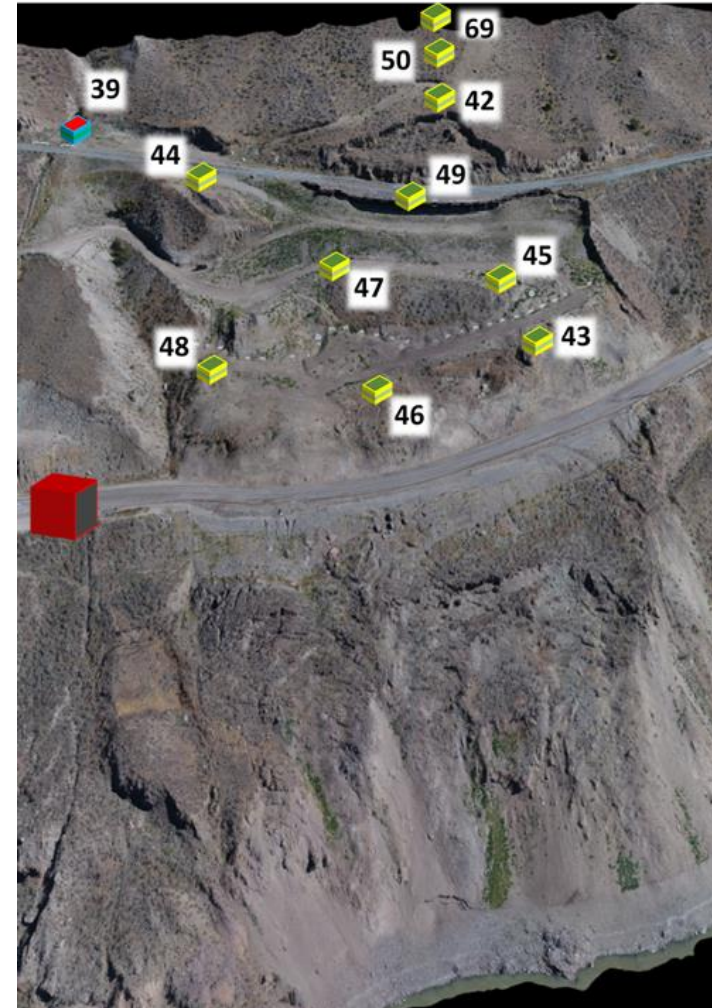
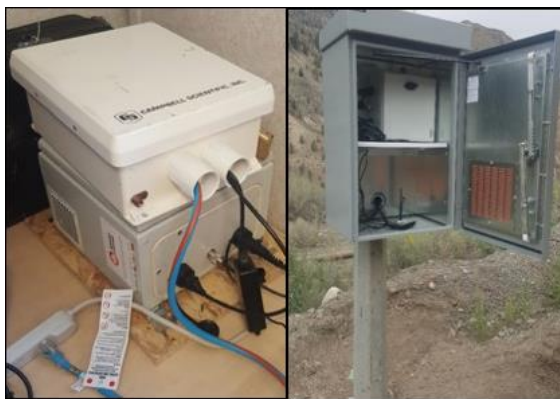
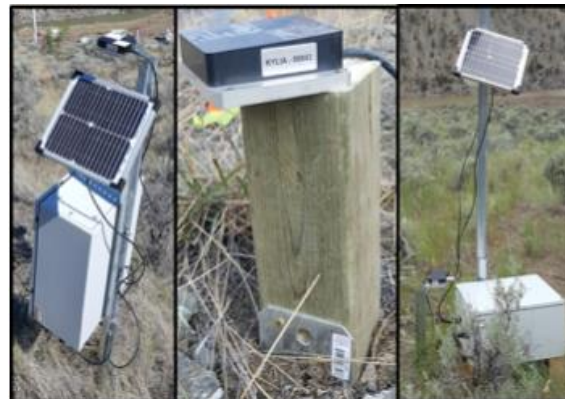
Geocubes

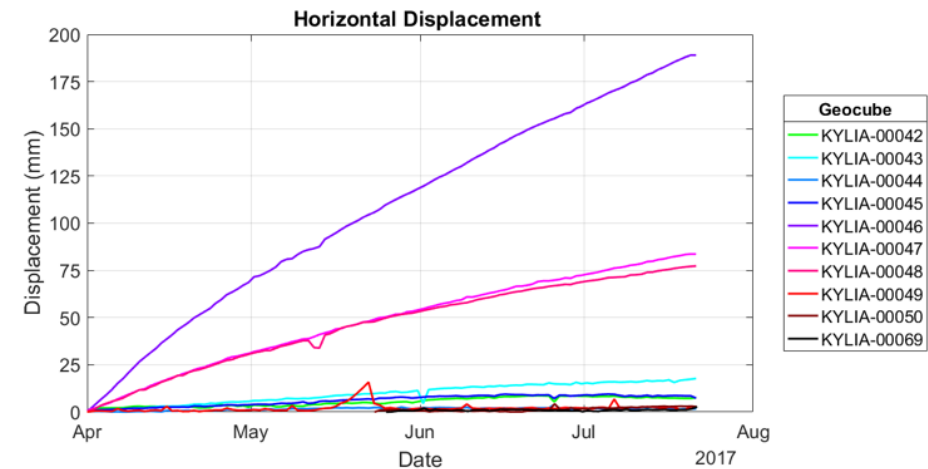
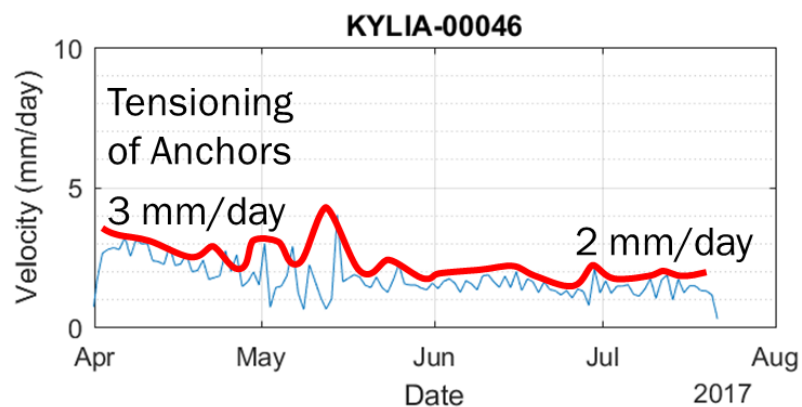
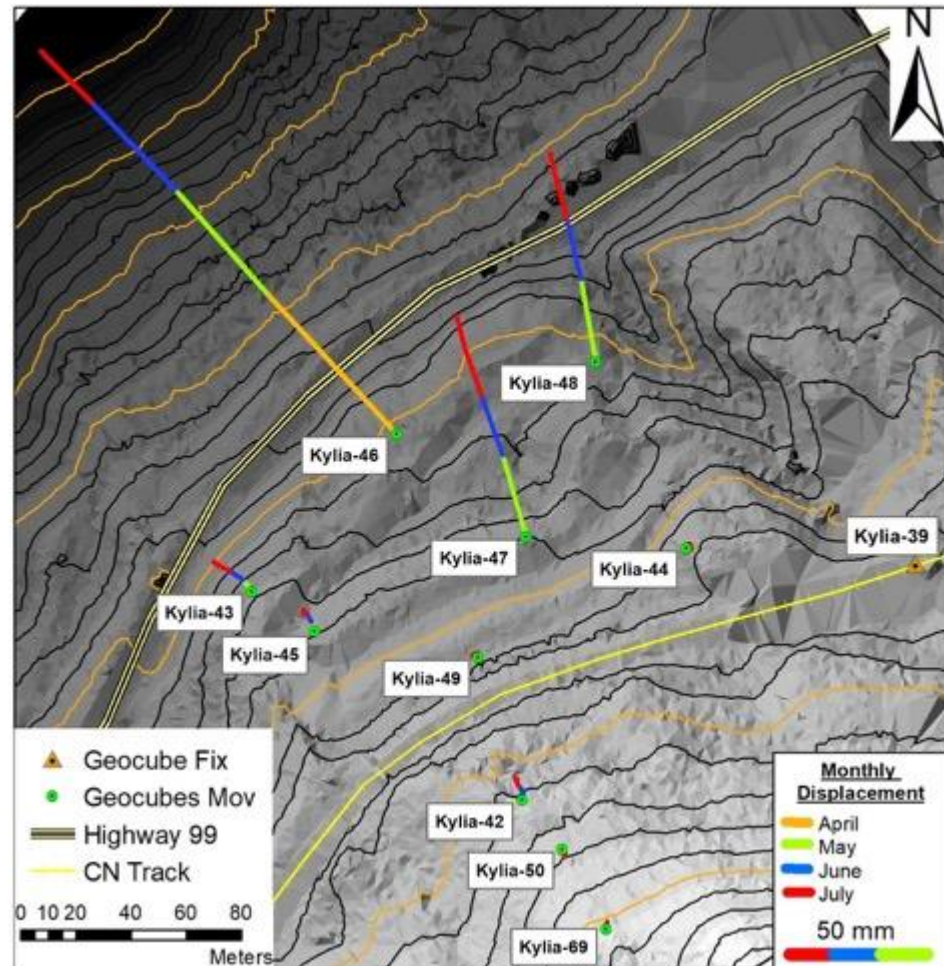
Geocubes

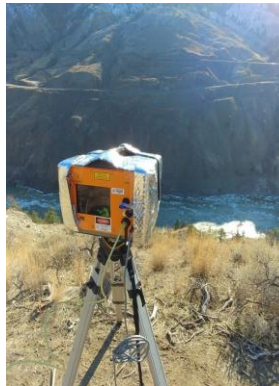
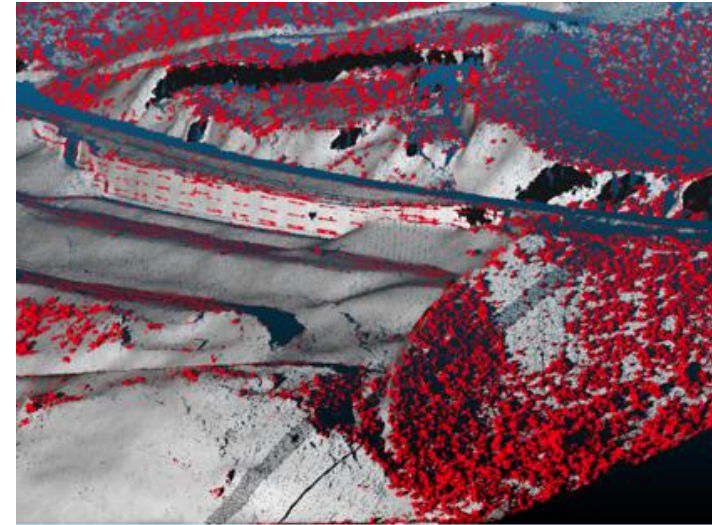
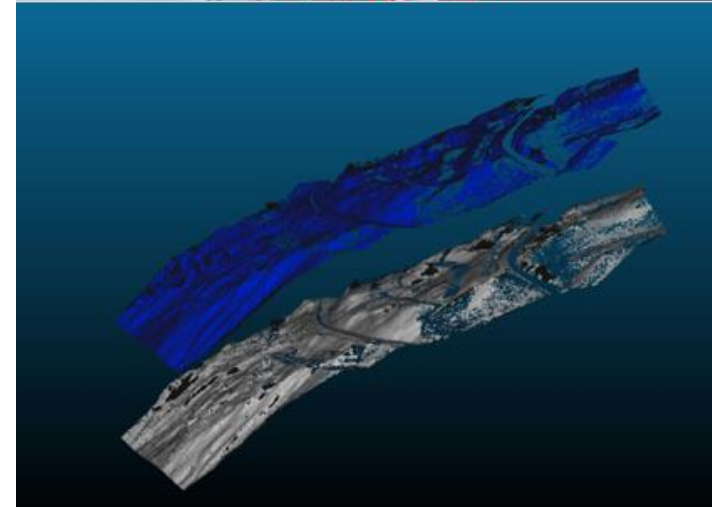
TLS – Change detection

Weather (Rain,
Sunlight, dust,
temperature)

Vegetation, snow,
external objects

Distance

Rate of movement

Stable areas or Shot
coordinates

Batteries/Generator

Shadows

SURVEY Plan
Location
Time
Frequency of Scan

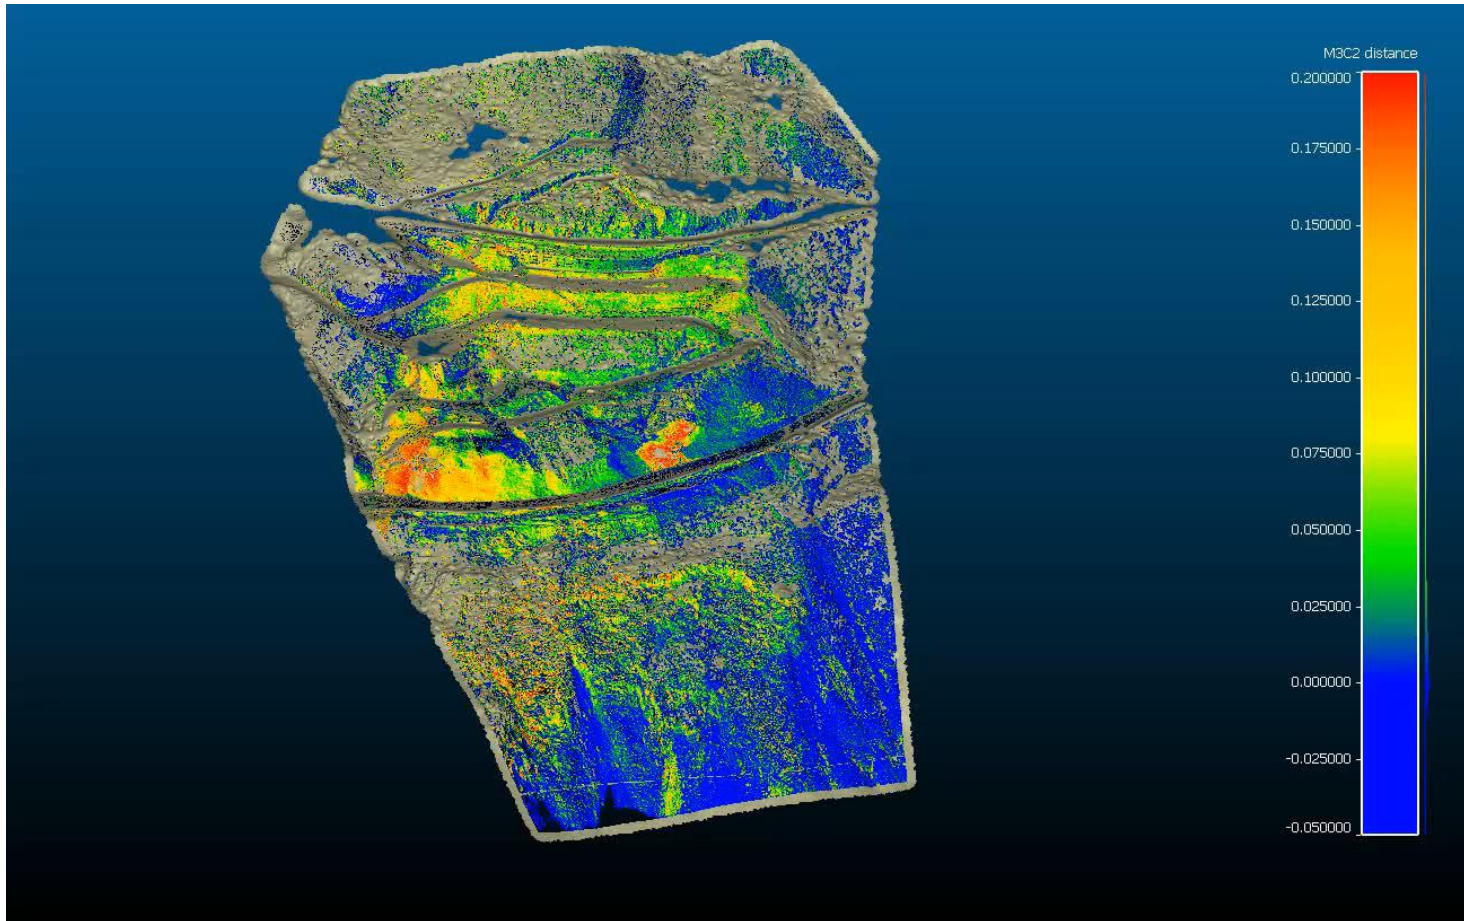
TLS – Change detection

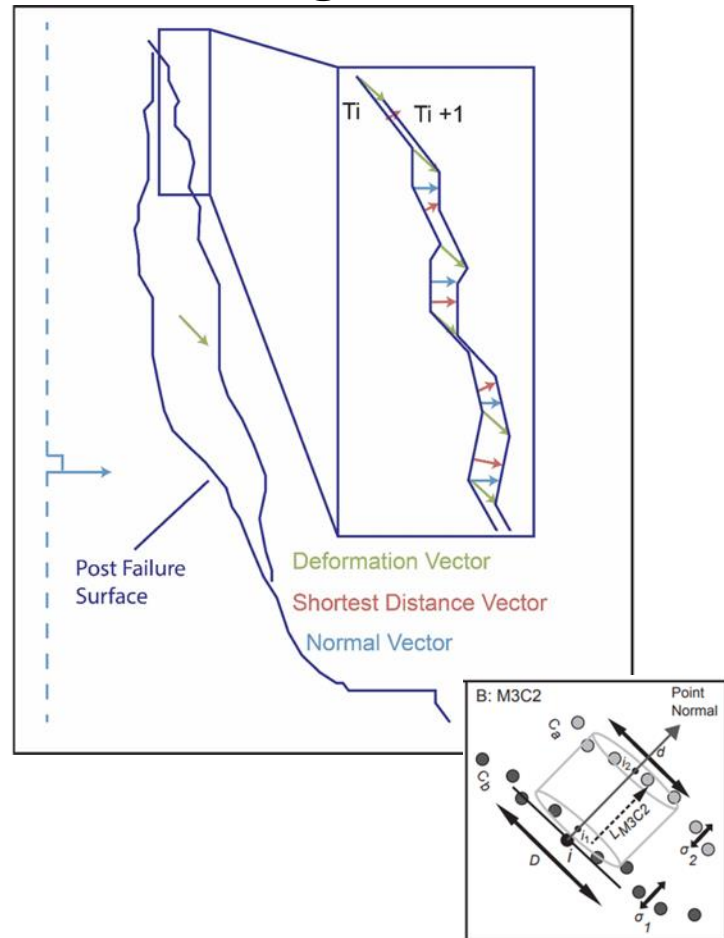
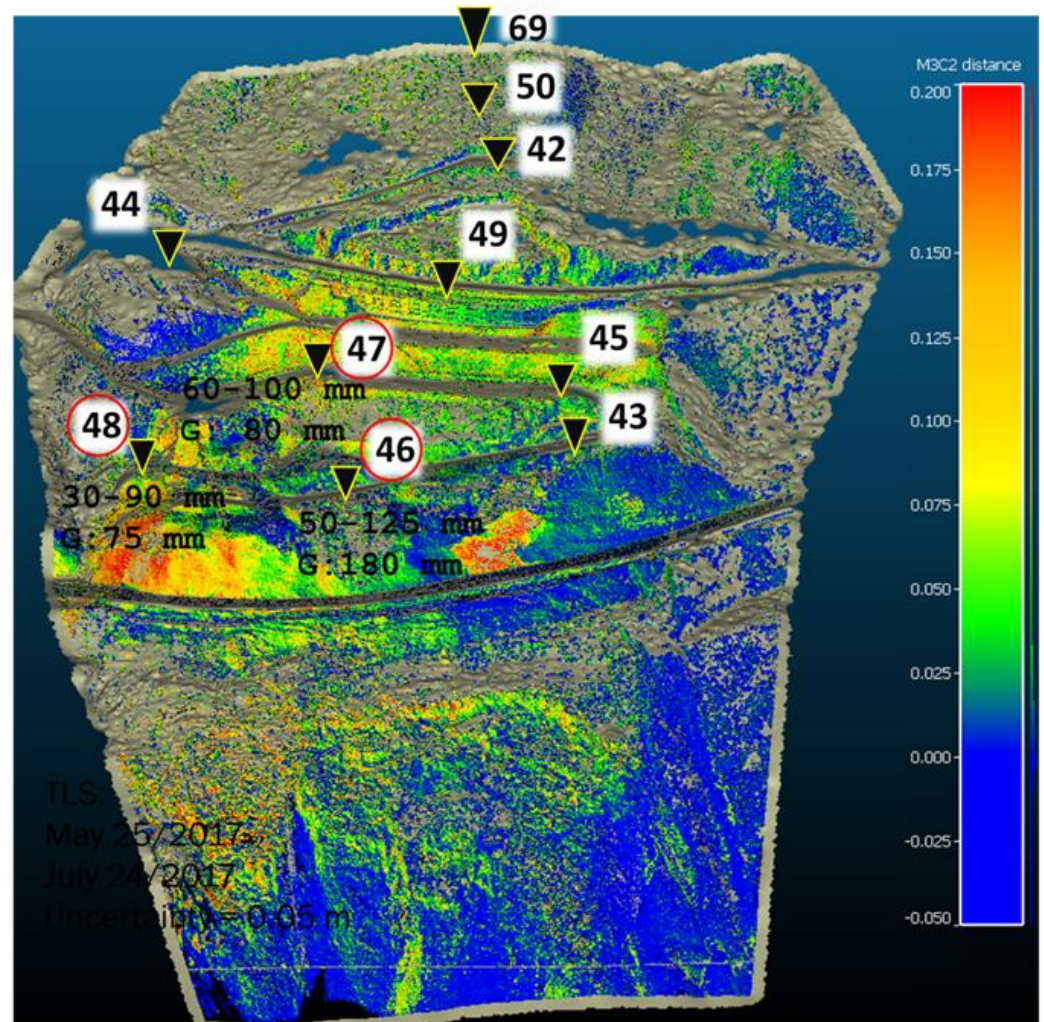
TLS – Change detection

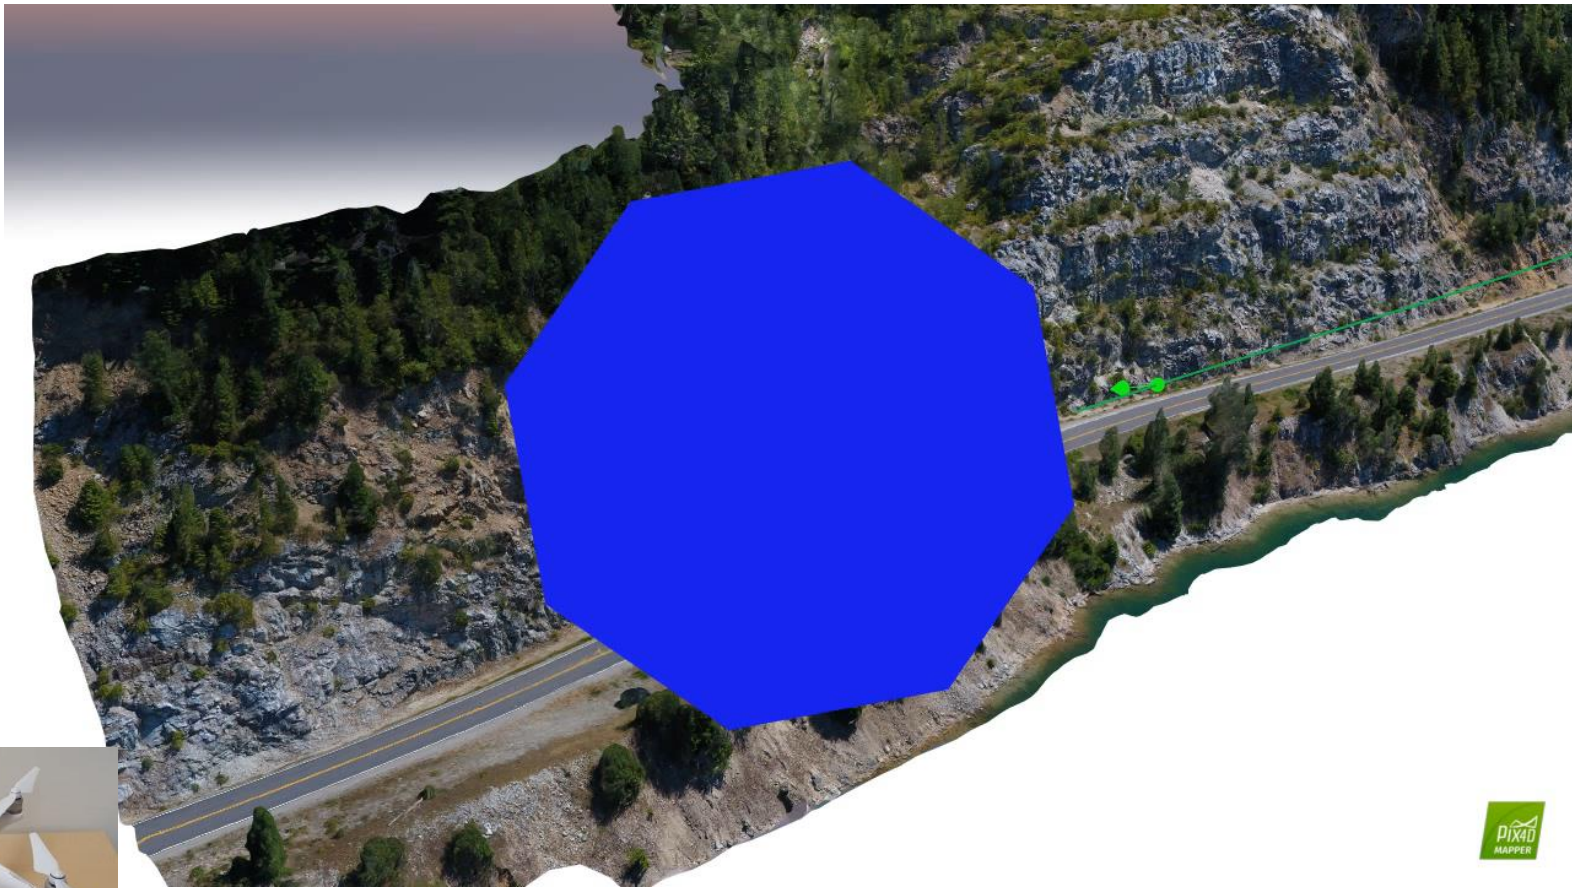
UAV model

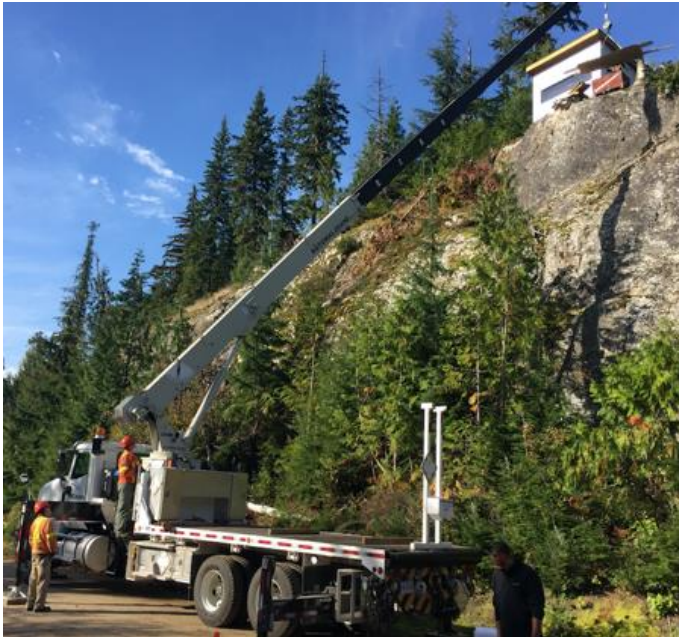
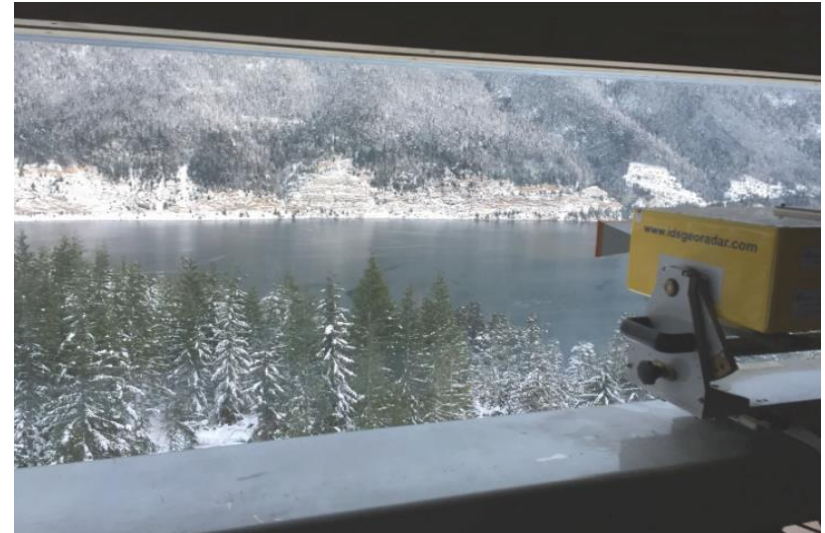
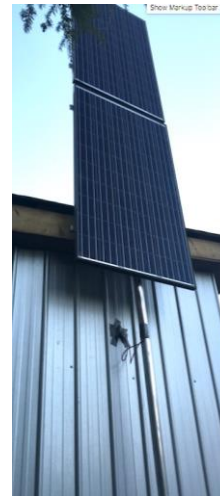
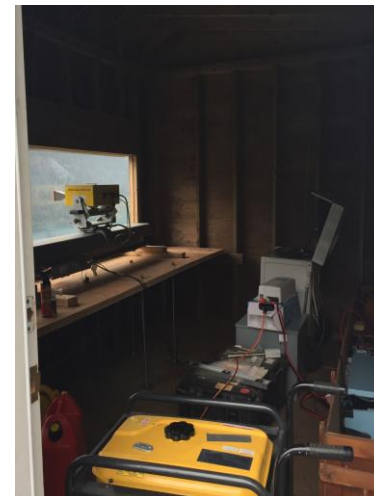
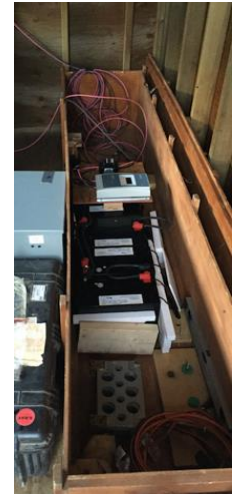
GB-InSAR

Three (parallel) double battery (series) packs for 300a 24v
Two 260 watt solar panels
System consumes 2.2 – 4.4 ah ...
However there's no sunlight!

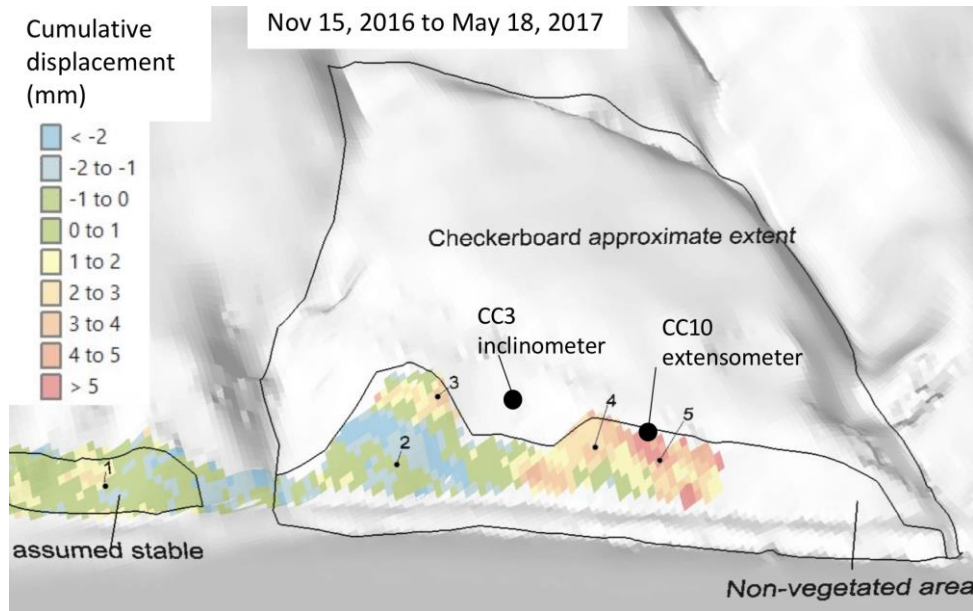
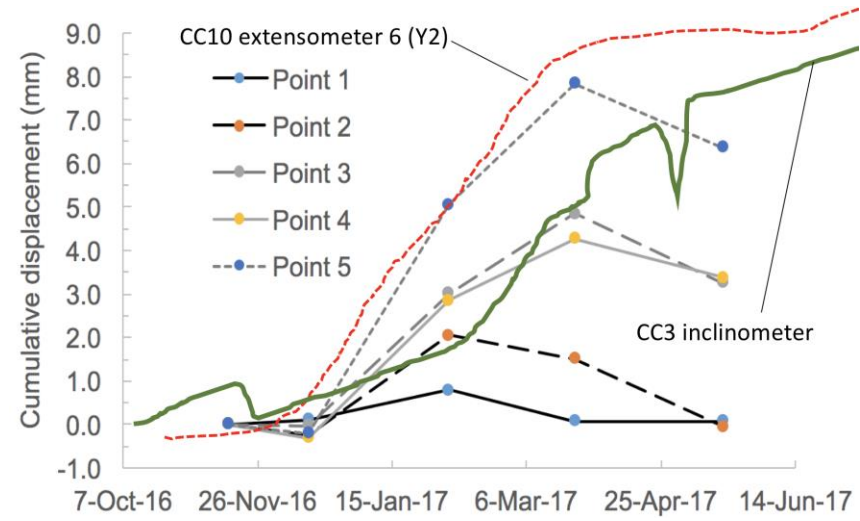
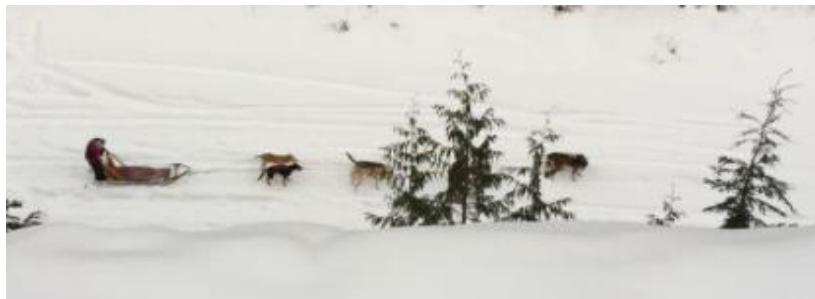
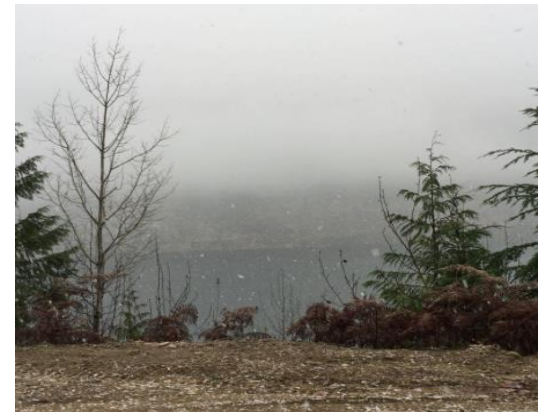
GB-InSAR

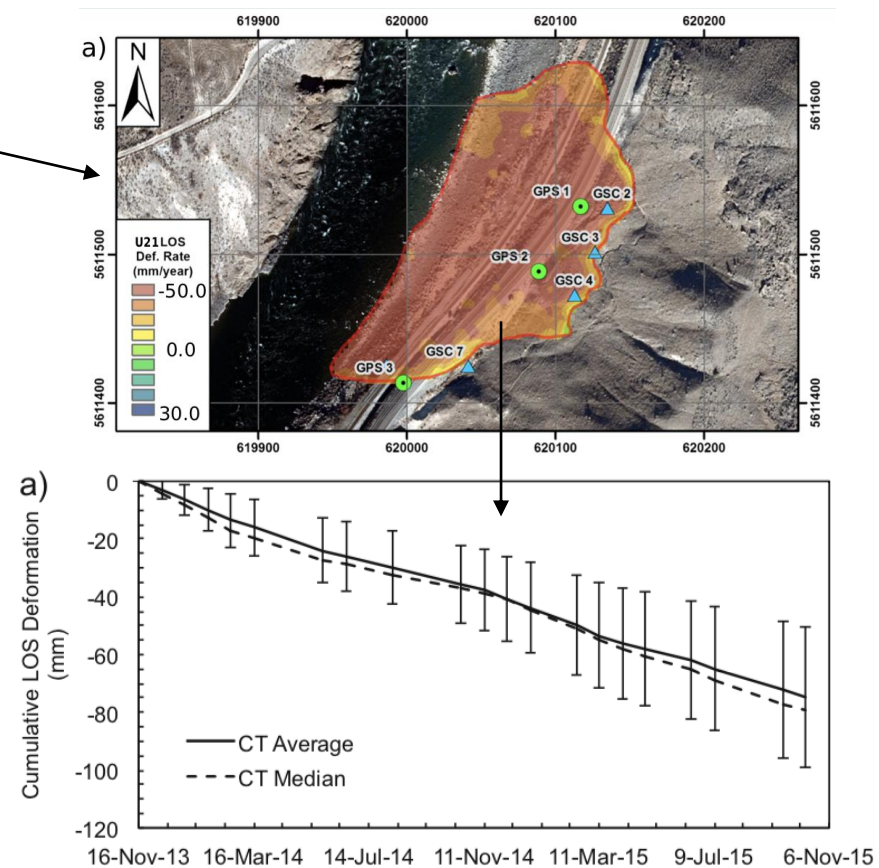
Satellite InSAR

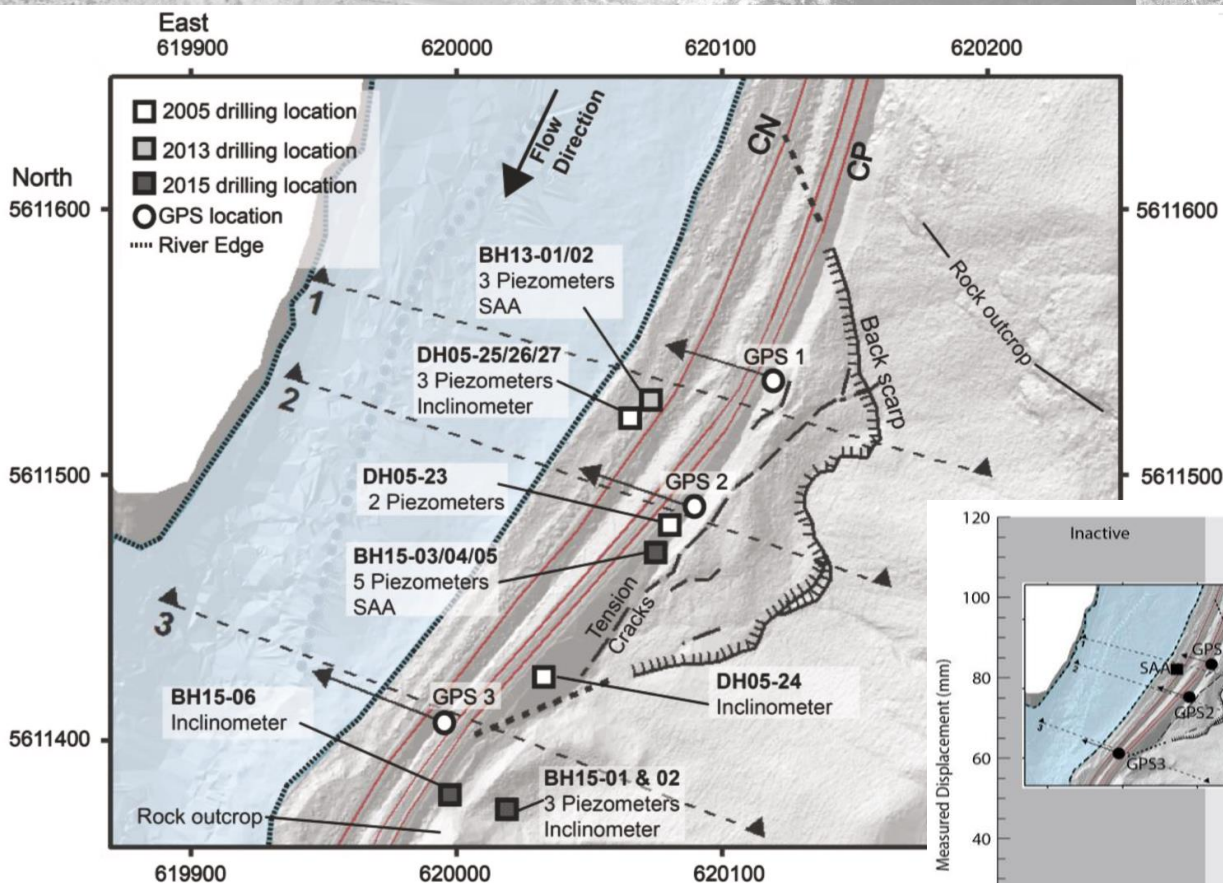
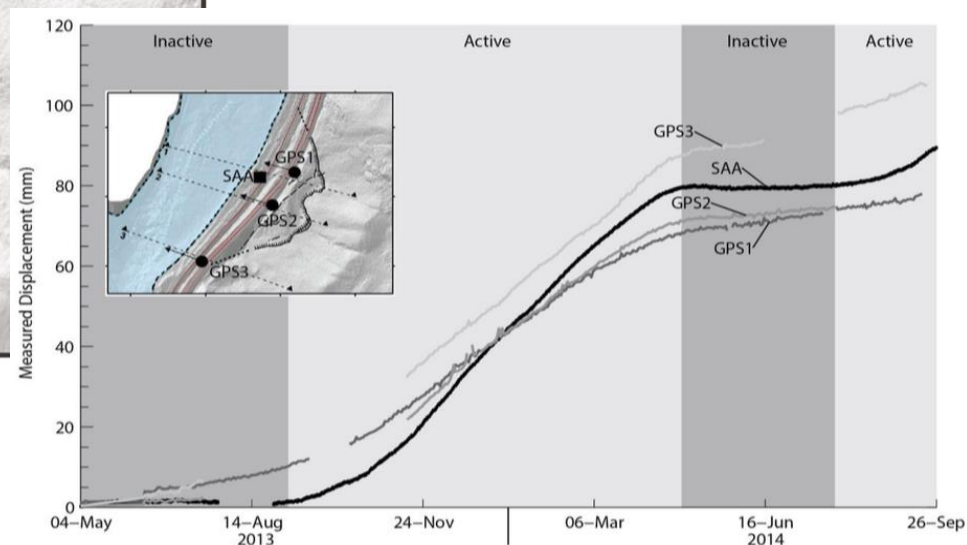
Base map = ALS

Ground instrumentation

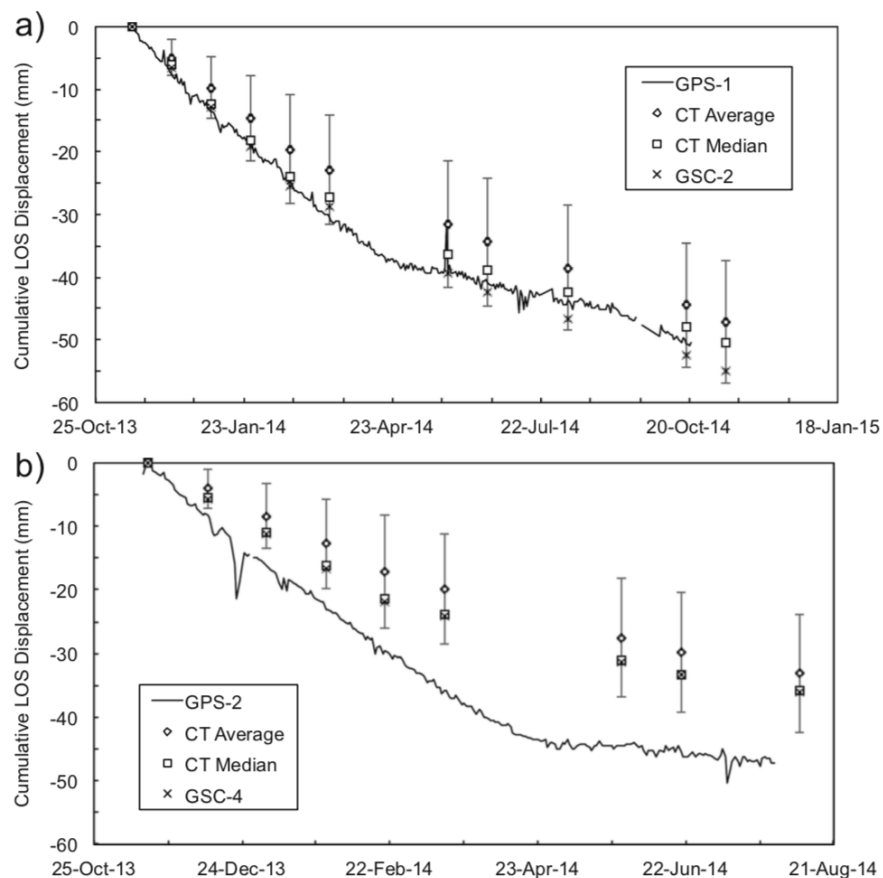
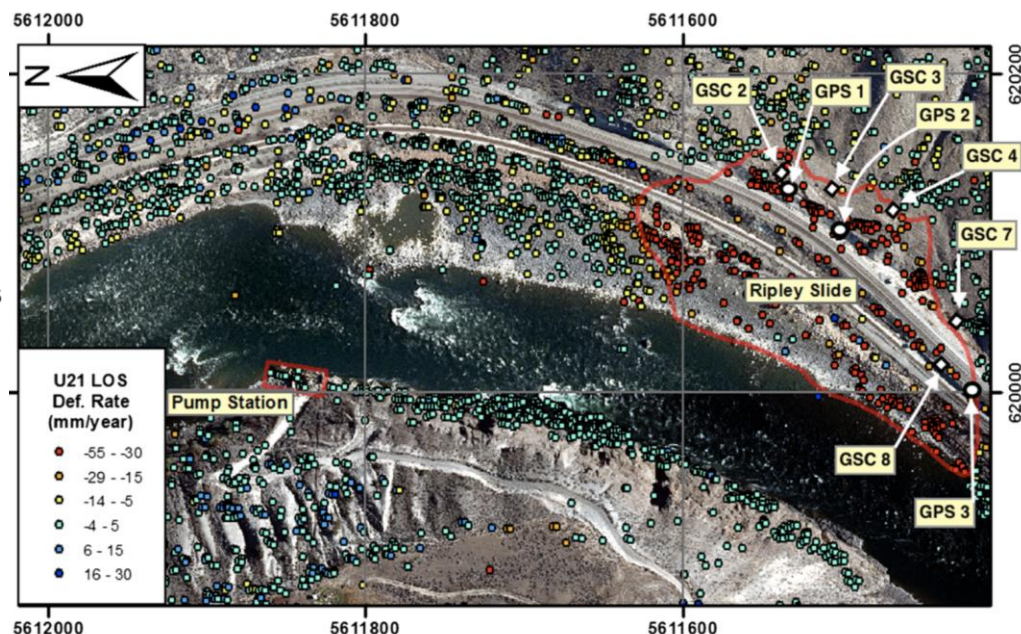
Ground instrumentation and InSAR

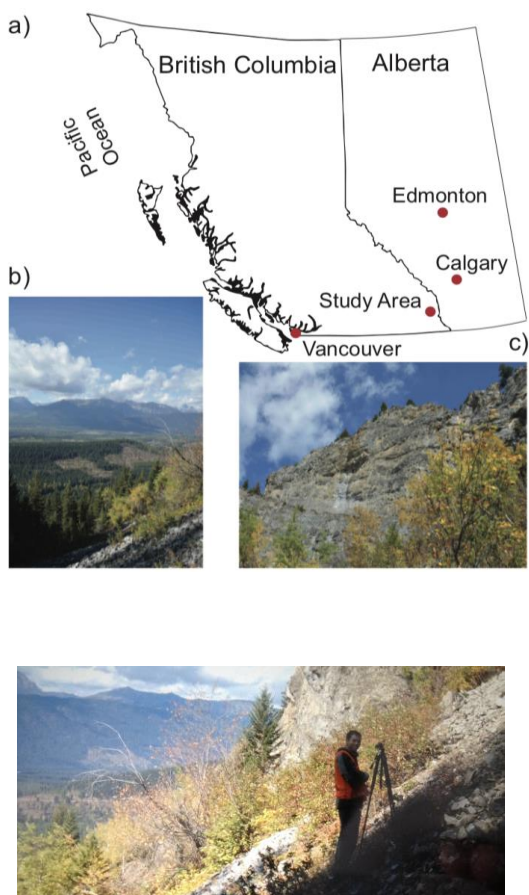
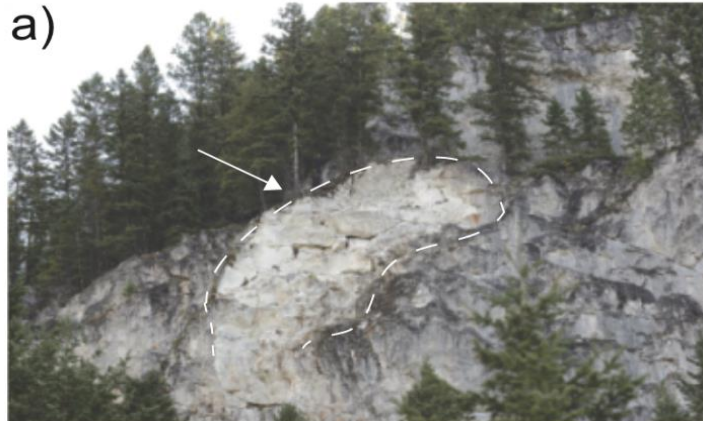
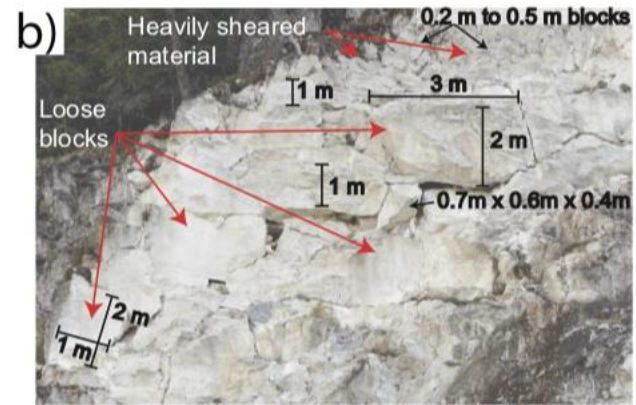
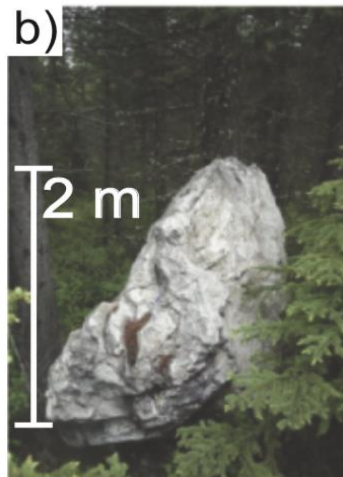
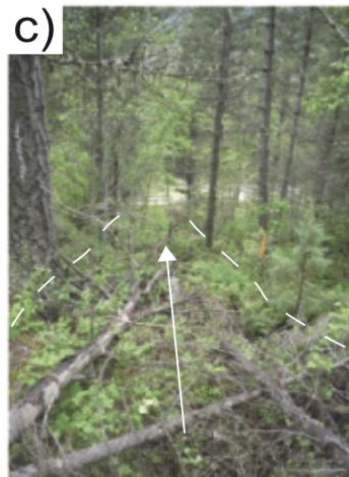
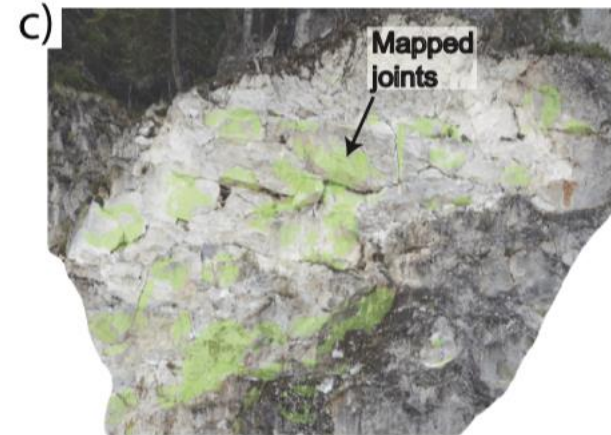
Photogrammetry for Structural Mapping – Tornado Mountain

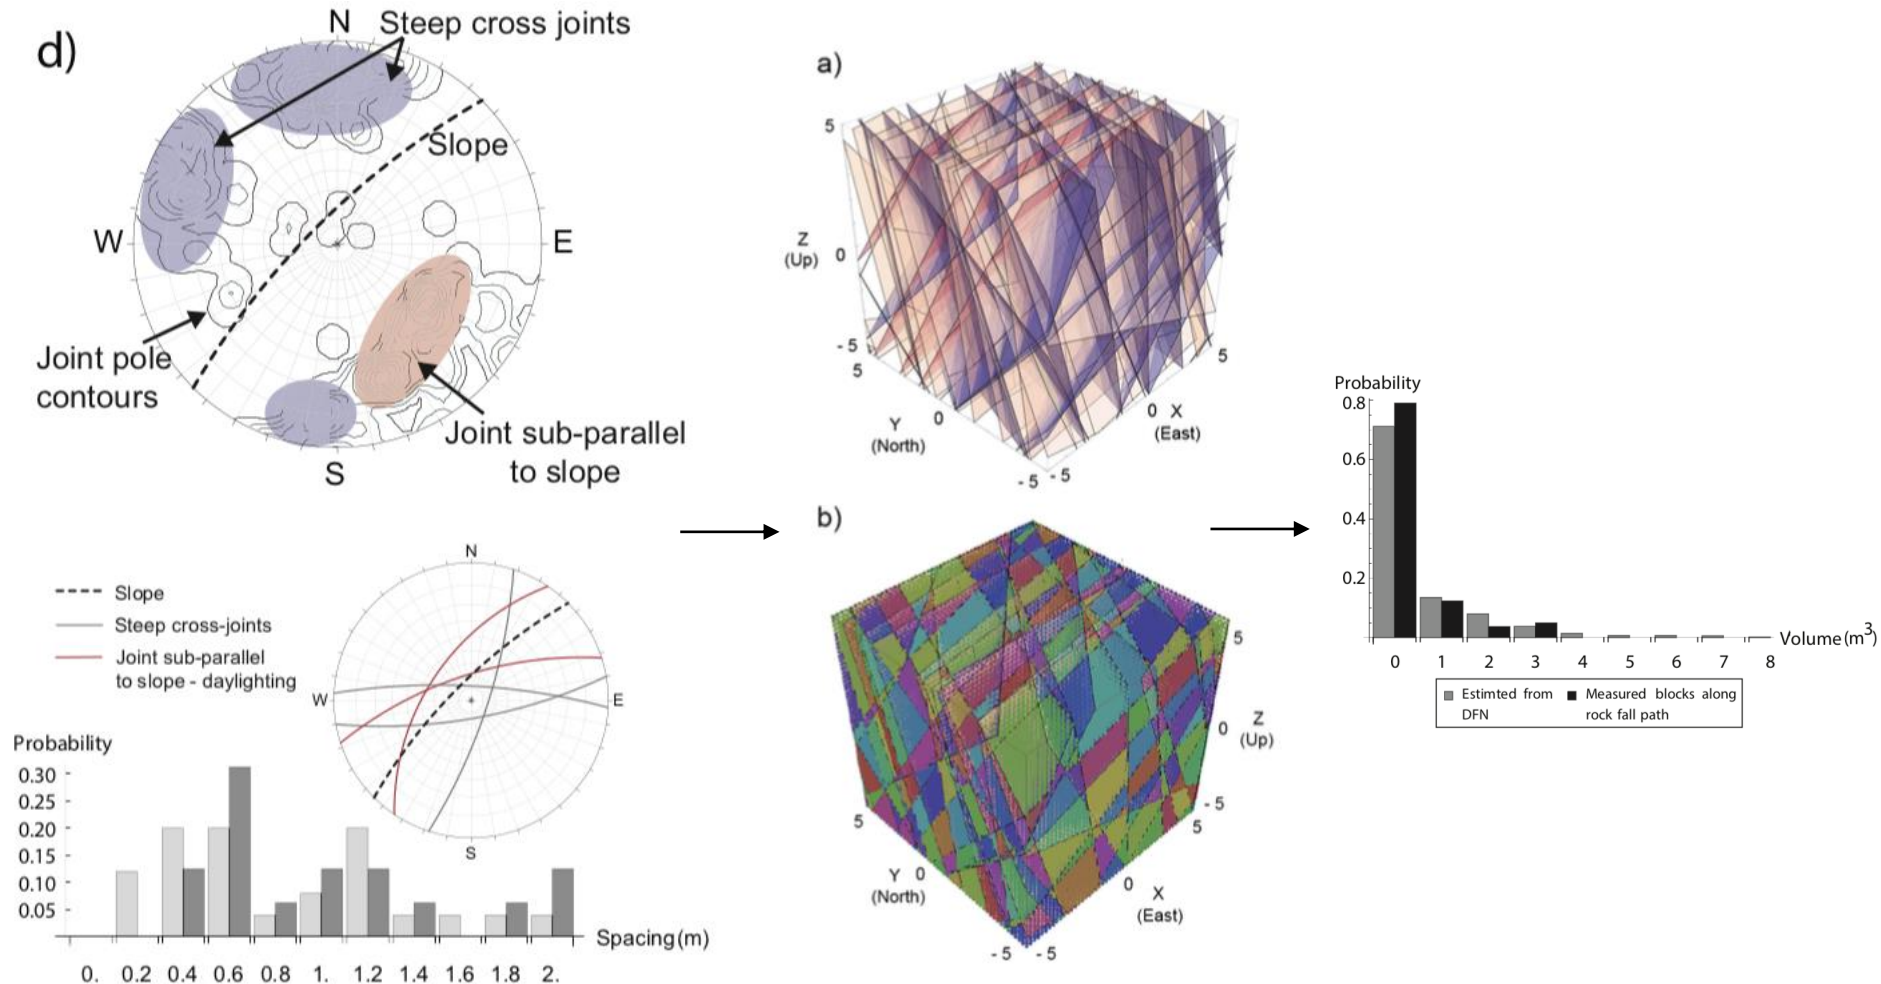
Photogrammetry for Structural Mapping – Tornado Mountain

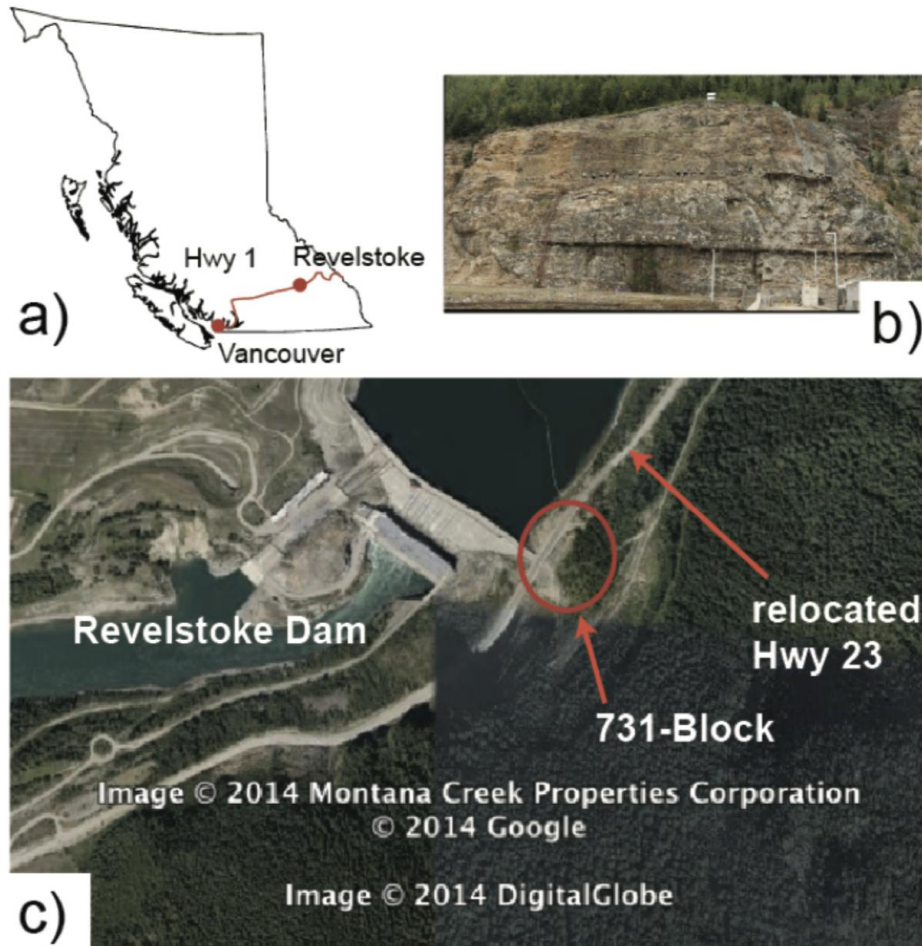
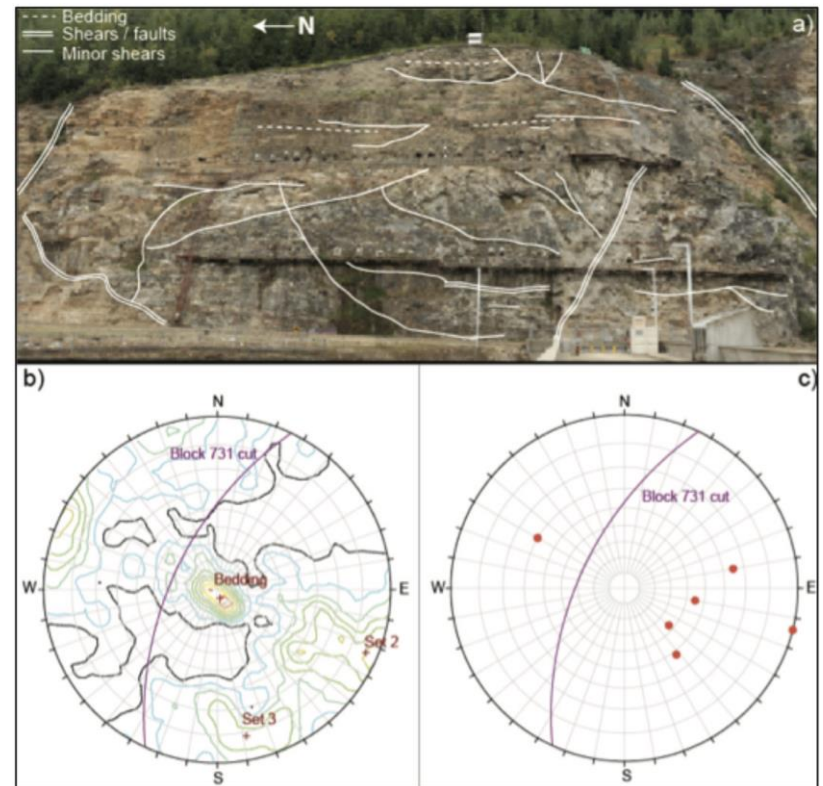
Photogrammetry for Structural Mapping

– Block 731
