# RIPRAP ASSESSMENT VARIOUS SITES HWY 40 NEAR GRANDE CACHE, AB

# Need for Riprap

# AT Heavy Rock Riprap Specs

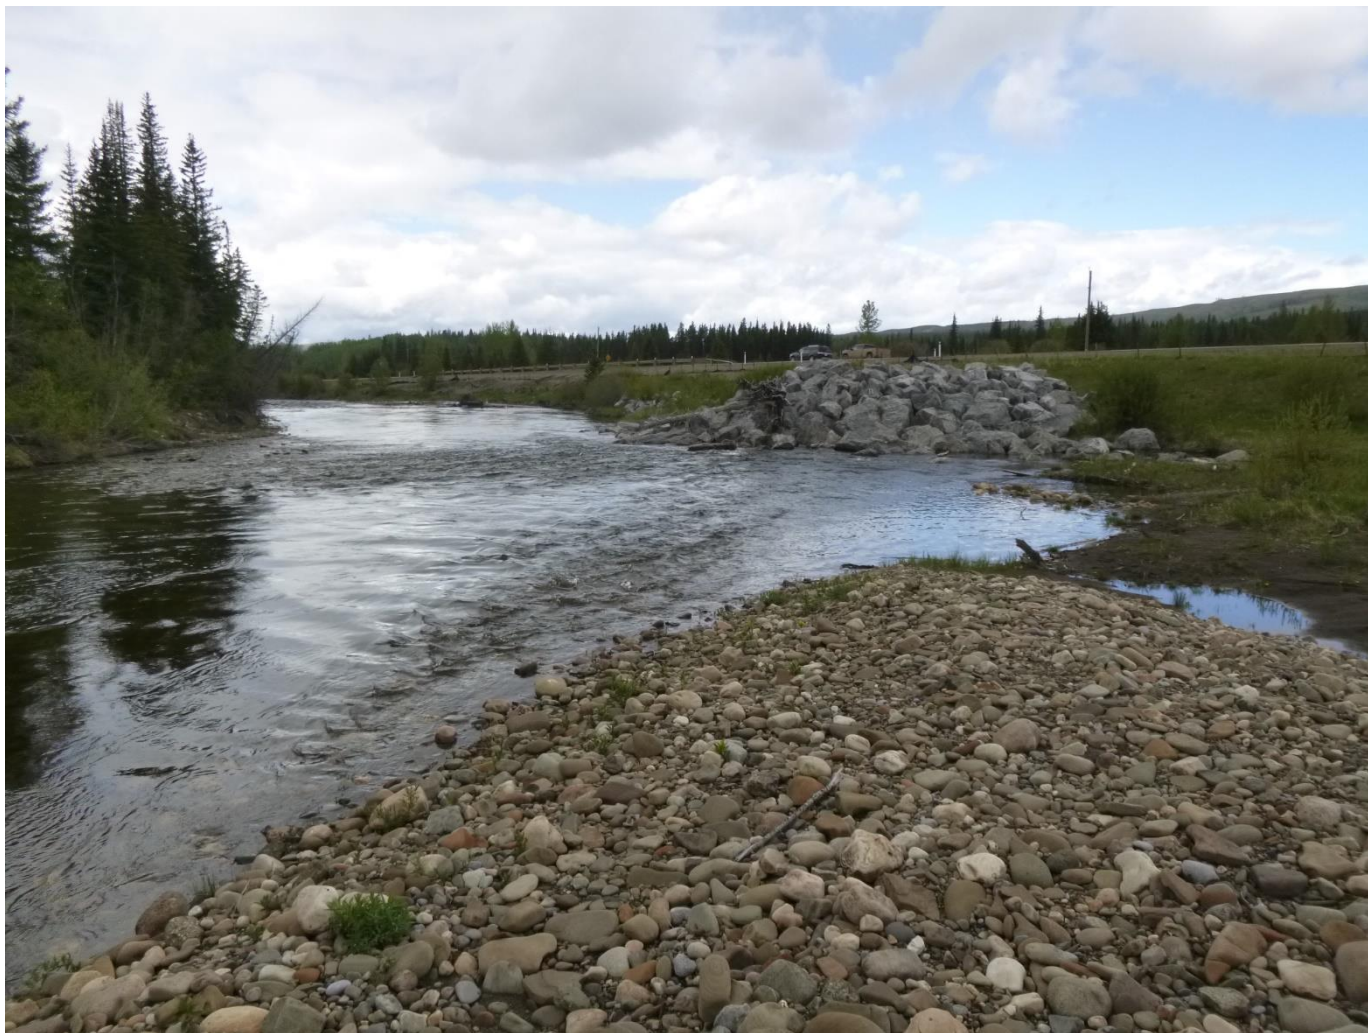
Limestone spur at Lone Teepee Creek

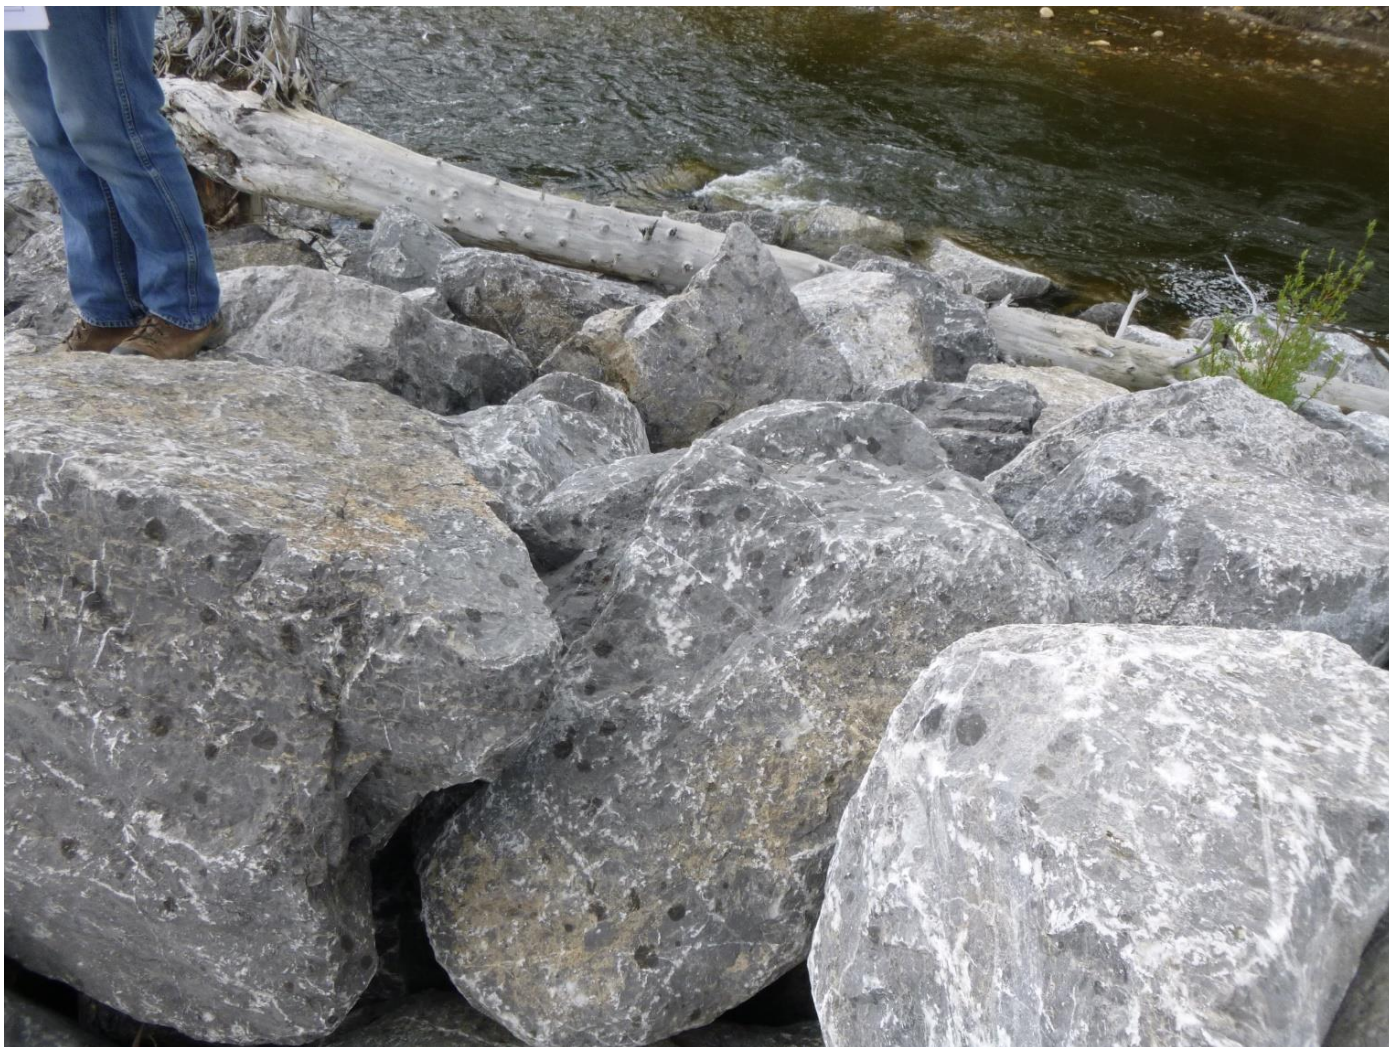
Close up view of limestone rock in spur

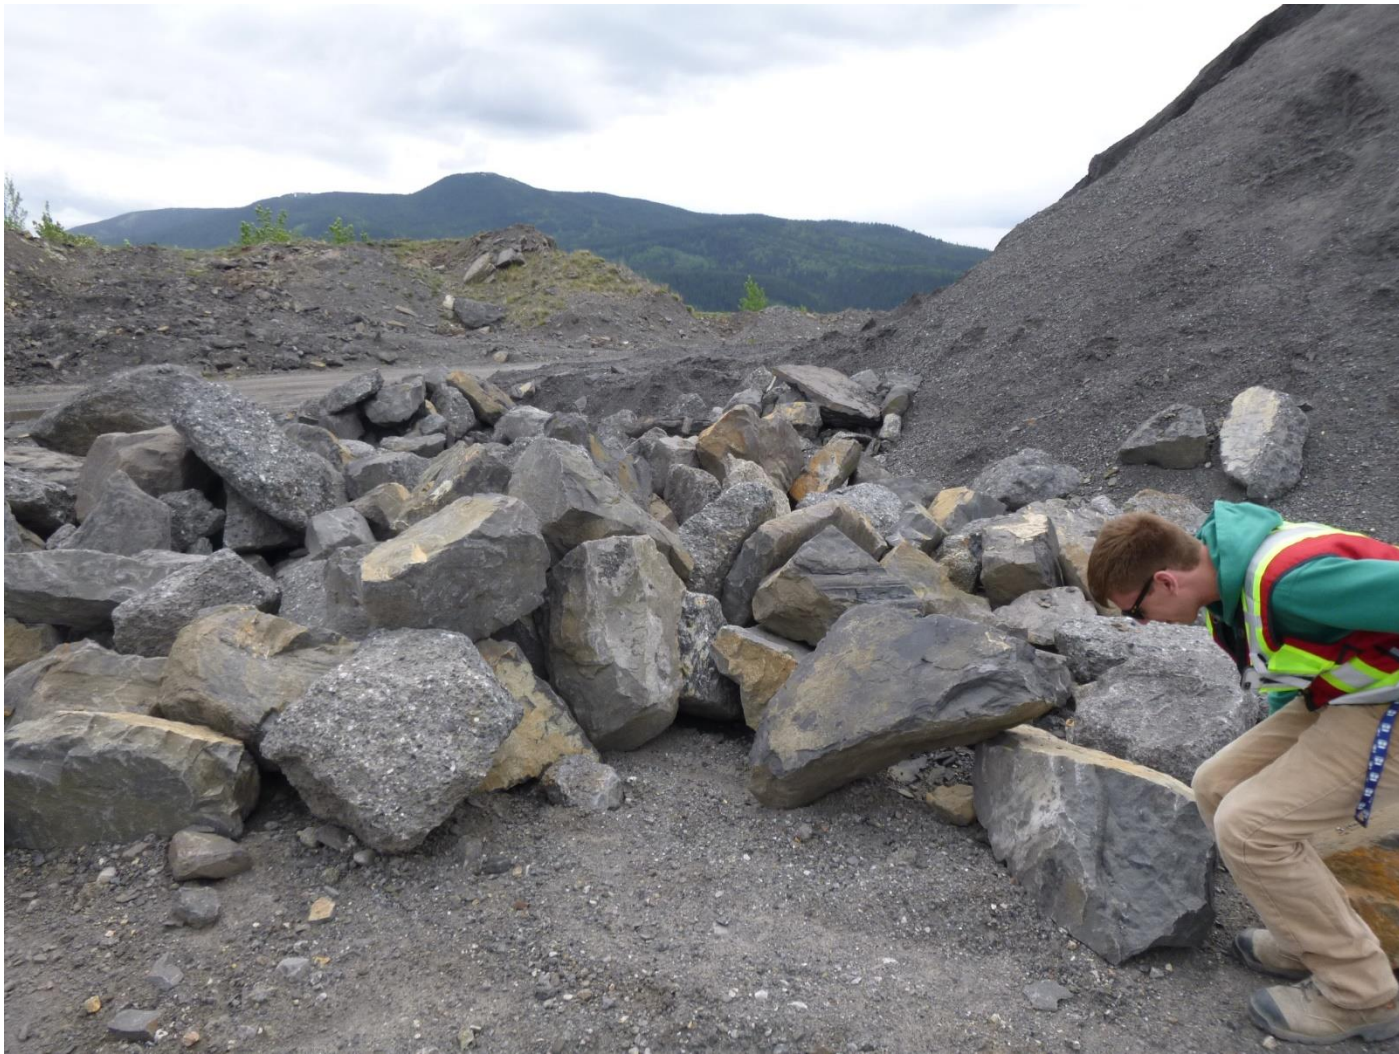
Typical rocks in Rodar pit – shale,  
sandstone, conglomerate, greywacke

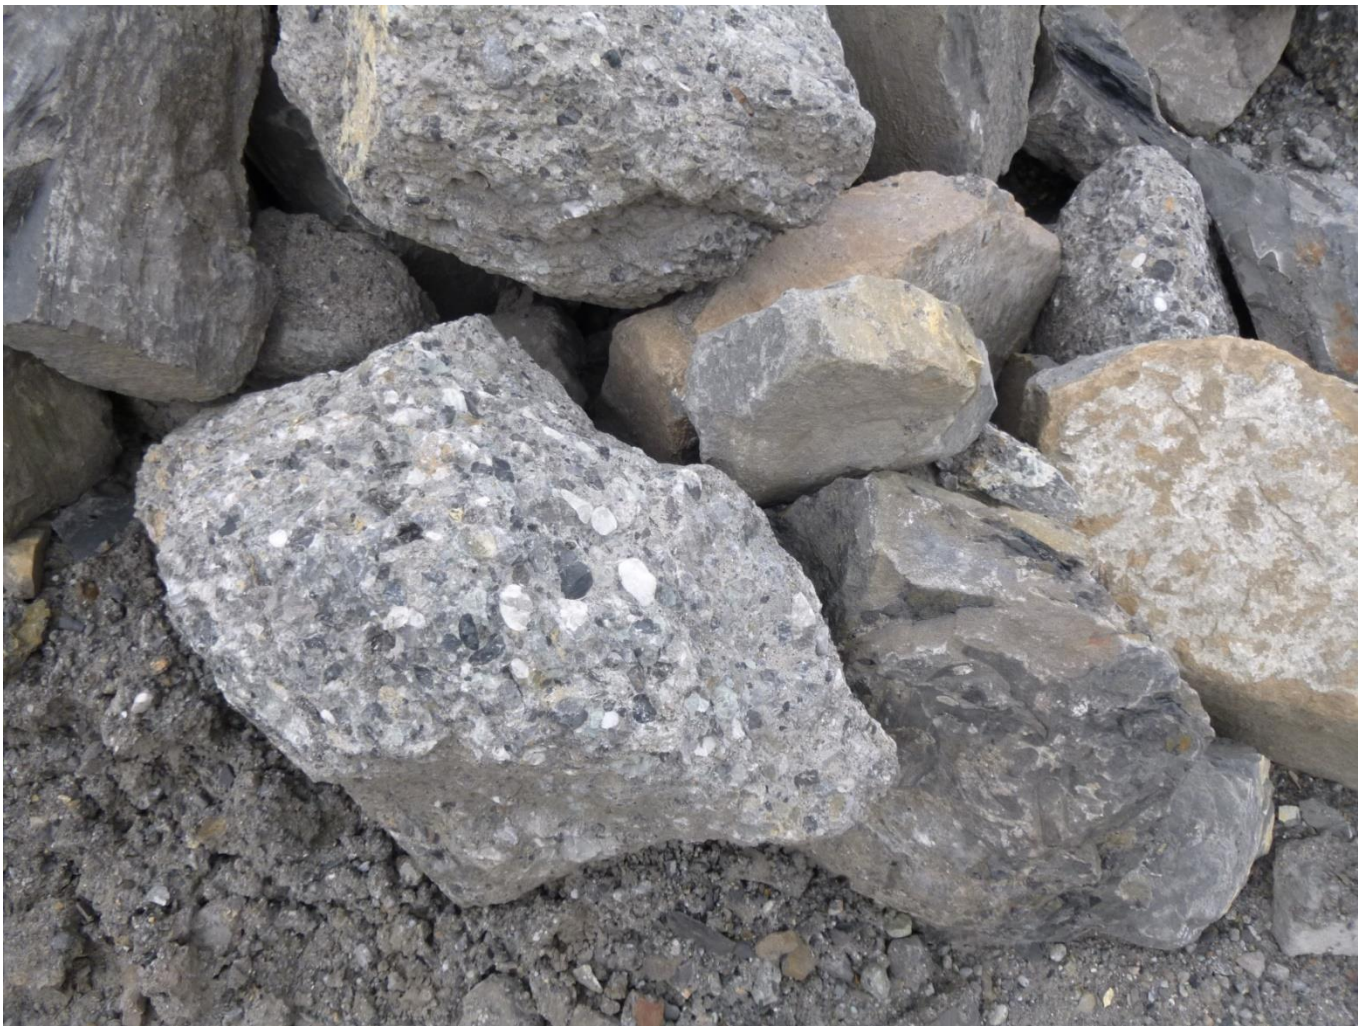
Conglomerate – Igneous coarse aggregate with sandstone matrix

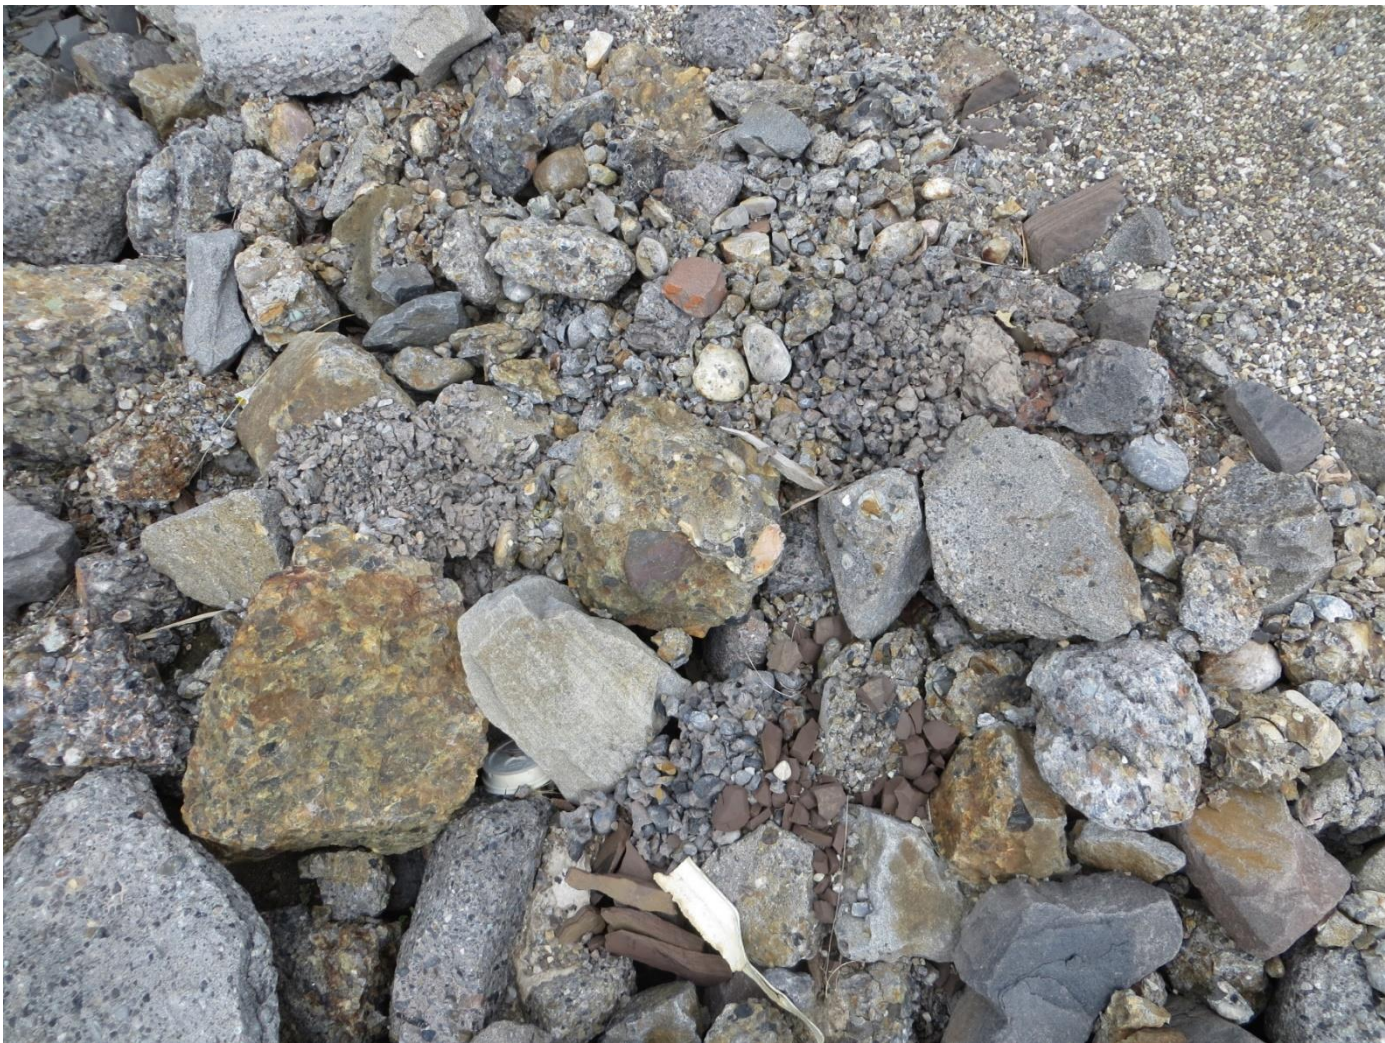
## Conglomerate deterioration – Ditch Grande Cache, 2016

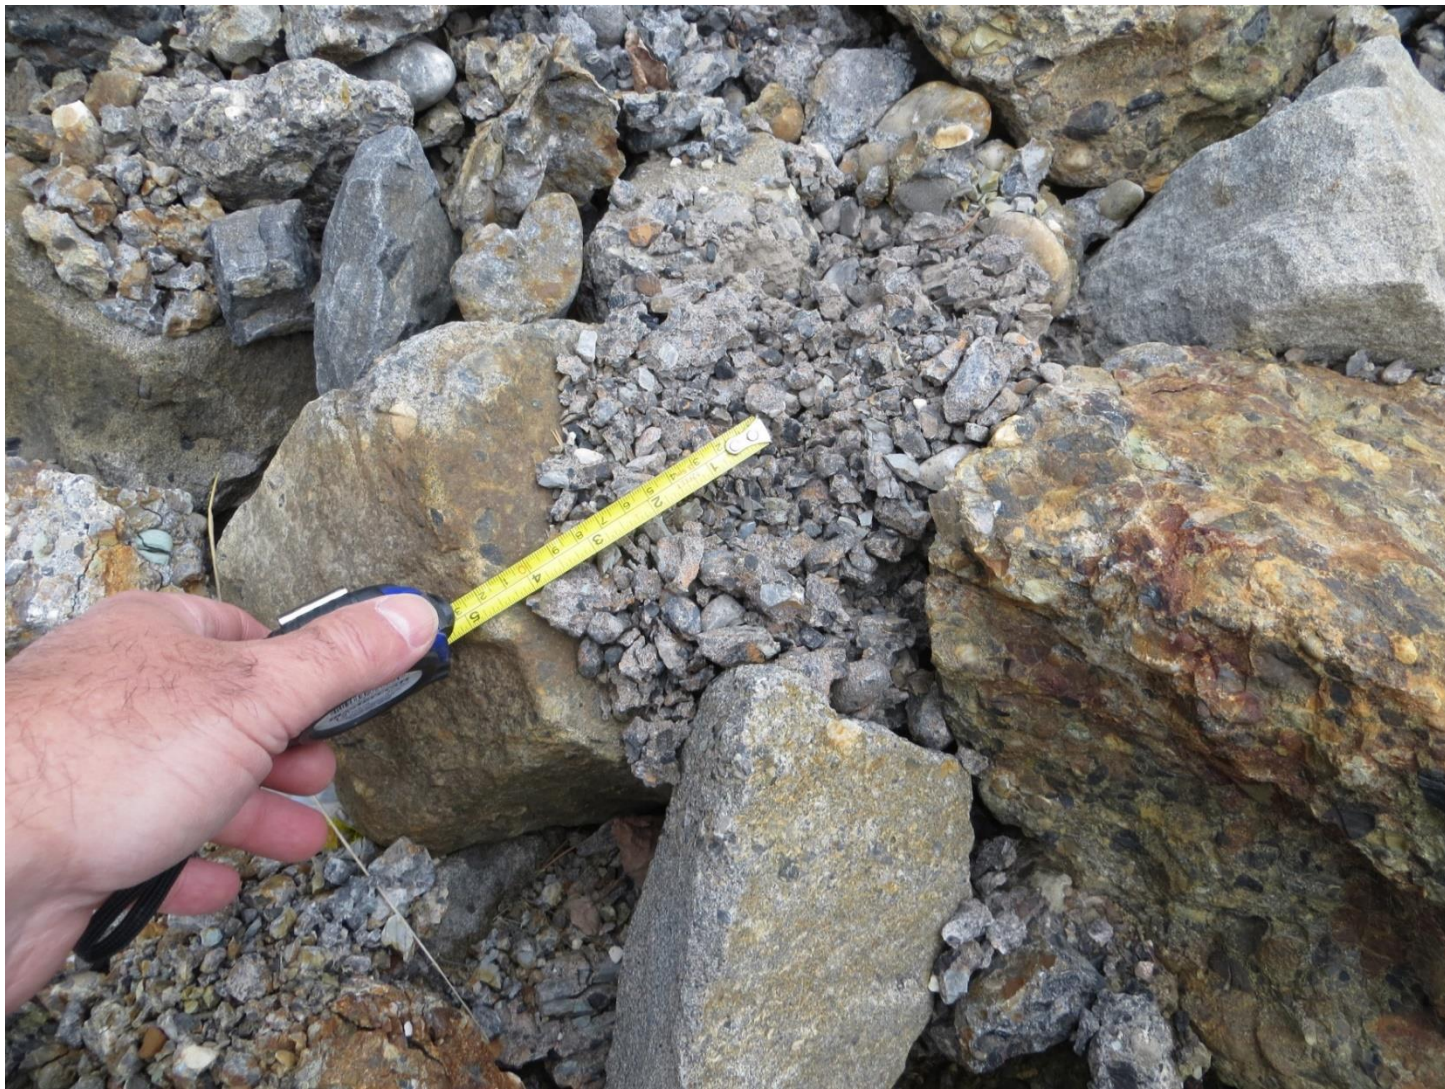
Weathering of the sandstone matrix – (7 yrs old)

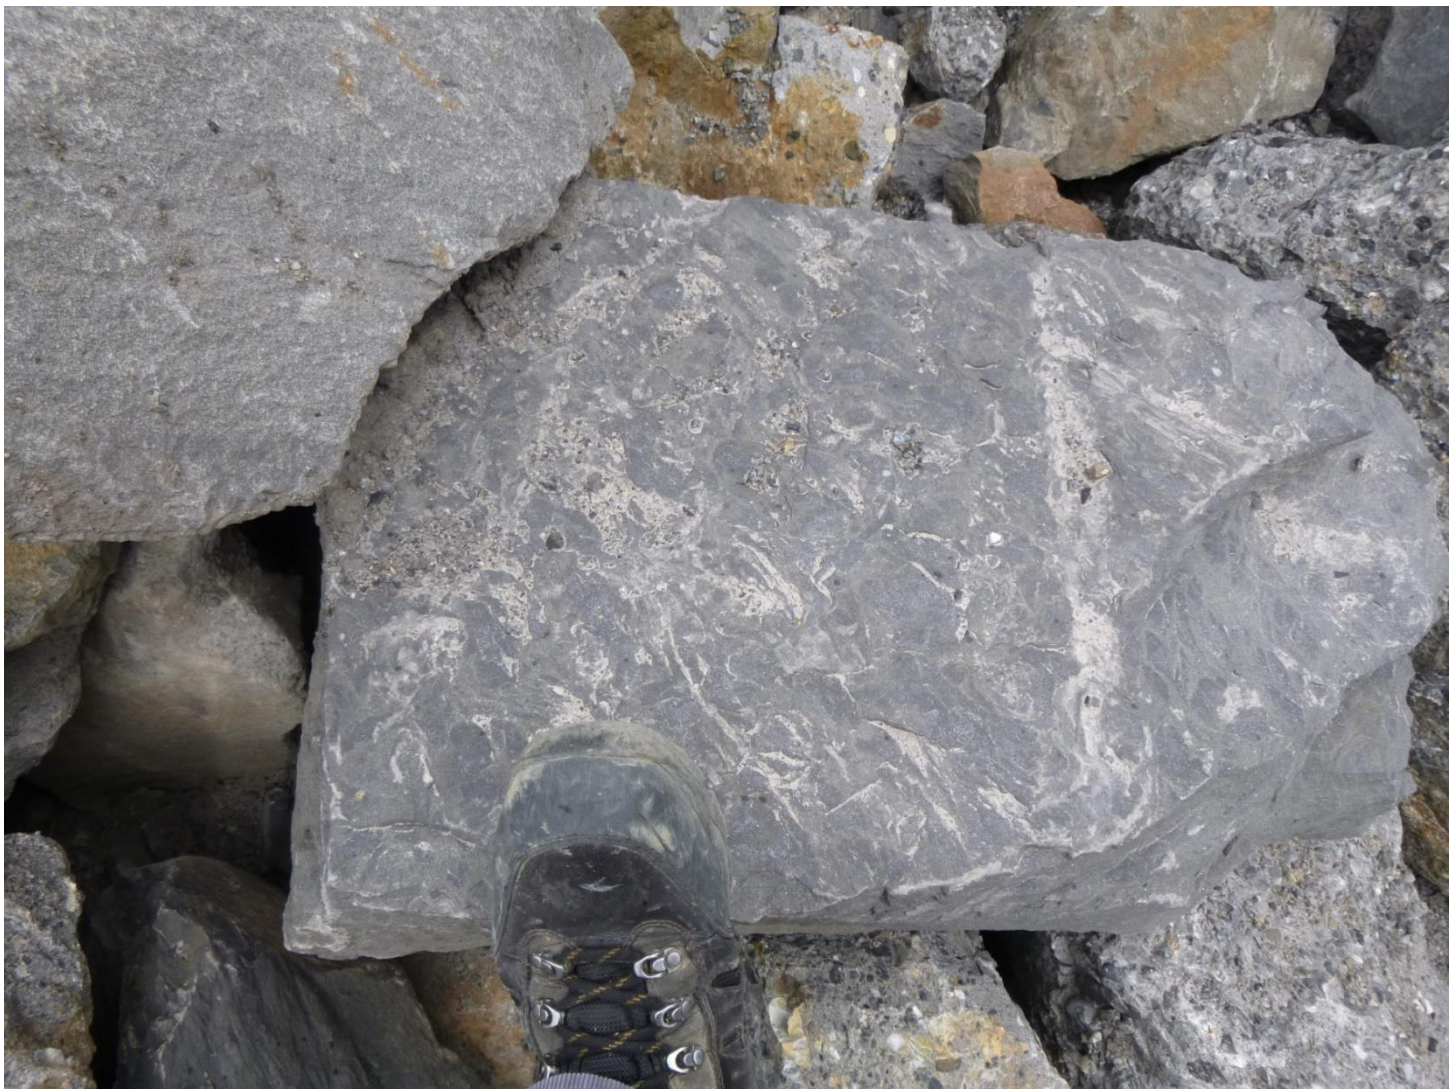
Shale

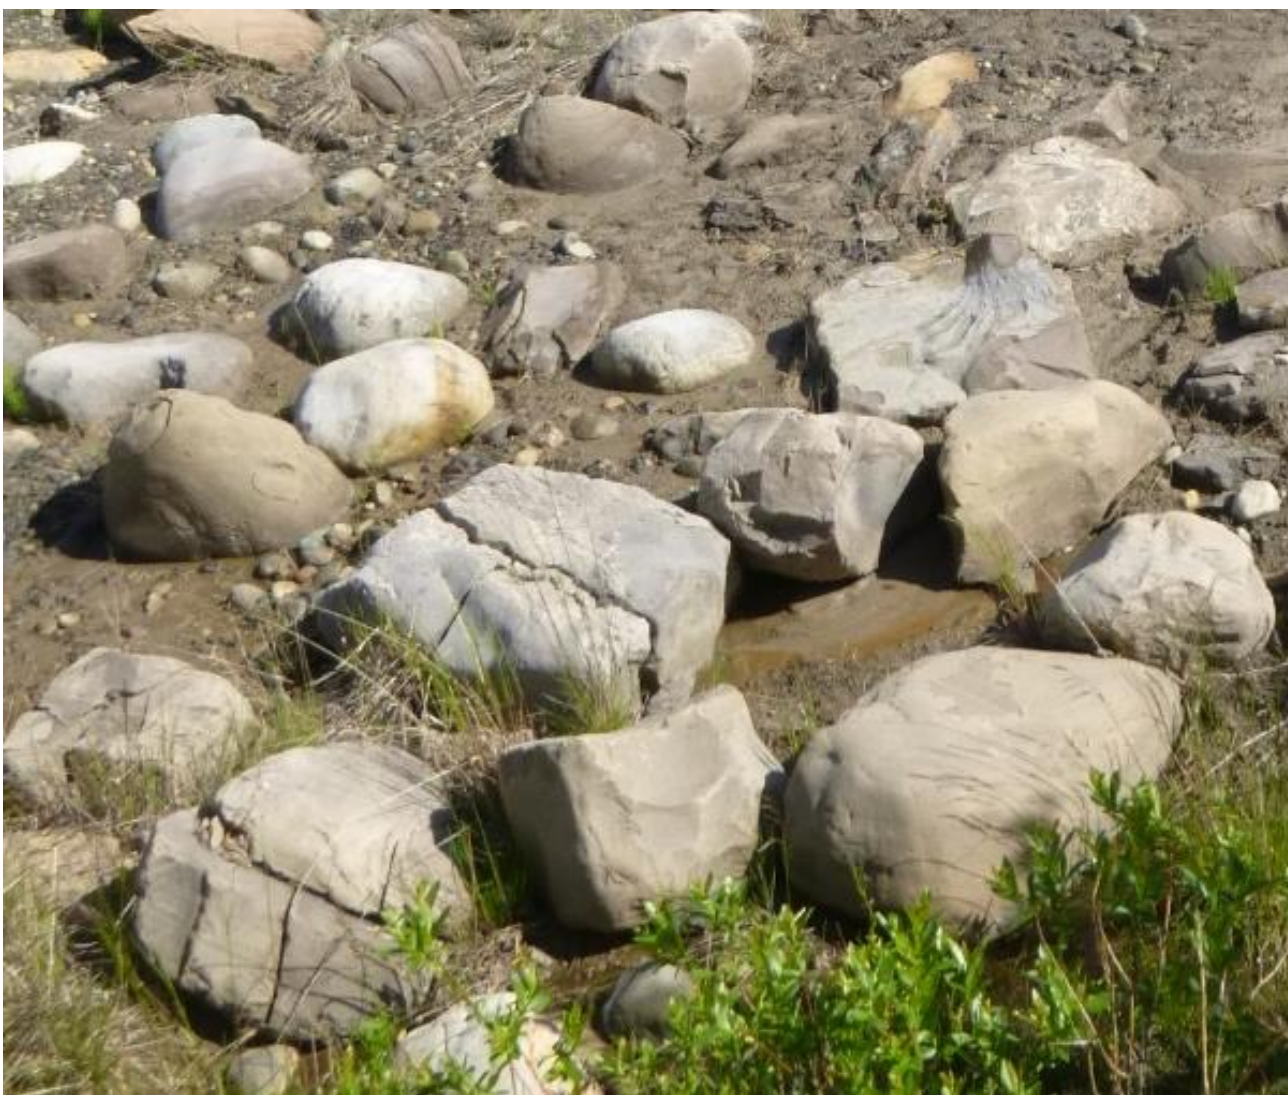
Splitting of sandstone (10 yrs old)

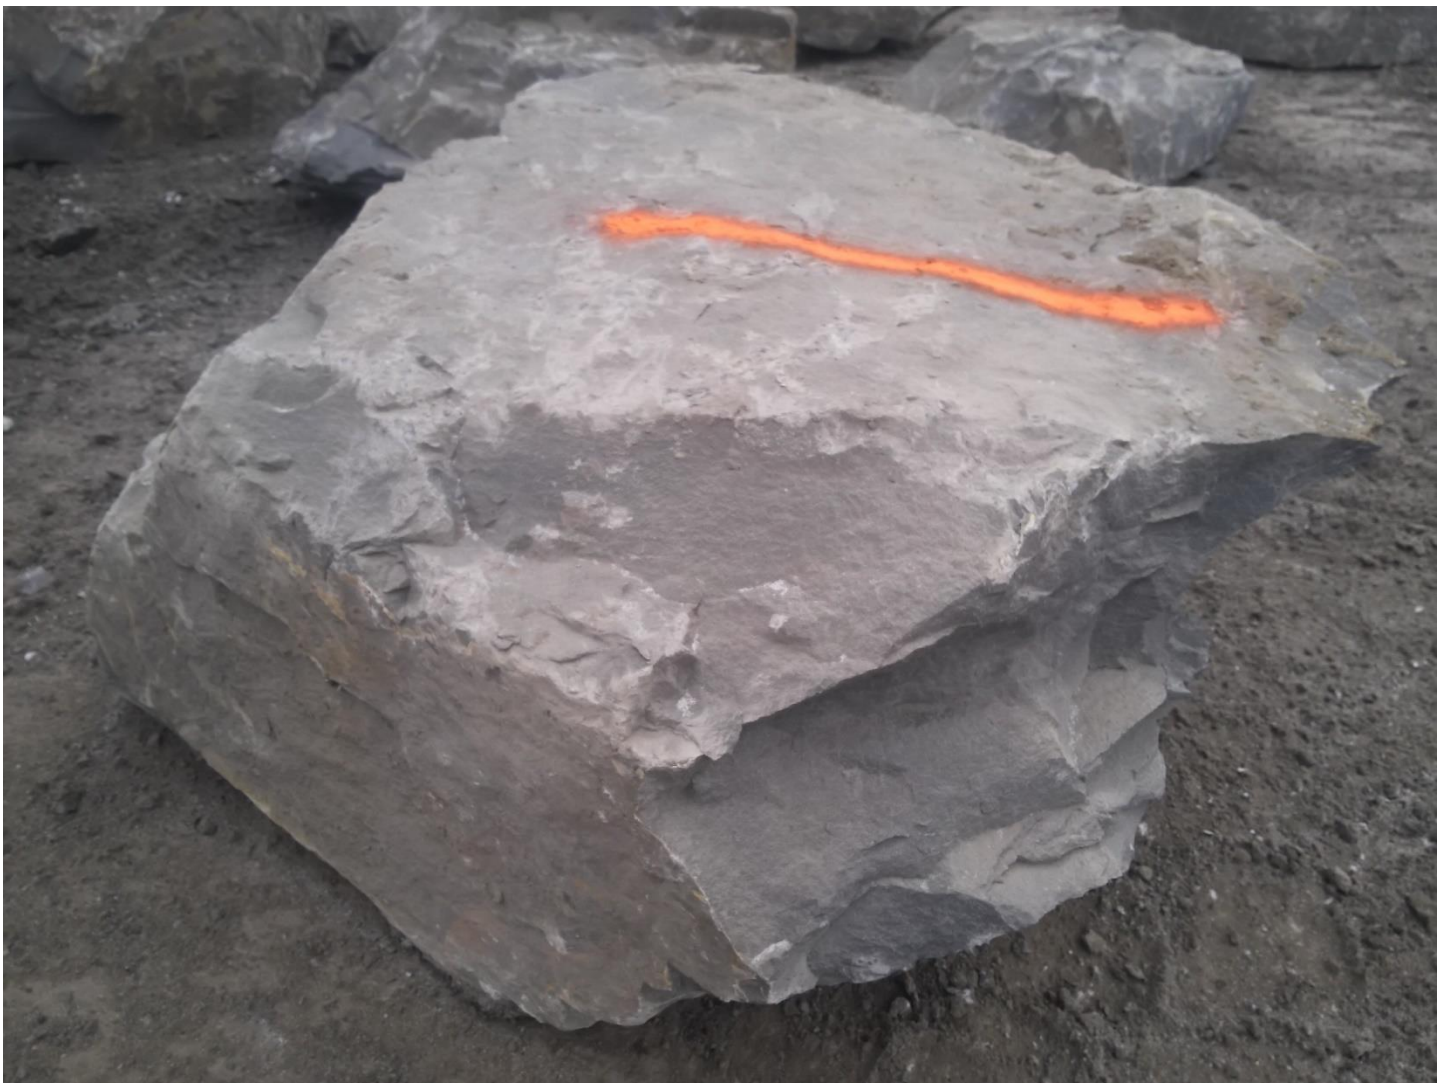
Greywacke - Good riprap

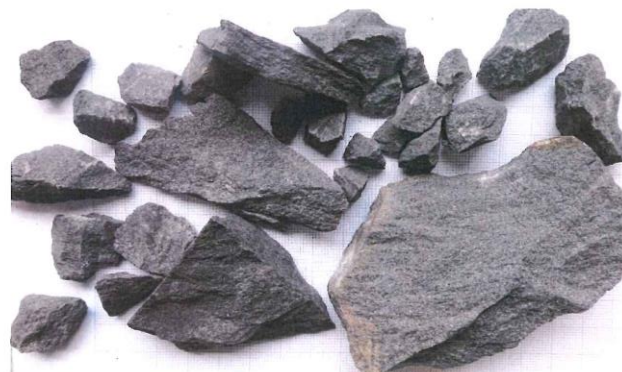
Photograph 1: Selection of crushed particles of the Edco Pit Class 3M rock, illustrating angular nature of the particles. A brown weathering halo is observed on the large fragment at lower right.

The particle geometry was variable, with particle shapes ranging from flaky and scooped to generally equidimensional/cubical. The flat/flaky pieces are likely due to the crushing process via a laboratory jaw crusher. The surface texture of particles was generally moderately rough.

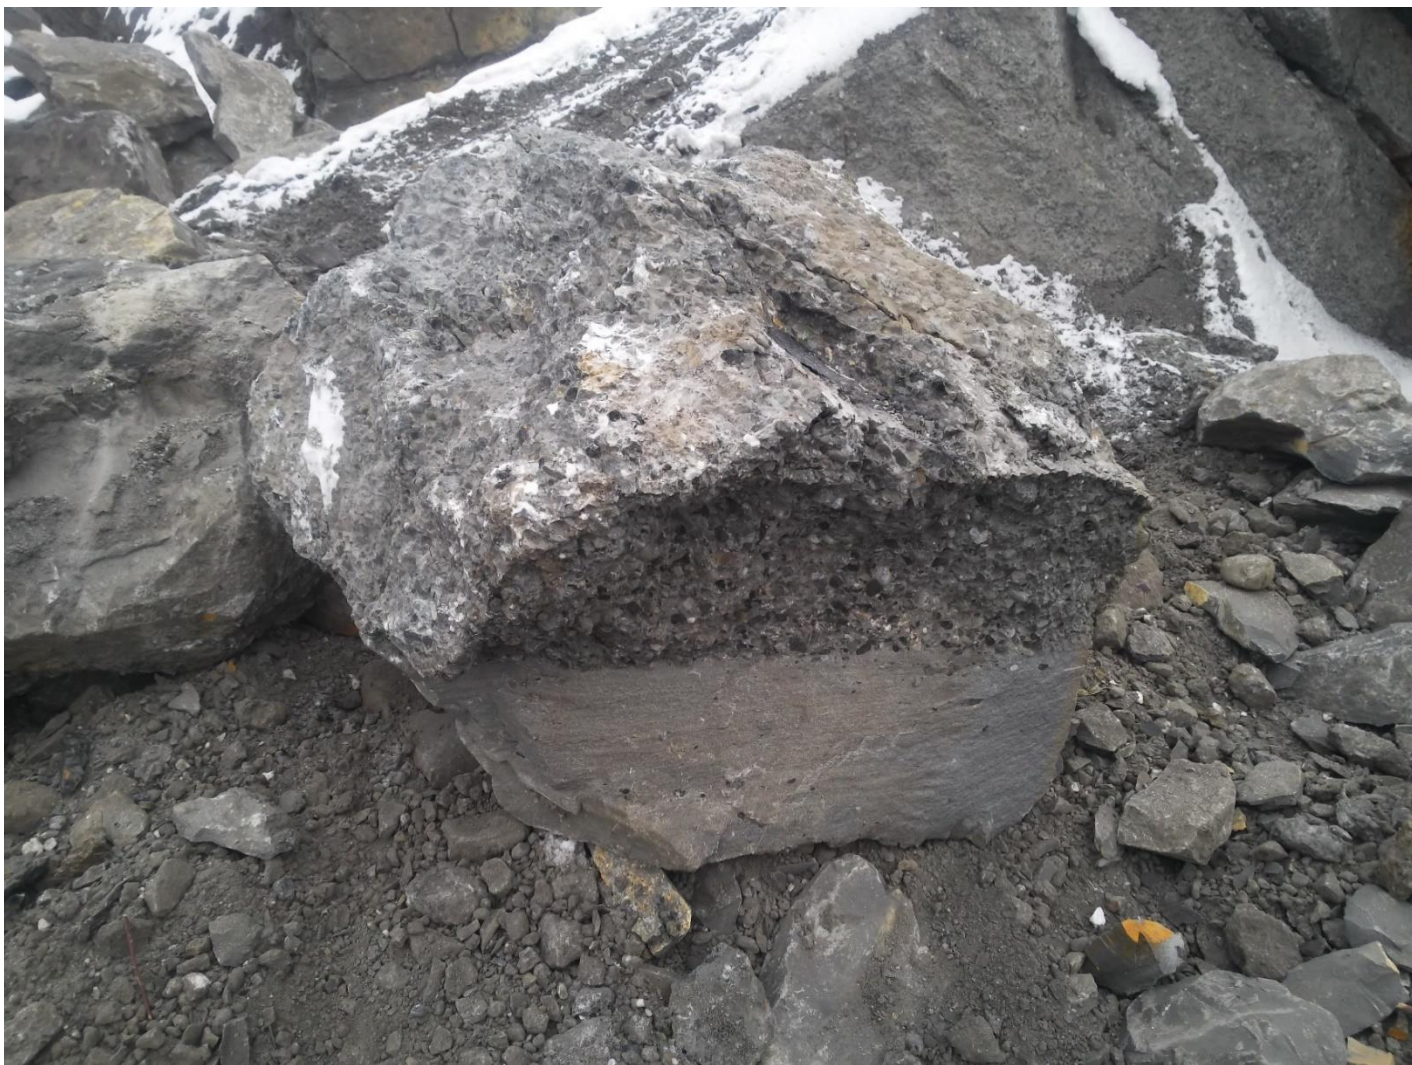
Rock rejected due to presence of conglomerate

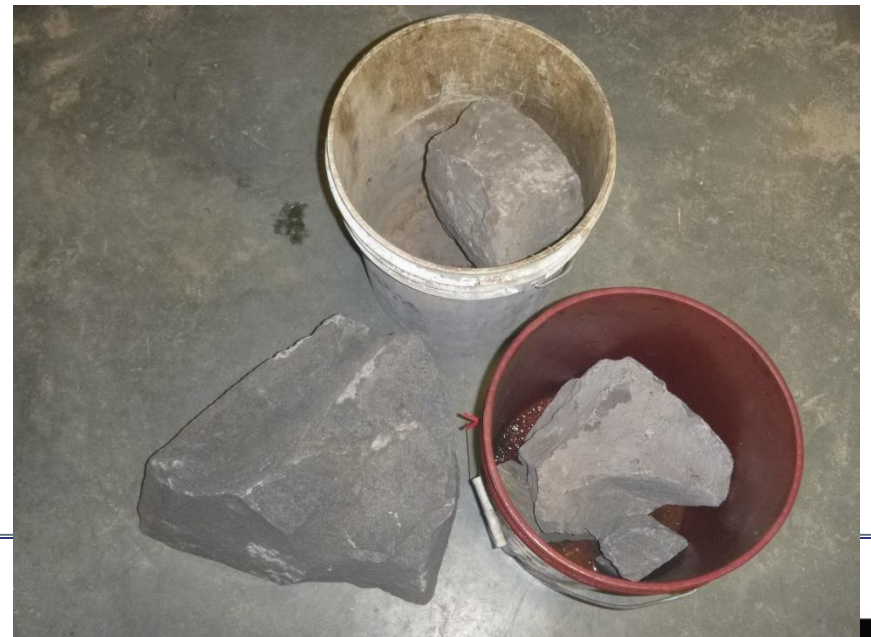
Sample being tested  
Feb., 2018

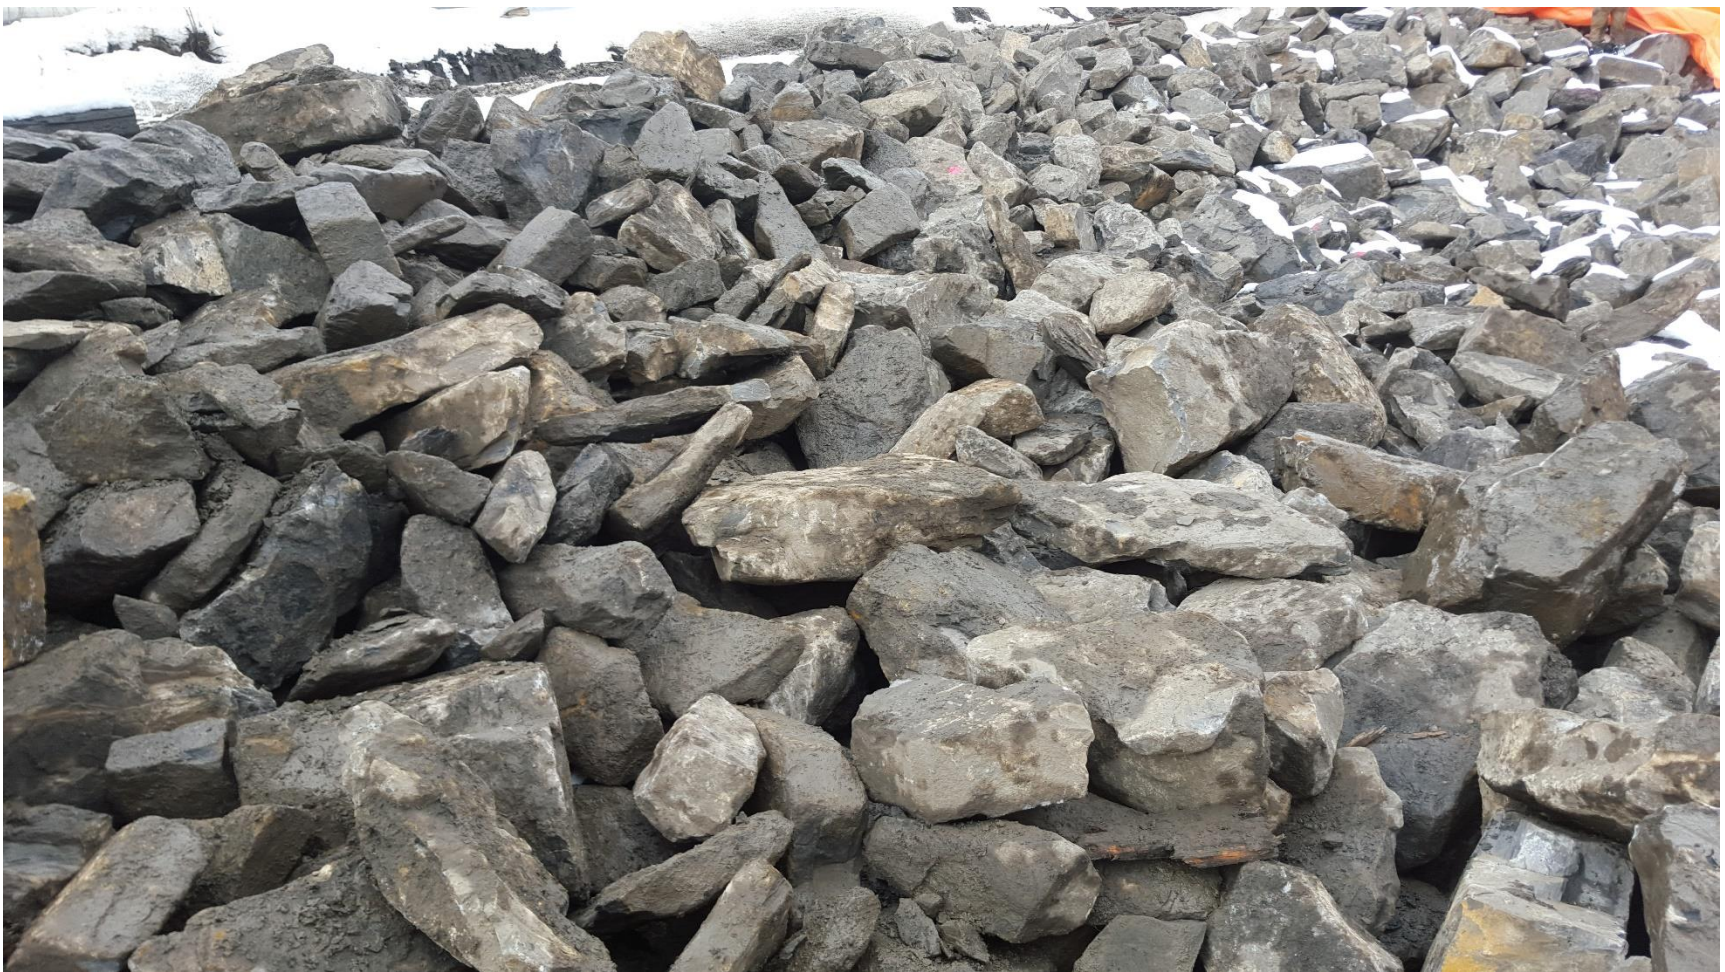
S-Curves: Good riprap in channel

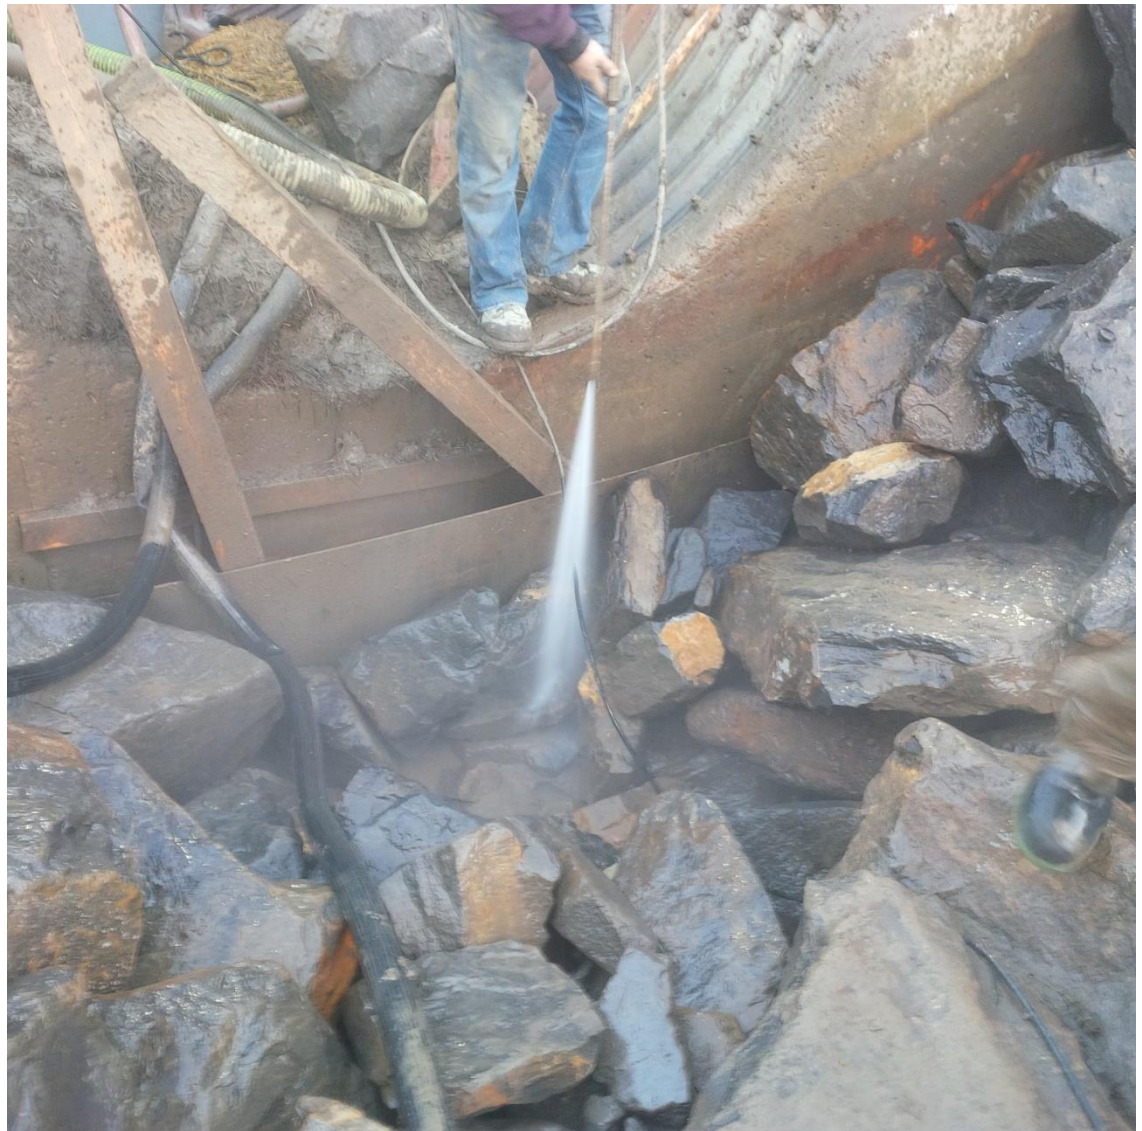
Washing Riprap  
in main channel  
before grouting

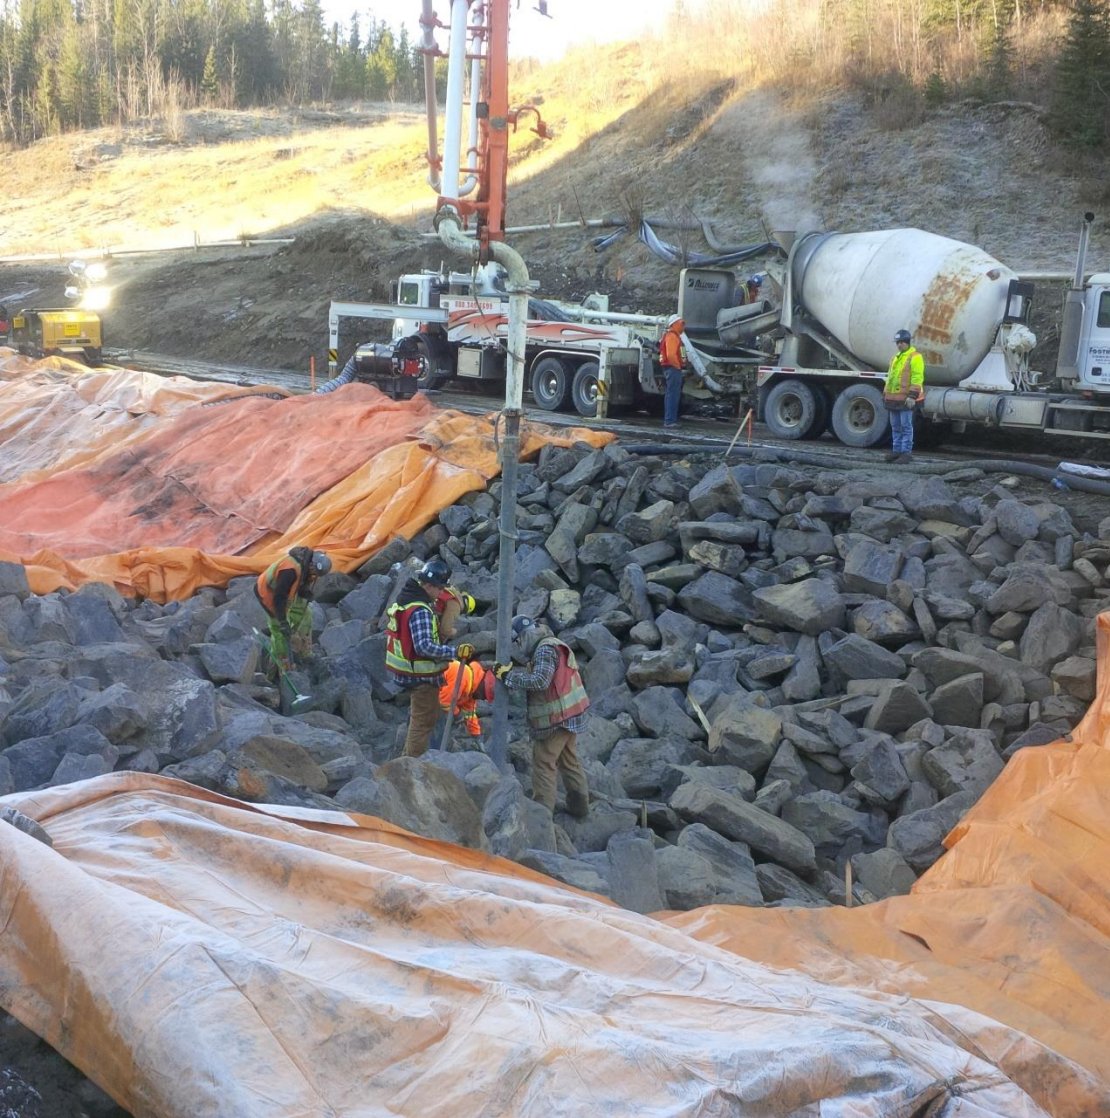
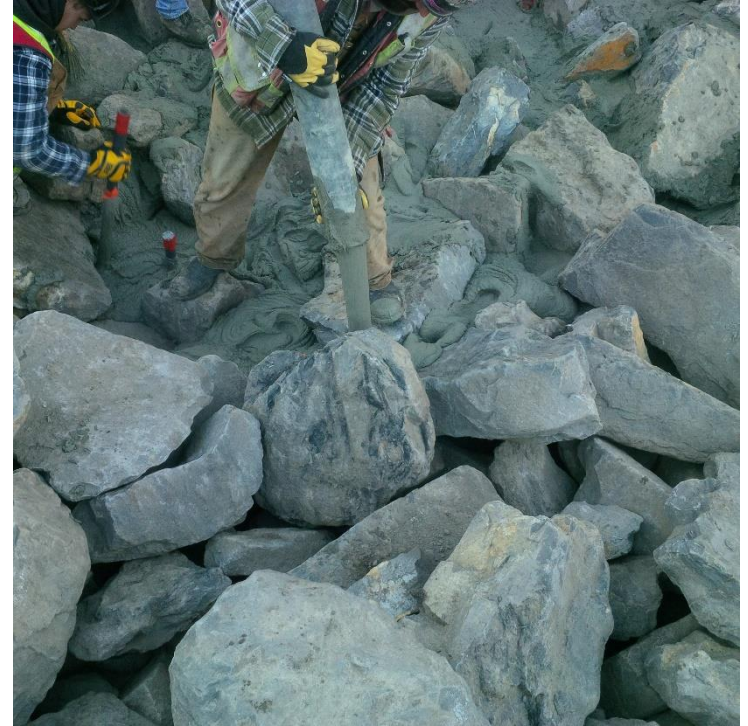
**S-CURVES**  
Grouting Riprap in  
main channel –  
Nov., 2016

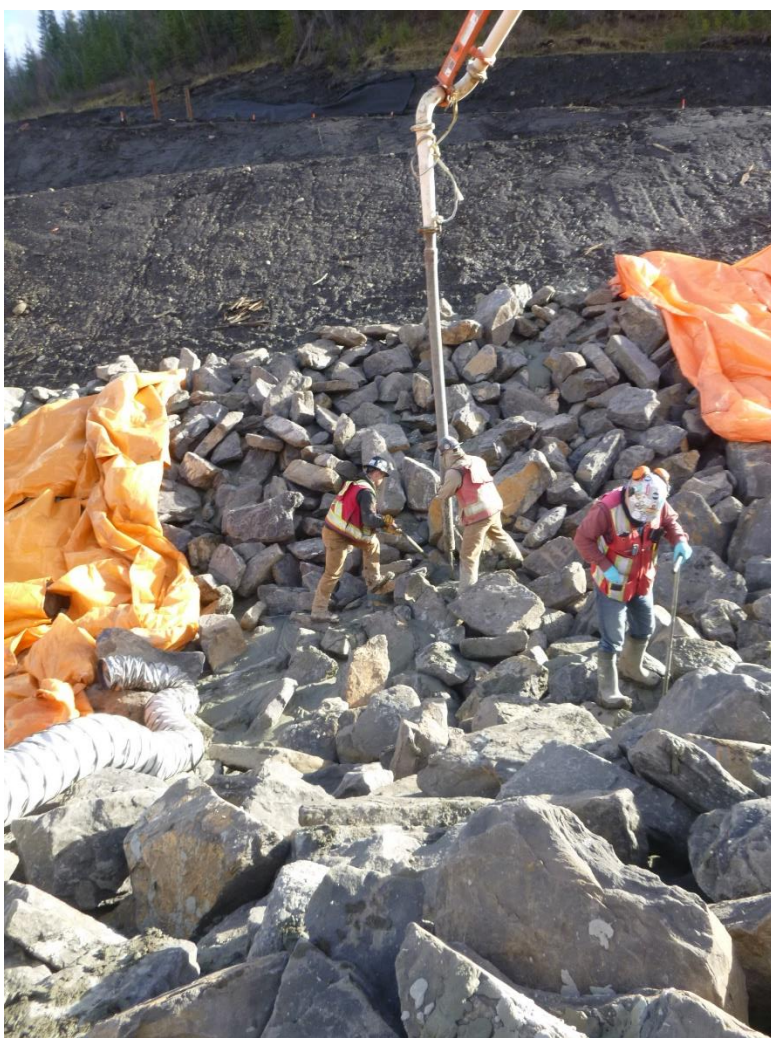
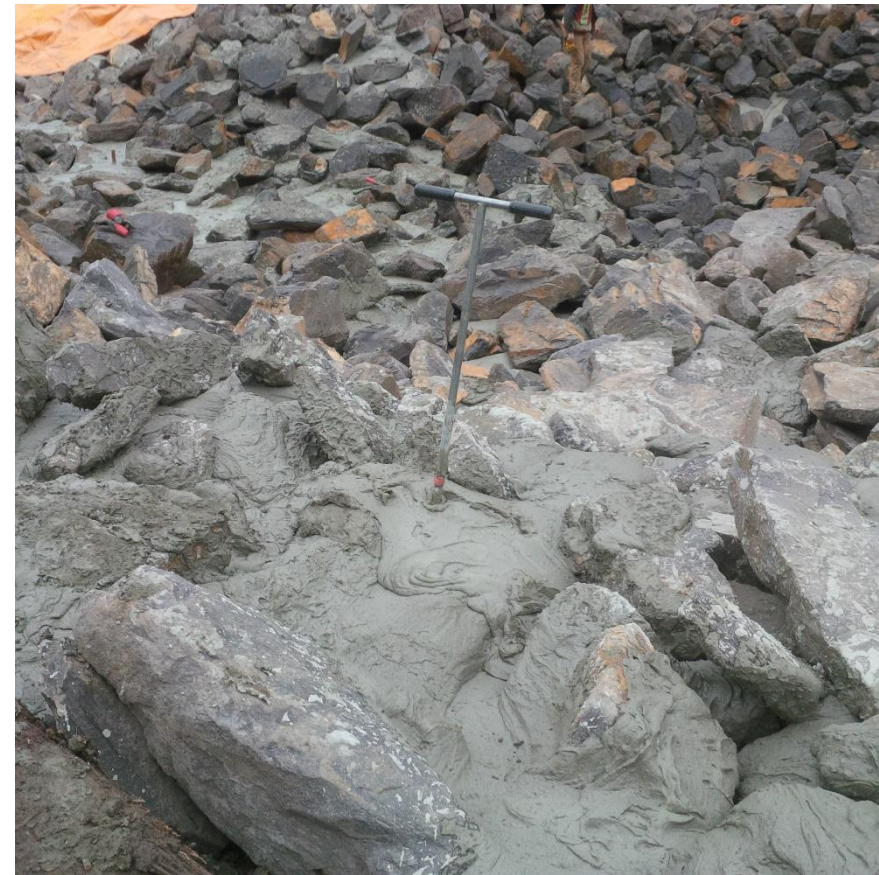
## S-CURVES Grouting Riprap in main channel/Measuring grout thickness
