Southern Alberta Rock Slope Stabilization Project

March 7, 2018

Rishi Adhikari

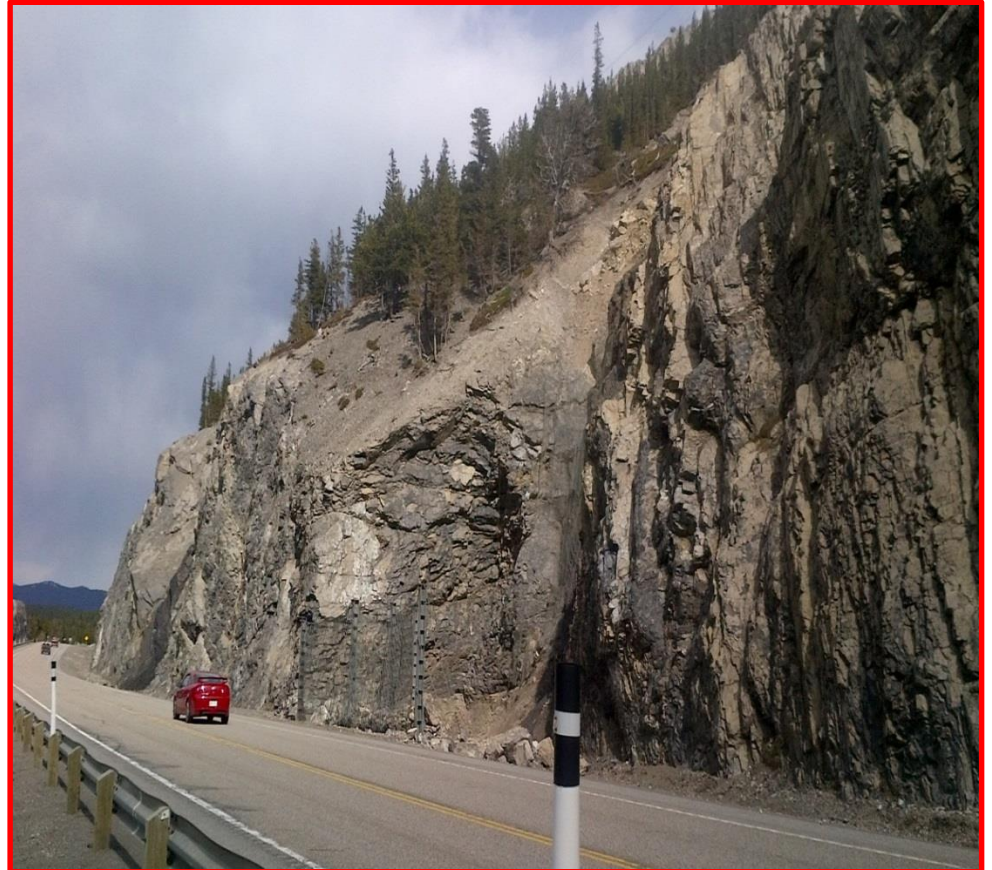
Crowsnest Lake Rock Cut Site

Location:

HWY3:02,
east of BC Border

Length: 700m

Rock Cut Face Height:
Varies - up to 55m

Rock Rolling Distance: ~
350m from the Highway
and >225m elevation
difference

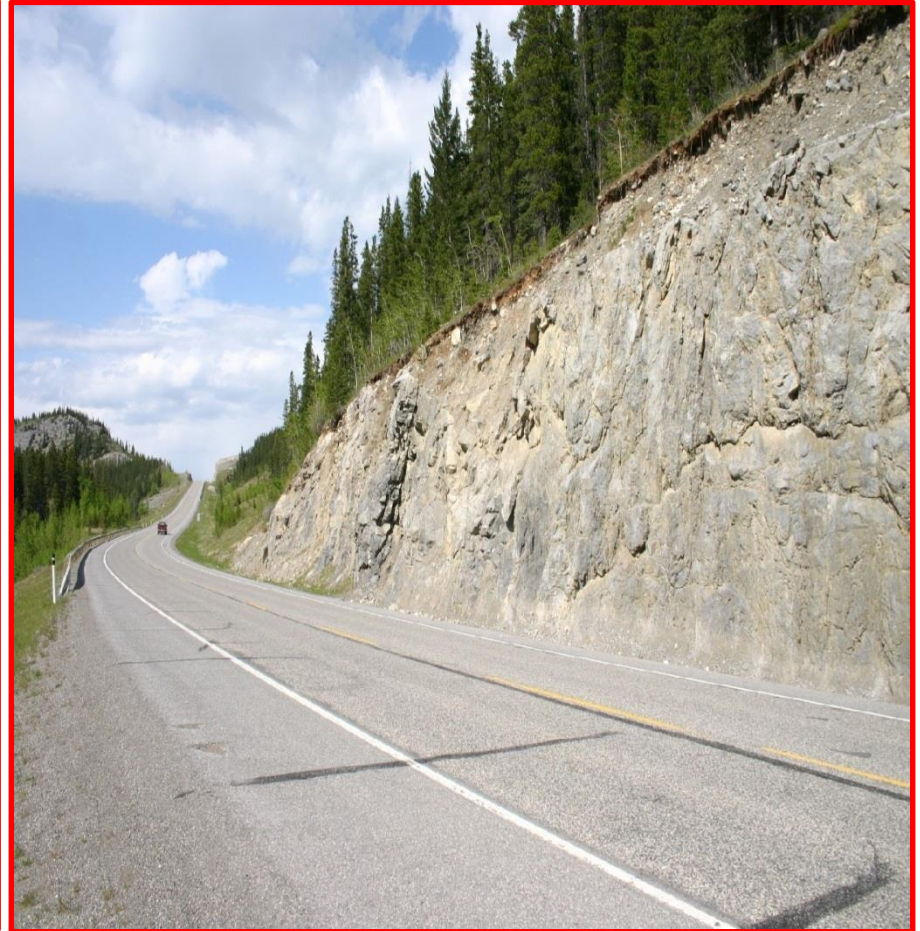
Mt Baldy Rock Cut Site

Location:

HWY40:12, @ Kananaskis

Length: 300m

Rock Cut Face Height:

Varies - up to 14m

Rock Rolling Distance: ~
100m from the Highway and
>40m elevation difference

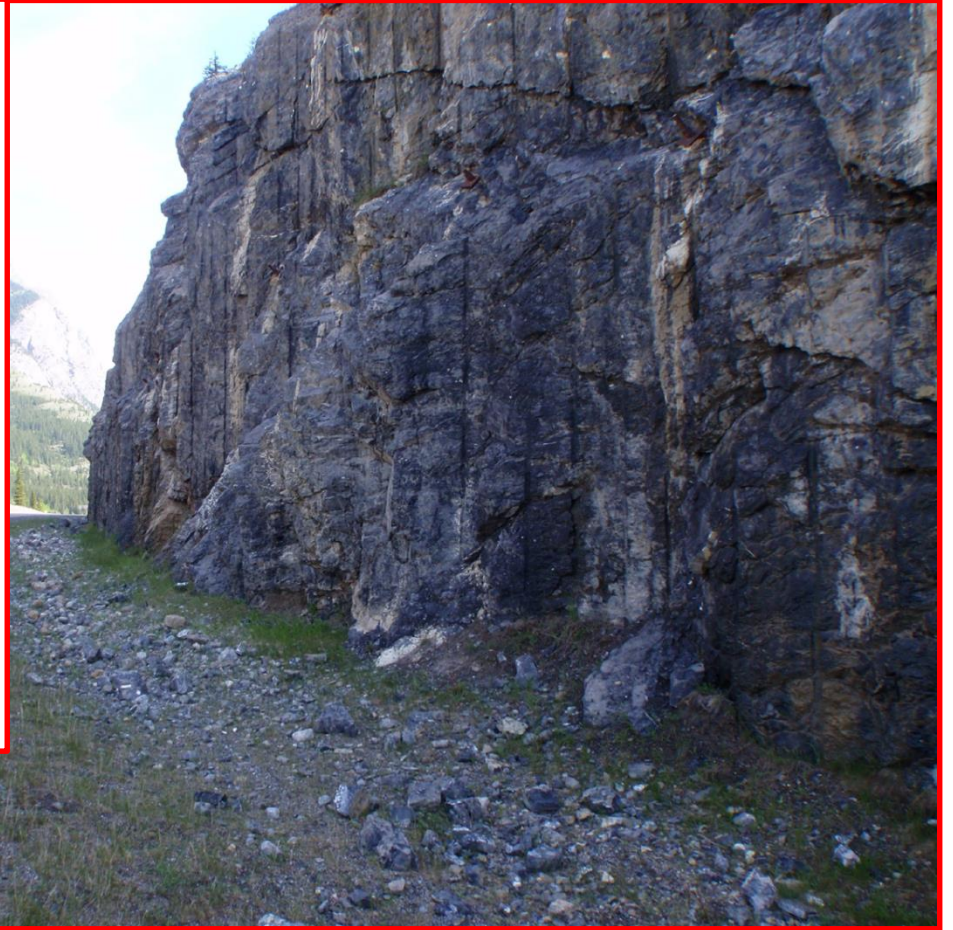
Galatea Creek Rock Cut Site

Highway: 40:12, @
Kananaskis

Length: 400m

Rock Cut Face Height:
Varies - up to 15m

Rock Rolling Distance: ~
60m from the Highway and
>30 m elevation difference

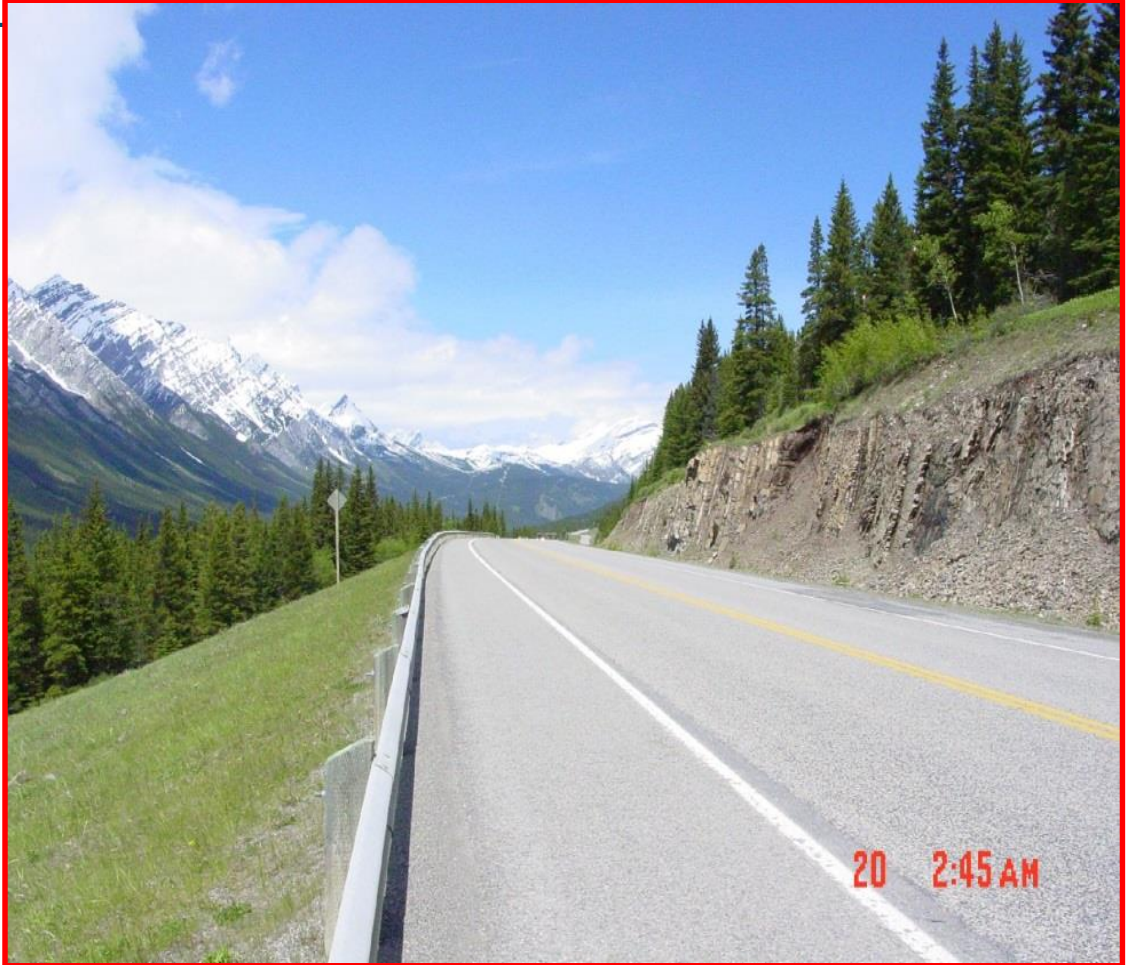
Issues Identified

- Rock of different sizes falls / rolls down to the pavement
- Debris flows down the hill to the road
- Environmental issues – Lake and river near by.
- Difficult terrain for surveying and construction

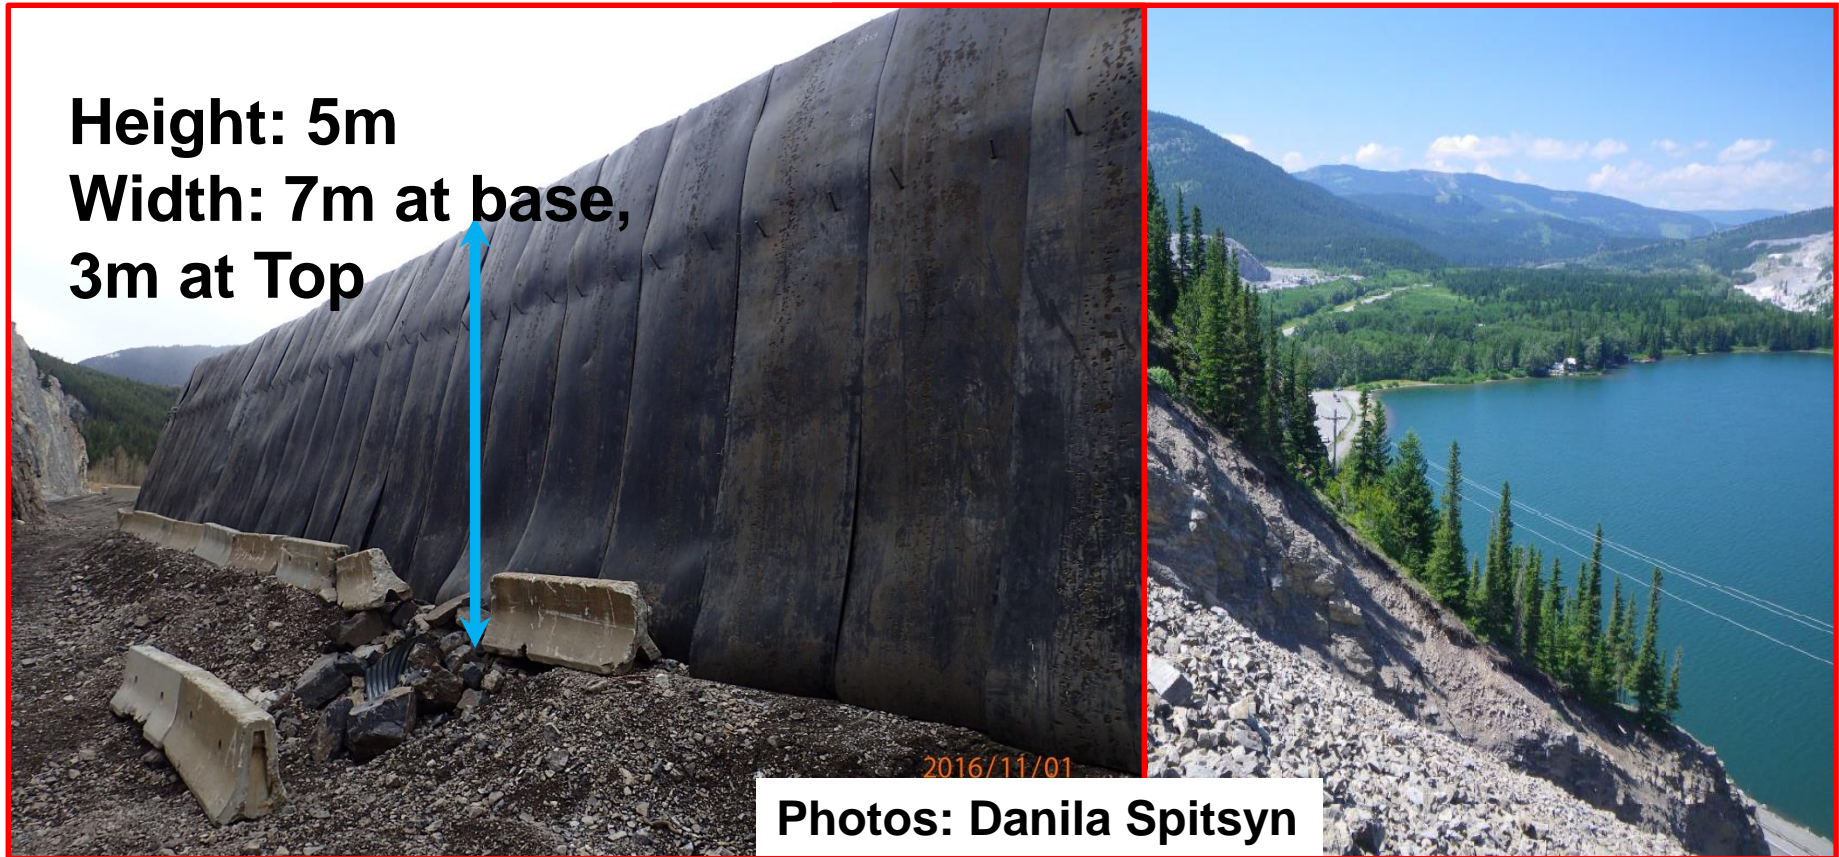
Solution Identified for Debris Flow

**Earthen Wall with gabion facings.
Impact surface lined with recycled conveyor belt.**

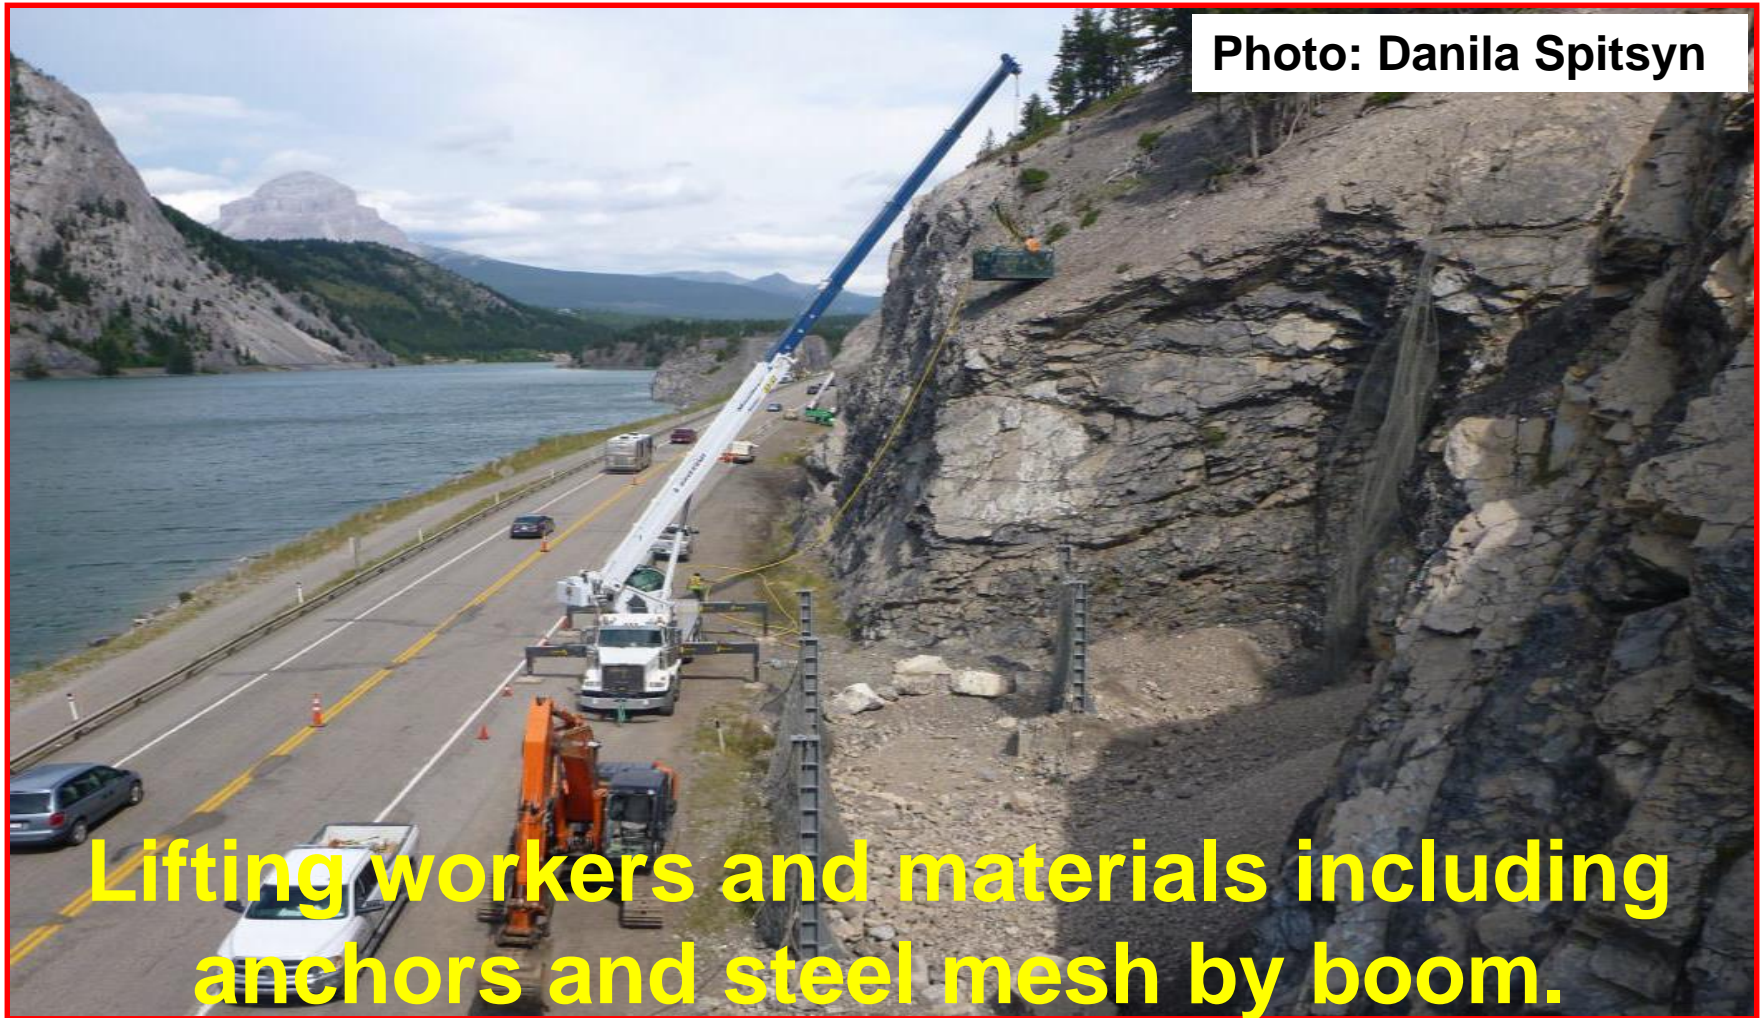
Solution Identified for Construction

Lifting workers and materials including anchors and steel mesh by boom.

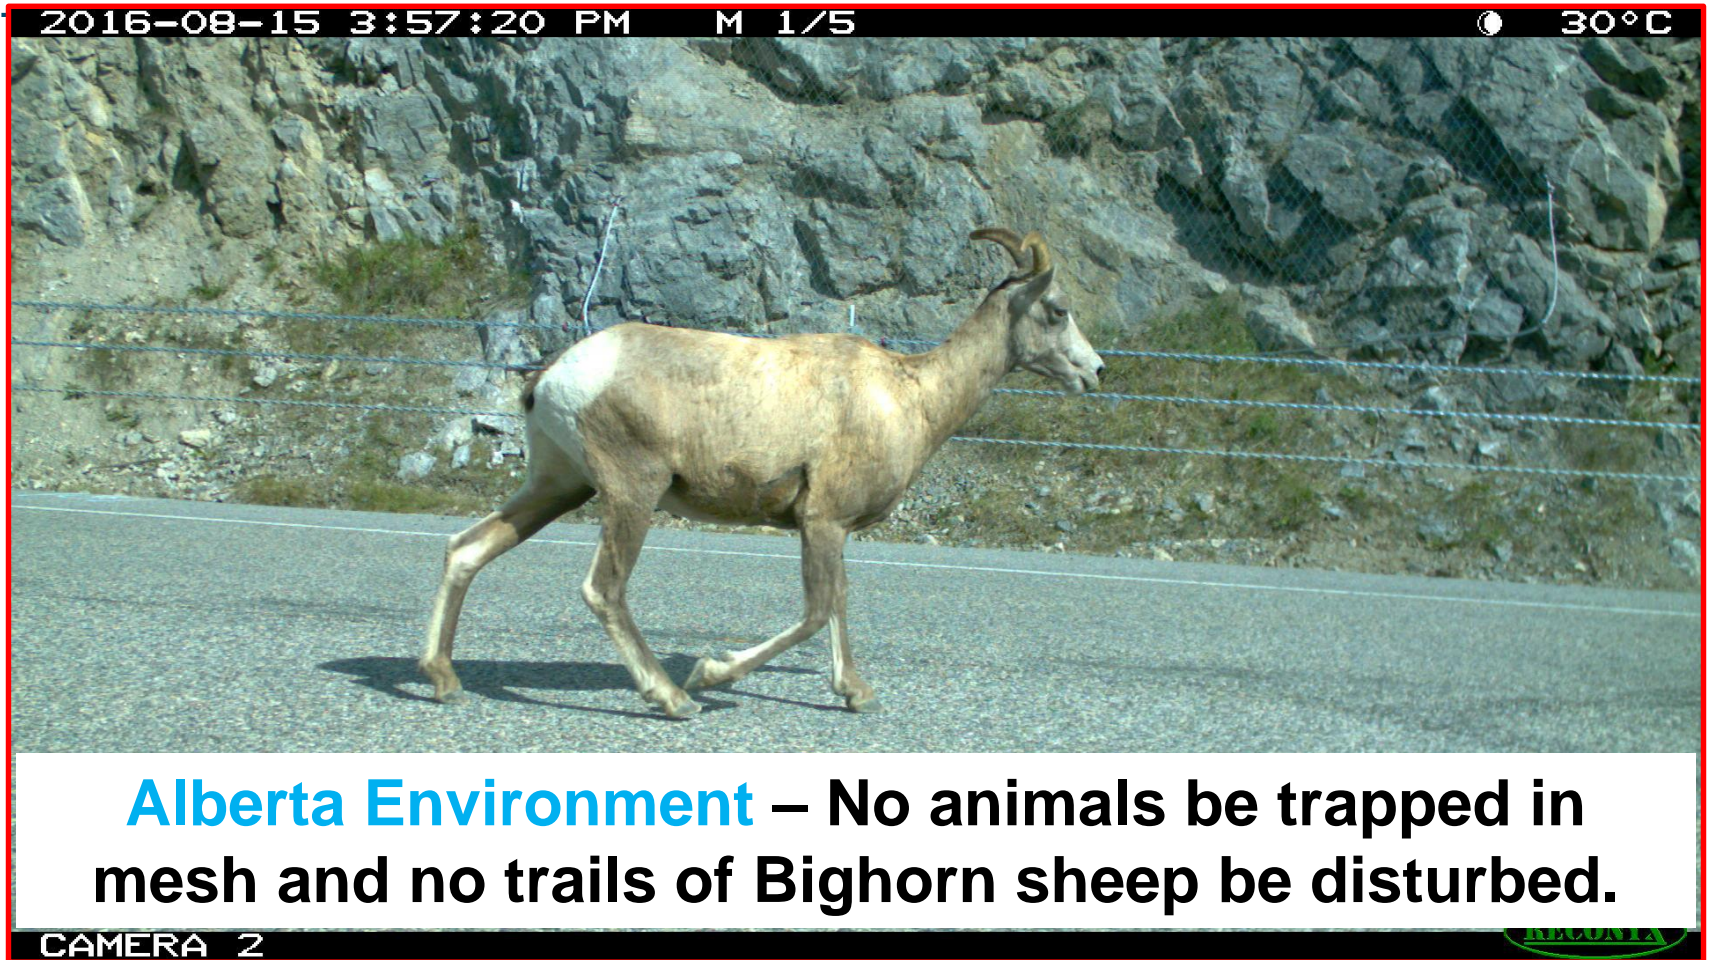
Constrain to the Solution

Alberta Environment – No animals be trapped in mesh and no trails of Bighorn sheep be disturbed.

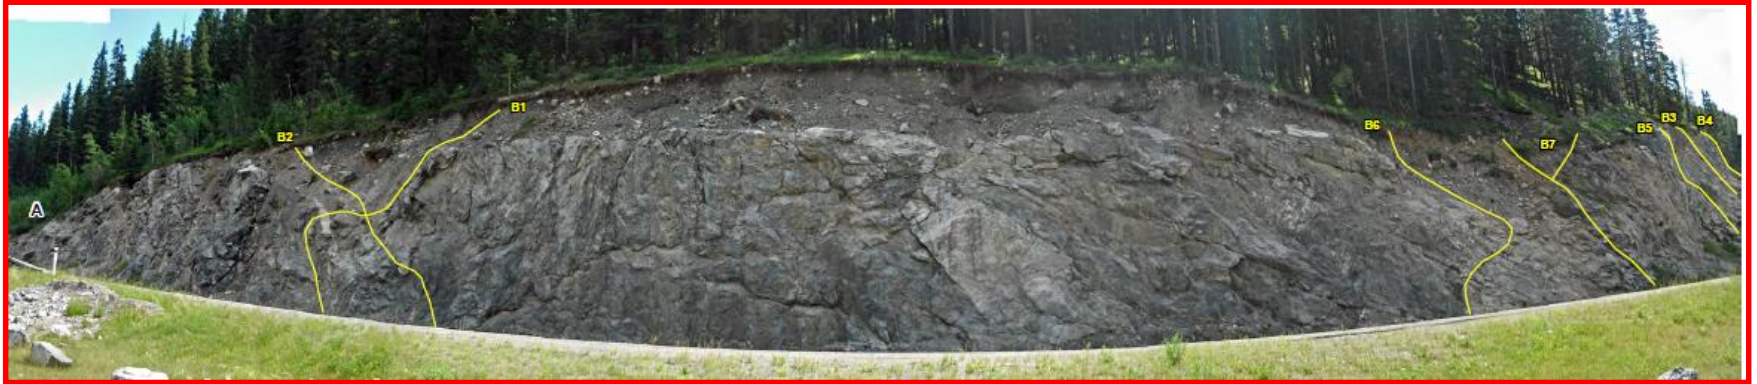
Wildlife Monitoring

- Motion detecting Cameras at Mt. Baldy and Galatea Creek Rock Fall sites.
- Monitored the motion of Wild Life for a year.
- Identified the trails taken by Bighorns.
- Left the trails undisturbed.
