PRODUCT INSPECTION

PRS-Neoweb	Product ID: 8255-21 Initiation Date: May 2013 Expiry Date: June 2015 Status: Trial Inspected by: R. Wang On: June 27, 2013
------------	---

Projects	Description	Application Date
1. Mitchell Beach Road that connects Township Road 474 to residential cabins on the northern shore of Pigeon Lake, Leduc Country	Single layer of Neoweb on the existing road surface of a length of 300m	June 2013
2. 7 th street between 15 th and 12 th Avenues in Nisku, Leduc County	PRS-Neoweb-reinforced base layer for a length of 500m two-lane road that serves as an access road to several industrial businesses	July to August 2012

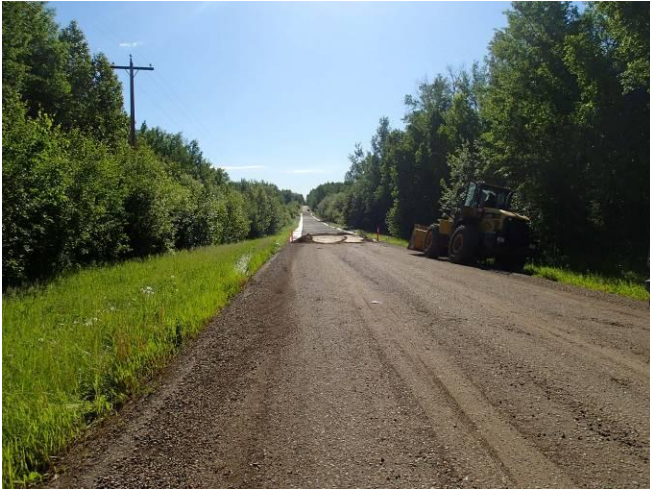
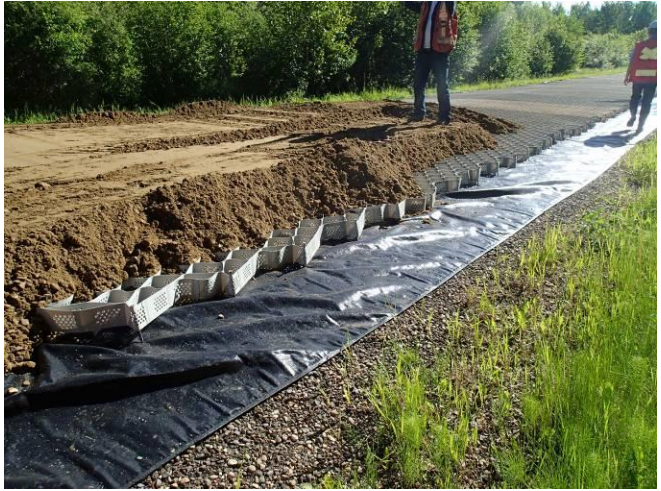
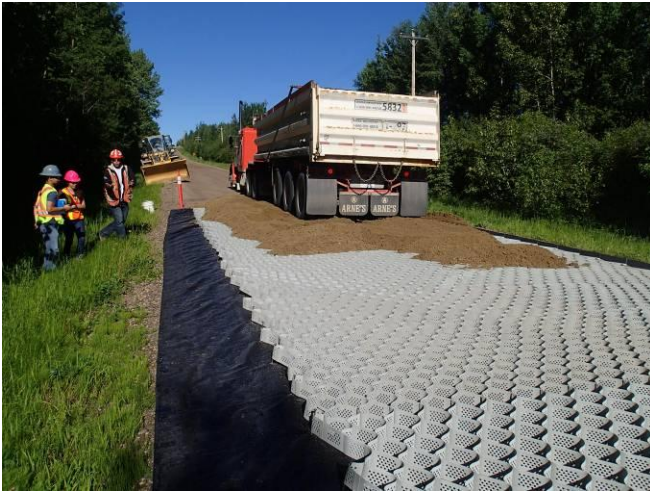
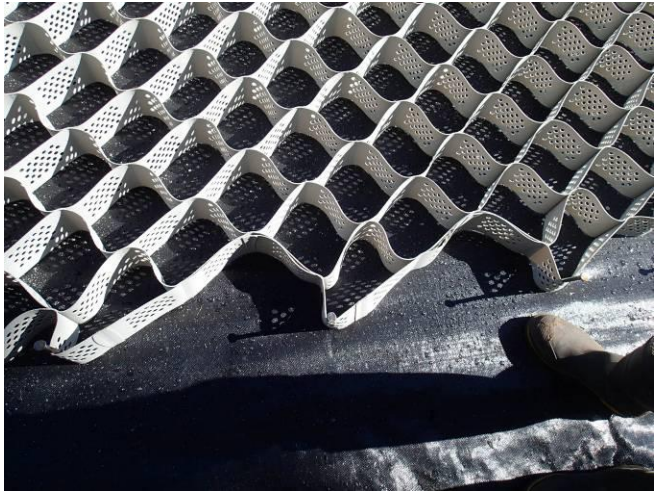
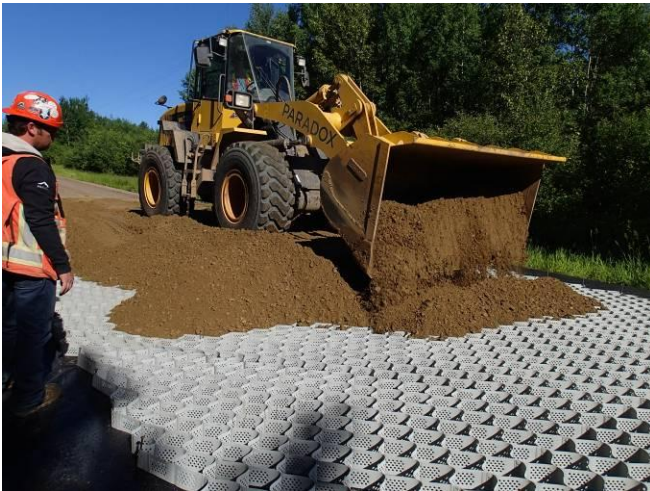
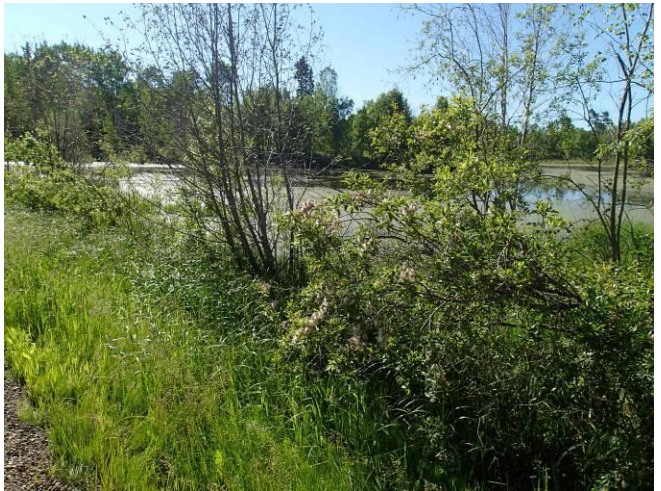
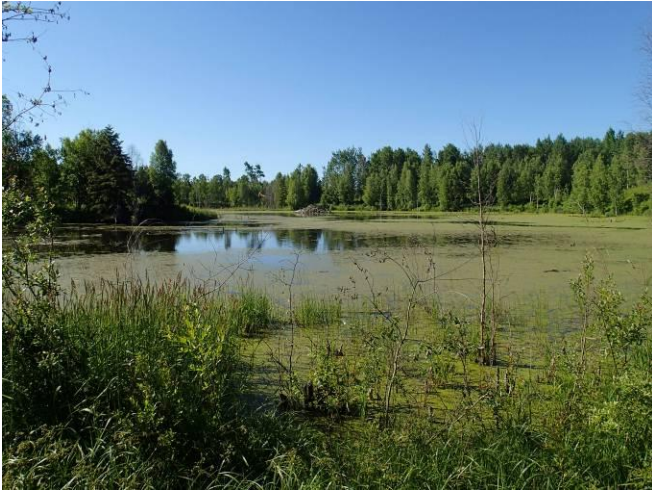
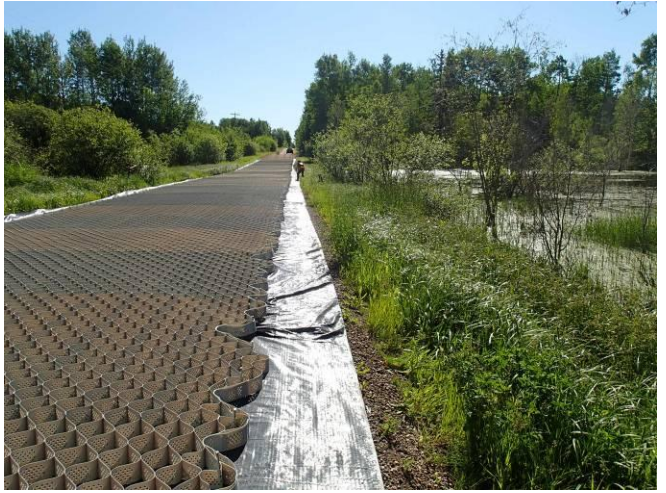
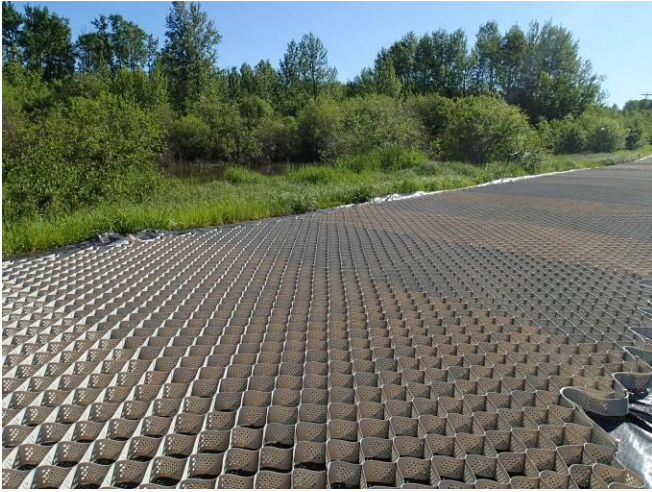
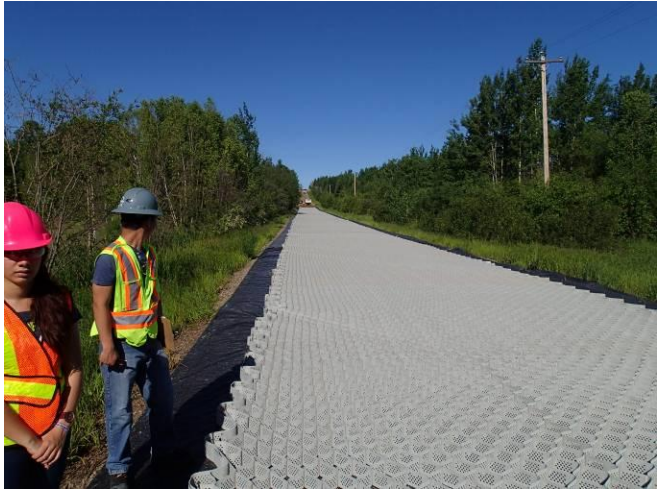
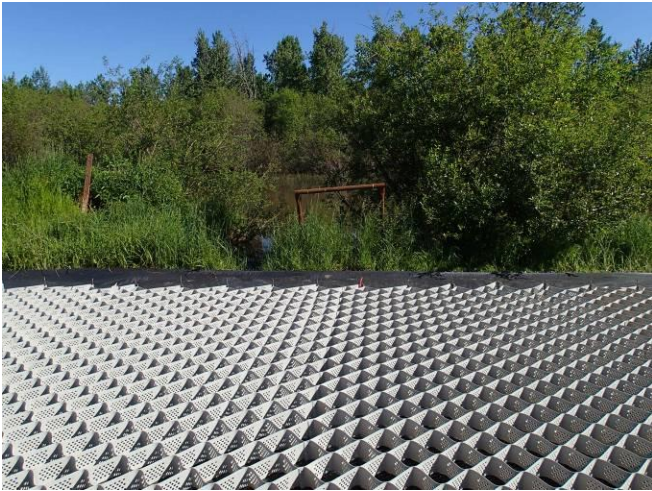
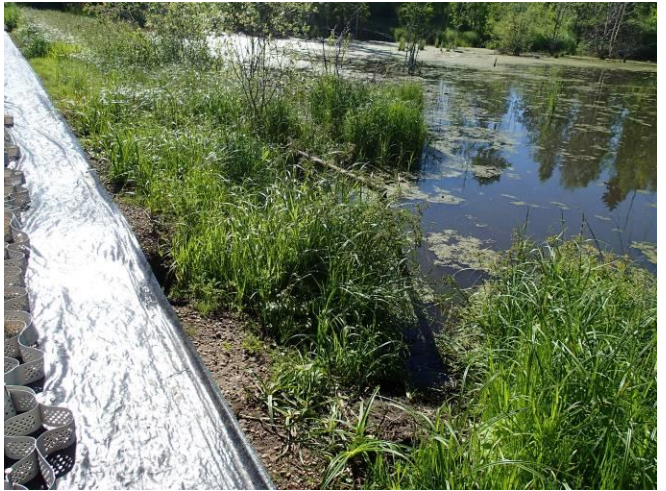
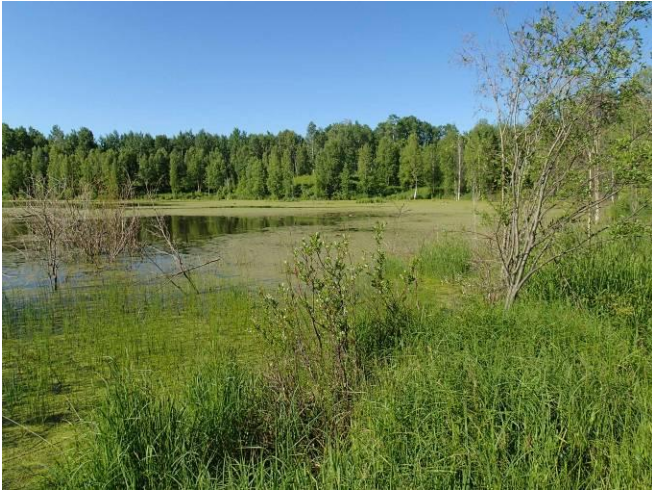
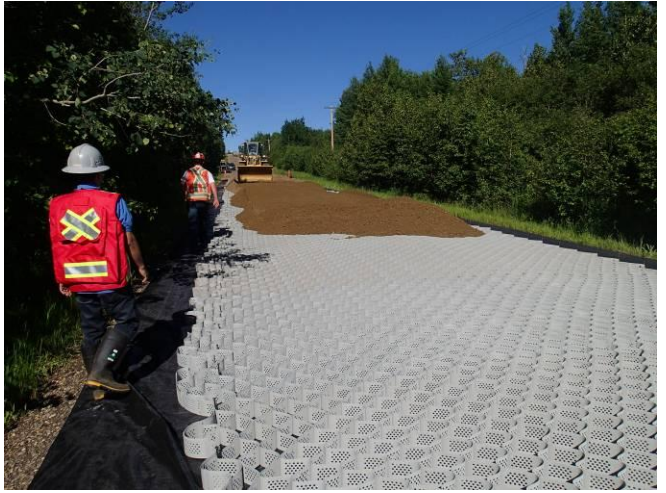
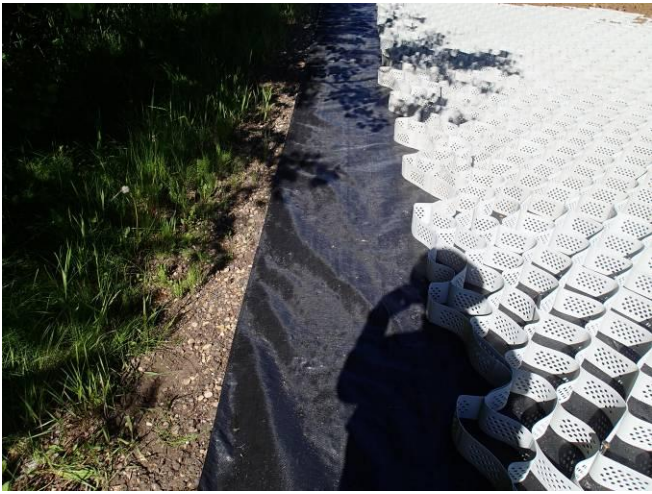
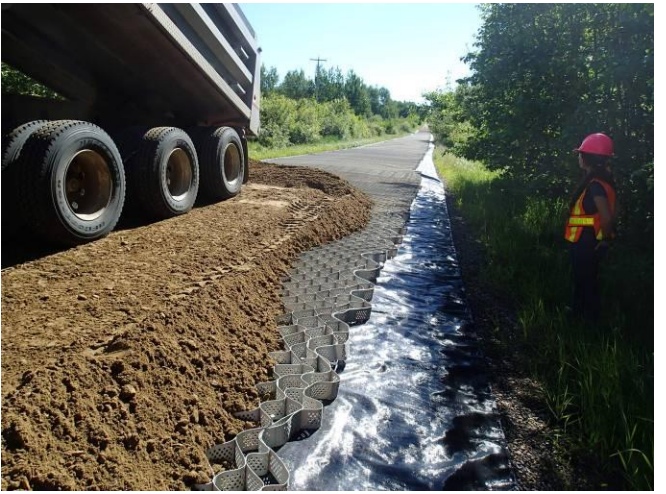
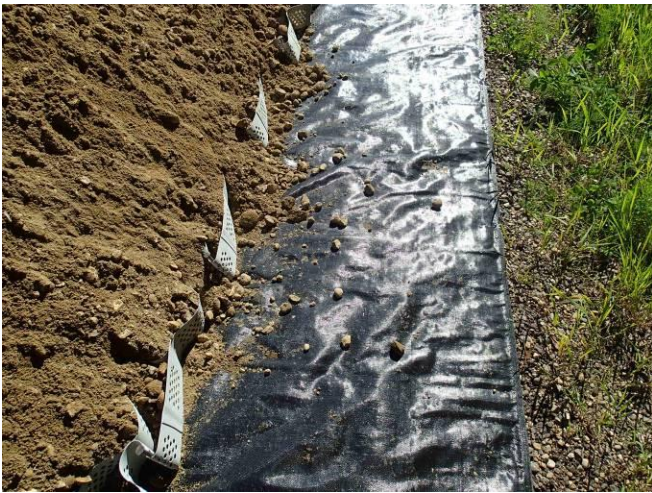
Site: Mitchell Beach Road

Two Neoweb projects were inspected as shown above – The first one under construction during the inspection while the second was already in service. The Mitchell Beach Road site was a rural gravel road of 300m in length which was located at and through, a low marsh and pond area. Two culverts across the road were located and the crowns were under water. Pondered water at this site may rise and lower periodically wetting the road bed materials. This action could result in distress to the road. Neoweb was being applied to support this section of the road.

Based on the data of project pricing provided by the applicant, it seems the first project has a turnkey unit cost of \$50/m². The first site was understood to have a long-standing frost-heave issue. The site will be inspected for a few seasons to check its longer term performance. The second project seems to be working very well – there was no rutting and distress observed on site.

Recommend that this product be advanced to “Trial Product” status with a two year evaluation period.

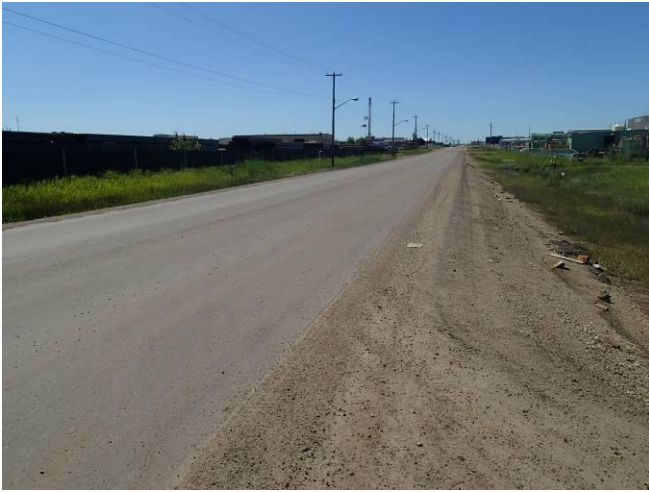
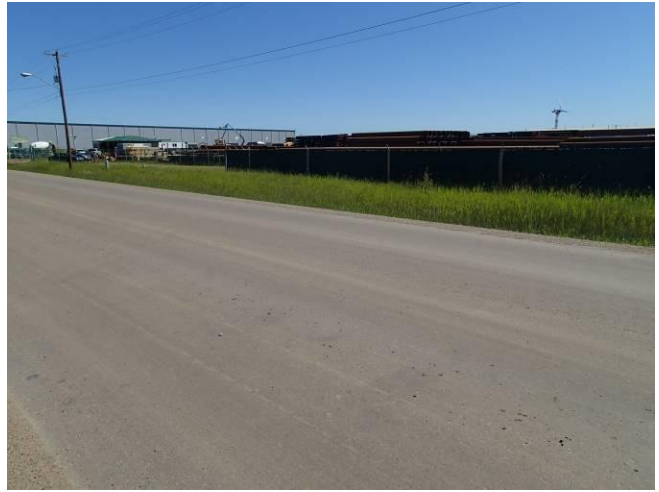
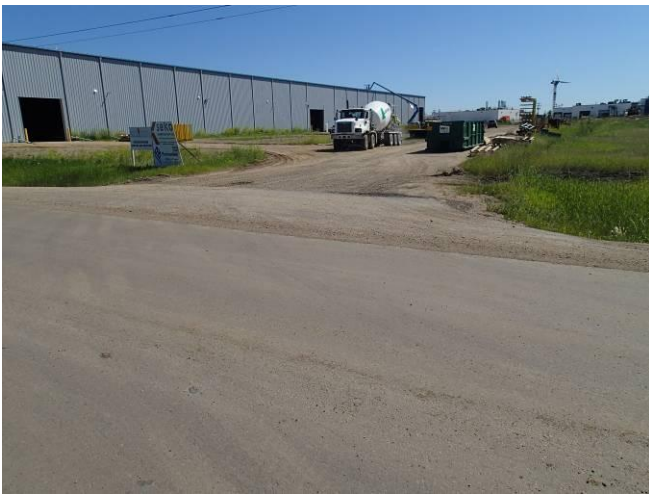
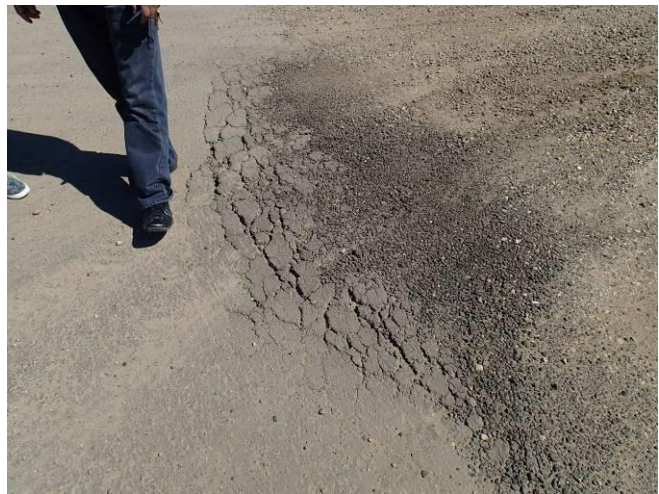
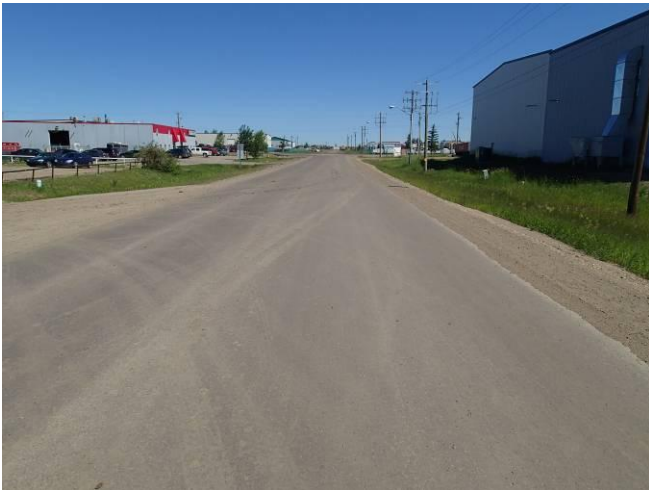
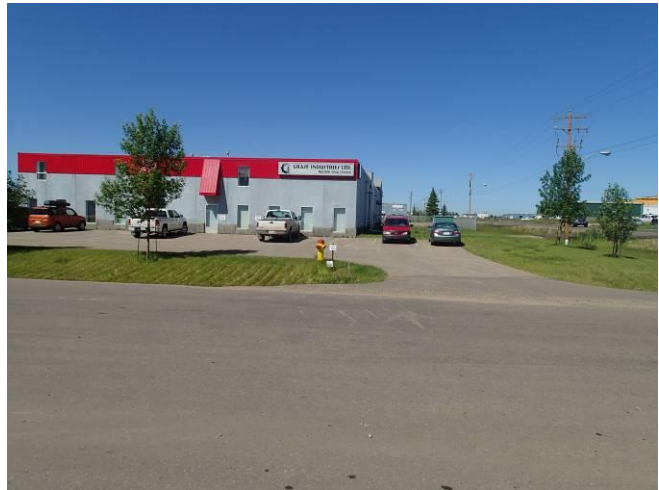
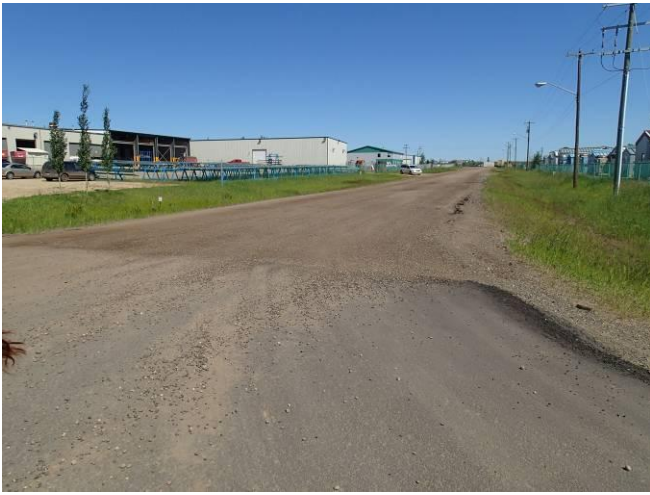
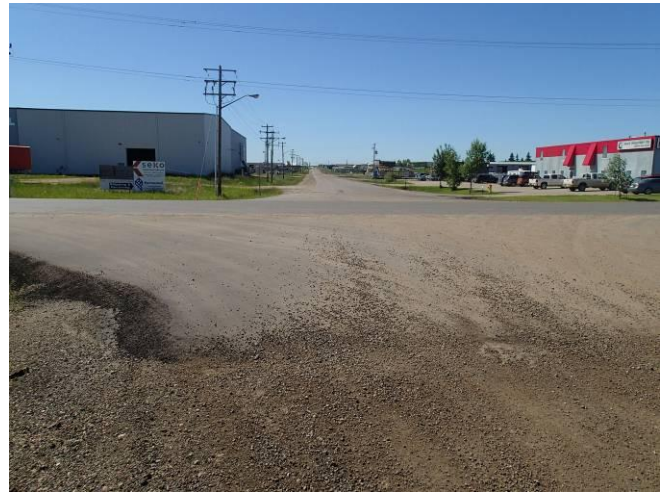
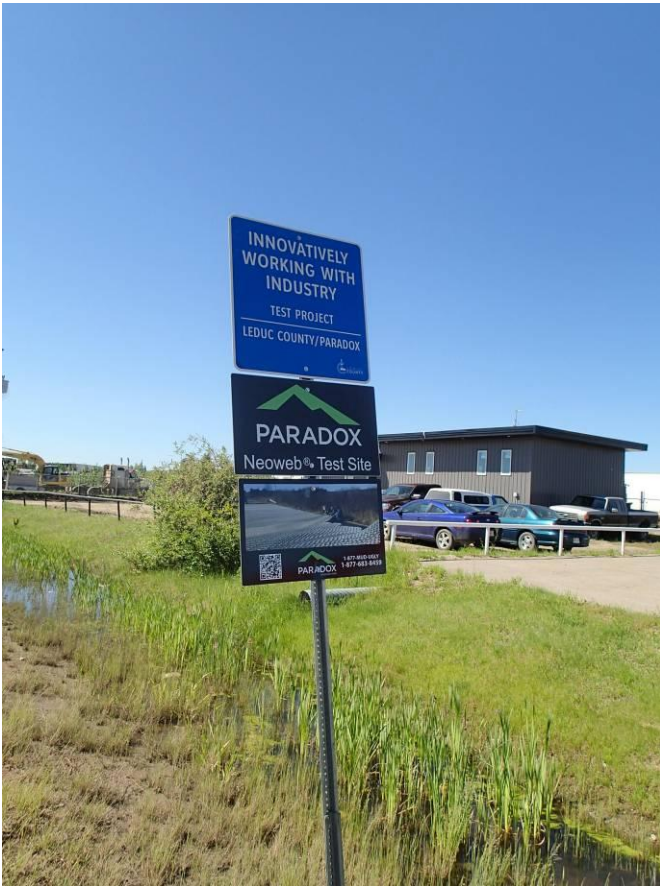
Site: 7th street in Nisku

The second project was a test site that was supported Leduc County and Paradox. The road section was in very poor serviceable condition. The original existing road surface had been graded, milled and leveled for Neoweb installation during the construction.
