Low VOC Traffic Paint (Acetone Based) Assessment

Highway Stoney Trail, Trial Project
Traffic paint applied in July 2014
Evaluated on December 8, 2014

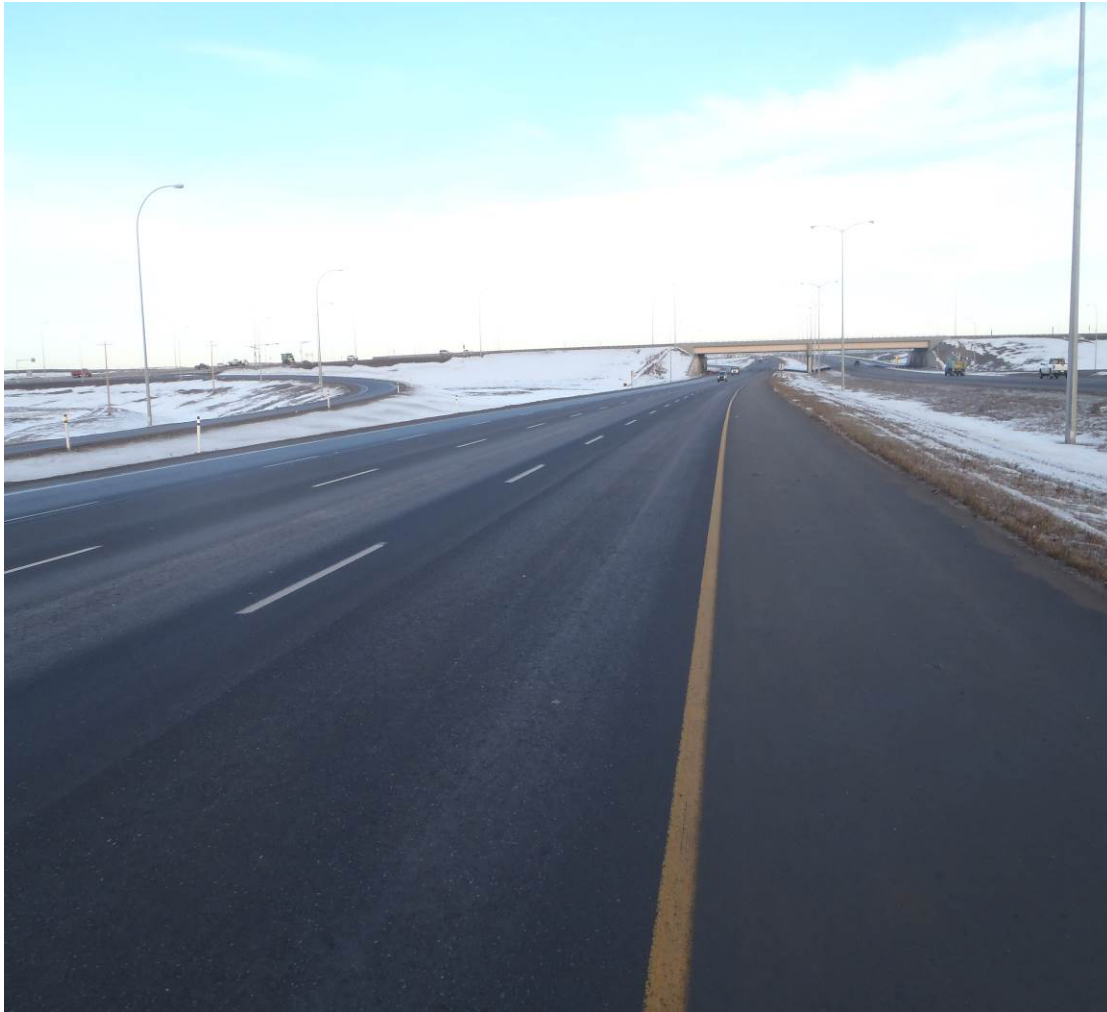
Stoney Trail – SE SB, 100m S. of Peigan Trail (3 rows of skip lines and 2 edge lines)

Overall view looking north

W. White edge line average retro-reflectivity – No readings in Dec. wet pavement = (Nov. 170 Mcd) (Oct. 273 Mcd) (Sept 243 Mcd) (Aug. 273Mcd)
1st white skip line average retro-reflectivity – No readings in Dec. wet pavement = (Nov. 76 Mcd) (Oct. 110 Mcd) (Sept 104 Mcd) (Aug. 221Mcd)
2nd white skip line average retro-reflectivity – No readings in Dec. wet pavement = (Nov. 124 Mcd) (Oct. 241 Mcd) (Sept 290 Mcd) (Aug. 350Mcd)
3rd white skip line average retro-reflectivity – No readings in Dec. wet pavement = (Nov. 230 Mcd) (Oct. 262 Mcd) (Sept 305 Mcd) (Aug. 377Mcd)
E. Yellow edge line average retro-reflectivity – No readings in Dec. wet pavement = (Nov. 133 Mcd (Oct. 197 Mcd) (Sept 161 Mcd) (Aug. 168Mcd)

Considering the heavy snow plow operations the traffic paint durability and glass bead retention is holding up very well.

The durability and visual appearance of all the lines is very good.

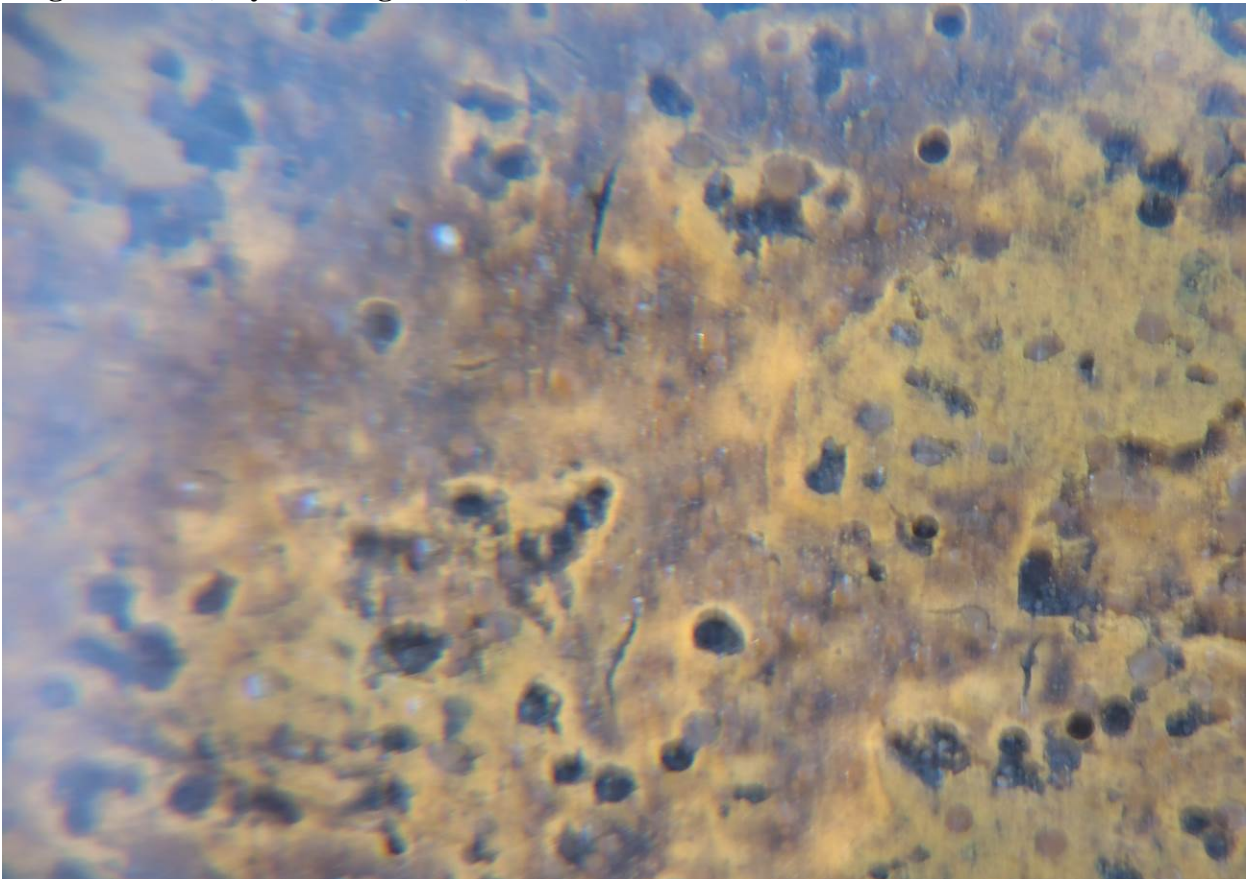
Magnification (E. yellow edge line)

The larger glass beads have come out of the paint due to the snowplow operations. Many smaller glass beads remain.

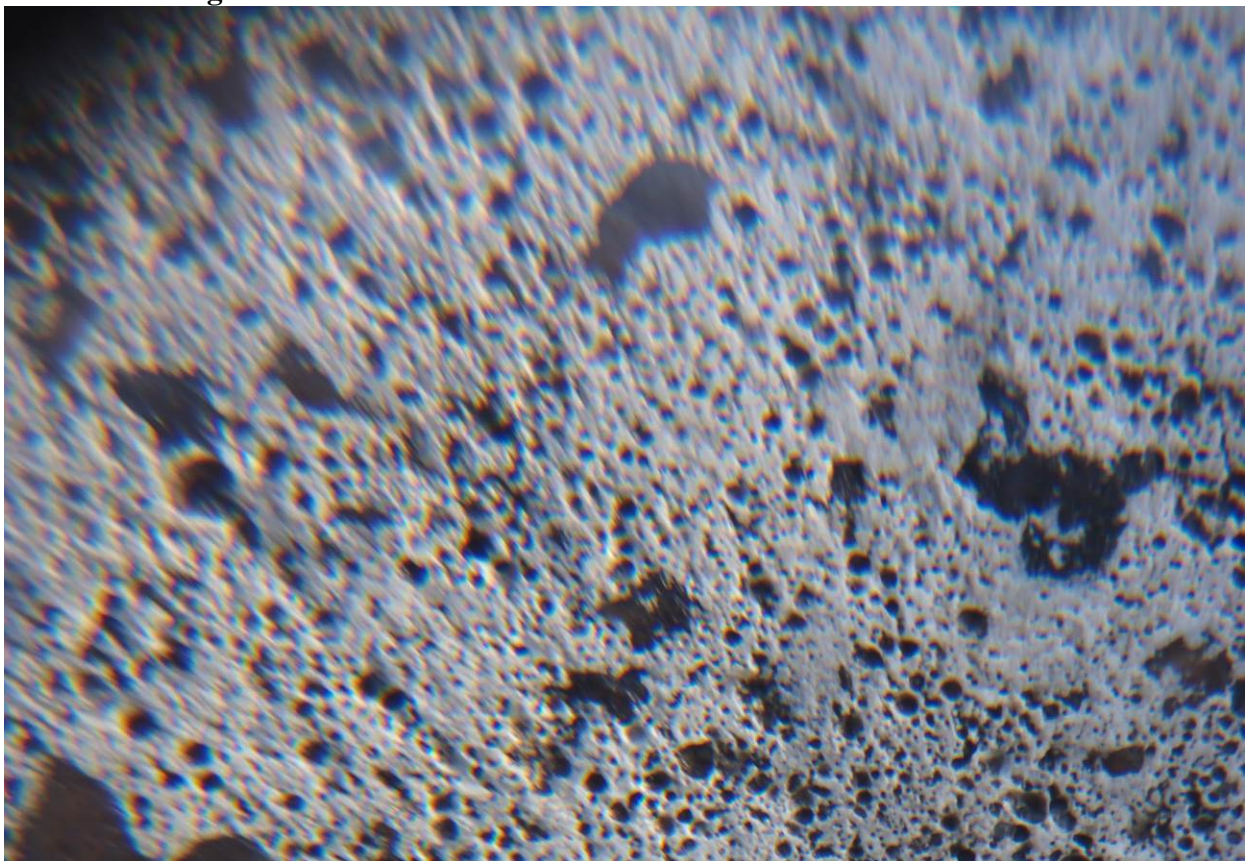
W. white edge line

Larger glass beads have popped out of the paint, snowplow damage. Smaller beads remain.

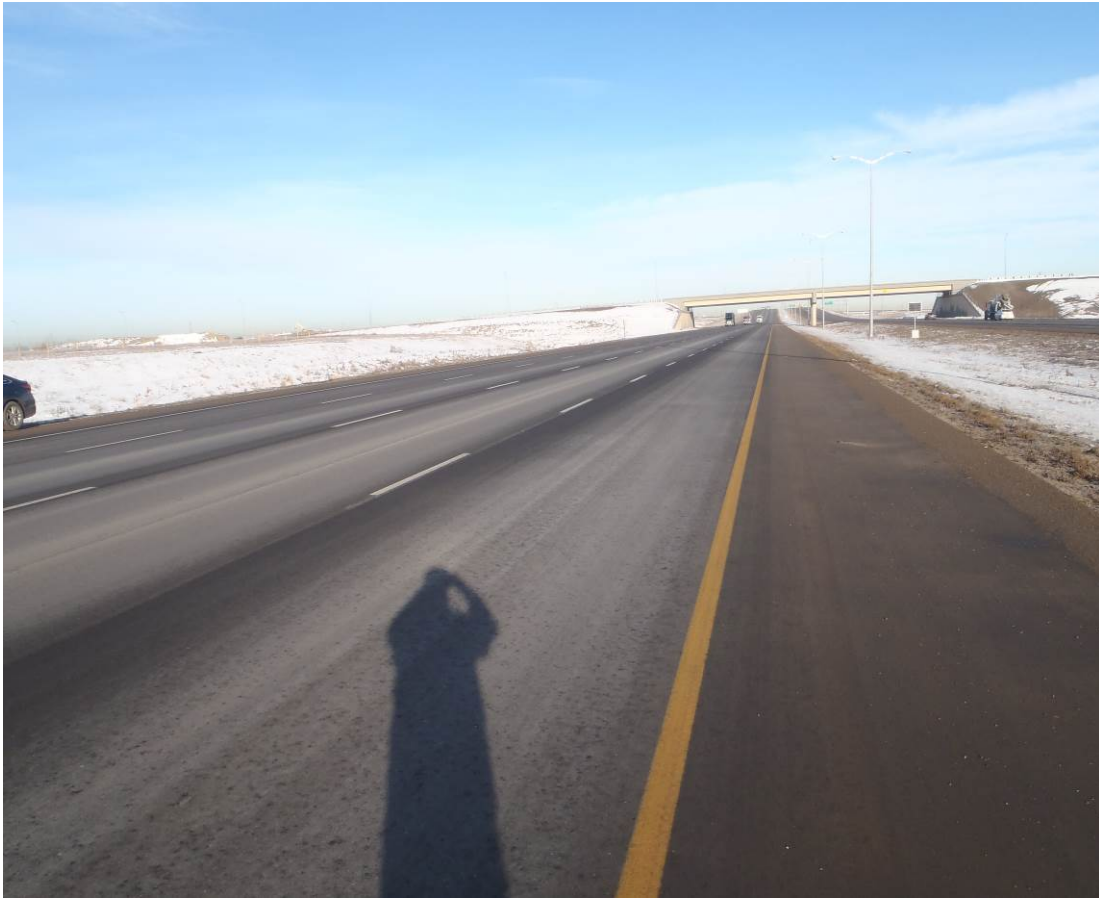
Stoney Trail – SE SB, Glenmore Trail SE 1 Km Sign (3 rows of skip lines and 2 edge lines)

Overall view, looking north

- W. White edge line average retro-reflectivity – No readings in Dec. wet pavement = (Nov. 169 Mcd) (Oct. 238 Mcd) (Sept 285 Mcd) (Aug. 344Mcd)
Ist white skip line average retro-reflectivity – No readings in Dec. wet pavement = (Nov. 88 Mcd) (Oct. 147 Mcd) (Sept 166 Mcd) (Aug. 266Mcd)
2nd white skip line average retro-reflectivity – No readings in Dec. wet pavement = (Nov. 182 Mcd) (Oct. 276 Mcd) (Sept 317 Mcd) (Aug. 346Mcd)
3rd white skip line average retro-reflectivity – No readings in Dec. wet pavement = (Nov. 206 Mcd) (Oct. 253 Mcd) (Sept 322 Mcd) (Aug. 373Mcd)
E. Yellow edge line average retro-reflectivity – No readings in Dec. wet pavement = (Nov. 151 Mcd) (Oct. 225 Mcd) (Sept 169 Mcd) (Aug. 159Mcd)

Retro-reflectivity is good when considering that snowplows have been operating on this road. The durability and daytime visibility is very good.

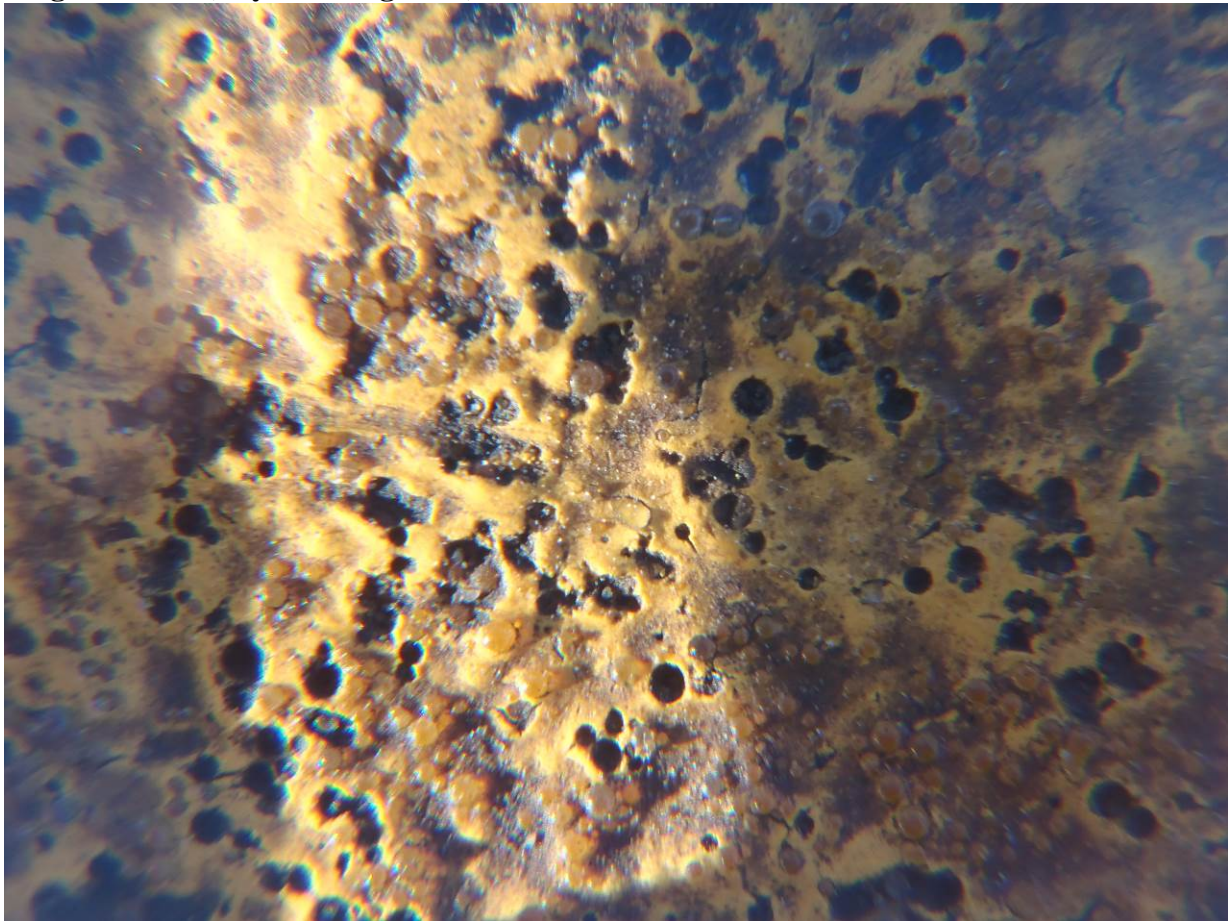
Magnification (E. yellow edge line)

Snowplow damage to glass beads, the larger glass beads have popped out. Smaller beads remain.

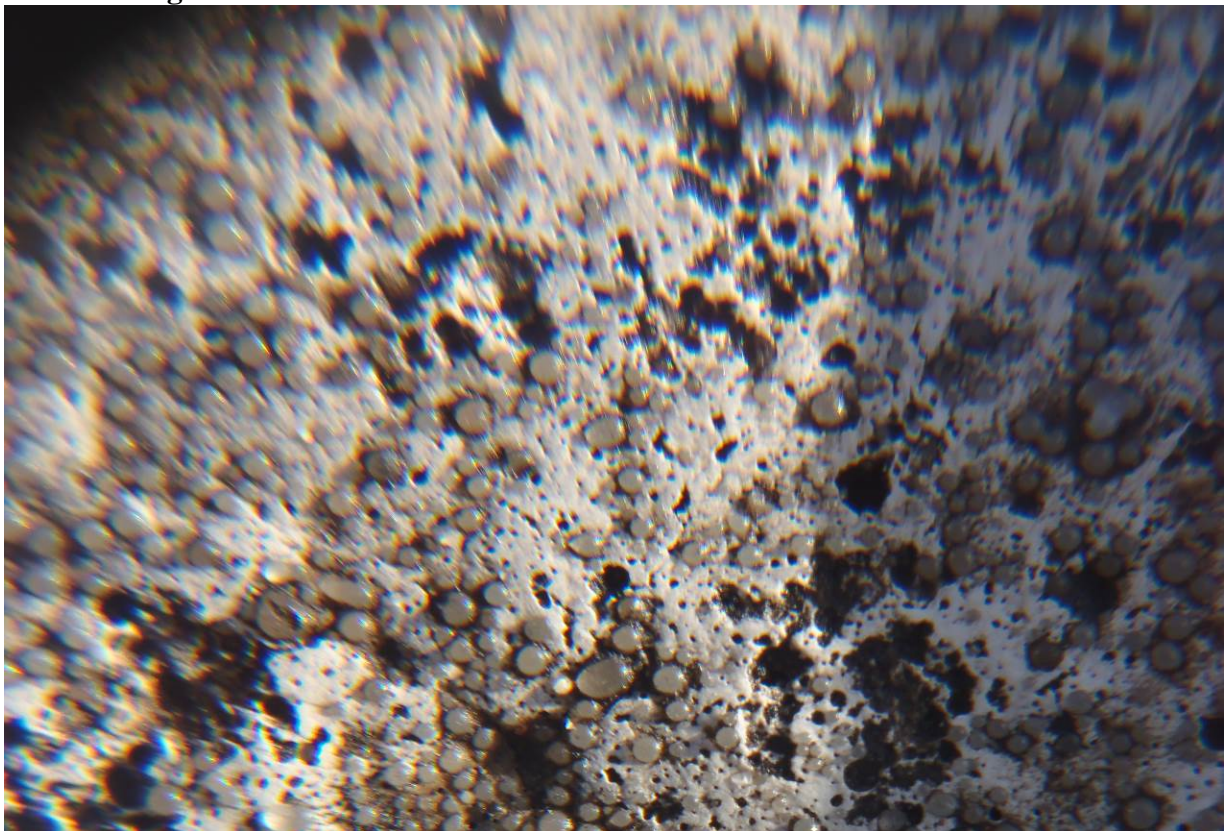
W. white edge line

Larger glass beads have popped out of the paint. Many smaller beads remain.

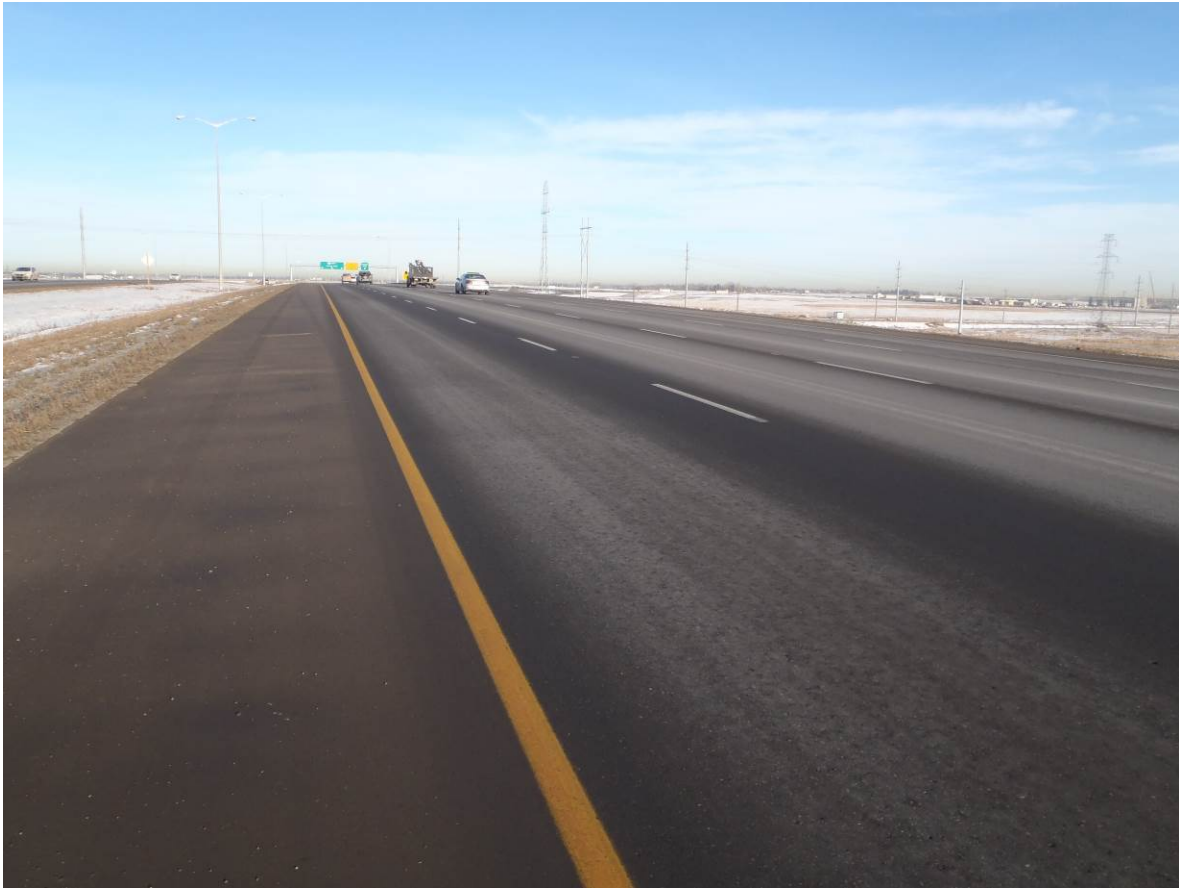
Stoney Trail – SE NB, 300m S. of Peigan Trail (3 rows of skip lines and 2 edge lines)

Overall view

- E. White edge line average retro-reflectivity – No readings in Dec. wet pavement = (Nov. 147 Mcd) (Oct. 330 Mcd) (Sept 348 Mcd) (Aug. 368Mcd)
- Ist white skip line average retro-reflectivity – No readings in Dec. wet pavement = (Nov.110 Mcd) (Oct. 256 Mcd) (Sept 295 Mcd) (Aug. 373Mcd)
- 2nd white skip line average retro-reflectivity – No readings in Dec. wet pavement = (Nov. 129 Mcd) (Oct. 258 Mcd) (Sept 240 Mcd) (Aug. 300Mcd)
- 3rd white skip line average retro-reflectivity – No readings in Dec. wet pavement = (Nov. 152 Mcd) (Oct. 330 Mcd) (Sept 346 Mcd) (Aug. 365Mcd)
- W. Yellow edge line average retro-reflectivity – No readings in Dec. wet pavement = (Nov. 144 Mcd) (Oct. 175 Mcd) (Sept 162 Mcd) (Aug. 173Mcd)

The retro-reflectivity is holding up very well at this location when considering snowplow operations on this road.

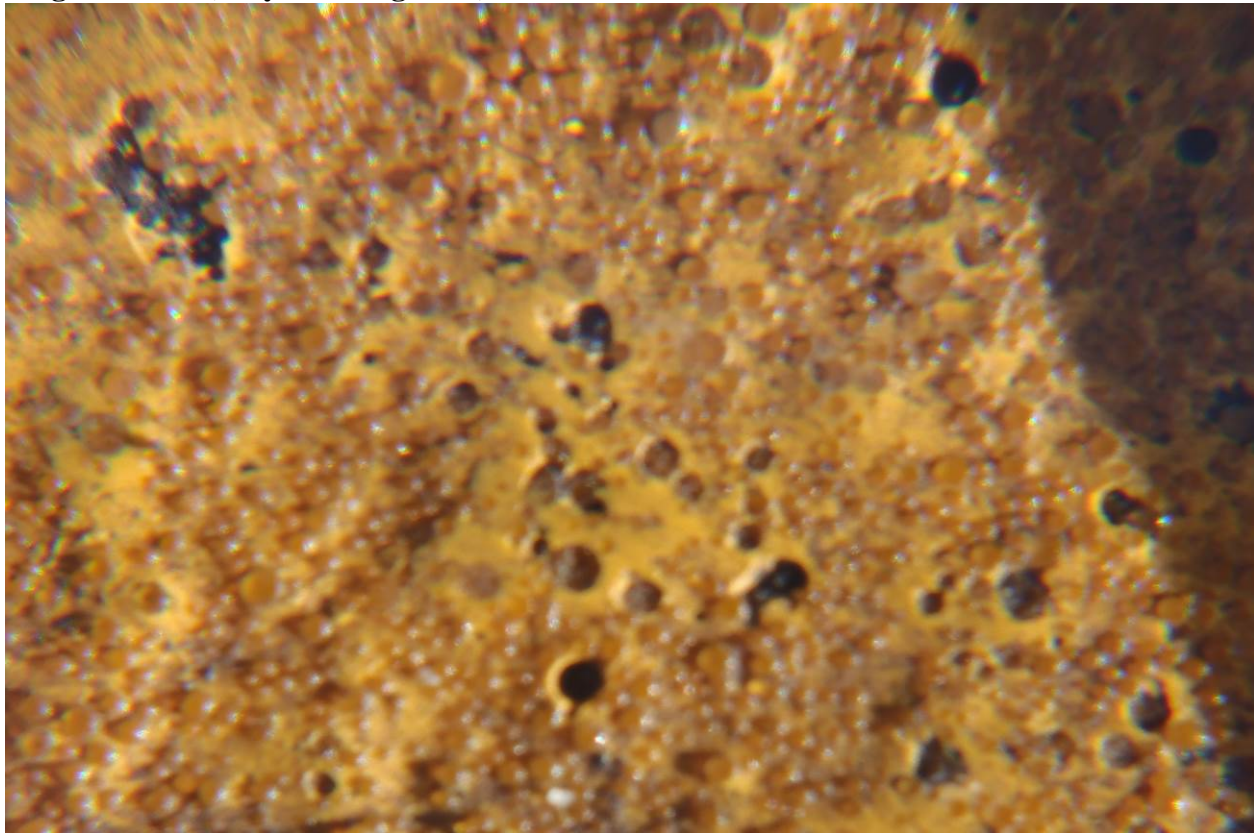
Magnification (W. yellow edge line)

Plenty of smaller glass beads remain in paint at this location.

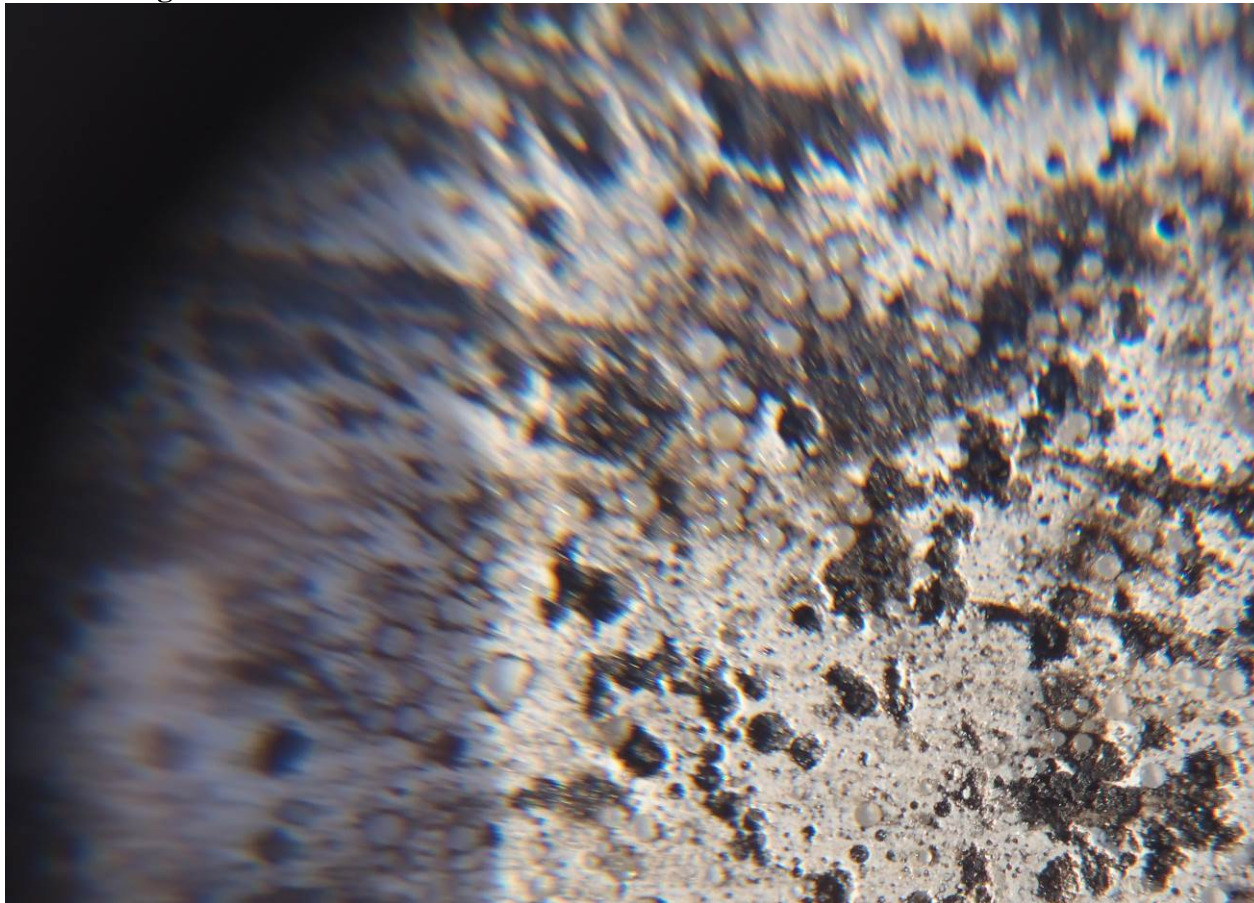
E. white edge line

Smaller glass beads remaining in paint.
