BF278 – Hwy 2A over Battle River near Ponoka

HDG:

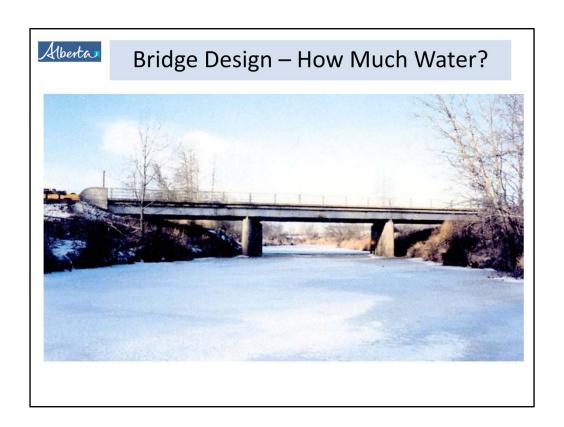
- Why does it matter?
- Typical bridge
- Looks like lots of capacity, when flow is low

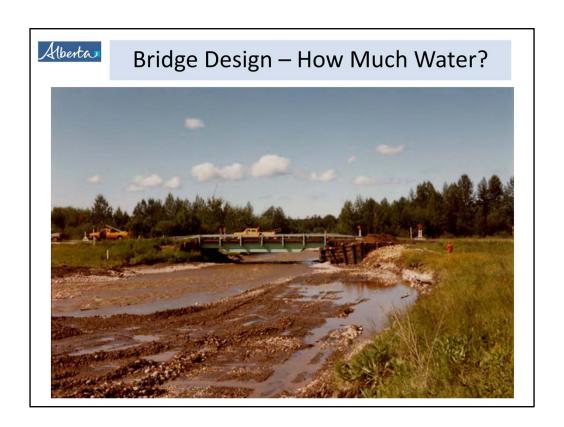
Hwy 33 over Island Ck near Kinuso

- Post 1983 flood
- Some repairs to abutment

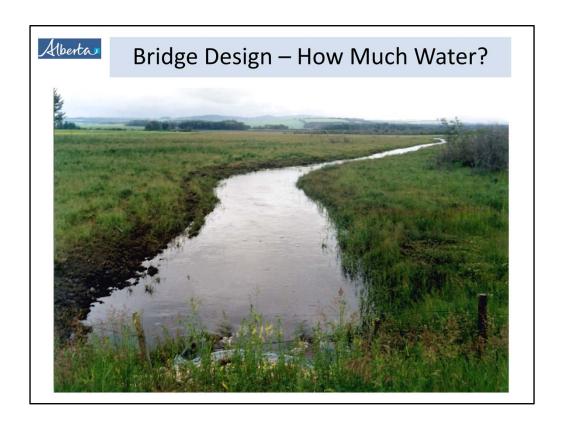
Physics:

- Most channels have trapezoidal shape up to bankfull
- Beyond this level, much of water goes into storage
- Does runoff make the channel or does channel control the runoff? Yes

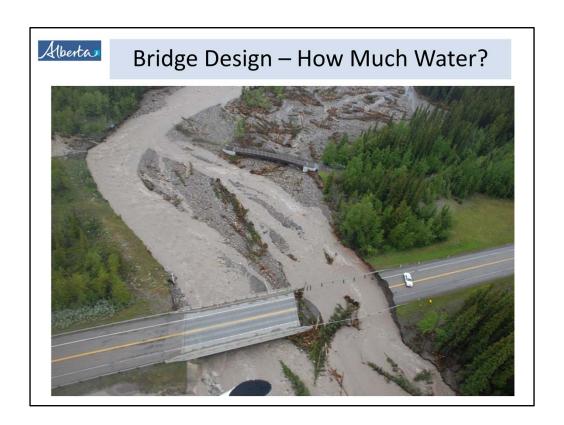
Hwy 40 (and pedestrian trail) over Evan Thomas Ck (south of Kananaskis Golf Course)

- Note drift impact
- Note lateral instability
- Opening OK, RPW not

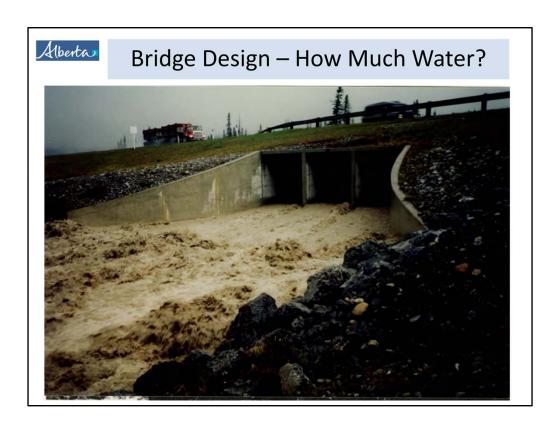
- Early in May 1990 flood
- Culvert working OK before plugged
- Note V, colour of water

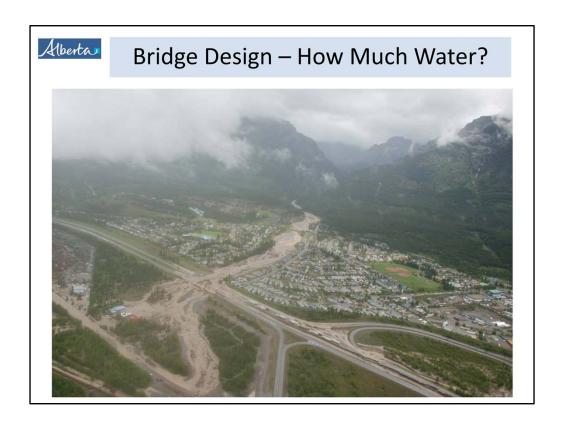
- Crossing alluvial fan
- Debris flow
- Closed for ~ 1 week
- Note lots of development adjacent to channel

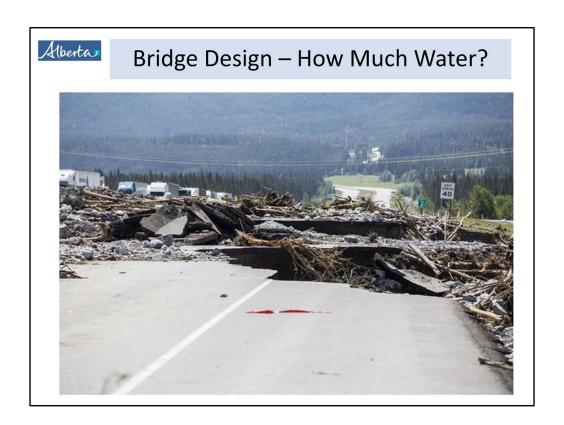
- Crossing alluvial fan
- Debris flow
- Closed for ~ 1 week
- Note damage, debris on top, trucks

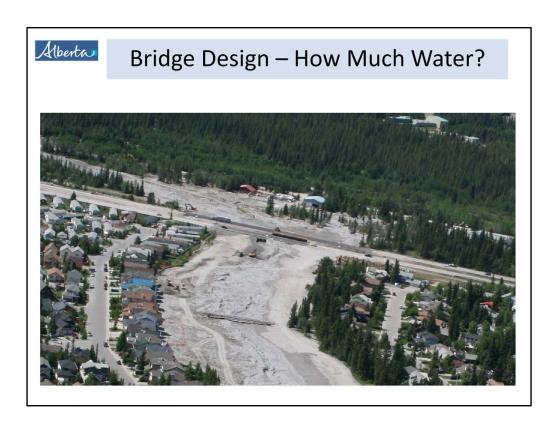
- 1 week later, looking d/s
- Highway now open restricted speed, lanes
- Difficulty in holding alignment, handling debris
