SITE NUMBER AND NAME: <b>S014 Bellevue Mine Sinkholes</b>		HIGHWAY & KM: 3:02, 27.203	PREVIOUS INSPECTION DATE: June 1, 2017	INSPECTION DATE: <b>May 10, 2019</b>
LEGAL DESCRIPTION: 04-21-007-03 W5M and 13-16-007-03 W5M	NAD 83 COORDINATES: UTM Northing Easting 11 5659724 614296		RISK ASSESMENT: PF: 2 CF: 3 TOTAL: 6	
AVERAGE ANNUAL DAILY TRAFFIC (AADT): 8020 (west), 6320 (east) (Ref. No. 70000008)			CONTRACTOR MAINTENANCE AREA (CMA): 26

PROJECT SOUTHERN REGION GEOHAZARD RISK MANAGEMENT PROGRAM

TITLE Site Plan S014 - Bellevue Sinkholes Hwy 3:02, km 27.203
SCALE 1:1,500	PROJECT No. A05115A03	FIG No. 1

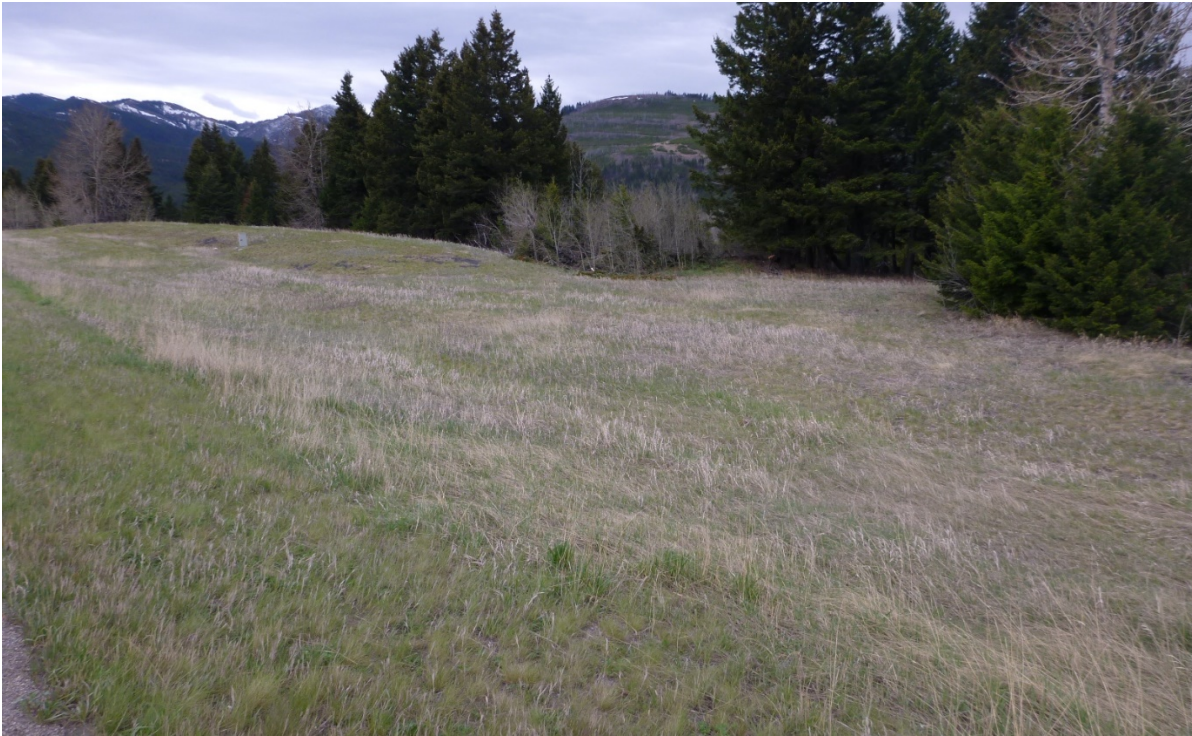
**Photo 1**      **Area of 2002 sinkholes west of the highway – no evidence of new sinkholes or pavement distress. Photo taken facing south on May 10, 2019.**

ITEM	CONDITION EXISTS		DESCRIPTION AND LOCATION	NOTICABLE CHANGE FROM LAST INSPECTION	
	YES	NO		YES	NO
Pavement Distress		X			X
Slope Movement		X			X
Erosion		X			X
Seepage		X			X
Culvert Distress		X			X
<b>COMMENTS</b>					
No change since previous inspection and no impact to road. Remove from GRMP.					
Possible sinkhole at waypoint 811, near to conifer. Small depression noted away from highway, possibly infilled previously.					
Previous review of site geology indicates that bedrock and coal seams are steeply dipping which indicates coal mining voids are also steeply dipping. Coal mine maps are unavailable and rogue mining (unlicensed and/or unreported mining) may have resulted in workings extending beyond the limits of mines shown on maps.

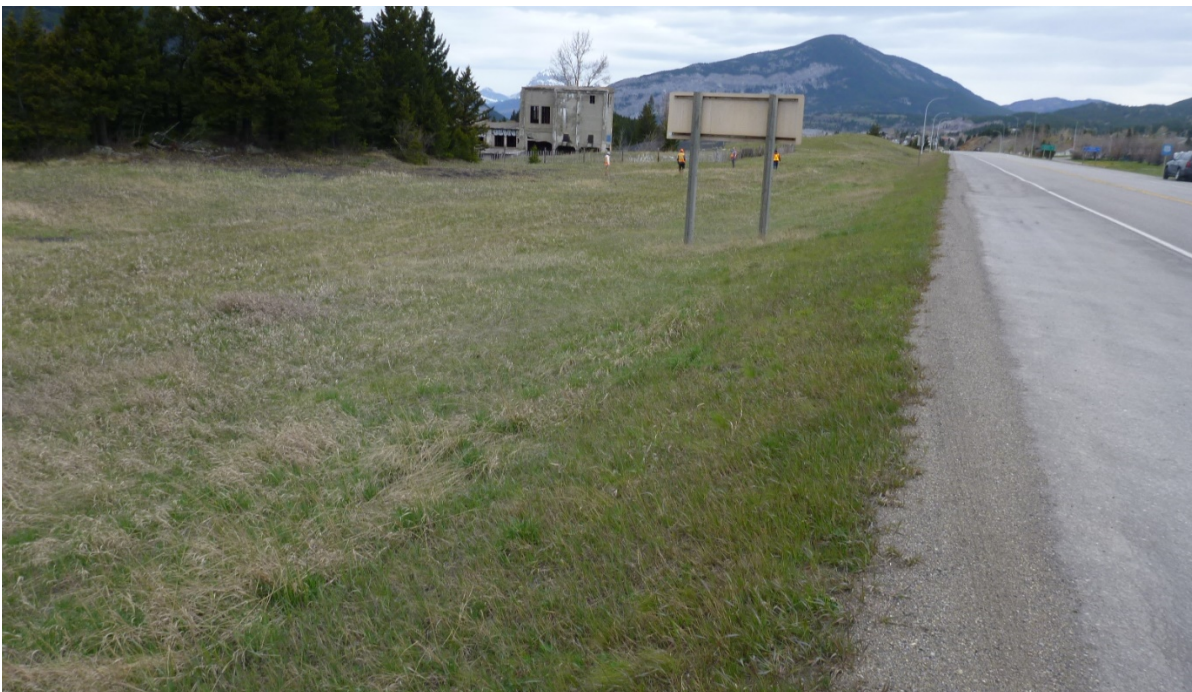
**Photo 2**      **Area of 2002 sinkholes west of the highway – no evidence of new sinkholes or pavement distress. Photo taken facing northwest on May 10, 2019.**

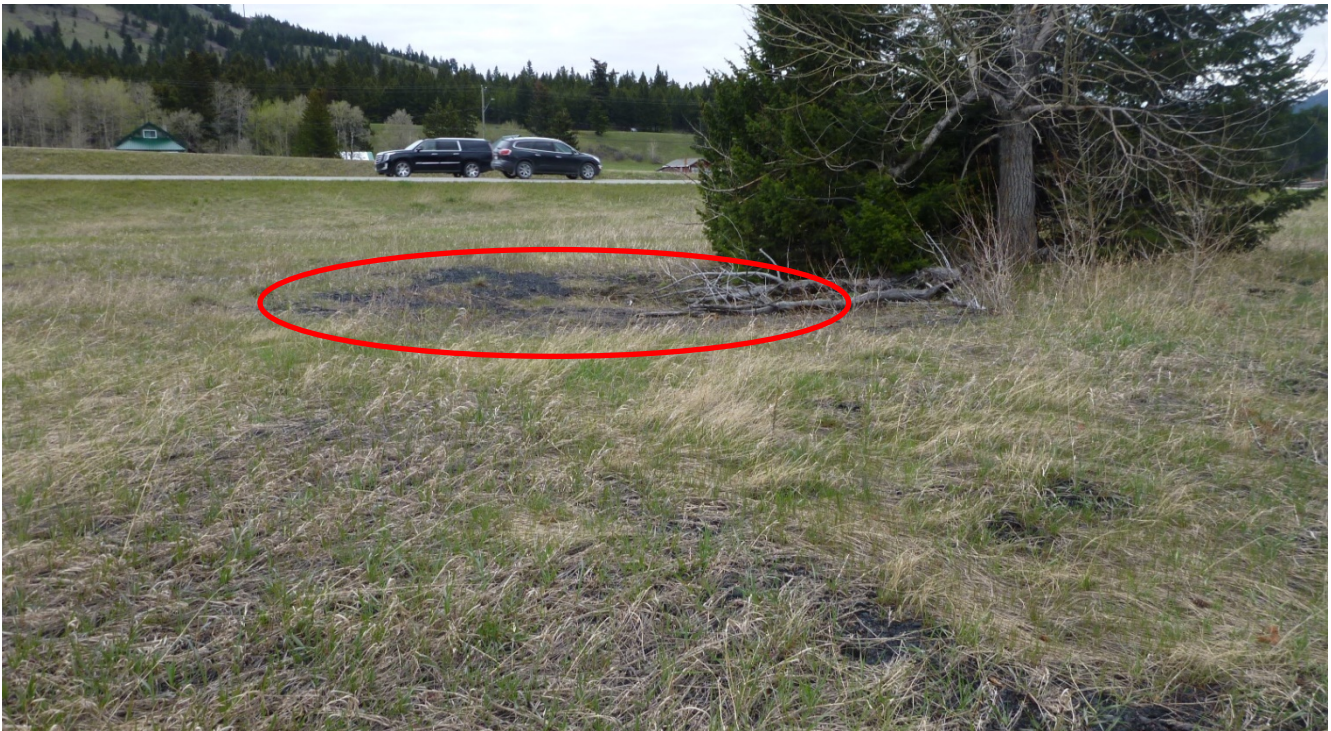
**Photo 3**      **Shallow depression at waypoint 811 (red circle). Possible sinkhole away from the road. Photo taken facing east on May 10, 2019.**
