Carsonite Roadmarkers and Curveflex delineators

Installation Date: October 2007

Evaluation Date: January 21, 2010

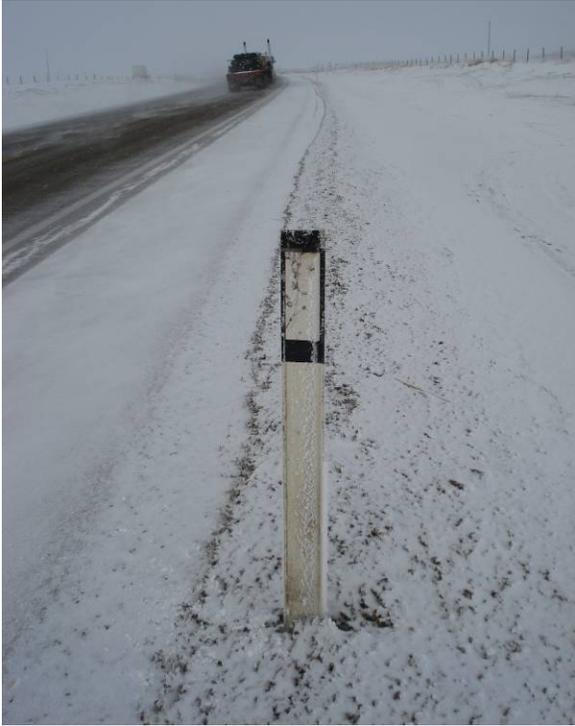
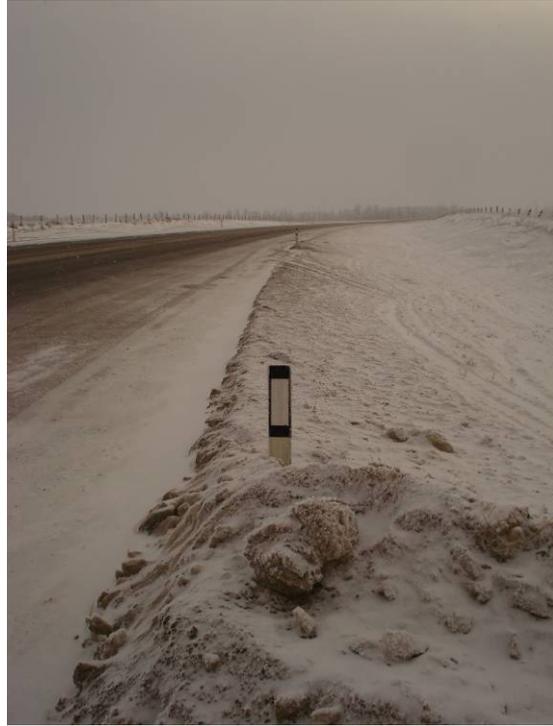
Carsonite Roadmarkers

The Carsonite delineators are performing very well at this location. A small percentage of the Carsonite delineators are damaged, however they are still in place.

Recommend advancing these two products to the Proven Products category.

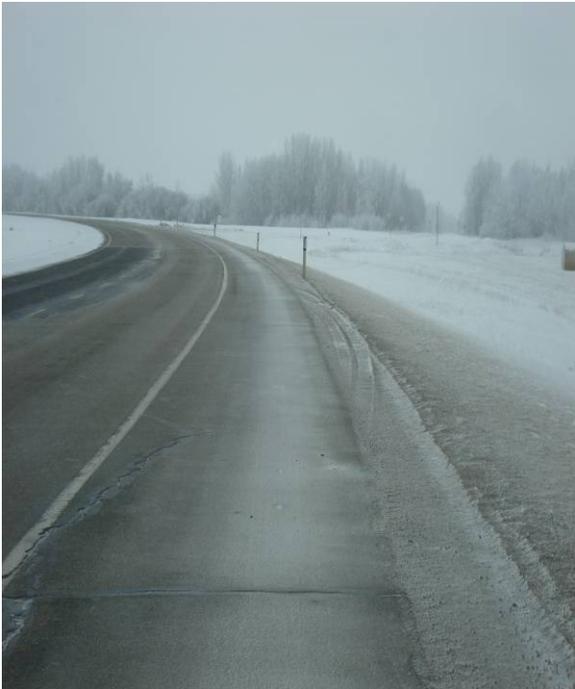
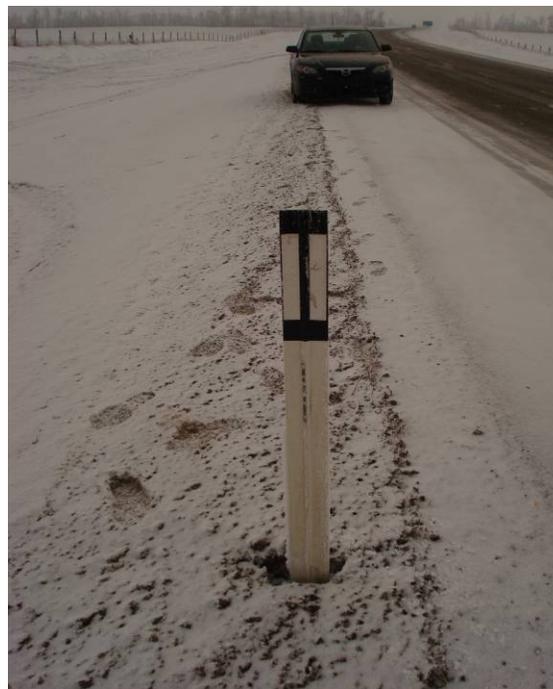
Carsonite Curveflex

The Carsonite delineators will flex above ground level, therefore they will rebound during vehicle impacts. These delineators should out perform the round delineator posts.

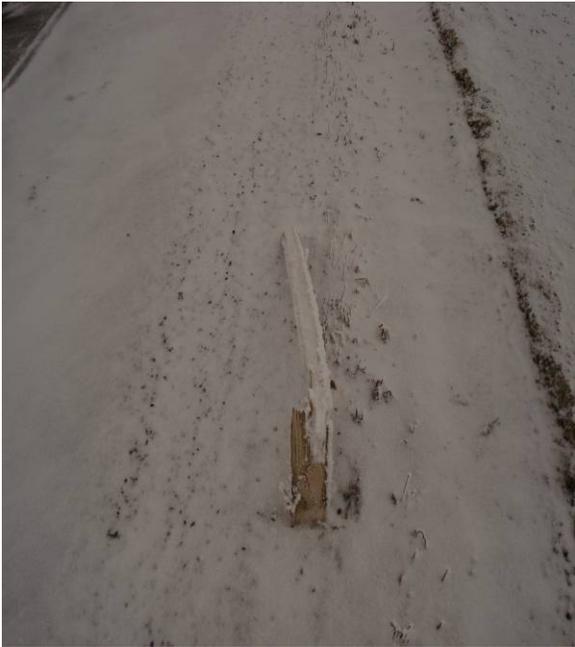
Damaged Carsonite delineator

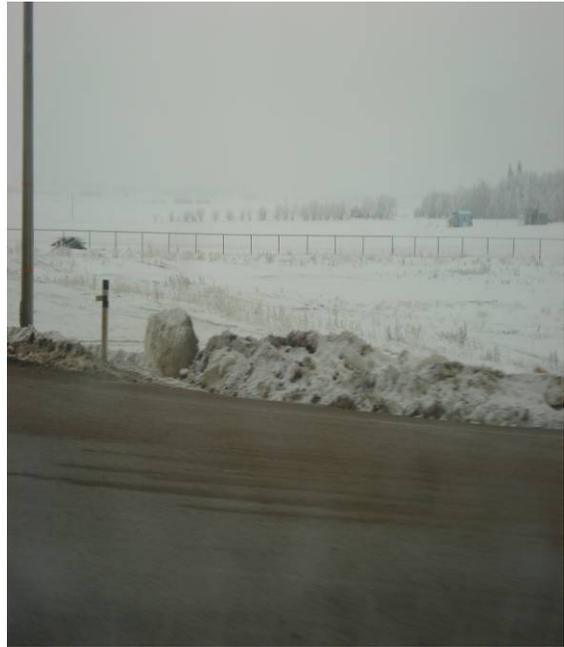
Reflective strip torn off the round regular delineator (common Problem)

The normal round delineator are showing many problems such as; reflective strips torn off or hanging, tops sheared off and post completely sheared off at the base.

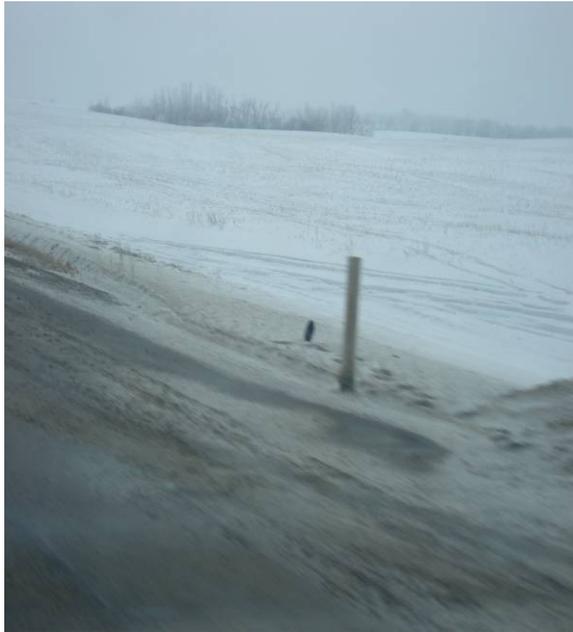
Top of regular round delineator with top torn off
