ALBERTA TRANSPORTATION AND  
ECONOMIC CORRIDORS GRMP  
PEACE REGION – (PEACE RIVER DISTRICT)  
INSTRUMENTATION MONITORING - SPRING 2025

Site Number	Location	Name	Hwy	km
PH090	HWY 744:04 C1 59.0	Judah Hill Trunk Slide	744:04	Km 59.0
<b>Legal Description:</b>		<b>UTM Co-ordinates</b>		
2-29-83-21 W5		11U E 482825.09	N	6230757.65

<b>Current Monitoring:</b>	10-June-2025	<b>Previous Monitoring</b>	22-Sep-2024
<b>Instruments Read By:</b>	Mr. Niraj Regmi, G.I.T and Mr. Godfred Etiendem, of Thurber

**SITE PH090-1: HWY 744:04, JUDAH HILL (TRUNK SLIDE)**

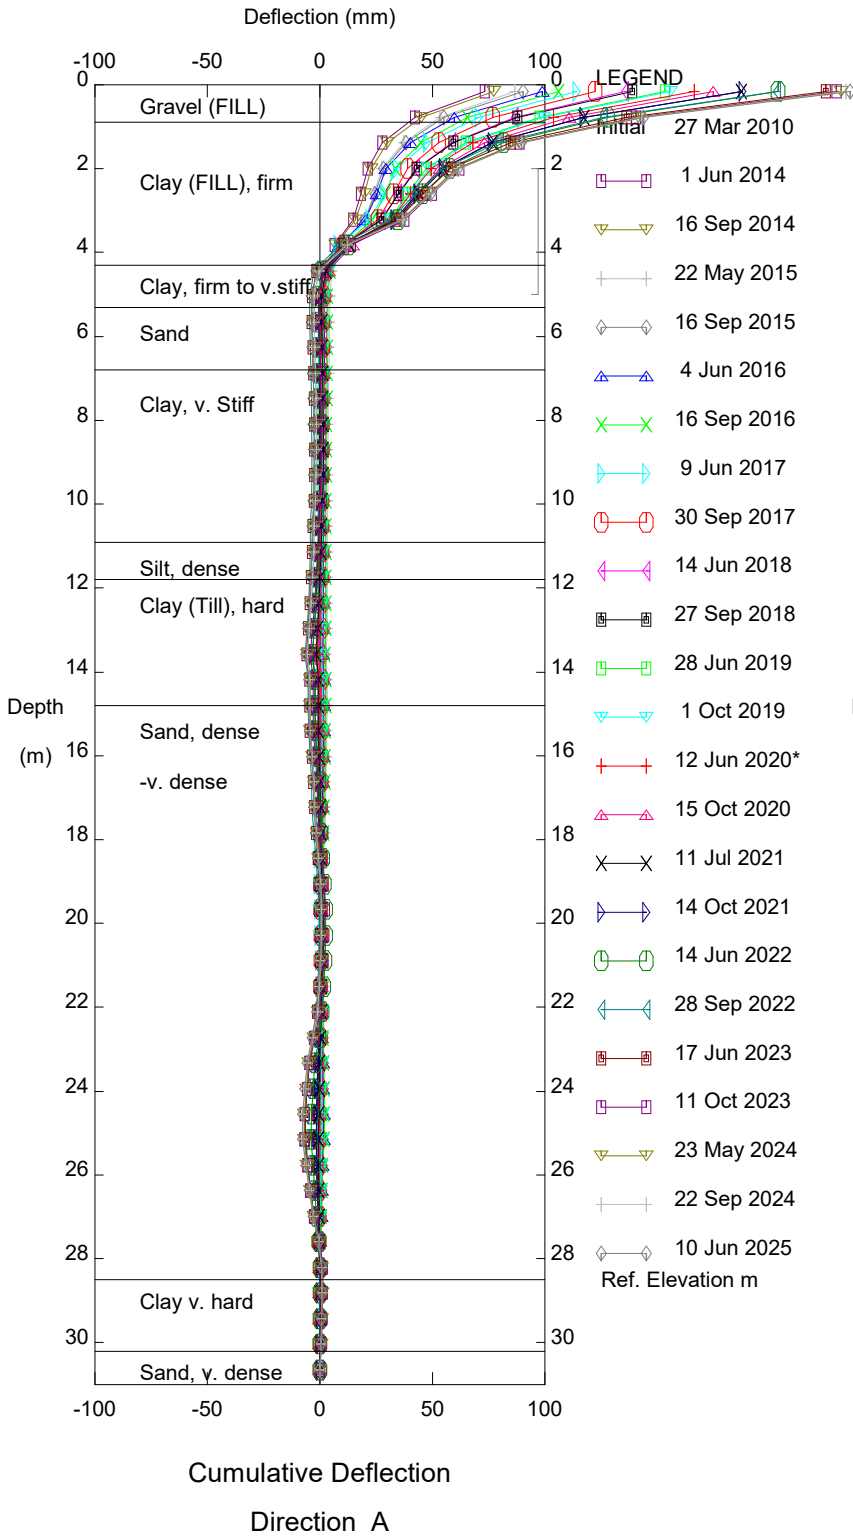
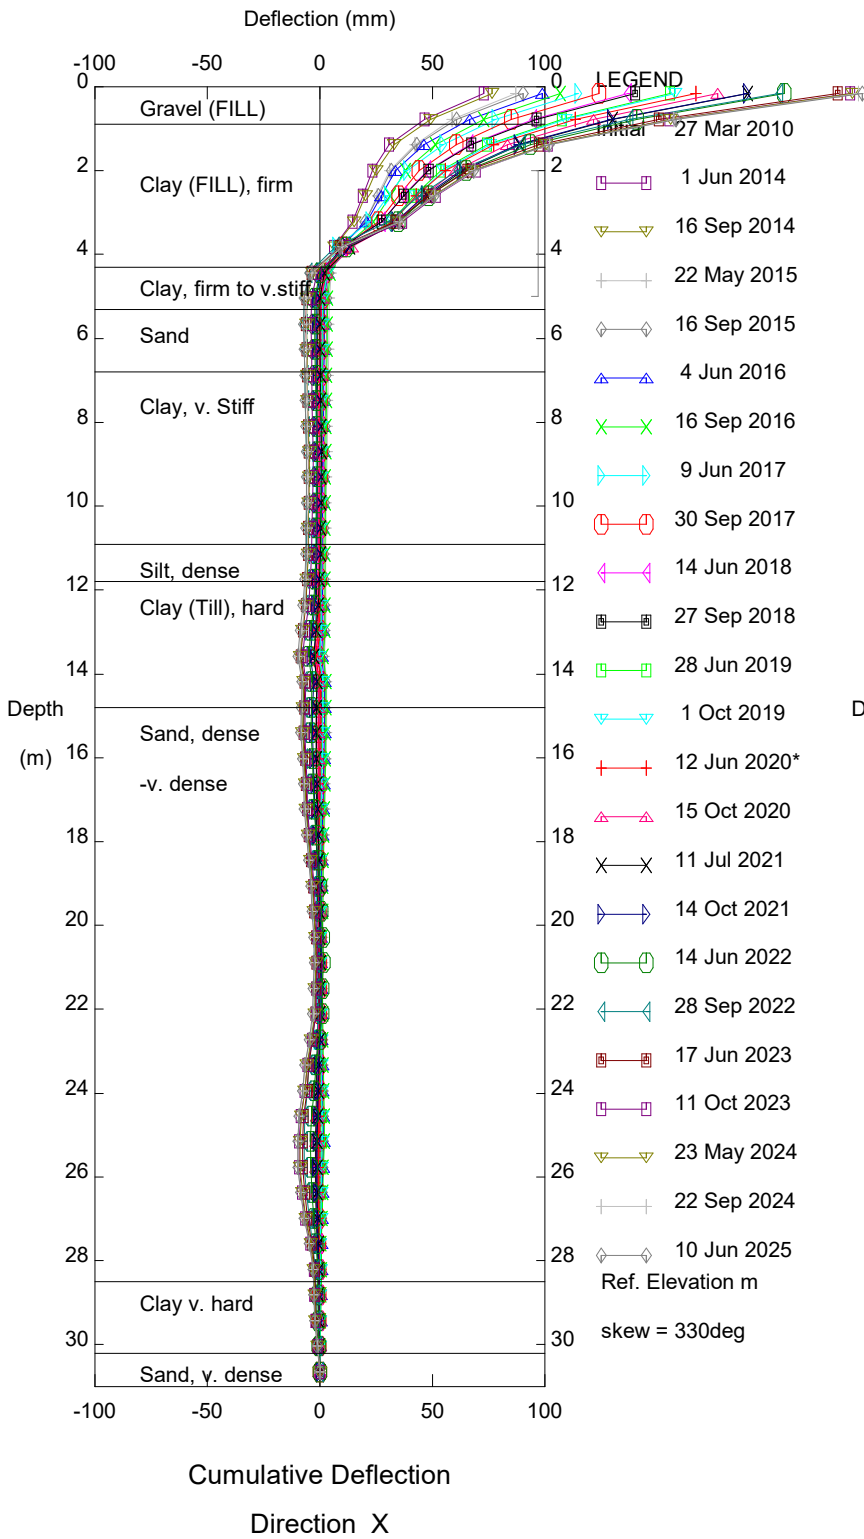
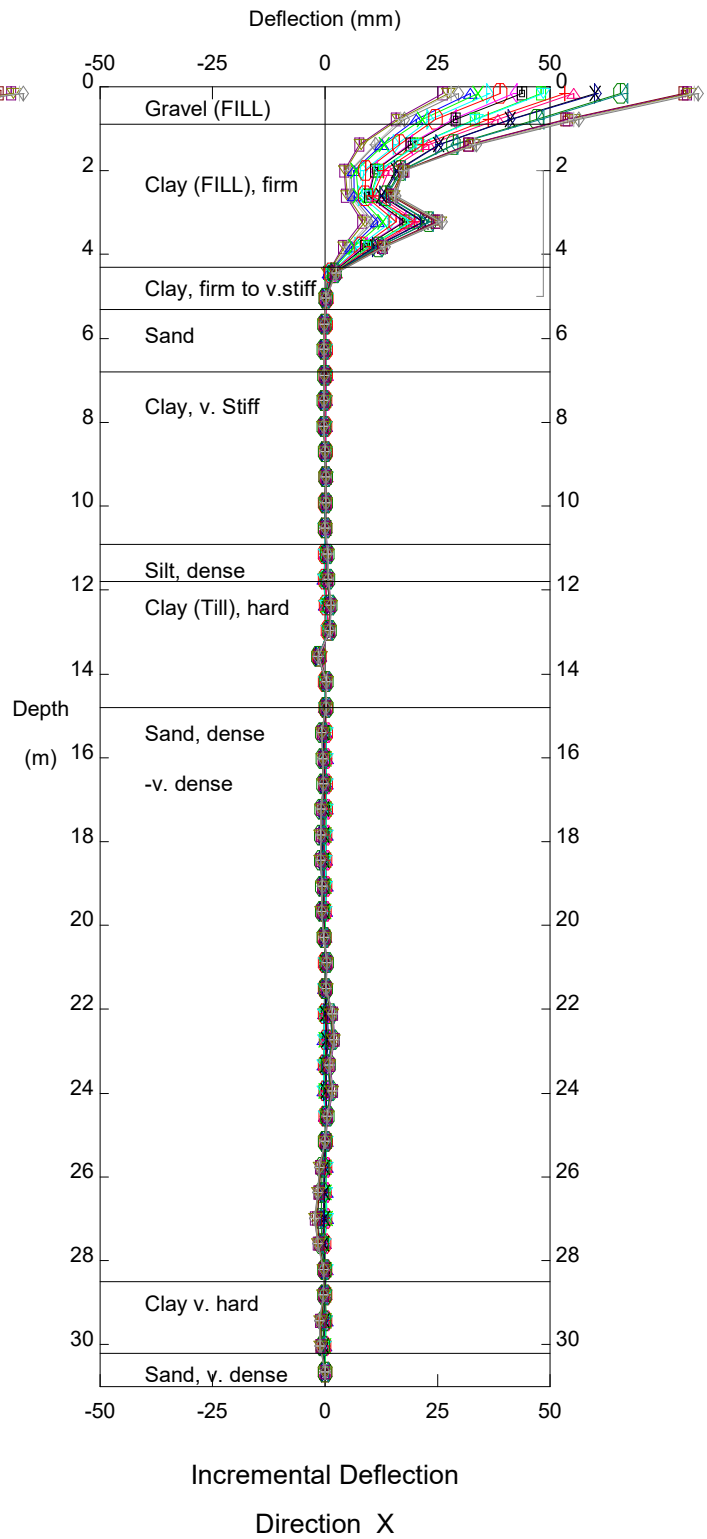
PH090 Judah Hill Trunk Slide, Inclinometer SI10-11

3.6 mm over 26.0 m to 29.0 m depth in 266° direction	4.3 mm/yr in September 2022			0.1	0.1	-1.6
SI10-11	March 2010	75.1 mm over 2.0 m to 5.0 m depth in 241° direction	11.9 mm/yr in October 2020	Operational	September 22, 2024	0.4	0.6	0.1

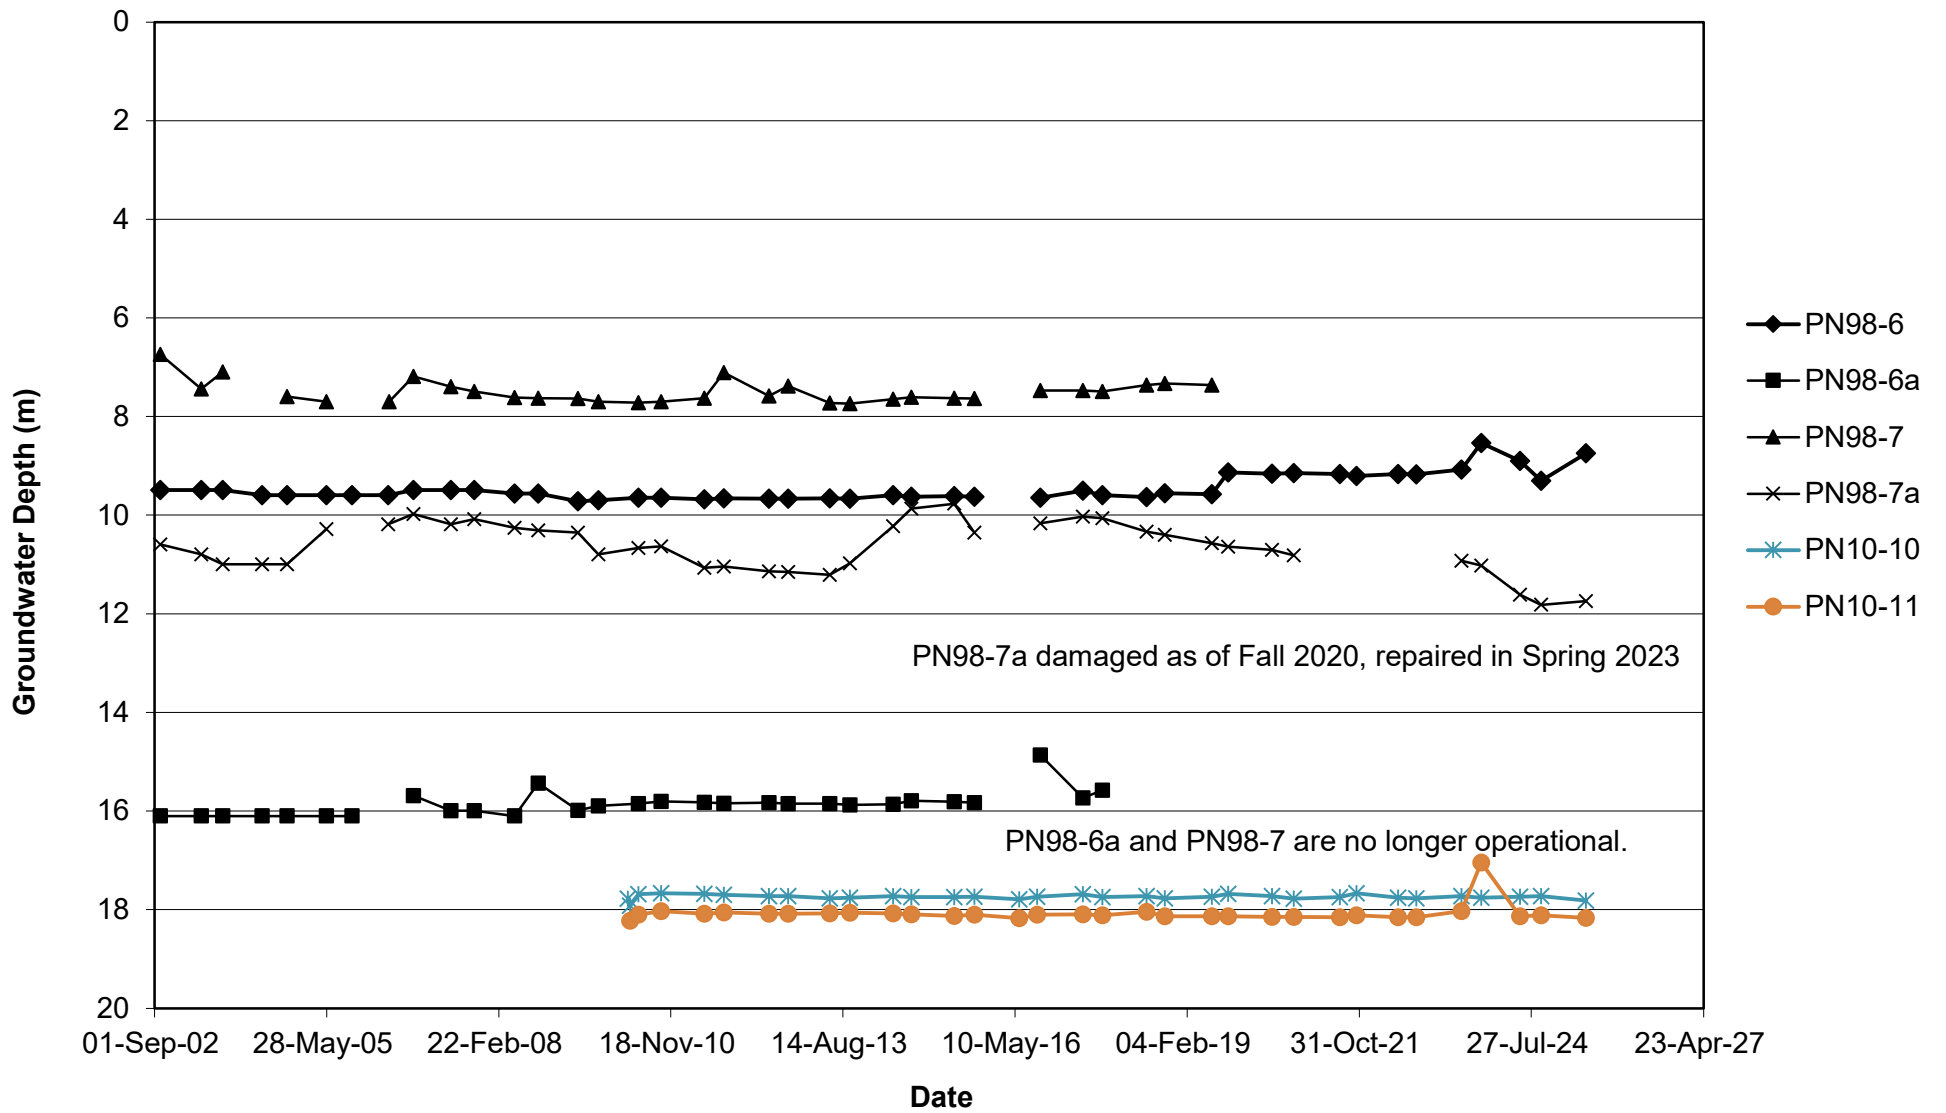
**FIGURE PH090-1  
PIEZOMETER DATA FOR HWY 744:04: JUDAH HILL TRUNK SLIDE**

decreases in groundwater level of 0.09 m and 0.06 m, respectively, since the fall of 2024 readings.
<b>Future Work:</b>	The instruments should be read again in the fall of 2026.
<b>Instrumentation Repairs:</b>	No instrument repairs are required at this time.
<b>Additional Comments:</b>	The deep zone of movement in S110-10 is a concern. Further assessment of the depth of movement relative to the highway and railway may inform future mitigation schemes. Development of an accurate cross section through this slide area would be a first step; this would require survey or LiDAR work.

INSTRUMENT #	DATE INITIALIZED	TIP DEPTH (m)	GROUND ELEV. (m)	CURRENT STATUS	HIGHEST MEASURED WATER LEVEL BGS (m)	MEASURED PORE PRESSURE (kPa)	CURRENT WATER LEVEL BGS (m)	PREVIOUS WATER LEVEL BGS (m)	CHANGE IN WATER LEVEL SINCE PREVIOUS READING (m)
PN98-6 (22830)	Oct. 26, 2000	9.8	N/A	Active	8.54 on October 11, 2023	10.4	8.74	9.30	0.56
PN98-6a (22833)	Oct. 26, 2000	16.2	N/A	Not Operational	14.86 on October 4, 2016	N/A	N/A	N/A	N/A
PN98-7 (22838)	May 10, 2001	7.8	N/A	Not Operational	6.74 on October 4, 2002	N/A	N/A	N/A	N/A
PN98-7a (22831)	May 10, 2001	16.2	N/A	Active	9.77 on May 22, 2015	43.7	11.74	11.82	0.08
PN10-10 (33088)	March 13, 2010	18.0	N/A	Active	17.67 on September 23, 2010	1.6	17.82	17.73	-0.09
PN10-11 (33077)	March 26, 2010	18.3	N/A	Active	17.04 on October 11, 2023	1.2	18.17	18.11	-0.06
