ALBERTA TRANSPORTATION AND  
ECONOMIC CORRIDORS GRMP  
PEACE REGION – (PEACE RIVER DISTRICT)  
INSTRUMENTATION MONITORING - FALL 2025

Site Number	Location	Name	Hwy	km
SH014	HWY 750:02 C1 30.582	Salt Creek Slide	750:02	Km 30.6
<b>Legal Description:</b> 16-34-76-14 W5		<b>UTM Co-ordinates</b>		
		11U E 558275	N	6165556

<b>Current Monitoring:</b>	22-Sep-2025	<b>Previous Monitoring</b>	05-Jun-2025
<b>Instruments Read By:</b>	Mr. Niraj Regmi, G.I.T and Mr. Angelo Castillo, Thurber

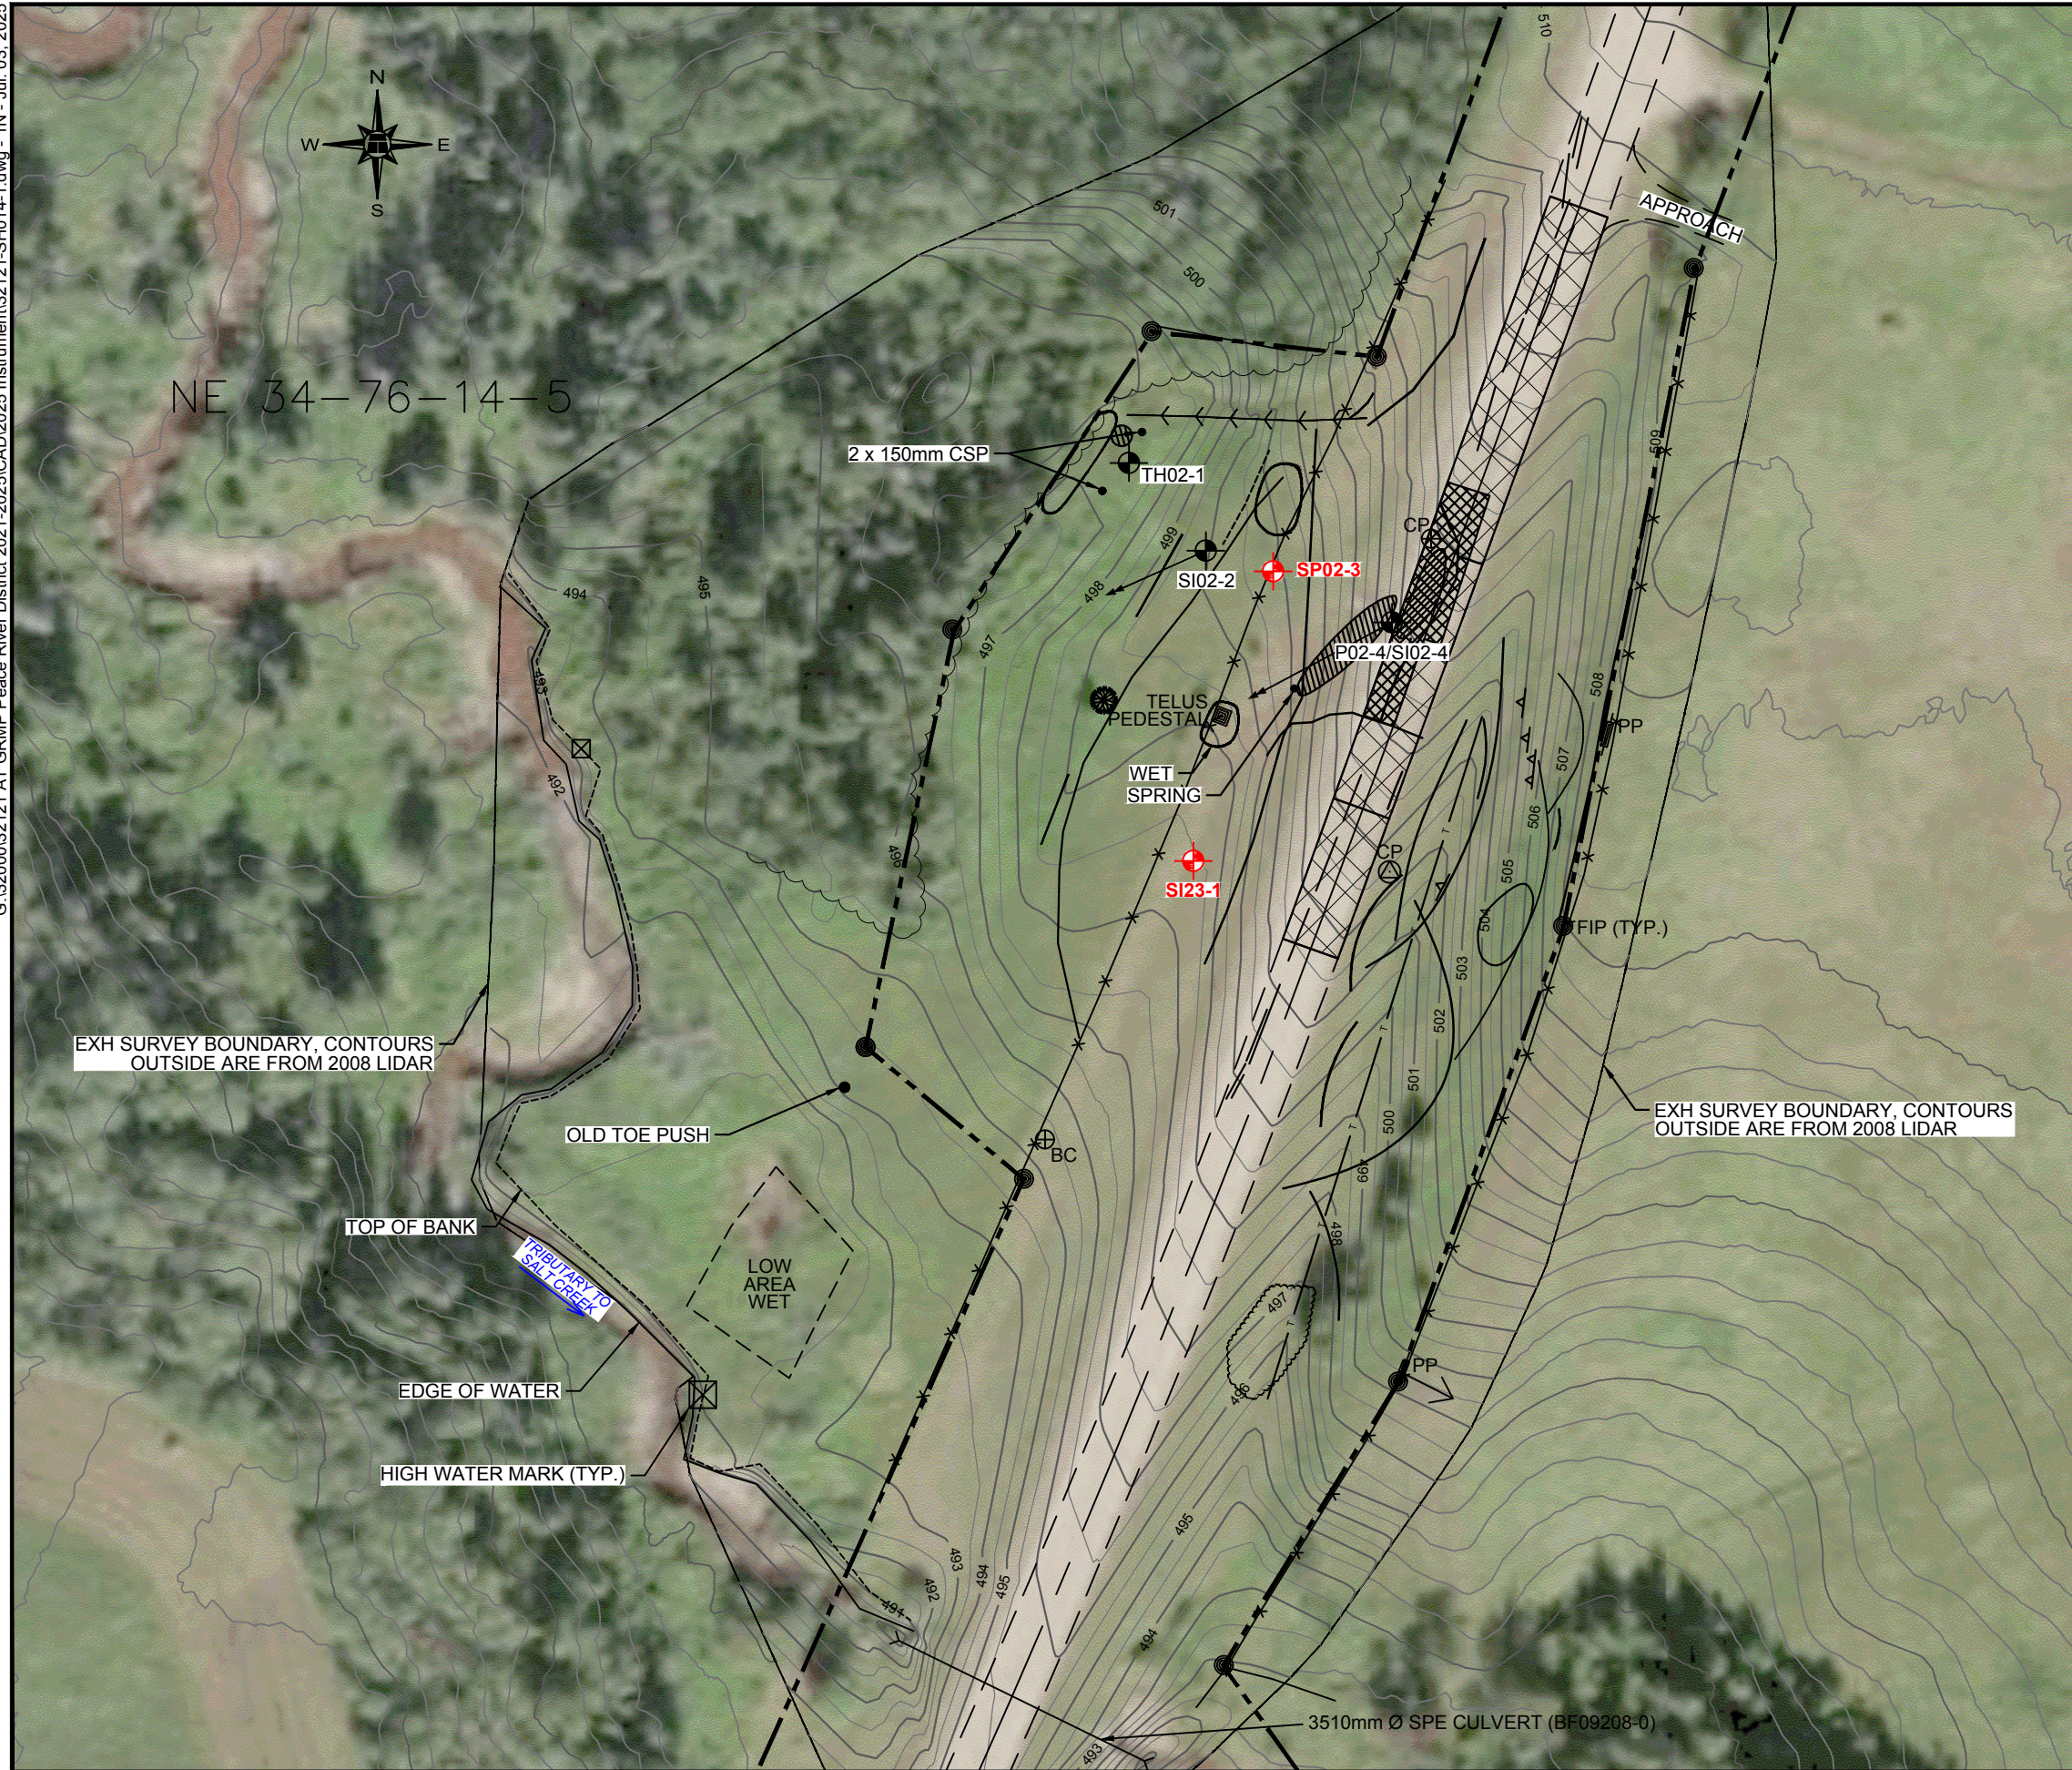
DWG NO. 32121-SH014-1

**PEACE REGION (PEACE RIVER DISTRICT)  
SH014-1: HWY 750:02 SALT CREEK SLIDE**

**SITE PLAN SHOWING APPROXIMATE  
INSTRUMENT LOCATIONS**

Drawing 32121-SH014 in Appendix A provides a sketch of the approximate location of the monitoring instrumentation for this site.

Drawing 32121-SH014 in Appendix A provides a sketch of the approximate locations of the monitoring instrumentation for this site.

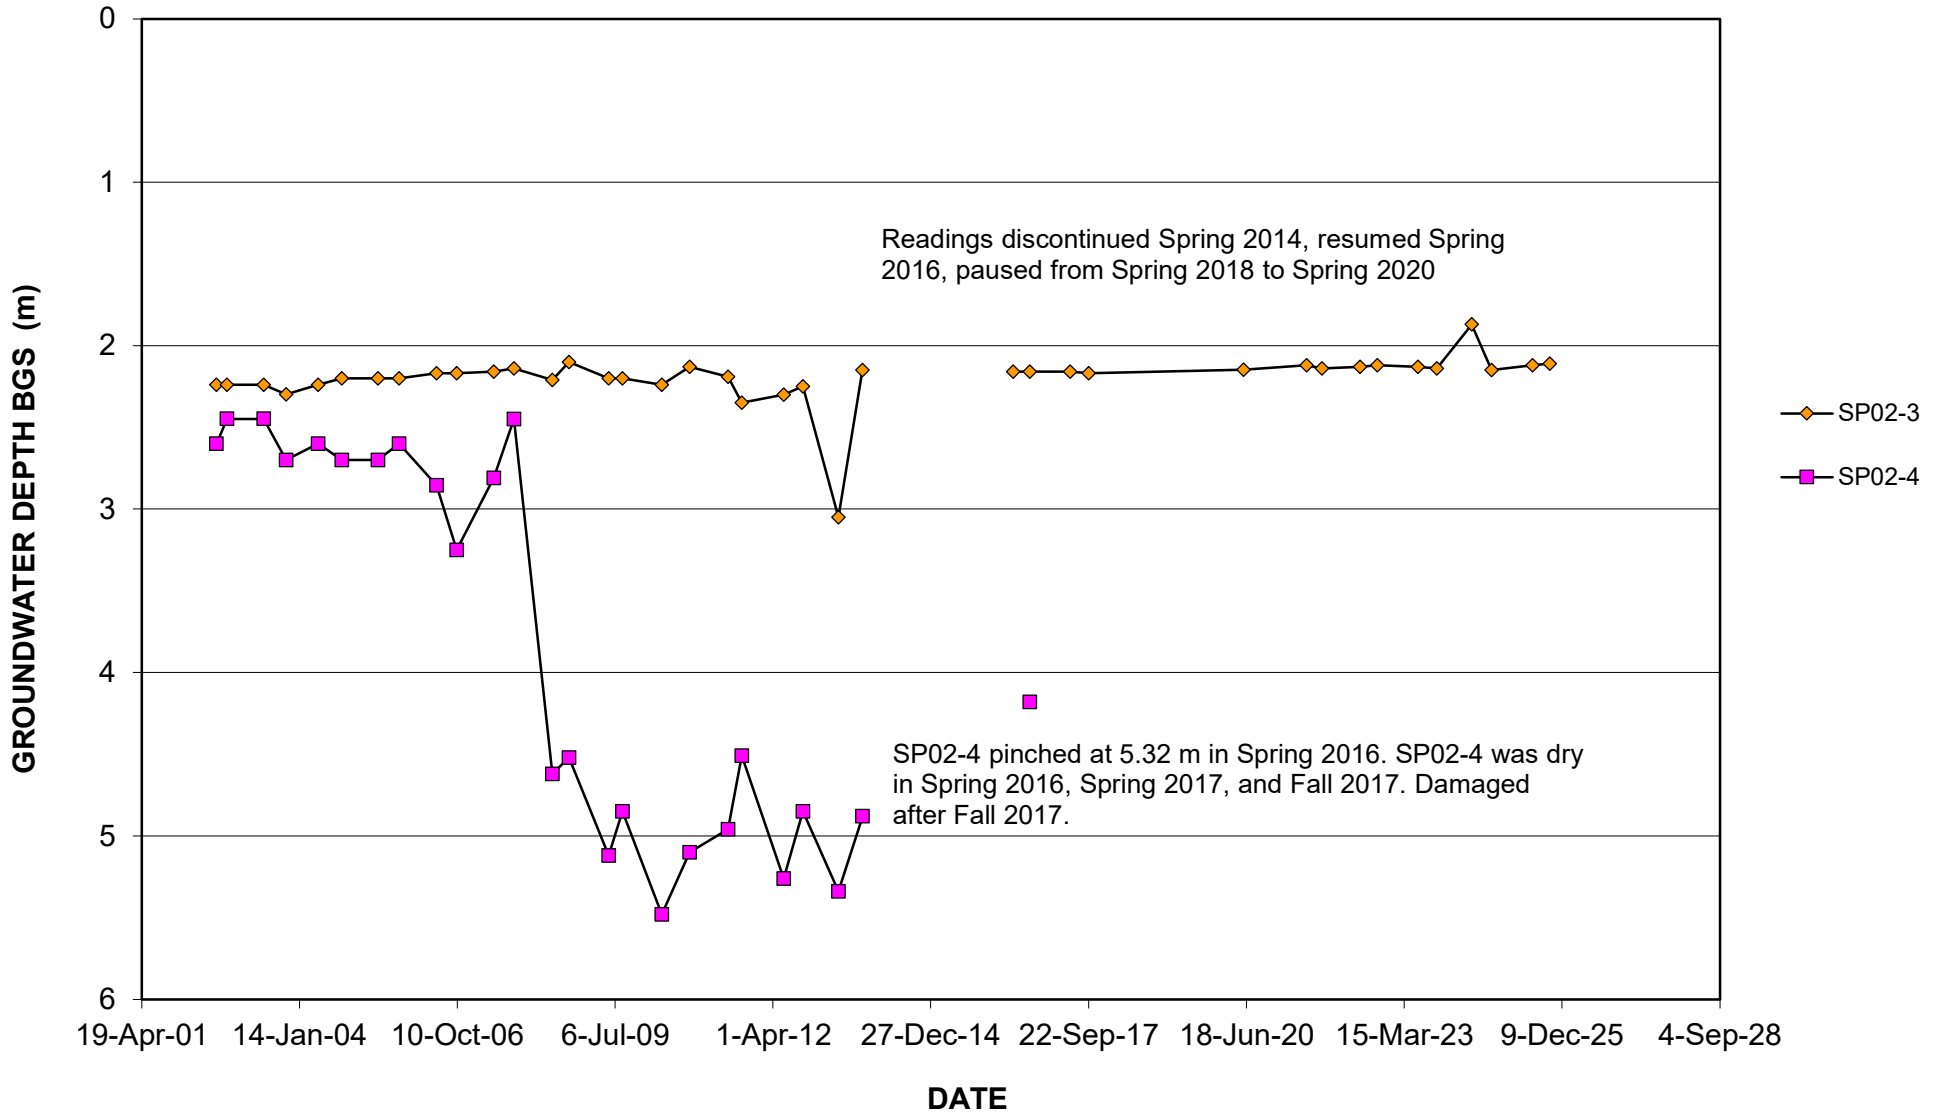
**FIGURE SH014-1  
HWY 750:04 SALT CREEK STANDPIPE PIEZOMETER DATA**

INSTRUMENT #	DATE INITIALIZED	TIP DEPTH (m)	GROUND ELEV. (m)	CURRENT STATUS	HIGHEST RECORDED GROUNDWATER LEVEL (mBGS)	MEASURED WATER DEPTH (mBGS)	PREVIOUS WATER DEPTH (mBGS)	CHANGE IN WATER LEVEL SINCE PREVIOUS READING (m)
SP02-3	August 7, 2002	3.59	N/A	Operational	1.87 in May 2024	2.11	2.12	0.01
SP02-4	August 7, 2002	8.38	N/A	Damaged	2.45 in October 2007	N/A	DRY (Sep. 22, 2017)	N/A
