Site Number	Location	Name	Hwy	km
SH014	HWY 750:02 C1 30.582	Salt Creek Slide	750:02	Km 30.6
Legal Description: 16-34-76-14 W5		UTM Co-ordinates		
		11U E 558275	N	6165556

**ALBERTA TRANSPORTATION AND ECONOMIC CORRIDORS GRMP (CON0022164)
PEACE REGION (PEACE RIVER DISTRICT)
INSTRUMENTATION MONITORING RESULTS**

SPRING 2025

SITE SH014: HWY 750:02 (SALT CREEK SLIDE)

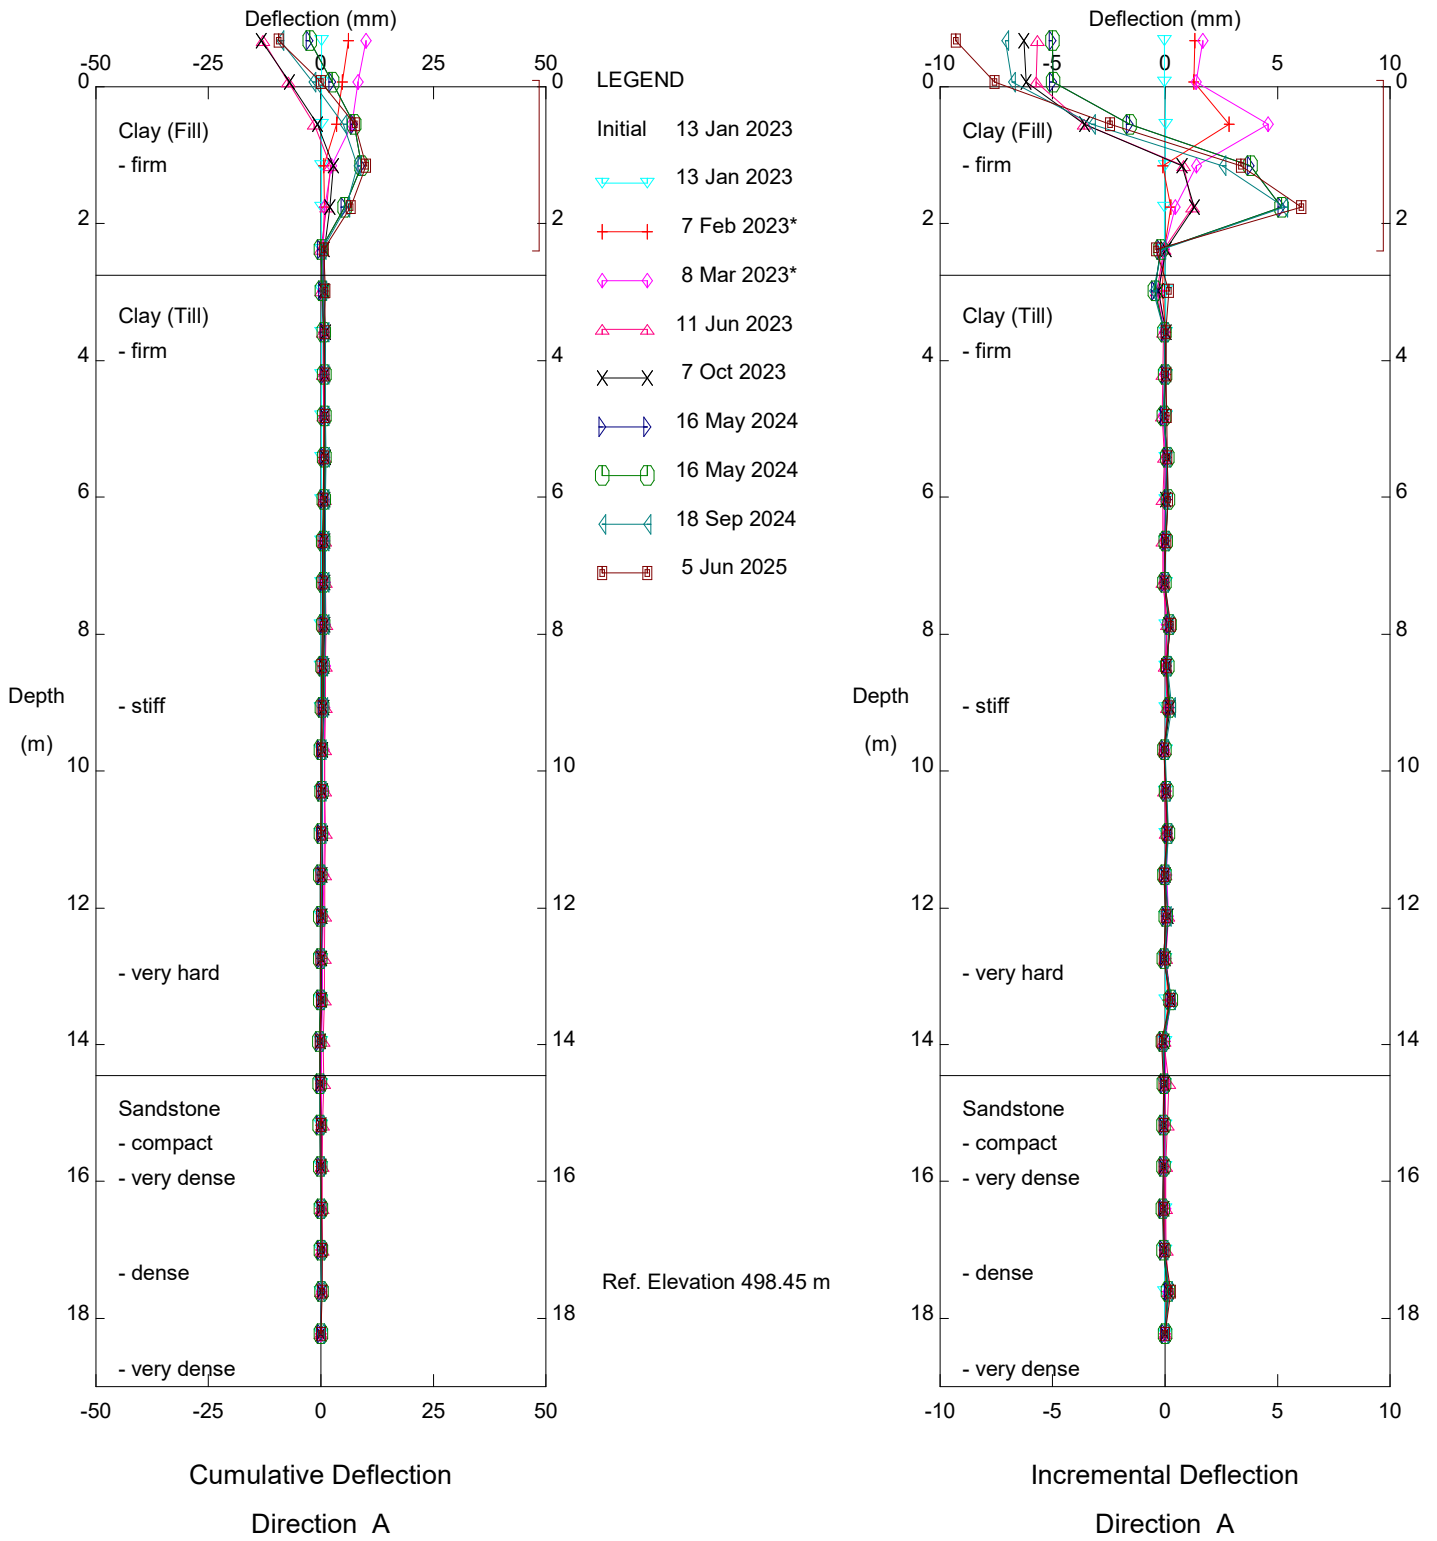
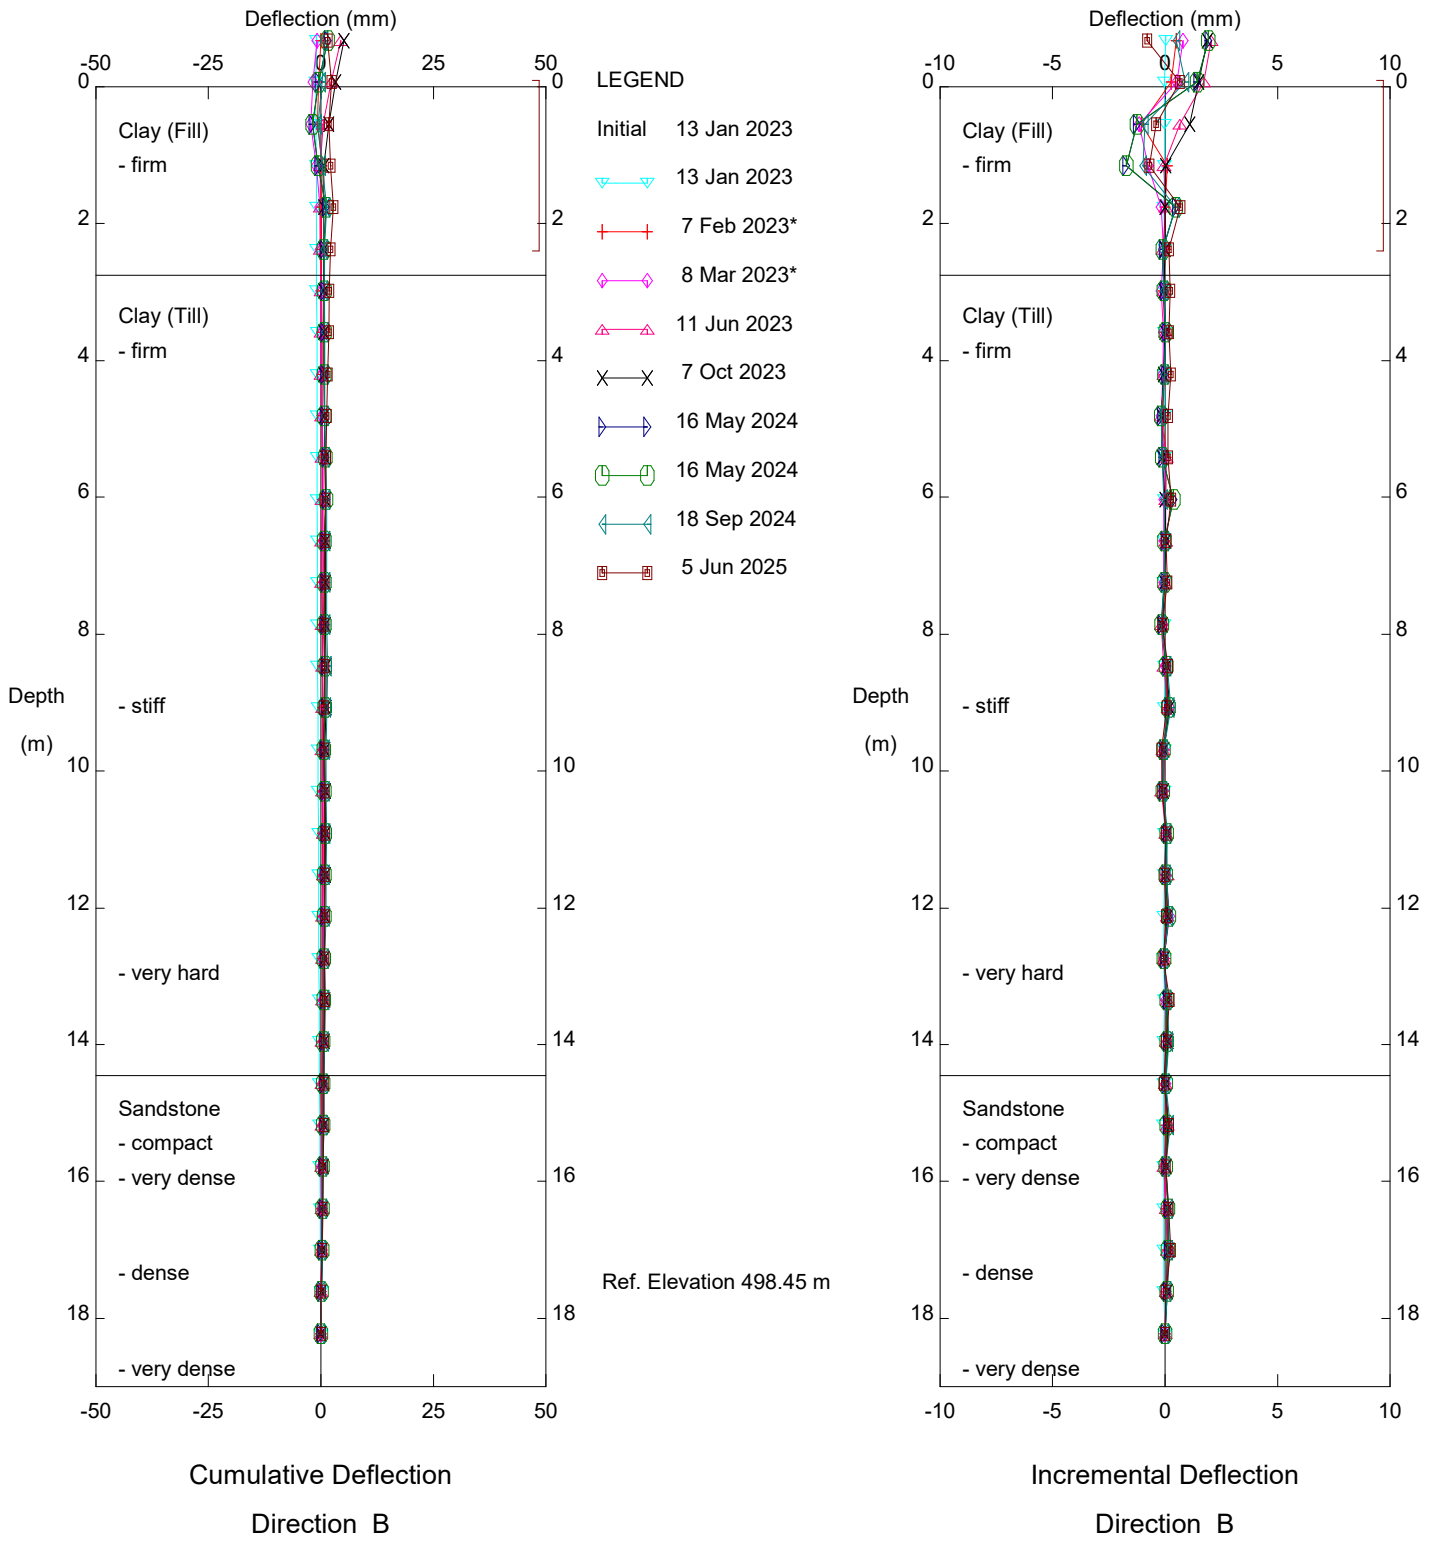
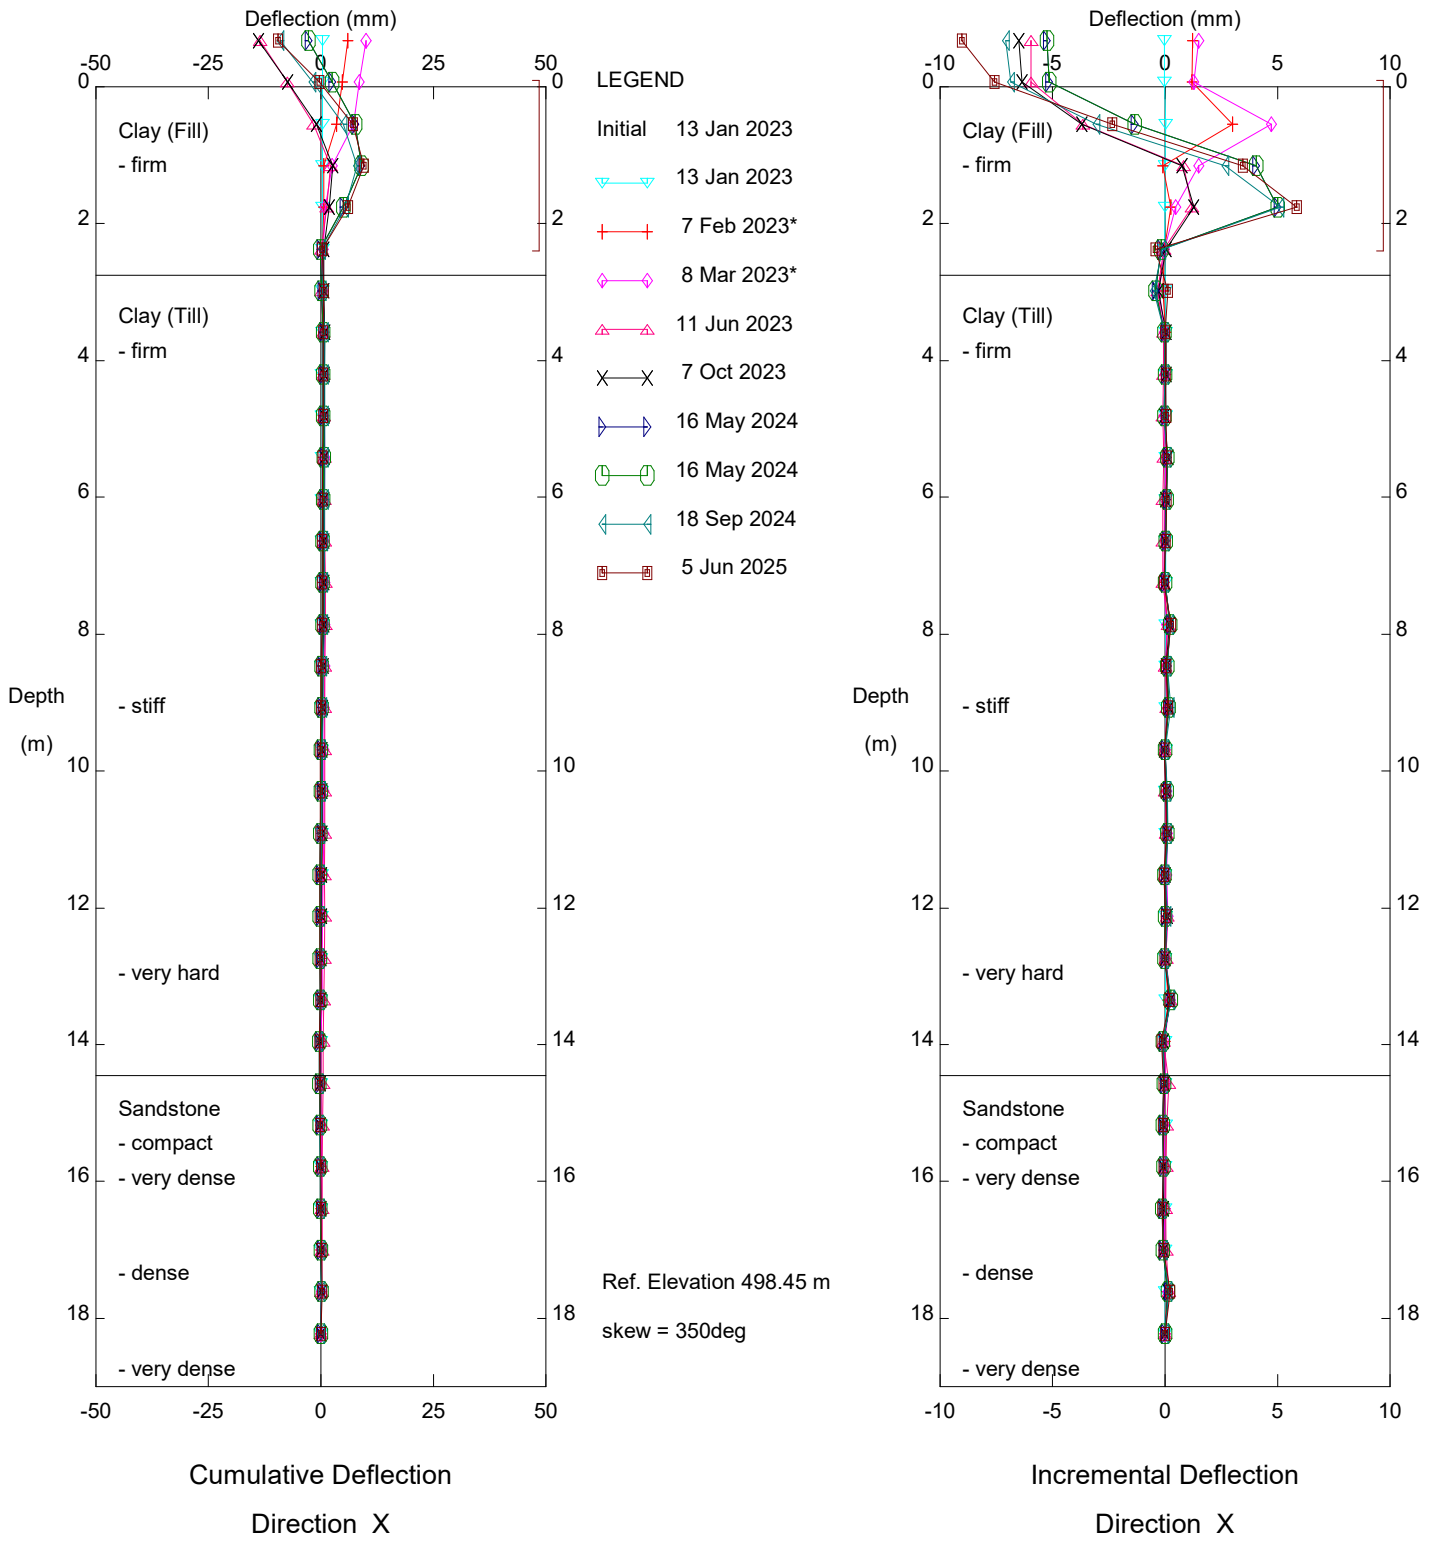
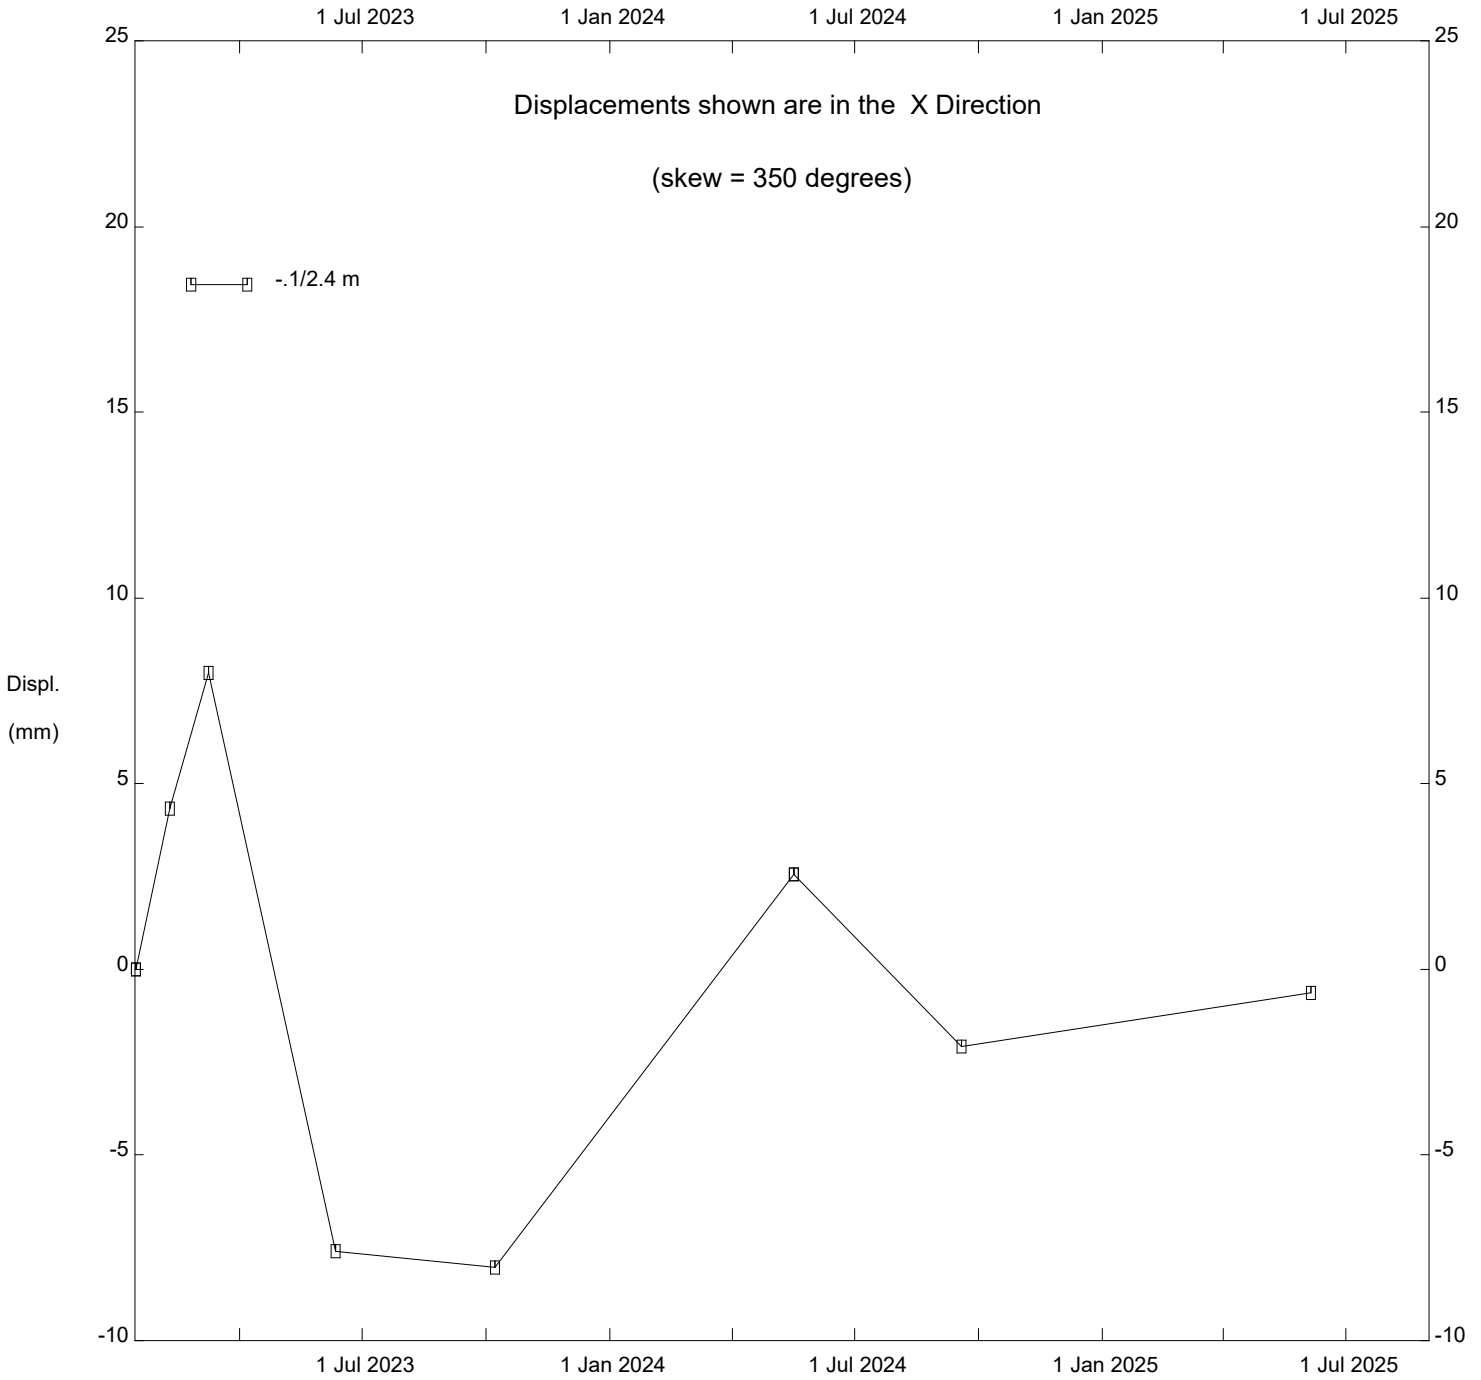
Hwy 750:02 (SH014) Salt Creek, Inclinometer SI23-1

Zones of New Movement:	
Interpretation of Monitoring Results:	<p>SI23-1 shows an erratic movement pattern in the upper fill layer above about 2.4 m depth. SI23-1 has shown a rate of movement of 2.0 mm/yr over 0 m to 2.4 m depth since the fall of 2024 readings. Prior instrumentation also showed movement at the upper clay or fill, and no movement zones in the lower till or sandstone layer.</p> <p>Standpipe piezometer SP02-3 showed an increase in groundwater level of 0.03 m since the fall of 2024 readings. The current water level in SP02-3 is 2.12 m below ground surface.</p>
Future Work:	The instruments should be read again in the spring of 2026.
Instrumentation Repairs:	No instrument repairs are required at this time.
Additional Comments:

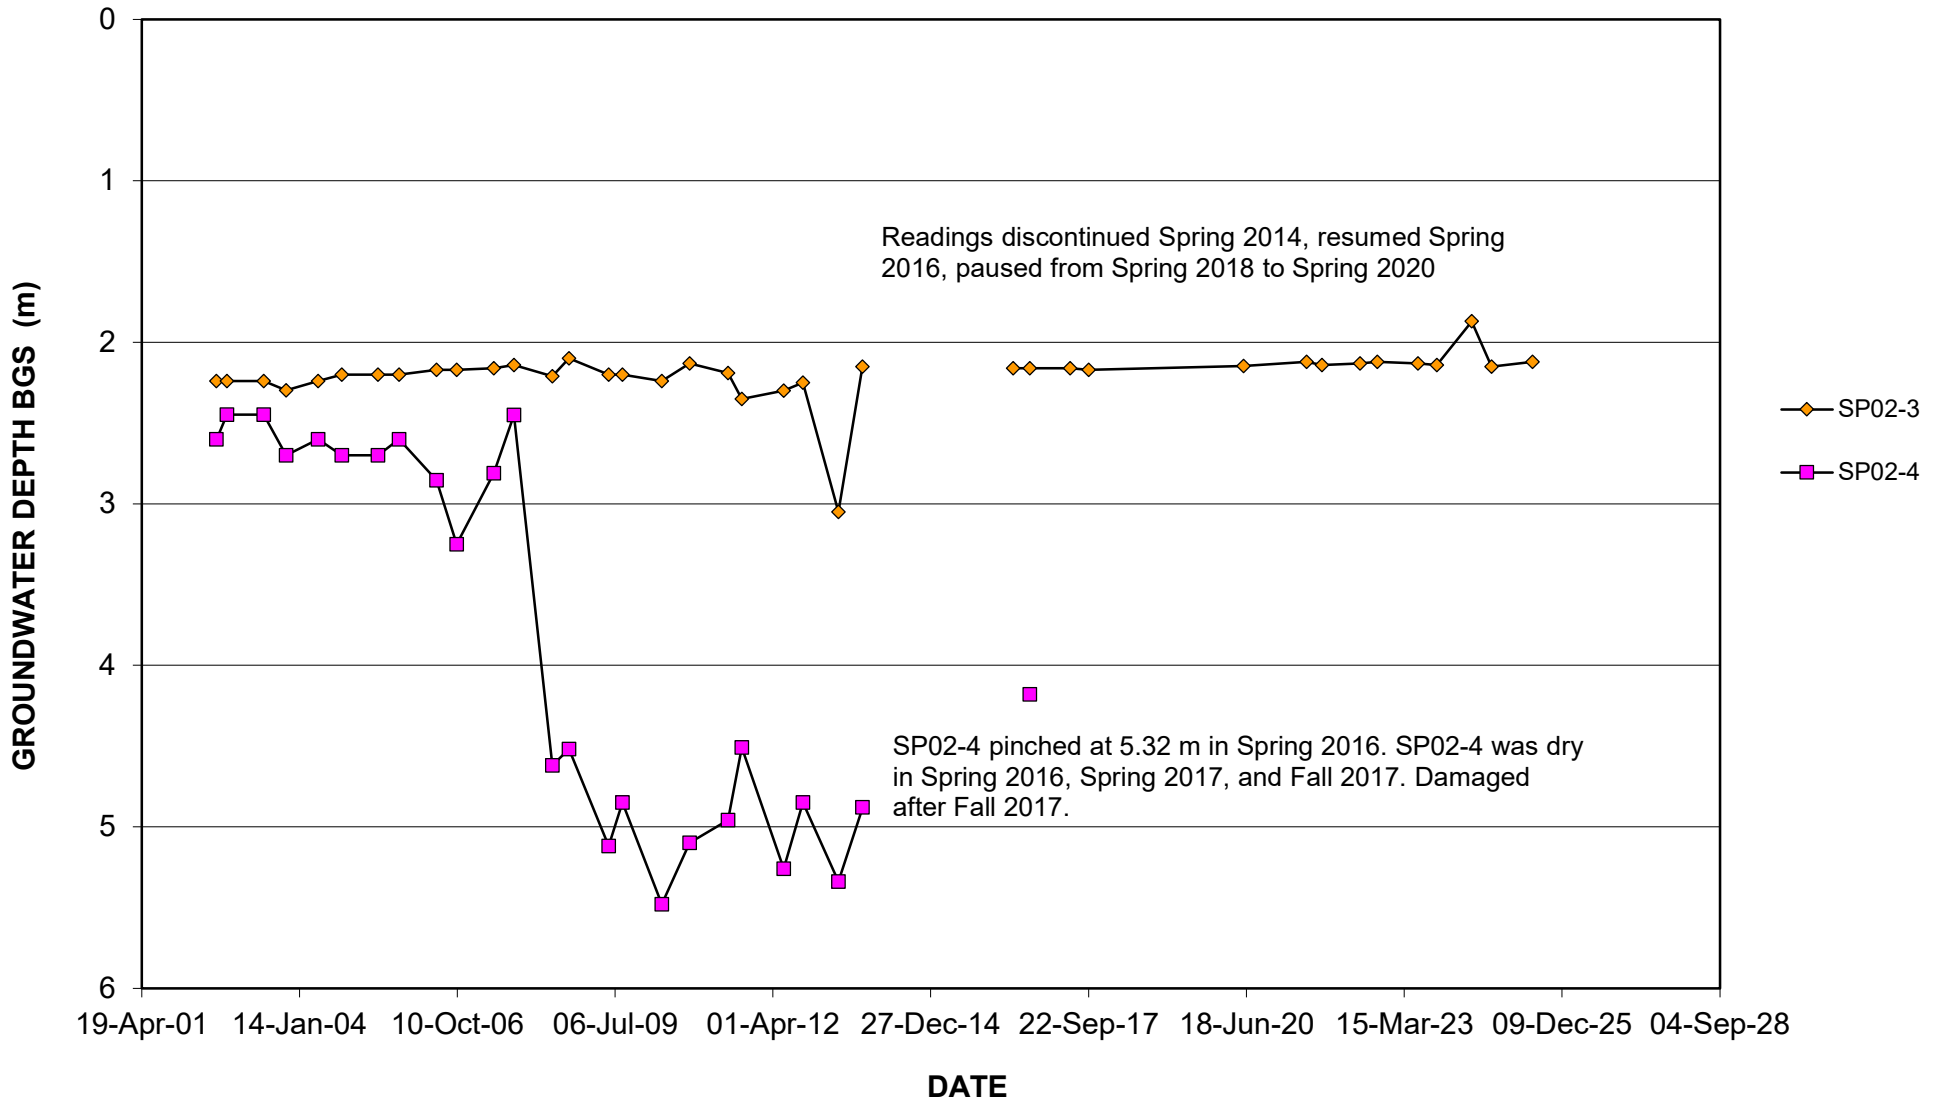
**FIGURE SH014-1
HWY 750:04 SALT CREEK STANDPIPE PIEZOMETER DATA**

INSTRUMENT #	DATE INITIALIZED	TIP DEPTH (m)	GROUND ELEV. (m)	CURRENT STATUS	HIGHEST RECORDED GROUNDWATER LEVEL (mBGS)	MEASURED WATER DEPTH (mBGS)	PREVIOUS WATER DEPTH (mBGS)	CHANGE IN WATER LEVEL SINCE PREVIOUS READING (m)
SP02-3	August 7, 2002	3.59	N/A	Operational	1.87 in May 2024	2.12	2.15	0.03
SP02-4	August 7, 2002	8.38	N/A	Damaged	2.45 in October 2007	N/A	DRY (Sep. 22, 2017)	N/A
