ALBERTA TRANSPORTATION AND ECONOMIC CORRIDORS GRMP
PEACE REGION – (PEACE RIVER DISTRICT)
FALL 2025

Site Number	Location	Name	Hwy	km
PH033	HWY 744:04 C1 59.451	CNR Slide- Judah Hill	744:04	Km 59.5
Legal Description:		**UTM Co-ordinates**		
2-29-83-21 W5		11U E 482662.27	N 6231329.62

ALBERTA TRANSPORTATION AND ECONOMIC CORRIDORS GRMP (CON0022164)
PEACE REGION (PEACE RIVER DISTRICT)
INSTRUMENTATION MONITORING RESULTS

SITE PH033-1: HWY 744:04, JUDAH HILL (CNR SLIDE)

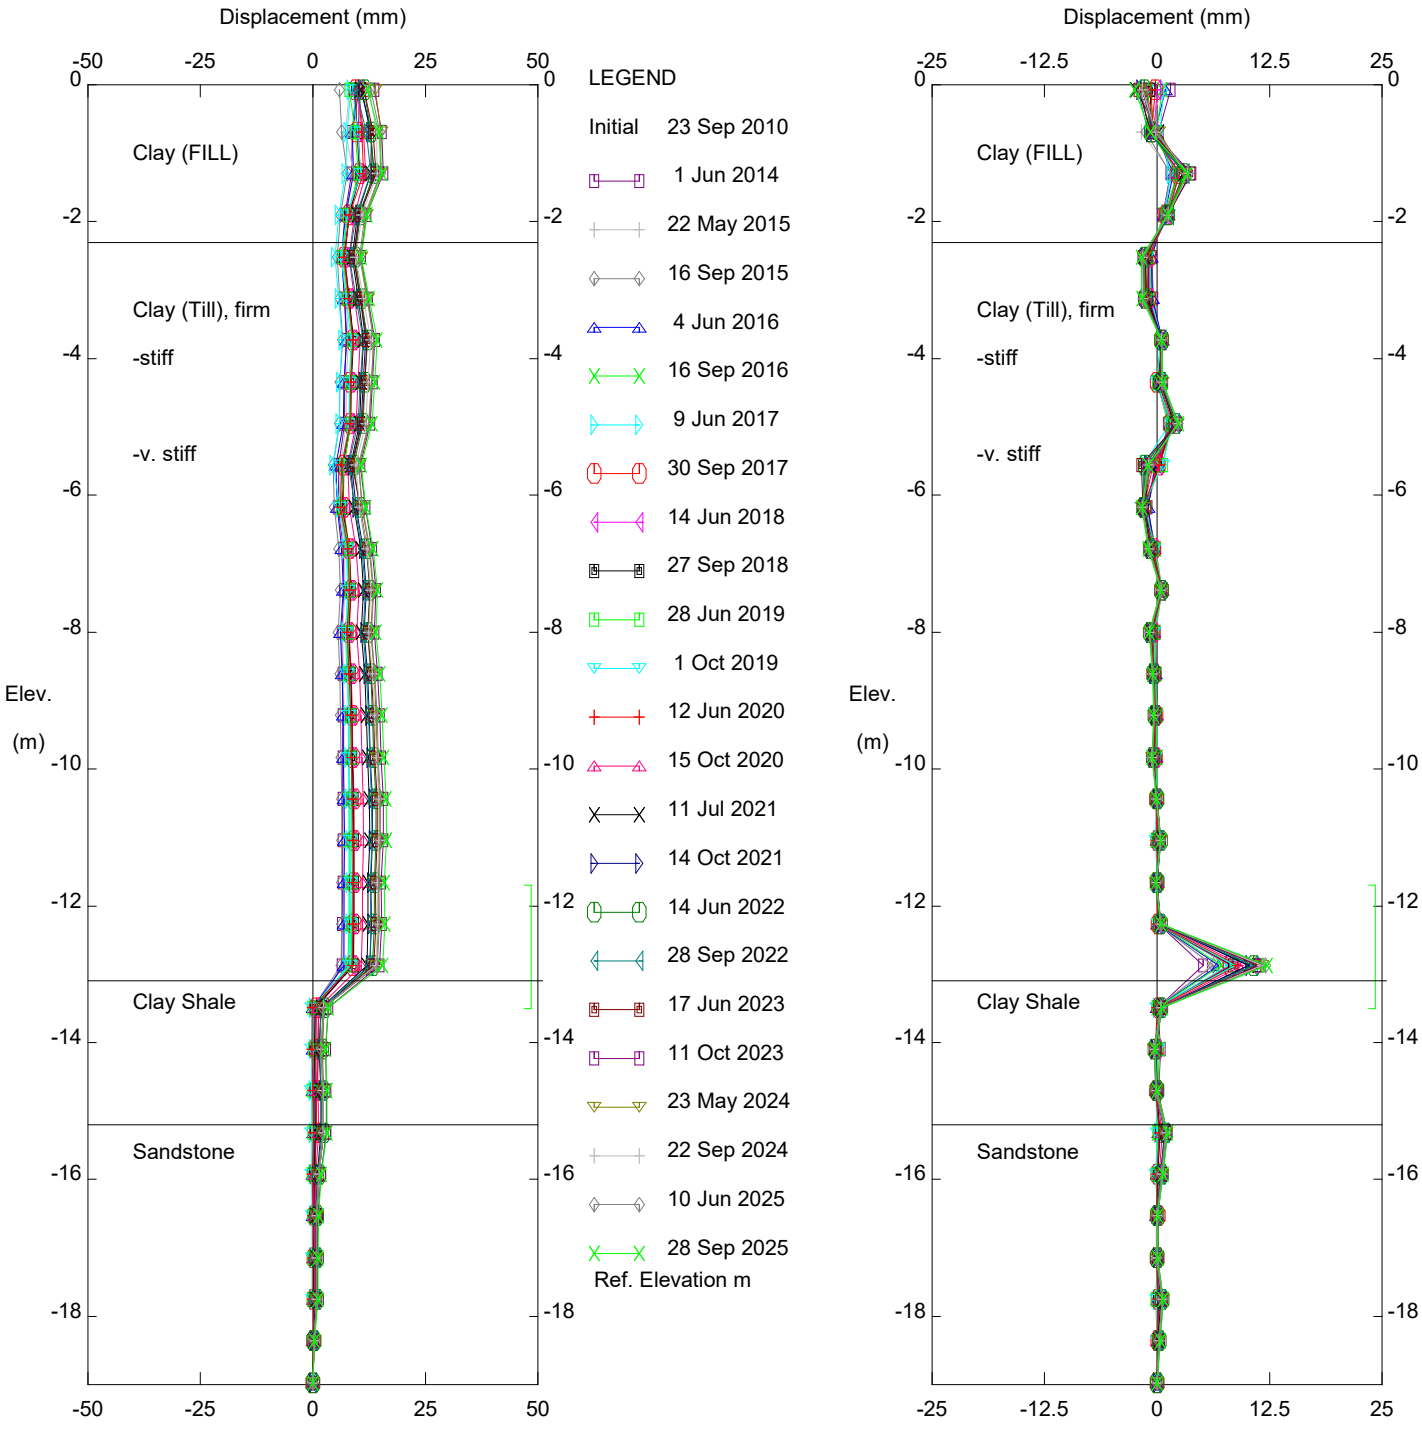
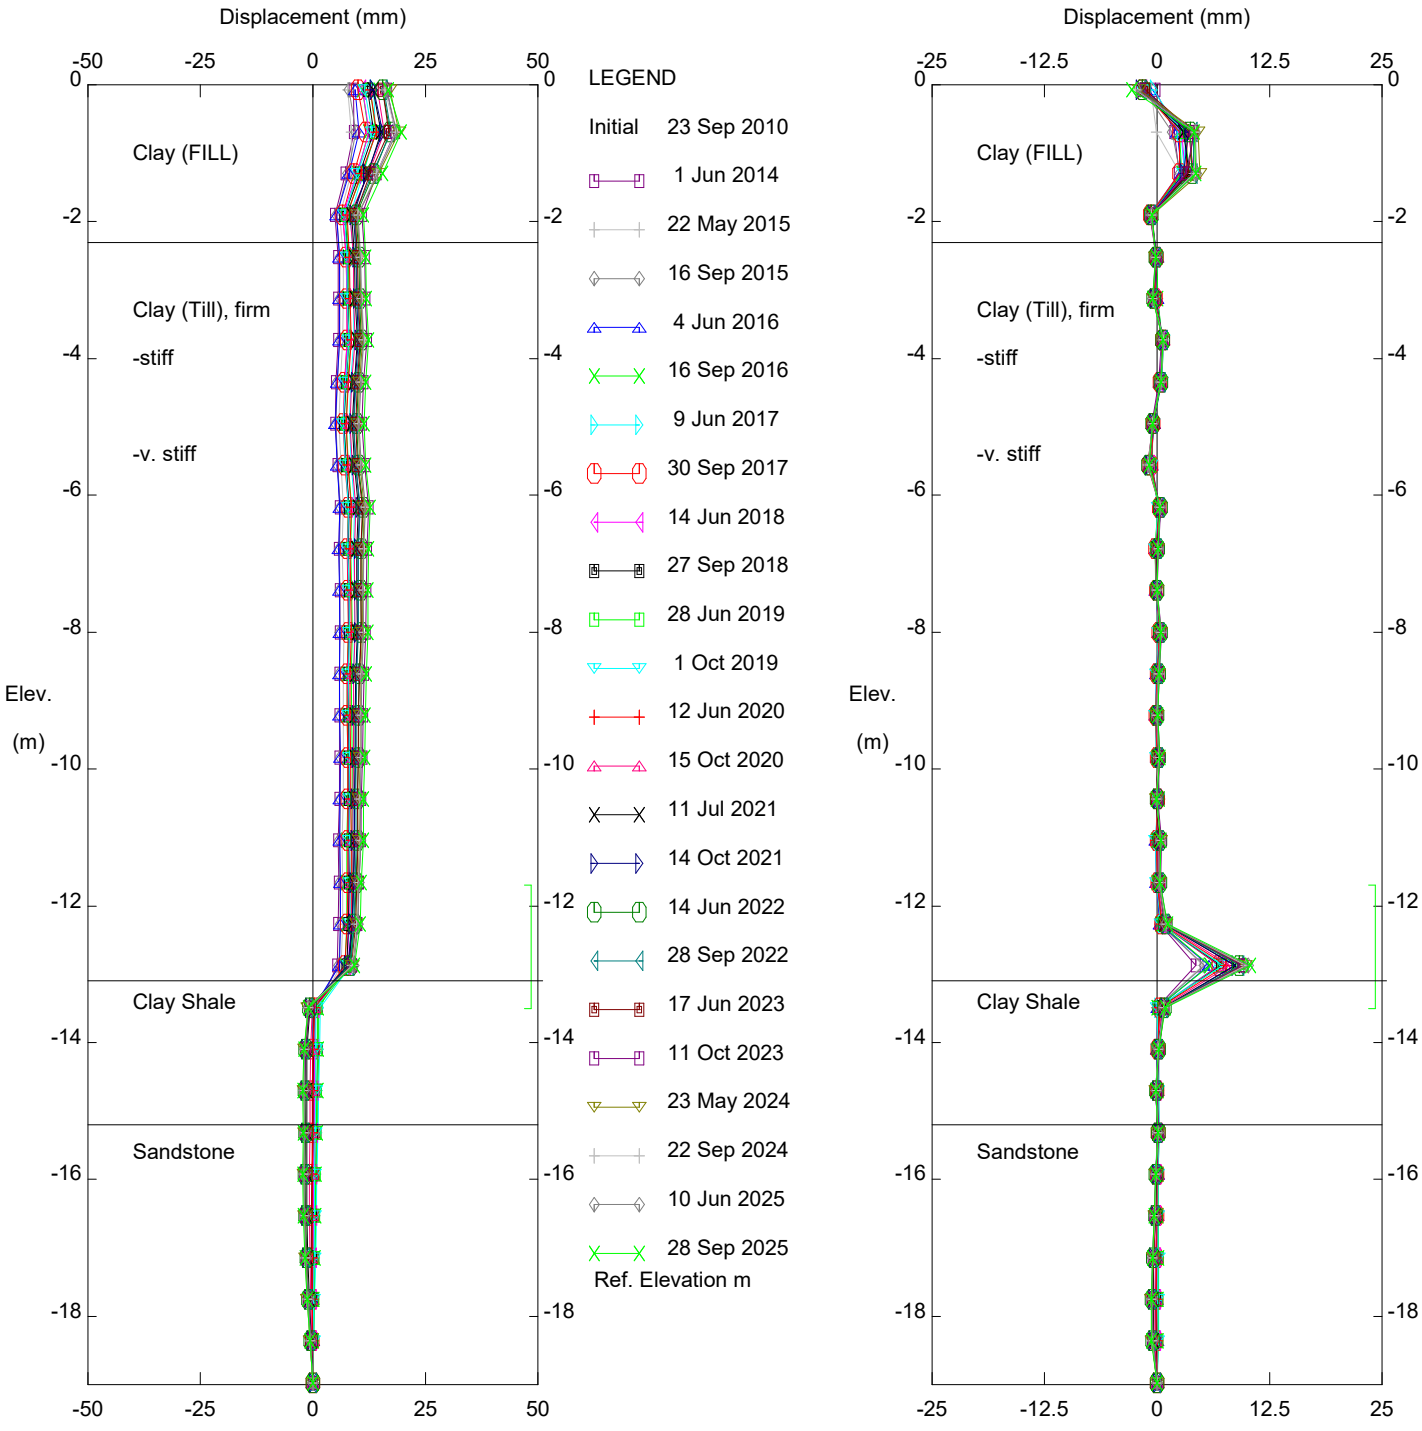
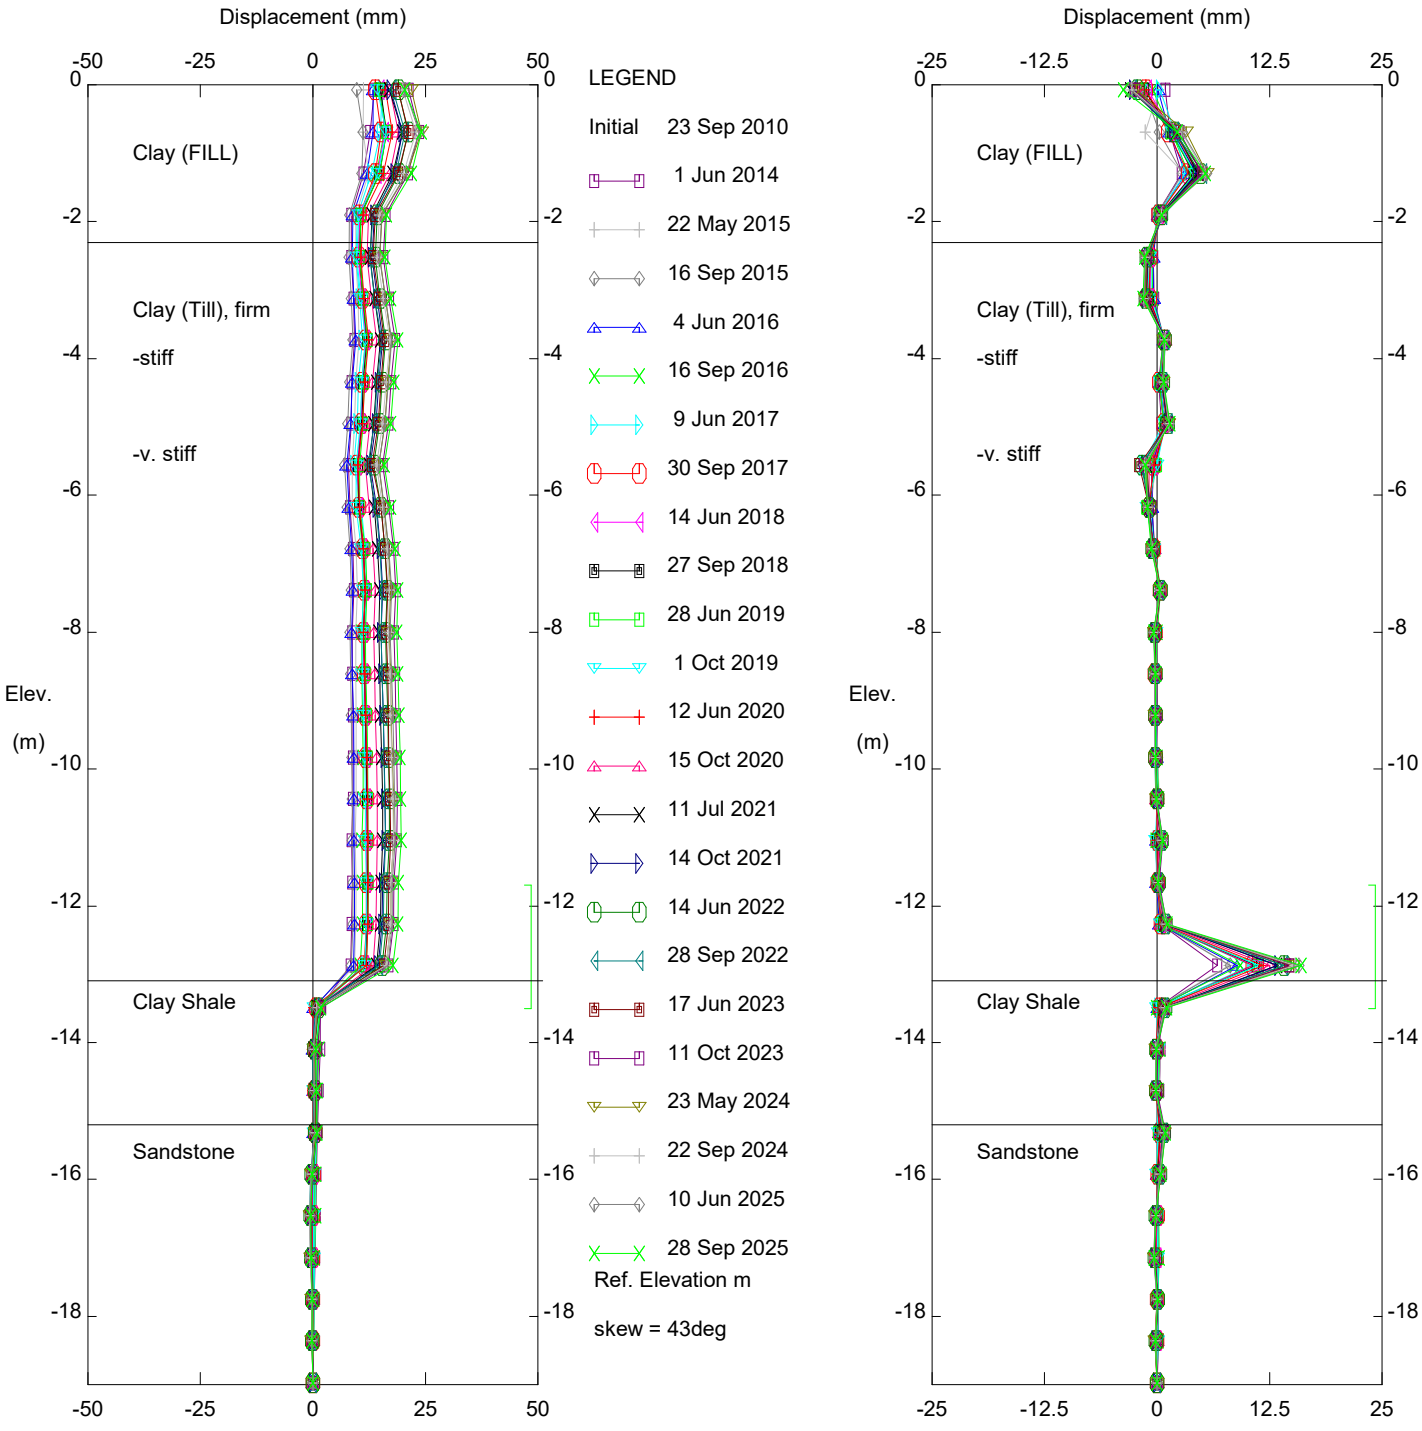
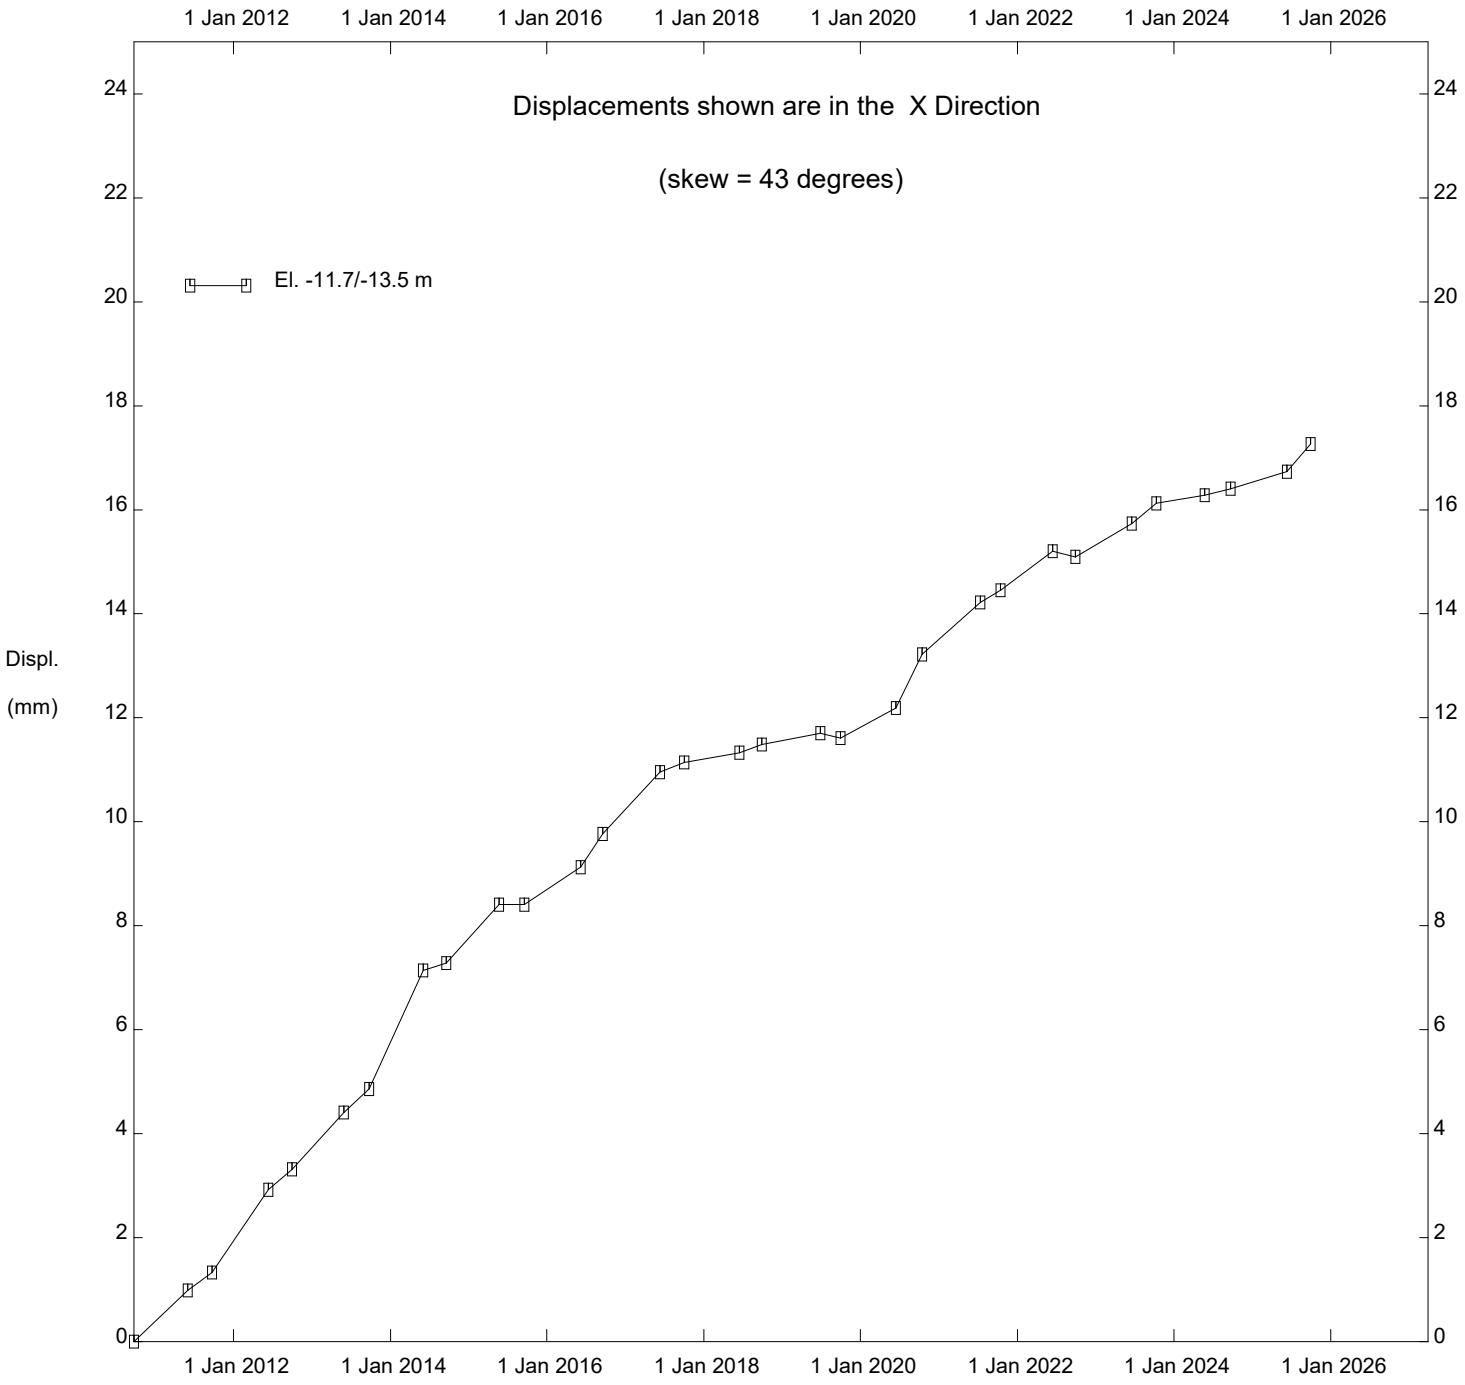
PH033-1 Judah Hill CNR Slide, Inclinometer SI10-16

Discussion	
Zones of New Movement:	None
Interpretation of Monitoring Results:	SI10-16 showed a rate of movement of 1.8 mm/yr over 11.7 m to 13.5 m depth since the spring of 2025 readings. SI10-17 showed a rate of movement of 0.4 mm/yr over 9.5 m to 11.3 m depth since the spring of 2025 readings. SI10-16 and SI10-17 are both shearing near the bottom of a stiff clay strata just above a clay shale strata. Pneumatic piezometer PN10-16 showed an increase in groundwater level of 0.09 m since the spring of 2025 readings.
Future Work:	The instruments should be read again in the spring of 2026.
Instrumentation Repairs:	No instrument repairs are required.
Additional Comments:
