Degradation Concerns related to Bridge Structures in Alberta

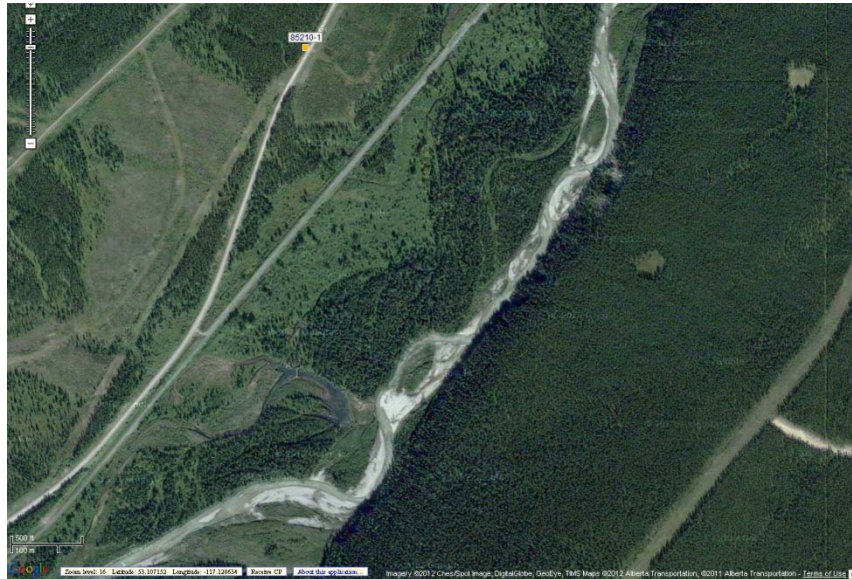
Stream bed. These reaches may be actively degrading. Unstable braided stream patterns are common, such as those seen along the upper McLeod River (Figure 3).

Figure 3: Upper McLeod River Reach Planform (Google Earth, 2012)

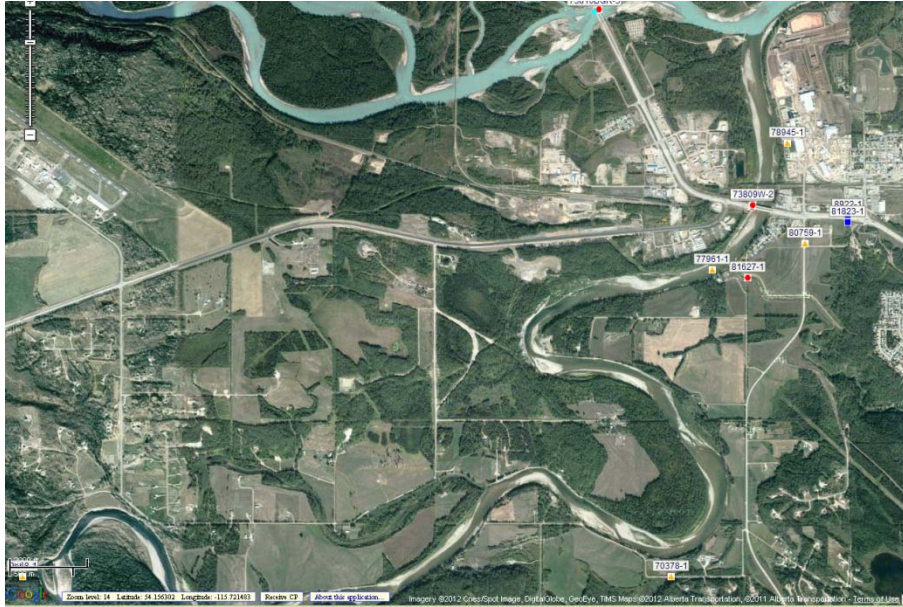
Downcutting - An alternative to the deposition reach near the mouth of the river is a downcutting reach, where the channel may be actively degrading in order to match the elevation of the receiving stream.

**Figure 5: Lower Reach McLeod River Planform;
Downcutting to meet the Athabasca River (Google Earth, 2012)**

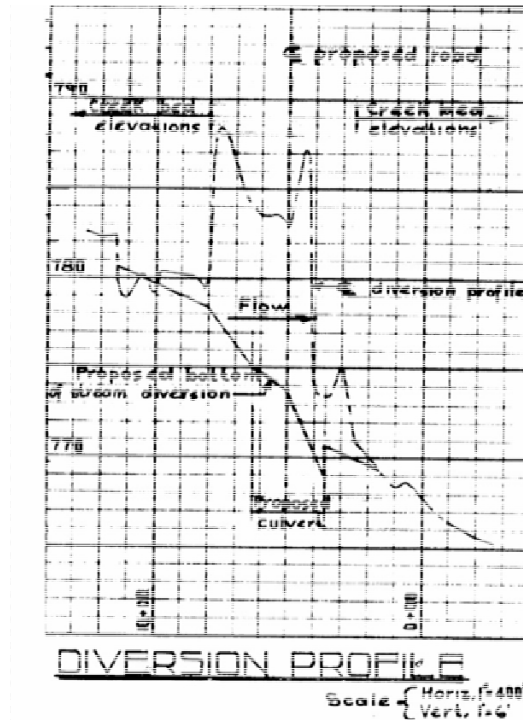
Stream Diversion Profile (extracted from DD385, 1963)

- 1963 – 2 -3670mm culverts installed on stream diversion (Figure below)
- 1990 – Highwater event. Hanging outlets (~1.5m above streambed)
- 2001 – Cut off wall installed beneath hanging outlets.
- 2010 – Structure condition warrants replacement

- from the 2012 survey, it is evident that degradation has occurred in the past and that the existing culvert structures are acting as controls to prevent degradation progression upstream. The stream has approximately the same slope upstream and downstream, with an elevation difference of about 2m.

- since the structure condition warrants replacement, remediation was not considered. In the past, a cutoff wall was installed to support the culvert structures and riprap was placed in the scour hole to dissipate outlet velocities and prevent structure undermining.

- two options were considered during replacement 1) setting the invert downstream and matching the downstream channel slope (upstream invert below streambed); allowing degradation to progress upstream and 2) setting the invert downstream and upstream to the existing streambed elevations (slope steeper than natural stream), preventing degradation progression

Option 2 was recommended as the replacement structure.

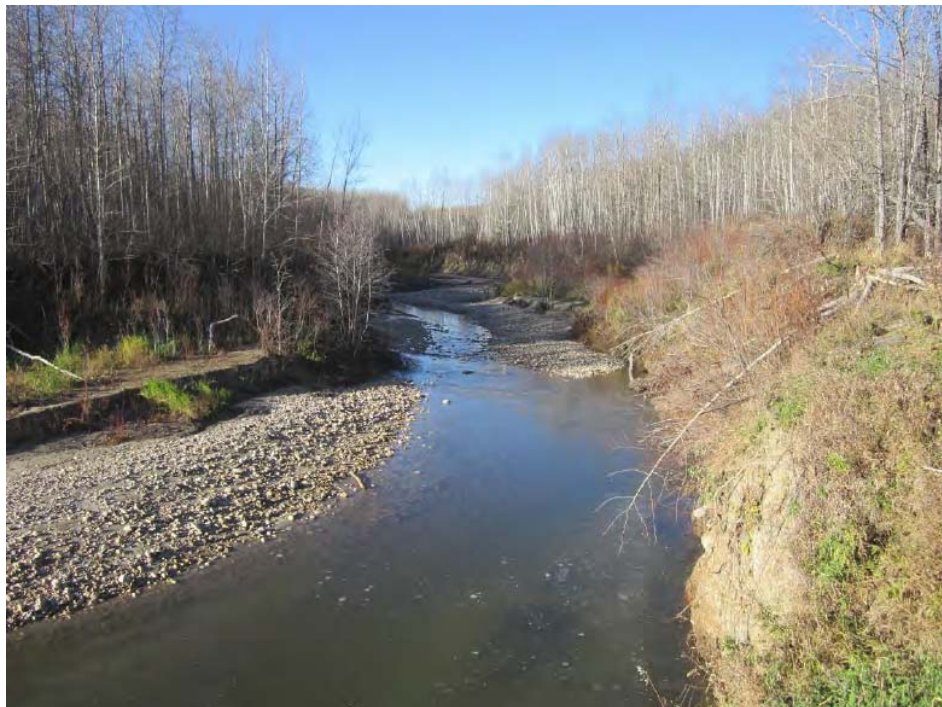
Looking at Upstream Channel from Upstream of the Drift Catcher

- from site photos, a large scour hole downstream of the outlet can be seen. This local scour hole is also seen on the survey. Site photos also show slumping, vertical banks in the downstream channel which could be indicative of degradation (if occurring along an entire section) and/or lateral stream instability (if occurring locally; outside of meander bends).
