Alberta Transportation
Central Region
#401, 4902 – 51 Street
Red Deer, Alberta
T4N 6K8

Central Region Landslide Assessment Site C18
SH837:02 Riverbank Slide @ km 1.9
July 2001 Inspection Report & Repair Recommendations - DRAFT

This report was prepared by Klohn Crippen Consultants Ltd. for Alberta Transportation Central Region under Contract No. CE053/2000.

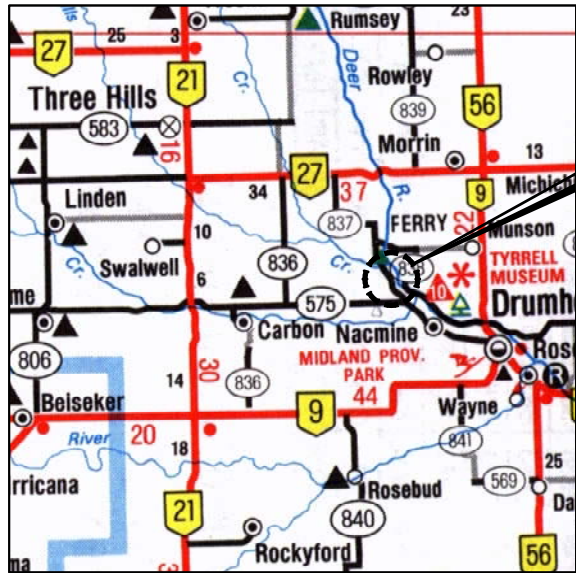
The slide area appears to be extending both upstream and downstream. Beyond the slide itself, cracks are appearing at the crest of the riverbank. The location of the cracks would tend to suggest that the near vertical banks located immediately to the north and south are becoming unstable. The overall extent of the unstable riverbank measures approximately 40 m.

DISPLACED SOIL
FAN IN RIVER
