June 11, 2002

Alberta Transportation
Central Region
#401, 4902 – 51 Street
Red Deer, Alberta
T4N 6K8

**Central Region Landslide Assessment Site C18
SH837:02 River Scour @ km 1.9
2002 Annual Inspection Report**

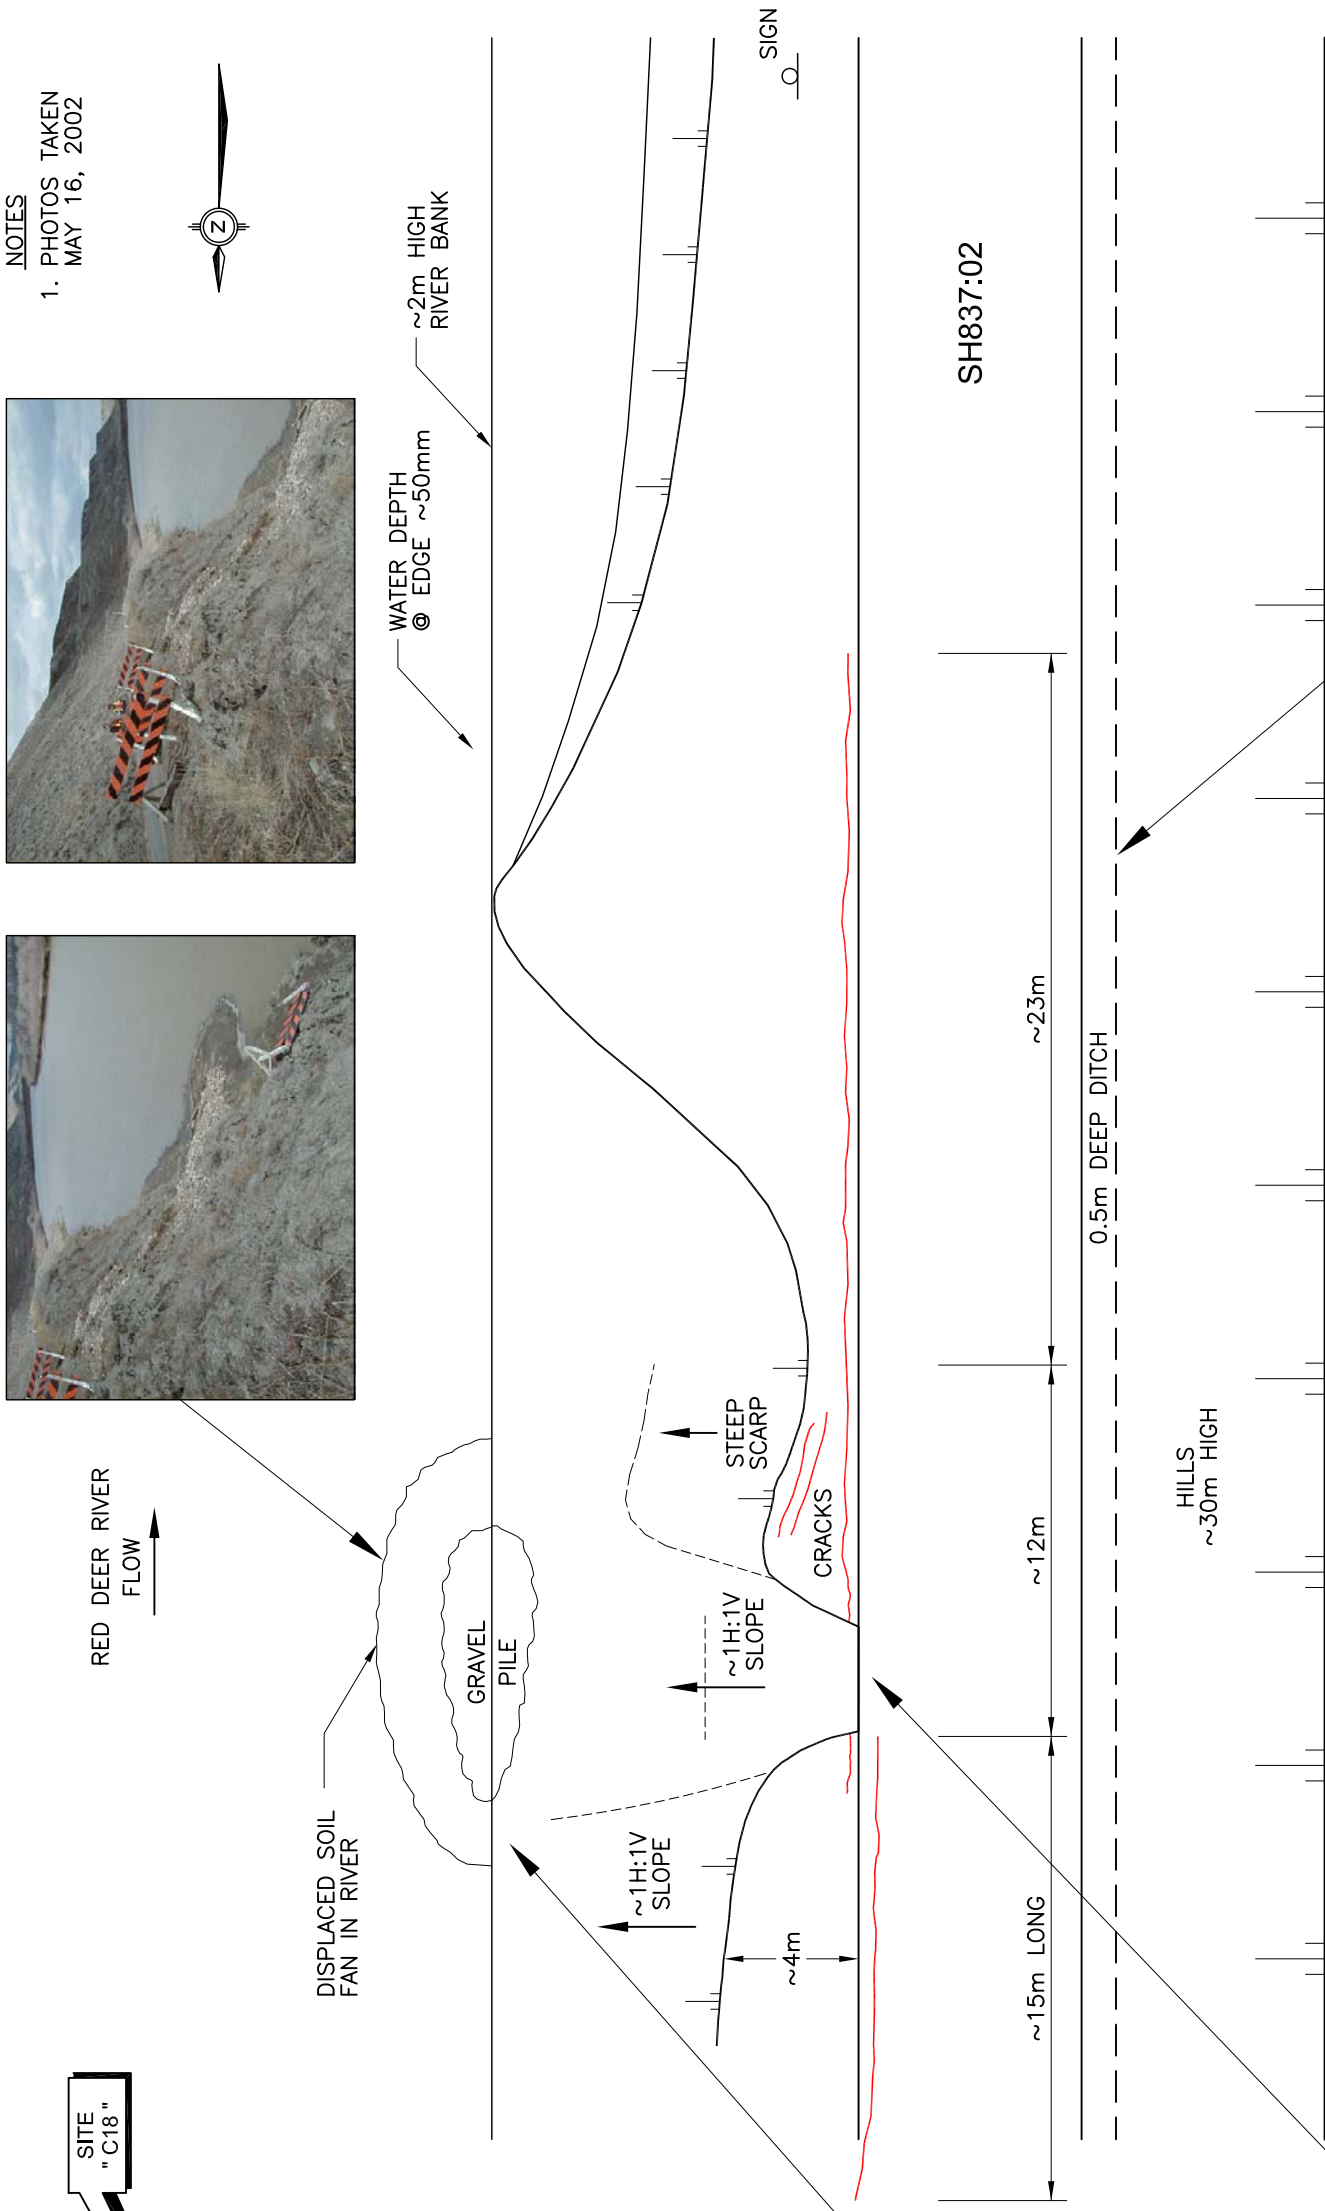
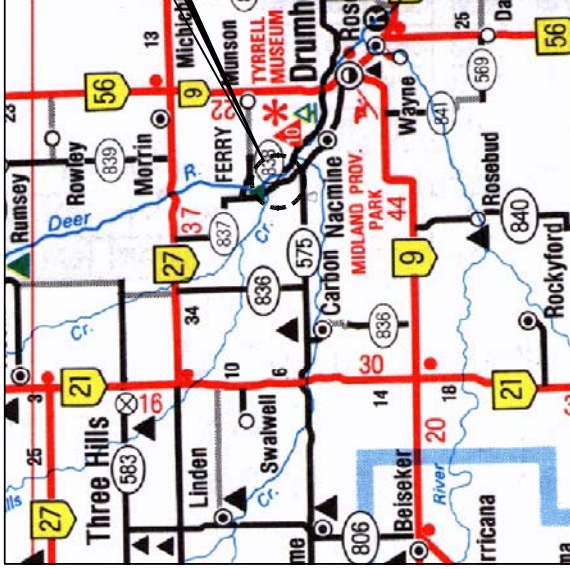
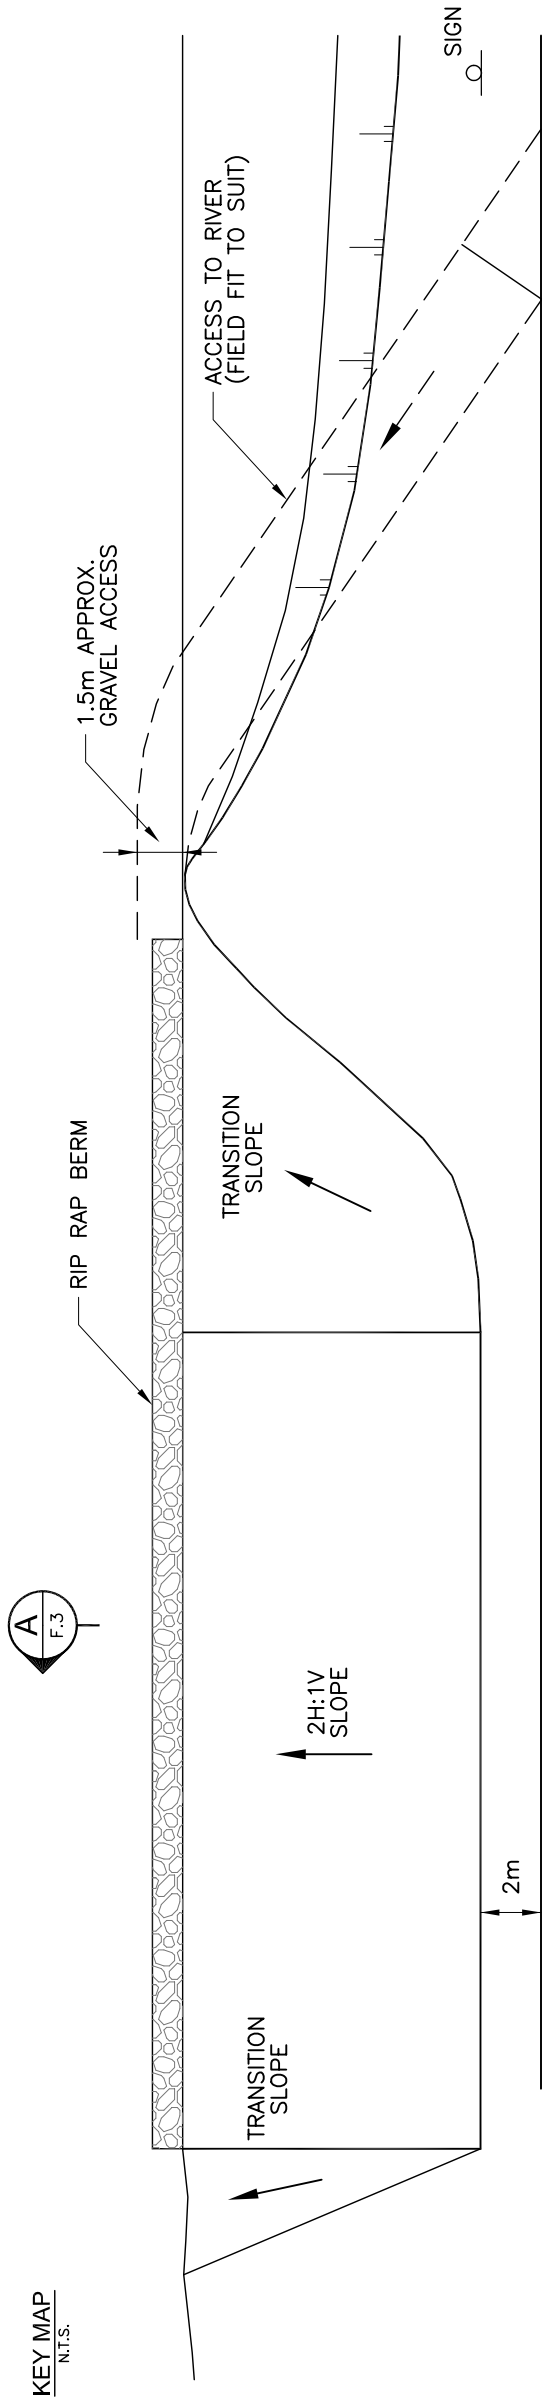
The current features of the site are illustrated in Figure 1 and in the attached photographs.

The slide is essentially unchanged from the previous visit on October 3, 2001, however additional minor cracks are forming at the crest of the riverbank and in the highway surface. The location of the cracks would tend to suggest that the near vertical bank that is located immediately to the north is becoming unstable.

The slide area appears to be extending both upstream and downstream. Beyond the slide itself, cracks are appearing at the crest of the riverbank. The location of the cracks would tend to suggest that the near vertical banks located immediately to the north and south are becoming unstable. The overall extent of the unstable riverbank measures approximately 40 m.
