February 18, 2003

File: 15-76-11

**NORTH CENTRAL REGION LANDSLIDE ASSESSMENT
HWY 43:16 WHITECOURT EAST HILL (NC1)
2002 ANNUAL INSPECTION REPORT**

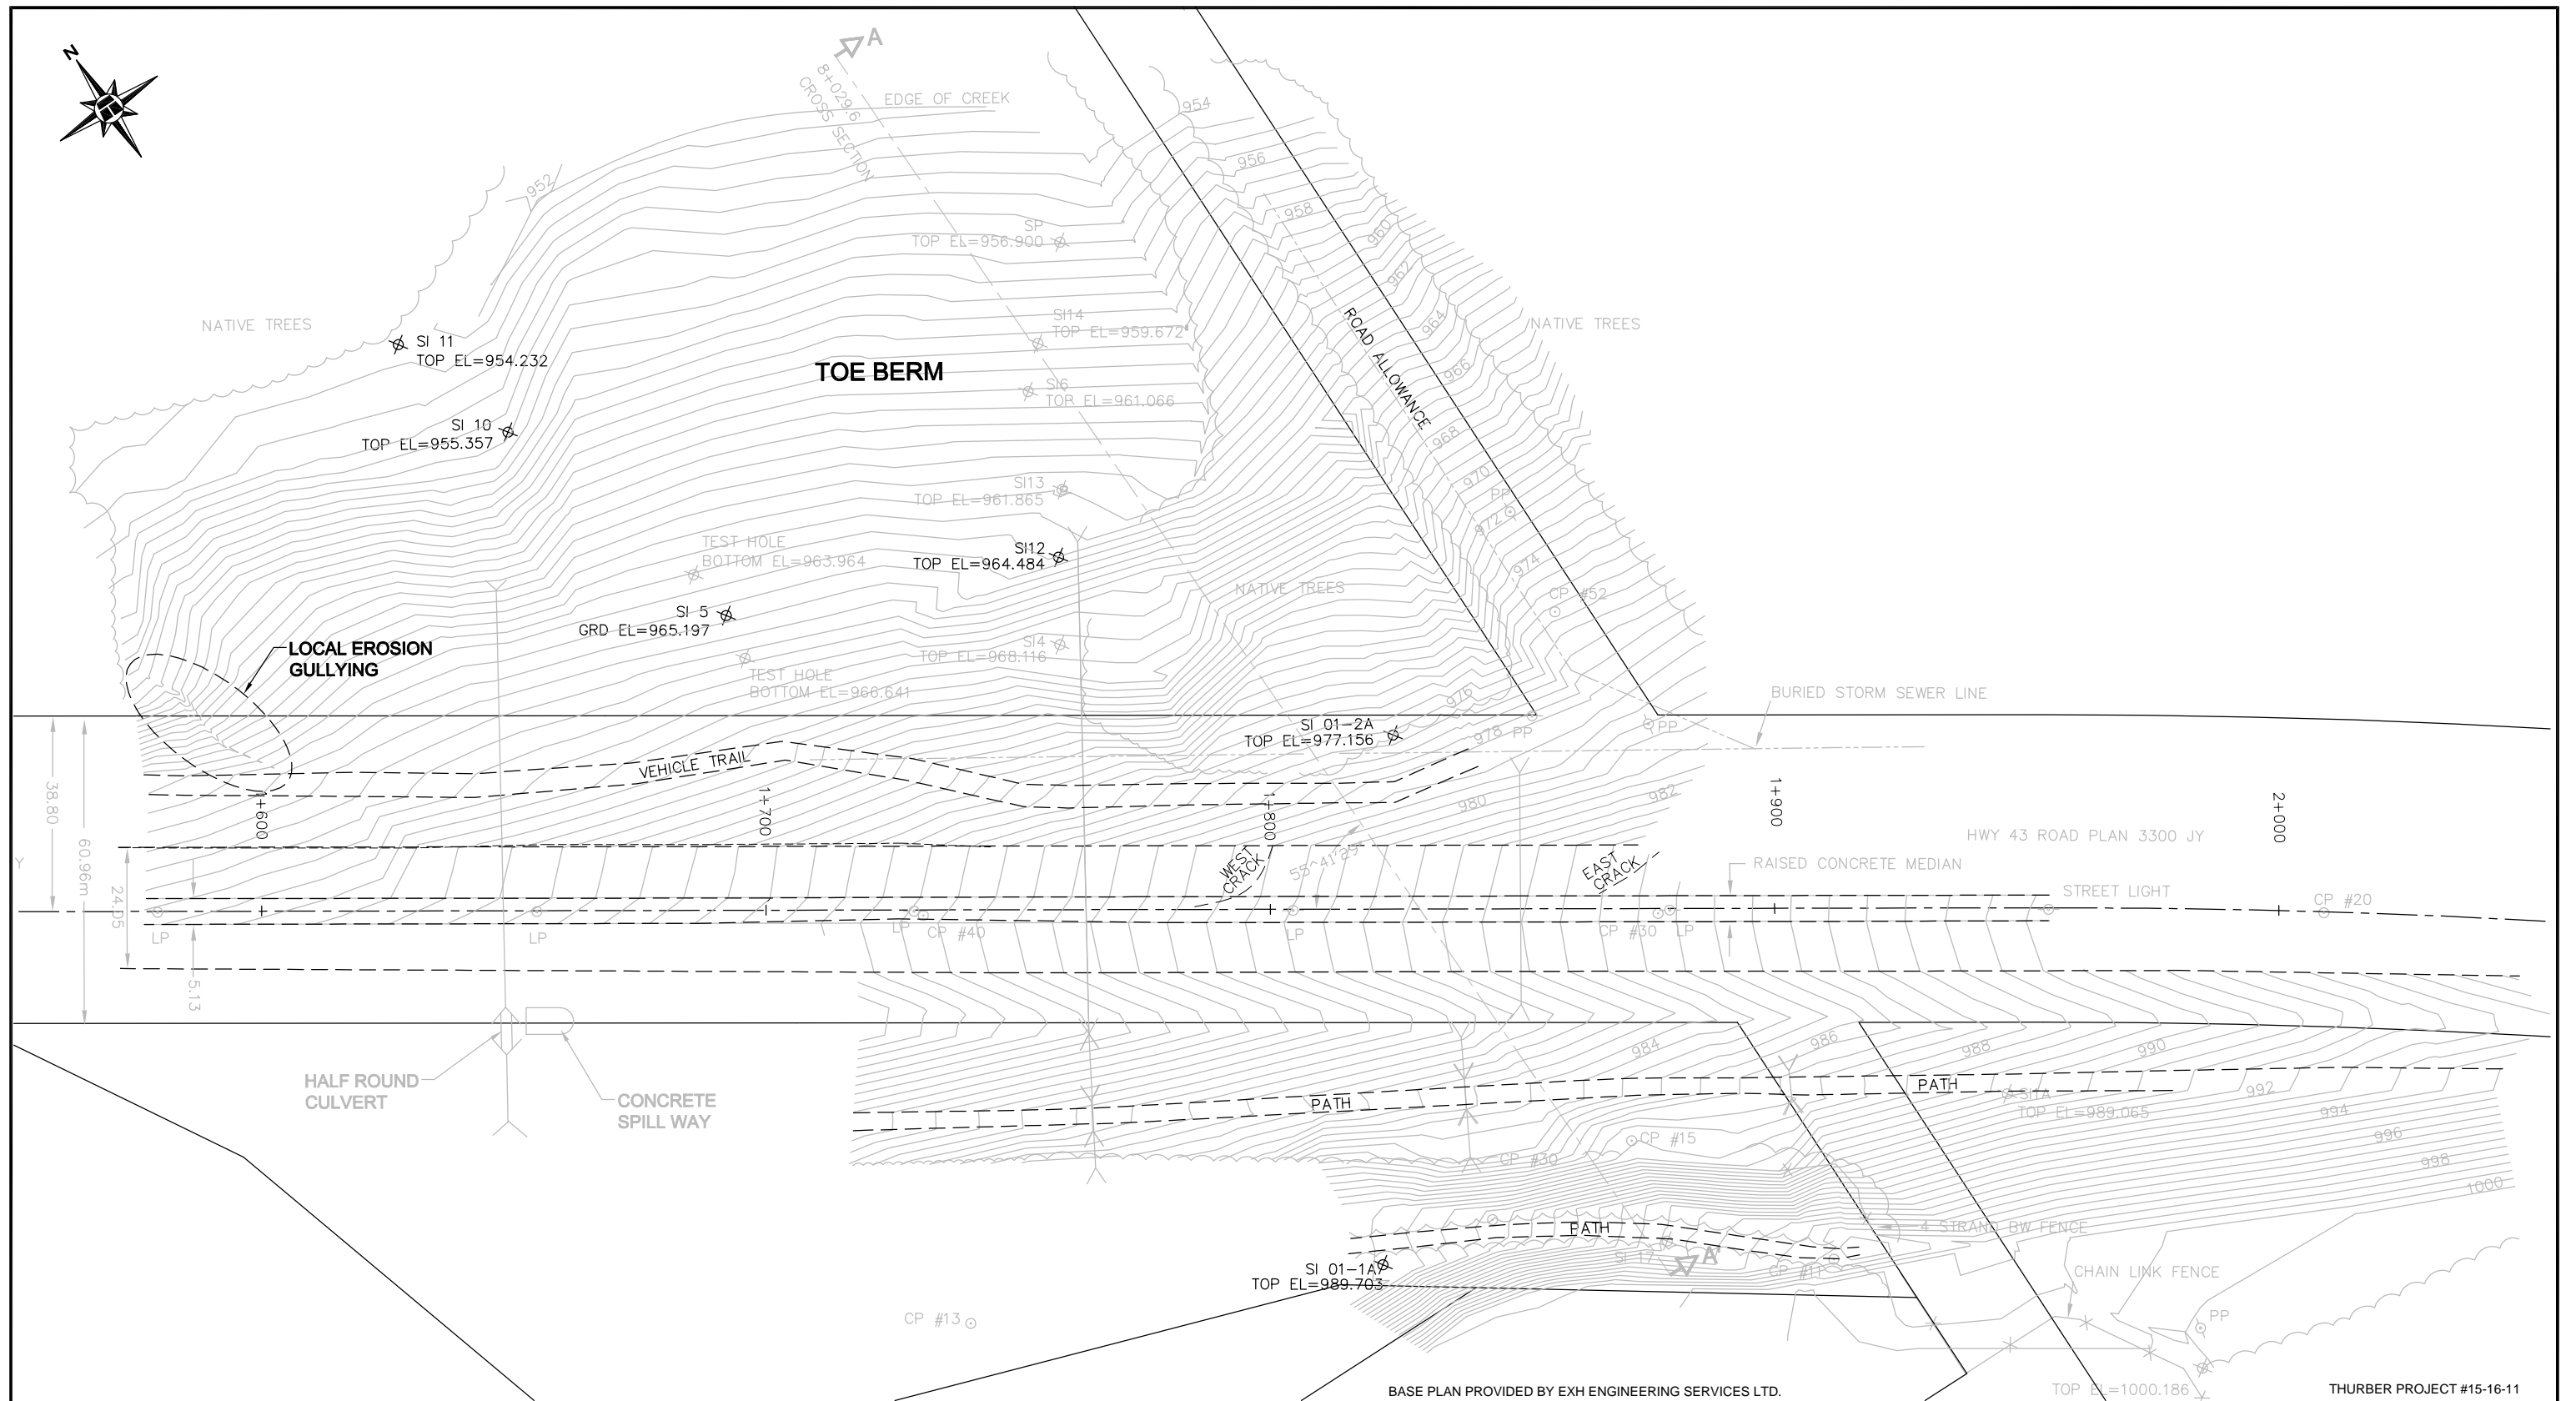
**CRACK PATTERN IN PAVEMENT
STATIONS 1+780 TO 1+880**

The ongoing development of the roadway surface cracking in the vicinity of Station 1+800 to 1+900 appears to have accelerated somewhat since that observed between the 2000 and 2001 site visits, however differential movement across the crack has not increased. In addition, slope movement rates measured in the inclinometers in the area have reduced since the last site reconnaissance. The crack development is not affecting the trafficability of the roadway surface at the present time. Ongoing movements in this area may however be expected, and may coincide with heavy or prolonged precipitation events. Continued visual monitoring of this area is recommended.

- ① 3-5mm DIFFERENTIAL DOWN TO THE NORTH (SAME AS NOTED IN 2001)
- ⊕ SLOPE INCLINOMETER
- NEW CRACKS IN 2002

A separate study is currently underway to assess potential remedial measures should the slope movements in the vicinity of Station 1+800 to 1+900 develop such that they impact the roadway surface. Field work including test holes and standpipe piezometers is recommended to determine the soil and groundwater conditions in the vicinity of the slide, which will allow for design of potential dewatering measures if appropriate. Additional slope inclinometers are also recommended to better delineate the slide zone.
