January 29, 2003

File: 15-76-11

**NORTH CENTRAL REGION LANDSLIDE ASSESSMENT  
SH 748:02 NORTH OF EDSON RIVER BRIDGE (NC15)  
2002 ANNUAL INSPECTION REPORT**

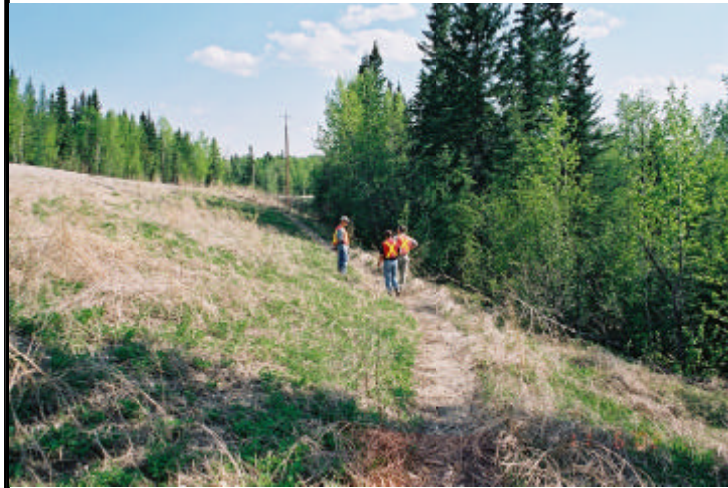
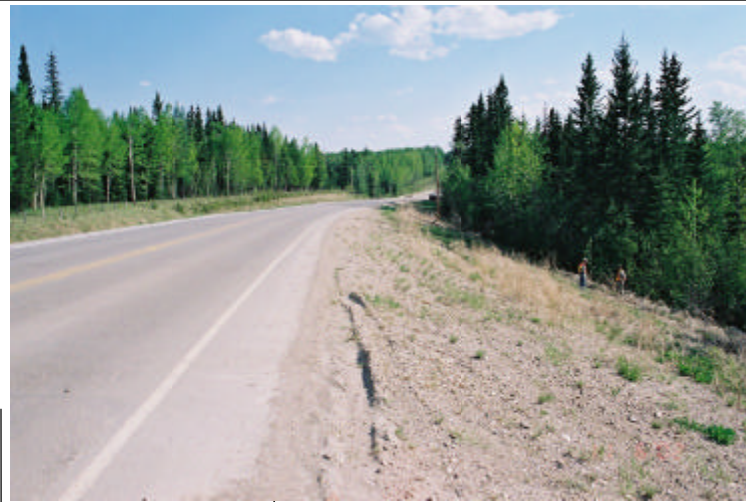
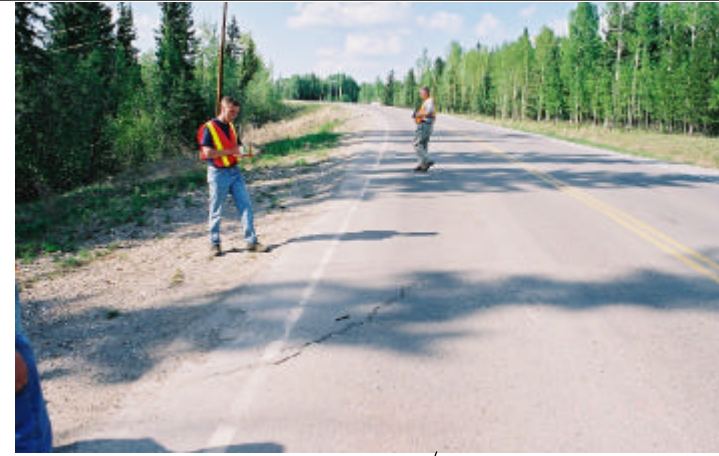
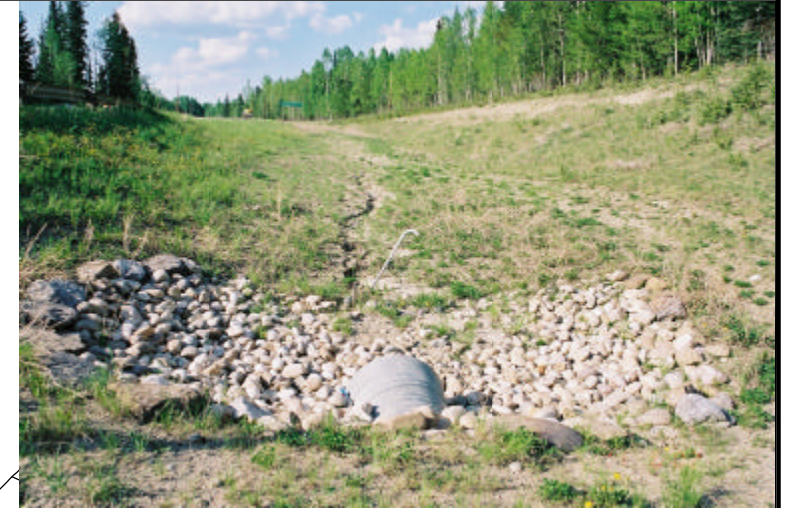
- An arc shaped crack approximately 2 metres long was noted in the roadway surface, located about 40 metres south of the retaining wall area approximately as shown on the site plan. There was no differential height across the crack at the time of the site reconnaissance.
- Slope movement was observed in the side slope at this location. A 15 m to 20 m long scarp feature was noted close to the river, splitting a tree. Photos of the pavement crack and scarp are provided in Section F.

The newly noted scarp located near the riverbank south of the repaired area is indicative of a slope failure, likely triggered by river erosion. The crack in the pavement surface indicates that a regressive failure may be occurring. As the toe of the slope moves toward the river it is likely allowing the block of soil behind it to move. It appears that this regressive slide behaviour has now impacted the roadway at the new location. This failure mechanism is likely similar to that of the original failure that has been repaired.

Continued visual monitoring of the area south of the repair should be undertaken. If further crack development occurs, consideration should be given to installation of slope monitoring instrumentation (inclinometers and piezometers) to gather geotechnical data to allow for design of remedial measures.
