**NORTH CENTRAL REGION LANDSLIDE ASSESSMENT  
H39:06 – SLIDE NEAR GREENWOOD LAKE ROAD (NC23)  
2002 ANNUAL INSPECTION REPORT**

This letter documents the 2002 annual site inspection of a portion of Highway 39:02 located at km 12.6. The work was undertaken by Thurber Engineering Ltd. (Thurber) in partial fulfillment of our Geotechnical Services, Monitoring and Assessment of Instrumentation and Landslides contract with Alberta Transportation (AT).

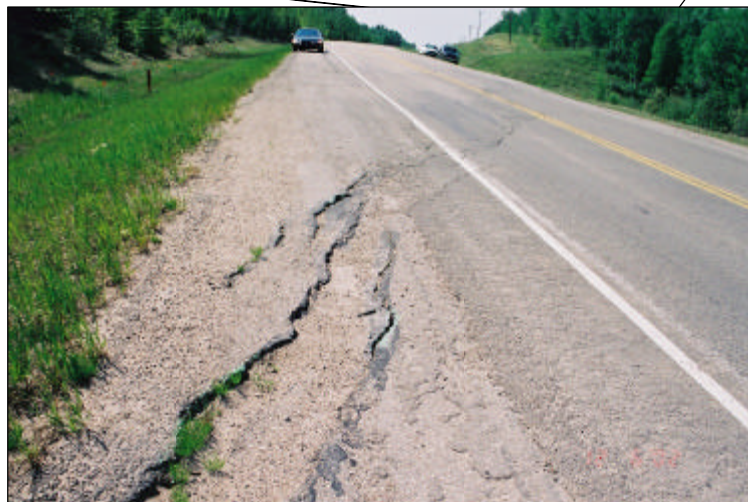
DRAWING No.  
FIGURE NC23-1 (2002)

- Tension cracking within the pavement surface was noted in three locations along the highway, located as shown on the site plan between the west culvert and the center (abandoned) culvert. The two easternmost cracks were present during the first site visit in 2001 and have some sections with crack widths of up to 25 mm and differential heights of up to 20 mm. The western most crack was new (i.e. not observed in 2001) and had no significant differential height across it.

- No signs of slope movement were observed on the back slope (south of the highway). A low area fed by an intermittent creek located south of the abandoned culvert inlet was filled with water at the time of the site reconnaissance. Drainage via the east ditch from the culvert inlet area is not effective at removing the water from this area. A sink hole exists above the abandoned culvert adjacent to the south pavement edge, with a diameter of about 0.6 m and a depth of approximately 0.4 m.

- No signs of slope instability were observed along the side slope north of the highway. An old scour feature was observed in the treed area north of the abandoned culvert outlet, resulting from previous water flow through the culvert.

Design work and tender preparation has been completed for this site, which includes regrading of the ponded water area south of the abandoned culvert, installation of a new culvert adjacent to the abandoned culvert, and installation of horizontal wells into the bedrock to relieve pore water pressures on the failure plane. Construction is recommended in 2003 to reduce further movements.
